**Type B - Risk Assessment Report
Private Water Supplies (Scotland) Regulations 2006**

RA / Supply Number:	RA/13/0108 Supply 50171	Date(s) of Assessment:	07/06/2023
Name of Supply:	The Old School	Description:	Domestic
Officer:	Stuart Aiken

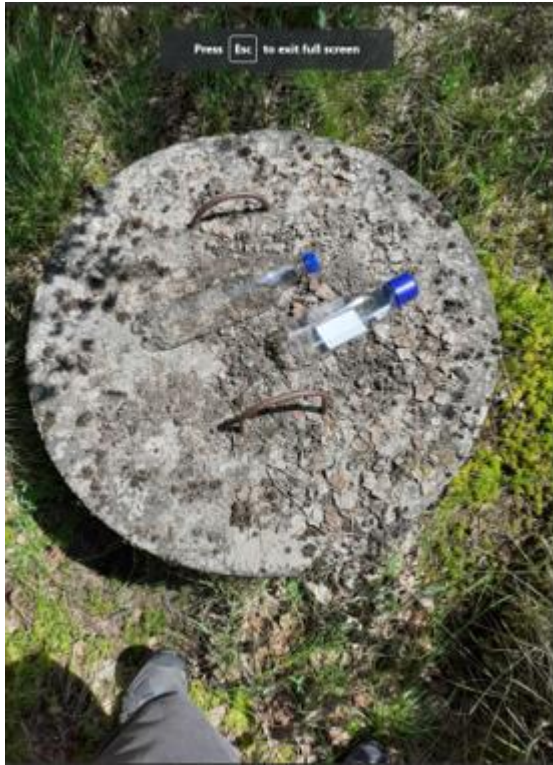
Details of supply system and associated water treatment (include sketch plan in Additional Notes section)	
Source	
Detail:	Spring feeds concrete ring with concrete lid.
Location Description:	Approx. 300m W of properties near pond
National Grid Reference:	329787 801189
Intermediate Storage Tank	
Detail:	Concrete ring acts as sand trap
Location Description:	A few metres from source.
National Grid Reference:	As above
Communal Treatment Type and its location	
Detail:	None.
Distribution Pipework Material	
Detail:	Alkathene.

Item	Issue	Works Required	Reason
1	There is no bacteriological treatment system on the supply.	Thoroughly cleanse and sterilise the supply system and install a point of entry UV treatment unit with appropriate prefilters (or other suitable treatment system as agreed in writing with the Environmental Health Section). If a UV is to be fitted then the maximum flow rate and bulb output should be set so that the water supply is exposed to a continuous UV dose of 40 mJ cm ⁻² .	To provide a wholesome water supply to your property.
2	The concrete chambers should be further protected from contamination.	a) Raise height of chamber to 150mm above ground level. b) Provide vermin proof, water tight and lockable lid.	To provide the most suitable conditions for the provision of a wholesome water supply at its source.
3	Ph is acidic.	Install ph treatment.	To minimise corrosion of metal surfaces in contact with supply.
