Address: Barn at Haywood Farm
Haywood Lane
Cheswardine
Market Drayton
TF9 2LW

Client: KKIP Farms

Inspection Date: 11th September 2023

1. EXECUTIVE SUMMARY

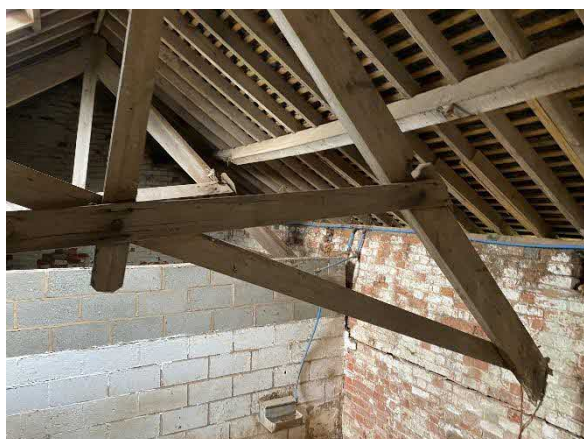
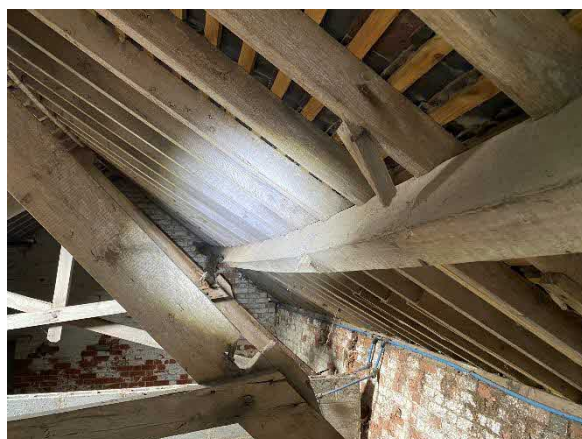
Timber decay to the feet of 2 no. scissor trusses, located to the centre of the building, has resulted in them becoming partially detached. This has further resulted in localised deflection of timber roof members and a degree of roof spread. The affected trusses will require repair or replacement to secure long term structural integrity.

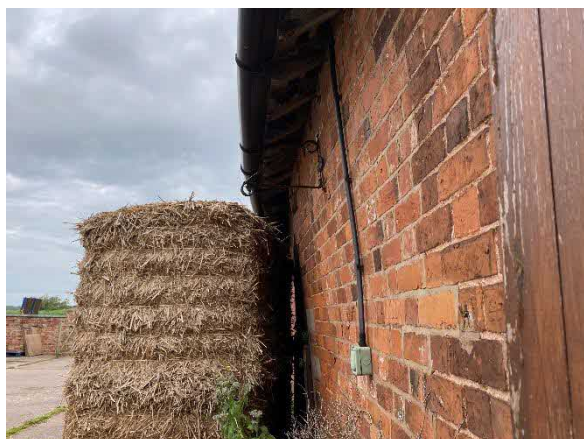
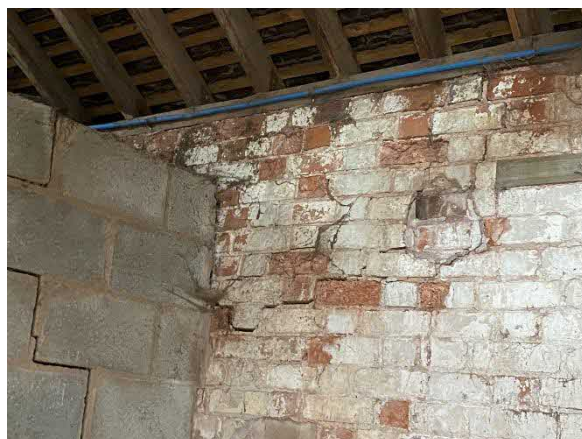
The exception to the above relates to the central section of the building, which as noted above, has suffered from a degree of roof spread resulting in localised cracking and movement of perimeter walls. Affected areas have suffered an outward rotation of high level masonry, which will require localised rebuilding to restore structural integrity.

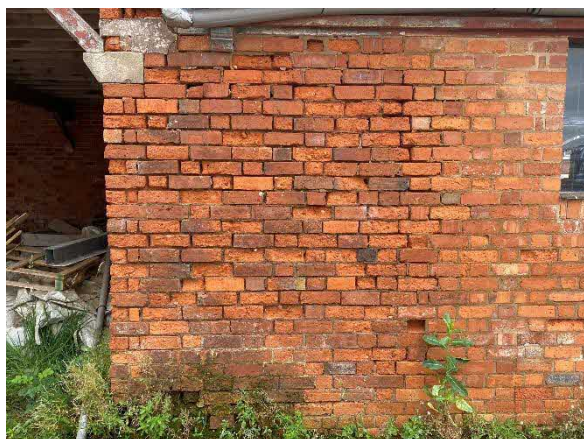
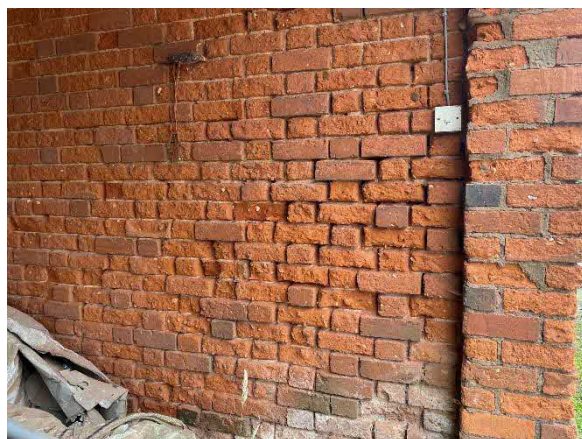
Localised areas of recessed pointing were identified throughout the building, which would benefit from re-pointing in a lime-based mortar. Additionally, spalling of brickwork was also noted in small areas. Isolated replacement of the most severely affected bricks would be considered beneficial.

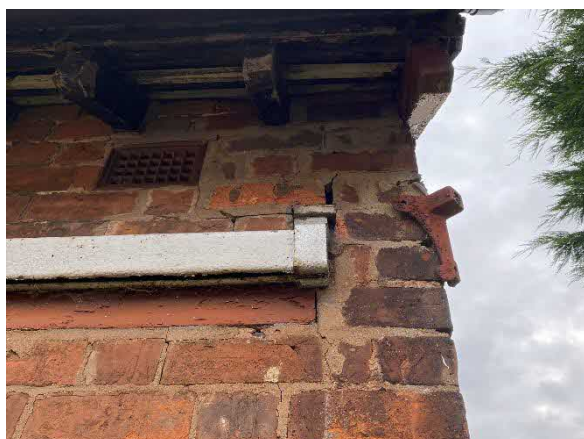
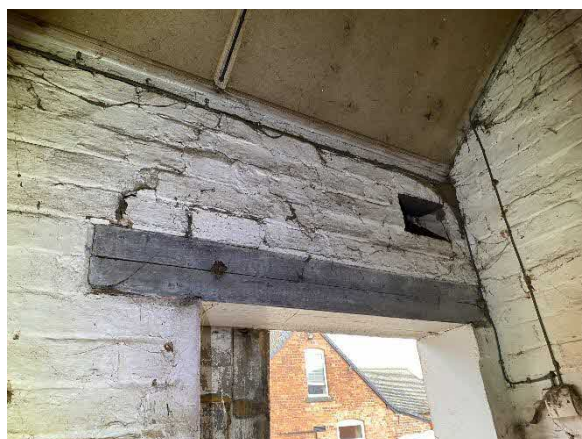
Openings throughout the building are provided with a combination of brick arch and timber lintels. Openings are generally in acceptable condition with only localised areas of minor cracking above. Where cracking is evident above openings minor repairs are required to ensure long term structural stability.

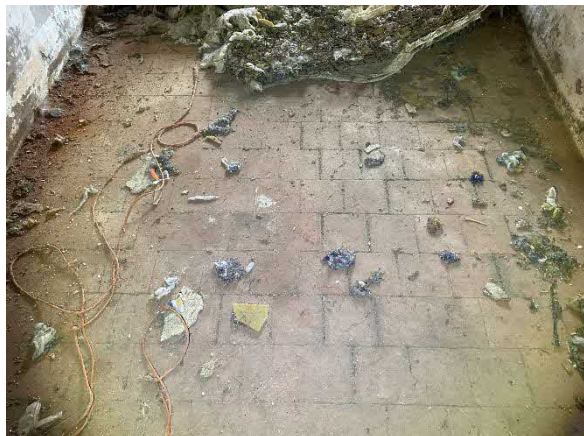
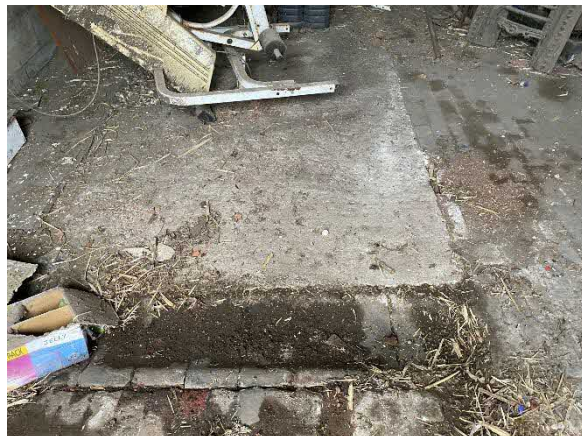
The ground floor comprises a combination of assumed ground bearing concrete, quarry tiles and brick flooring, likely laid directly over bare earth. Although generally

in fair condition, the existing floors will require replacement with a modern counterpart as part of any conversion works given their existing makeup and varying levels. Removal and replacement of the existing floor will not be detrimental to the overall structural integrity of the building.
