GEOSHIELD Verification Report

PROJECT REFERENCE: GEO102776

REPORT NUMBER: 015 REPORT DATE: 31/01/2023

PROJECT: Dalby Avenue

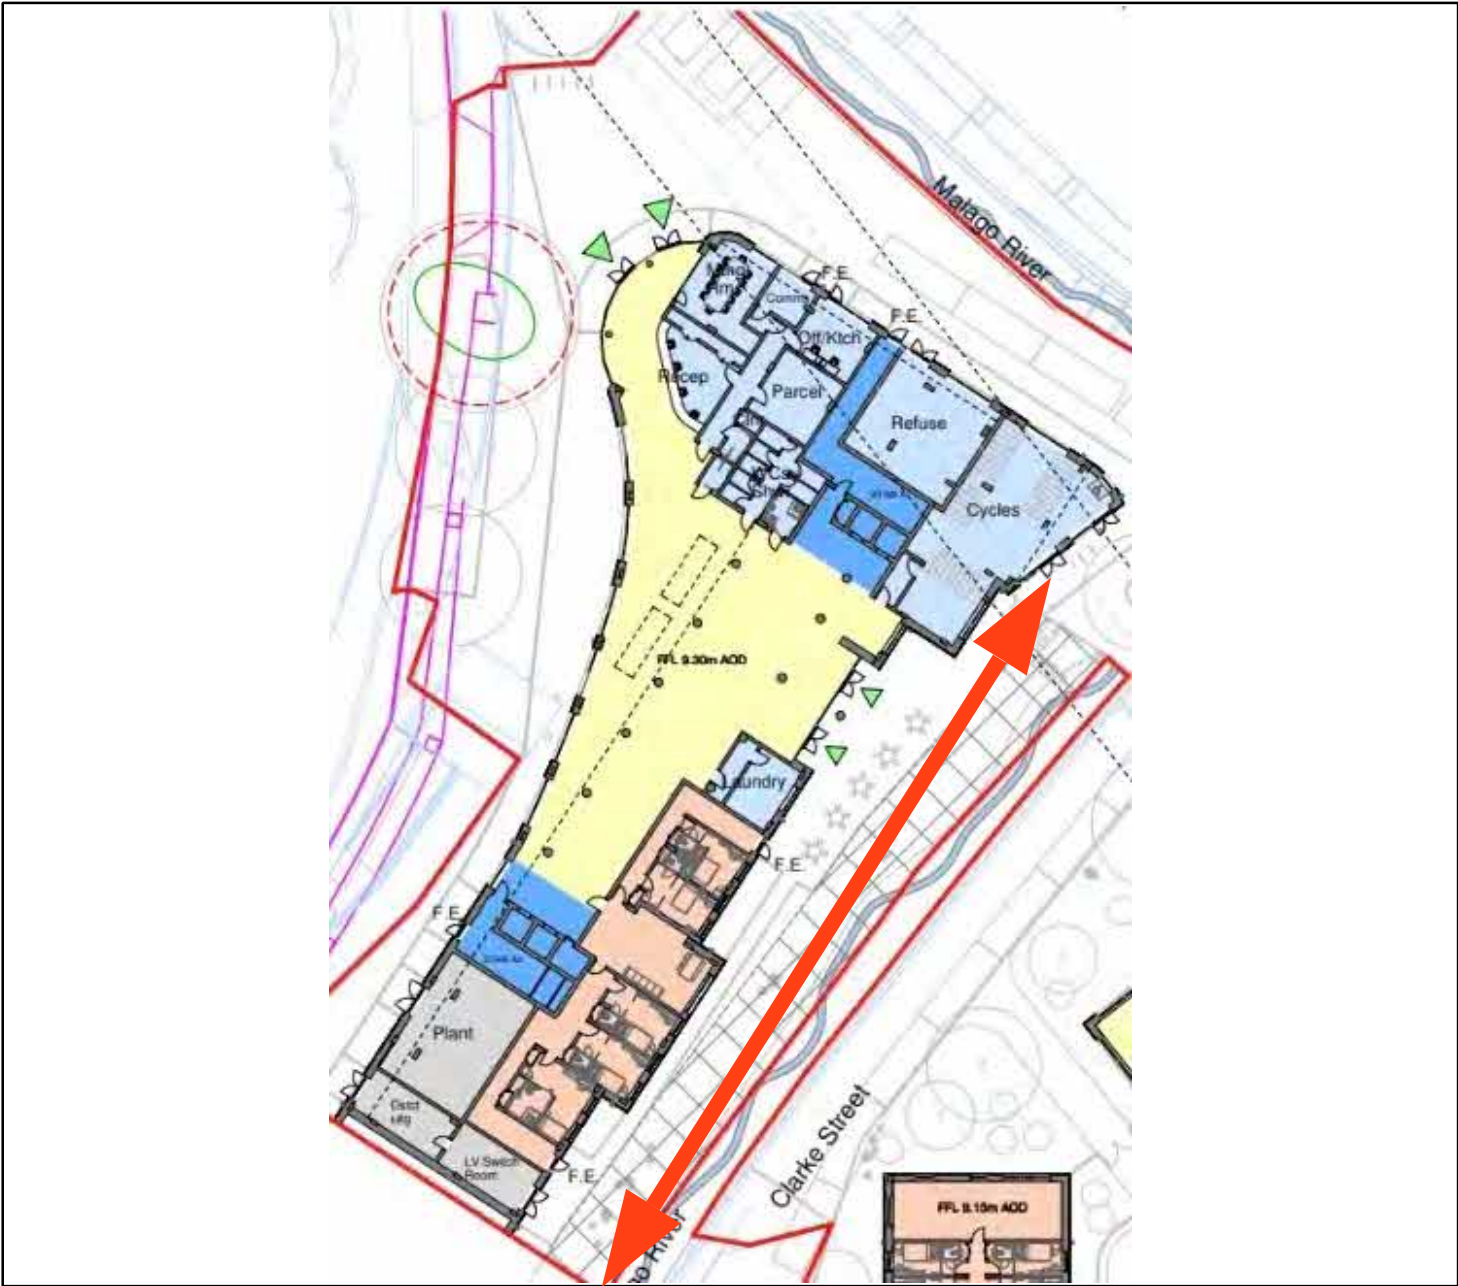
33% of the Block A perimeters highlighted in red above shows where verification

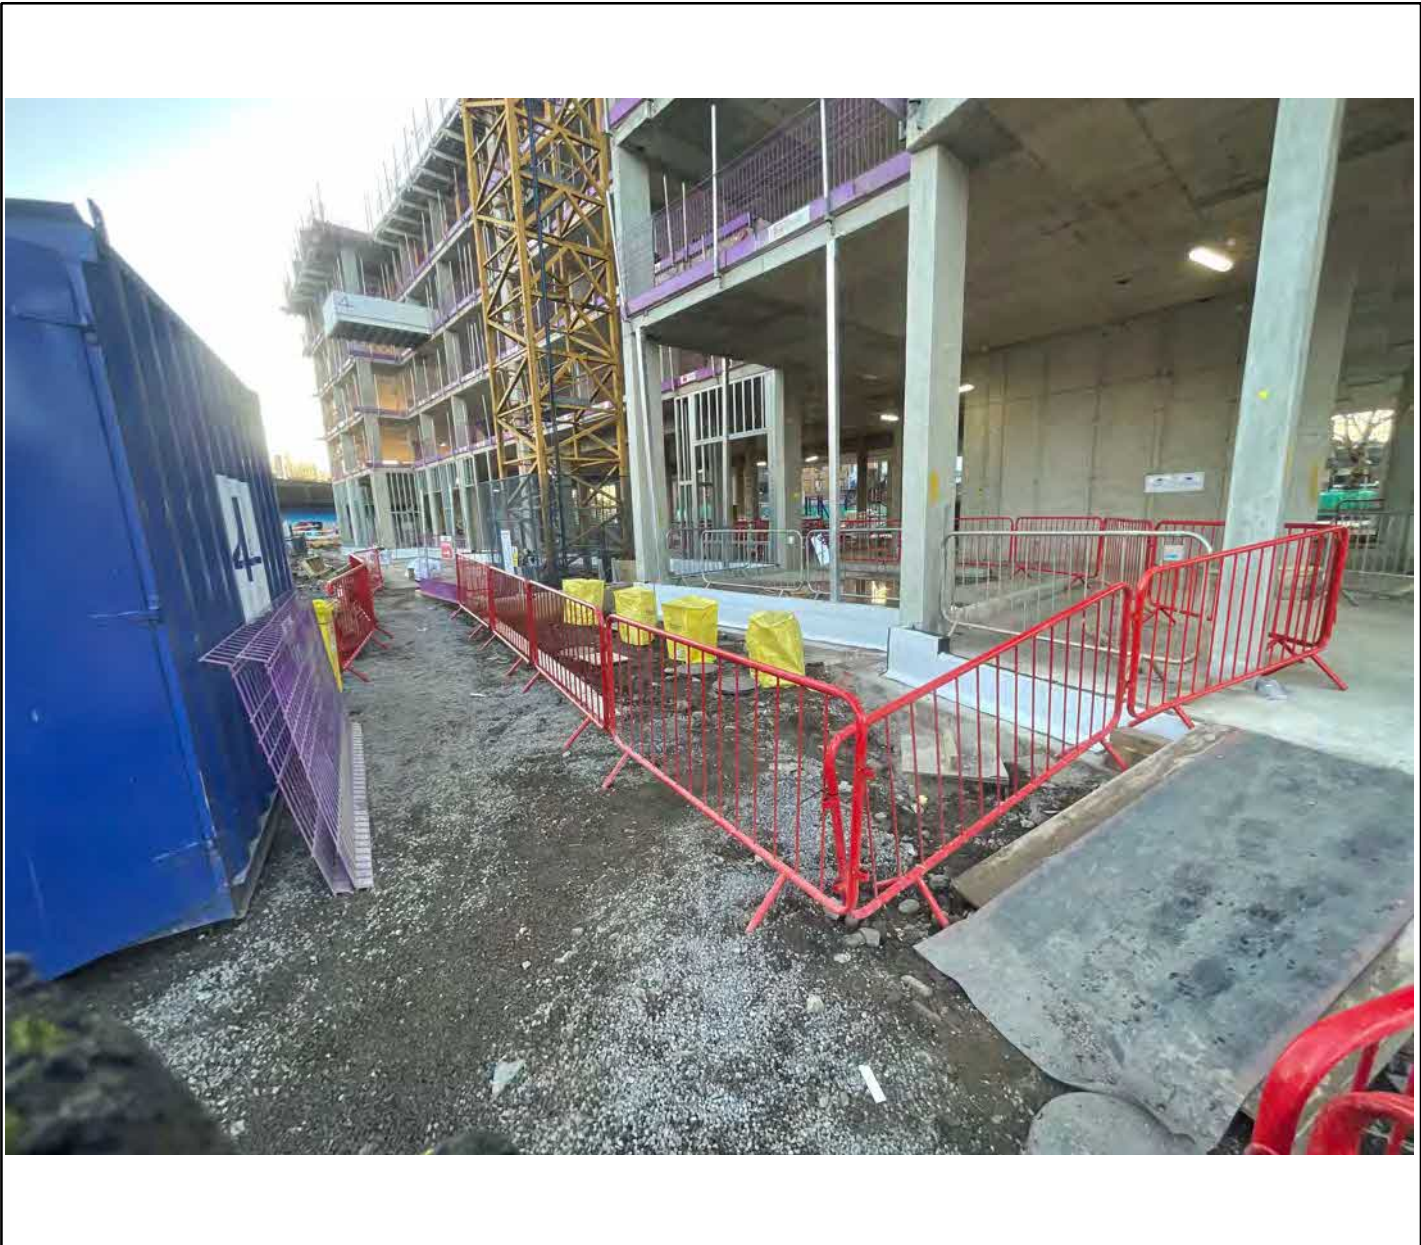
The photograph above shows an overview of the FIS Hydroprufe 8000 which

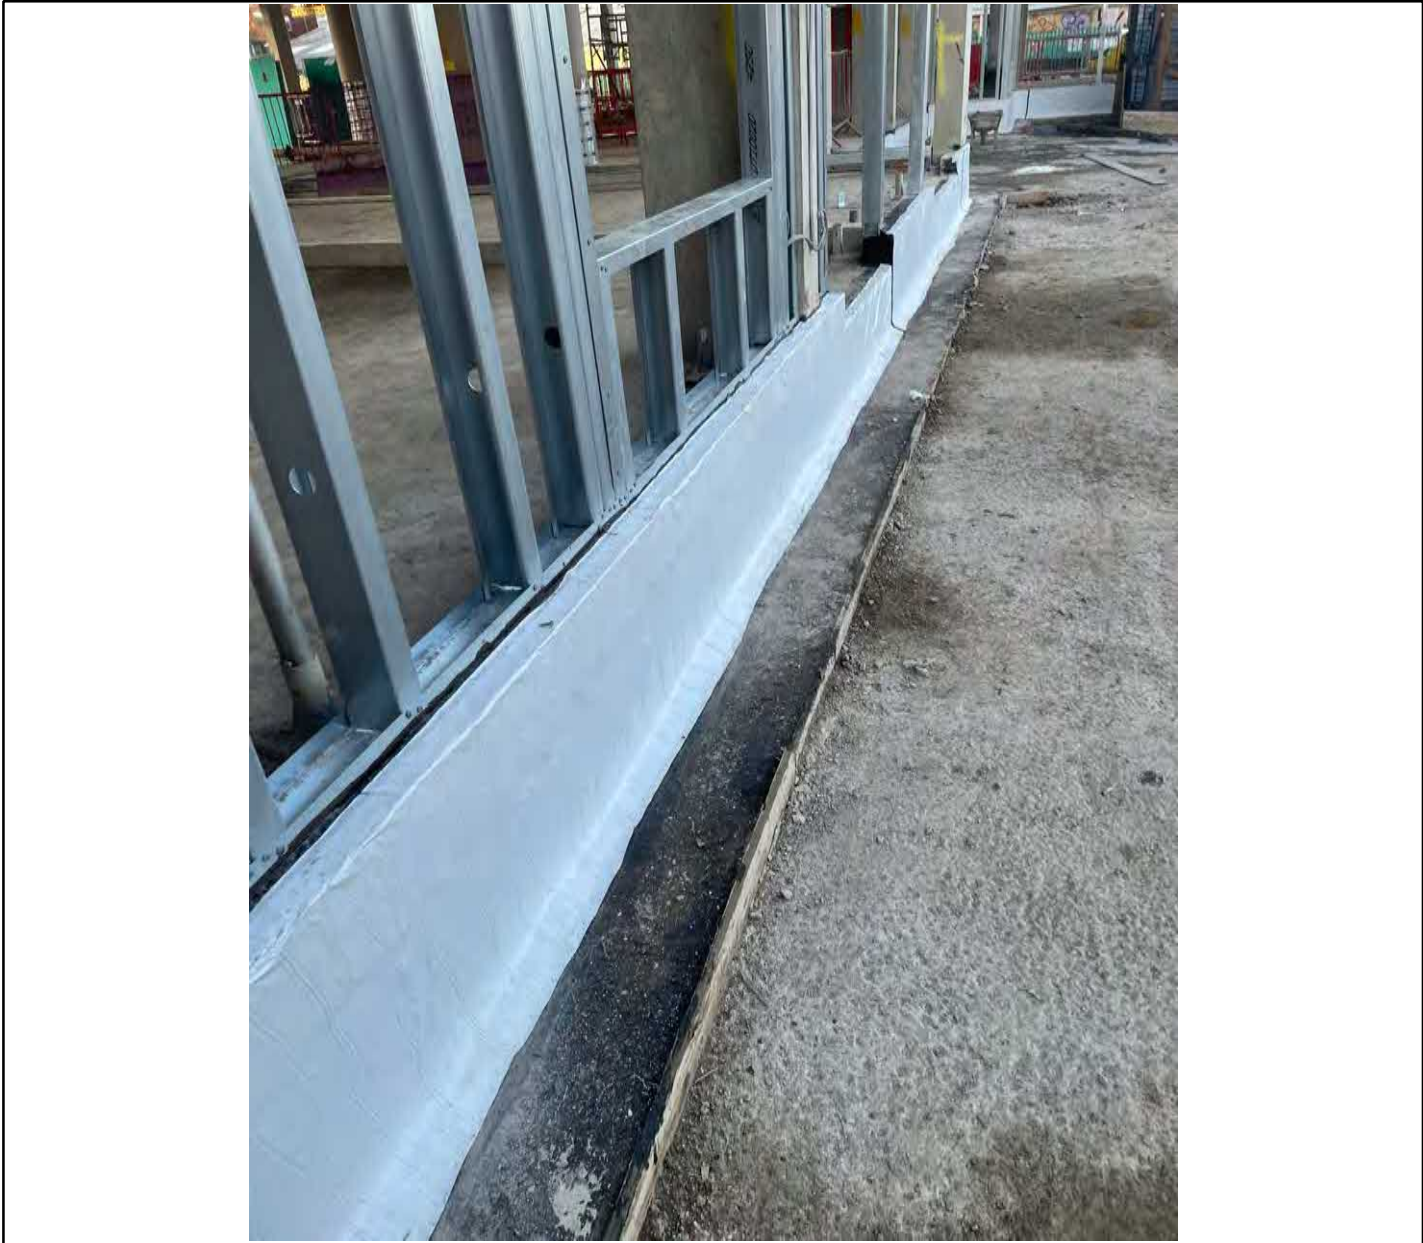
The photograph above shows an additional overview photograph of the Block

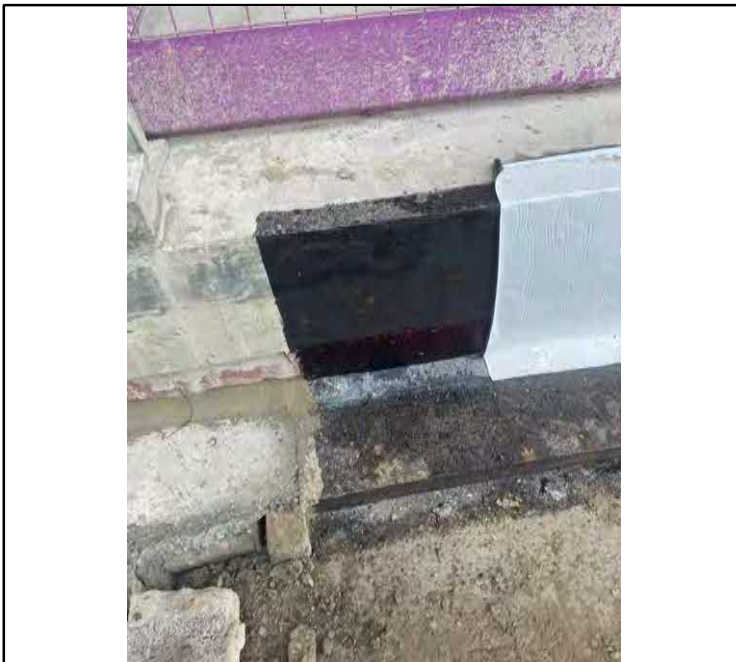
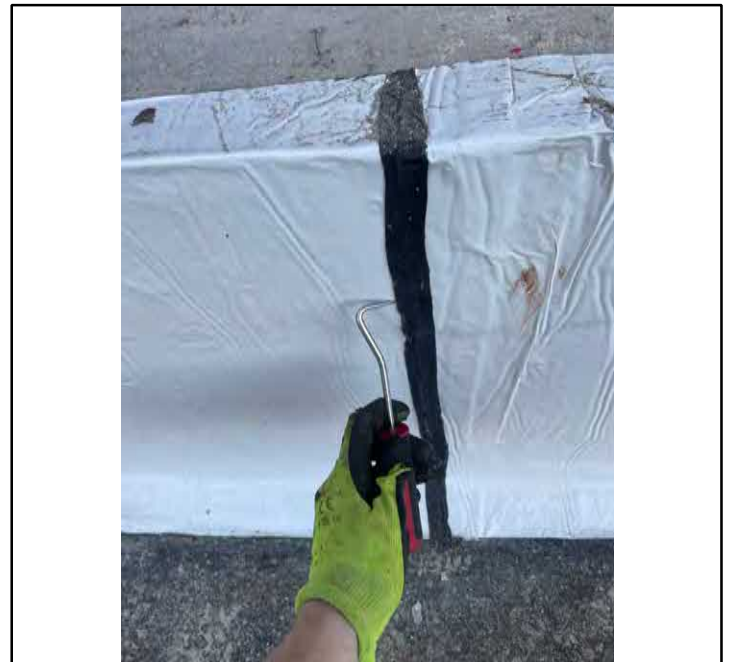
LOCATION/GRID LINE: Block A - Perimeters 33%.

The first photograph below shows the installers have first applied primer to the edge of the Block A slab and concrete up stands. The primer has the been allowed to dry before adhering the FIS Hydroprufe 8000.

The photograph above shows a pick and probe test carried out to a sealed lap of the FIS Hydroprufe 8000. Verified in accordance with CIRIA 735.

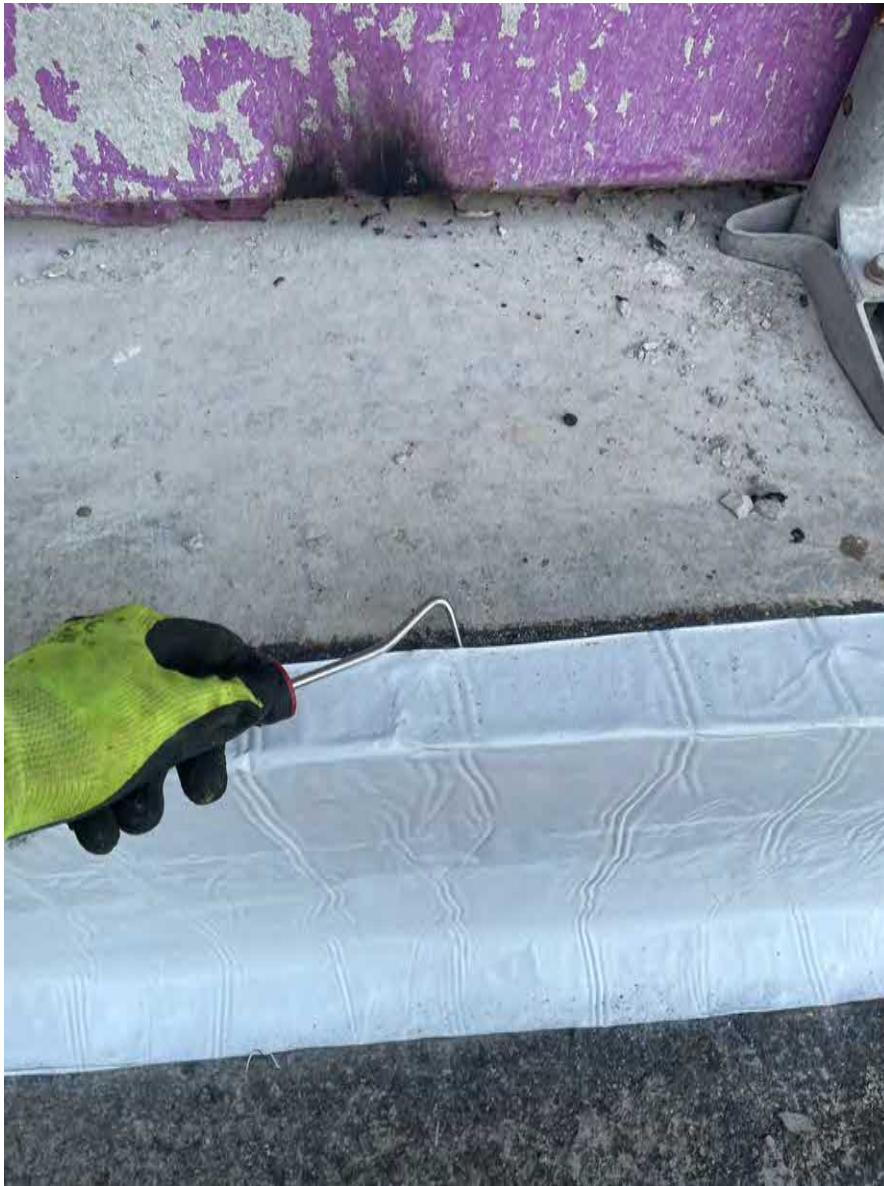
The photograph above shows a pick and probe test carried out to the seal achieved between the FIS Hydroprufe 8000 and the primed concrete slab. A gas blow torch has been used to aid in the adherence of the FIS Hydroprufe 8000. No faults or defects were identified during this visit. Verified in accordance with CIRIA 735.

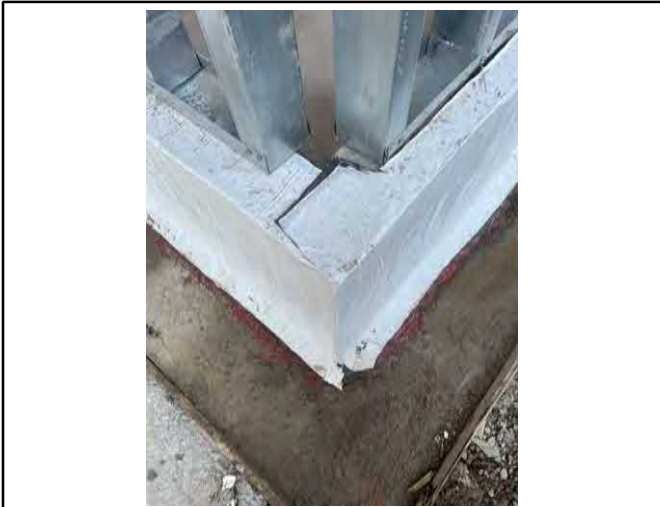
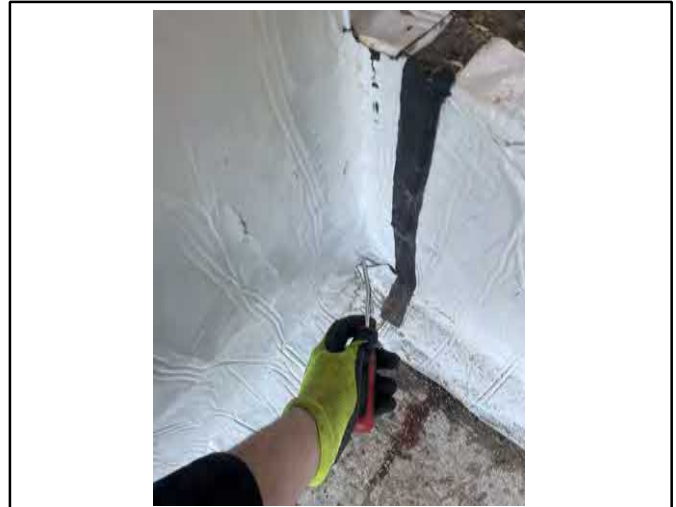
LOCATION/GRID LINE: Block A - Perimeters 33%.

The installers have first installed the FIS Hydroprufe 8000 self adhesive membrane tight to the corners to ensure the self adhesive is all in contact with the primed concrete.

A gas blow torch and pressure has been applied to aid in the adherence of the FIS Hydroprufe 8000 self adhesive membrane. The second photograph above shows a pick and probe test carried out to a sealed corner detail. The installers have achieved a strong seal.

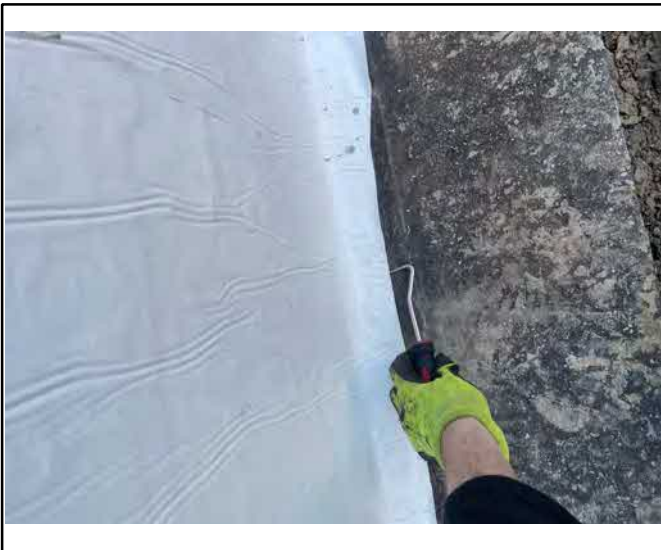
Pick and probe test carried out to the

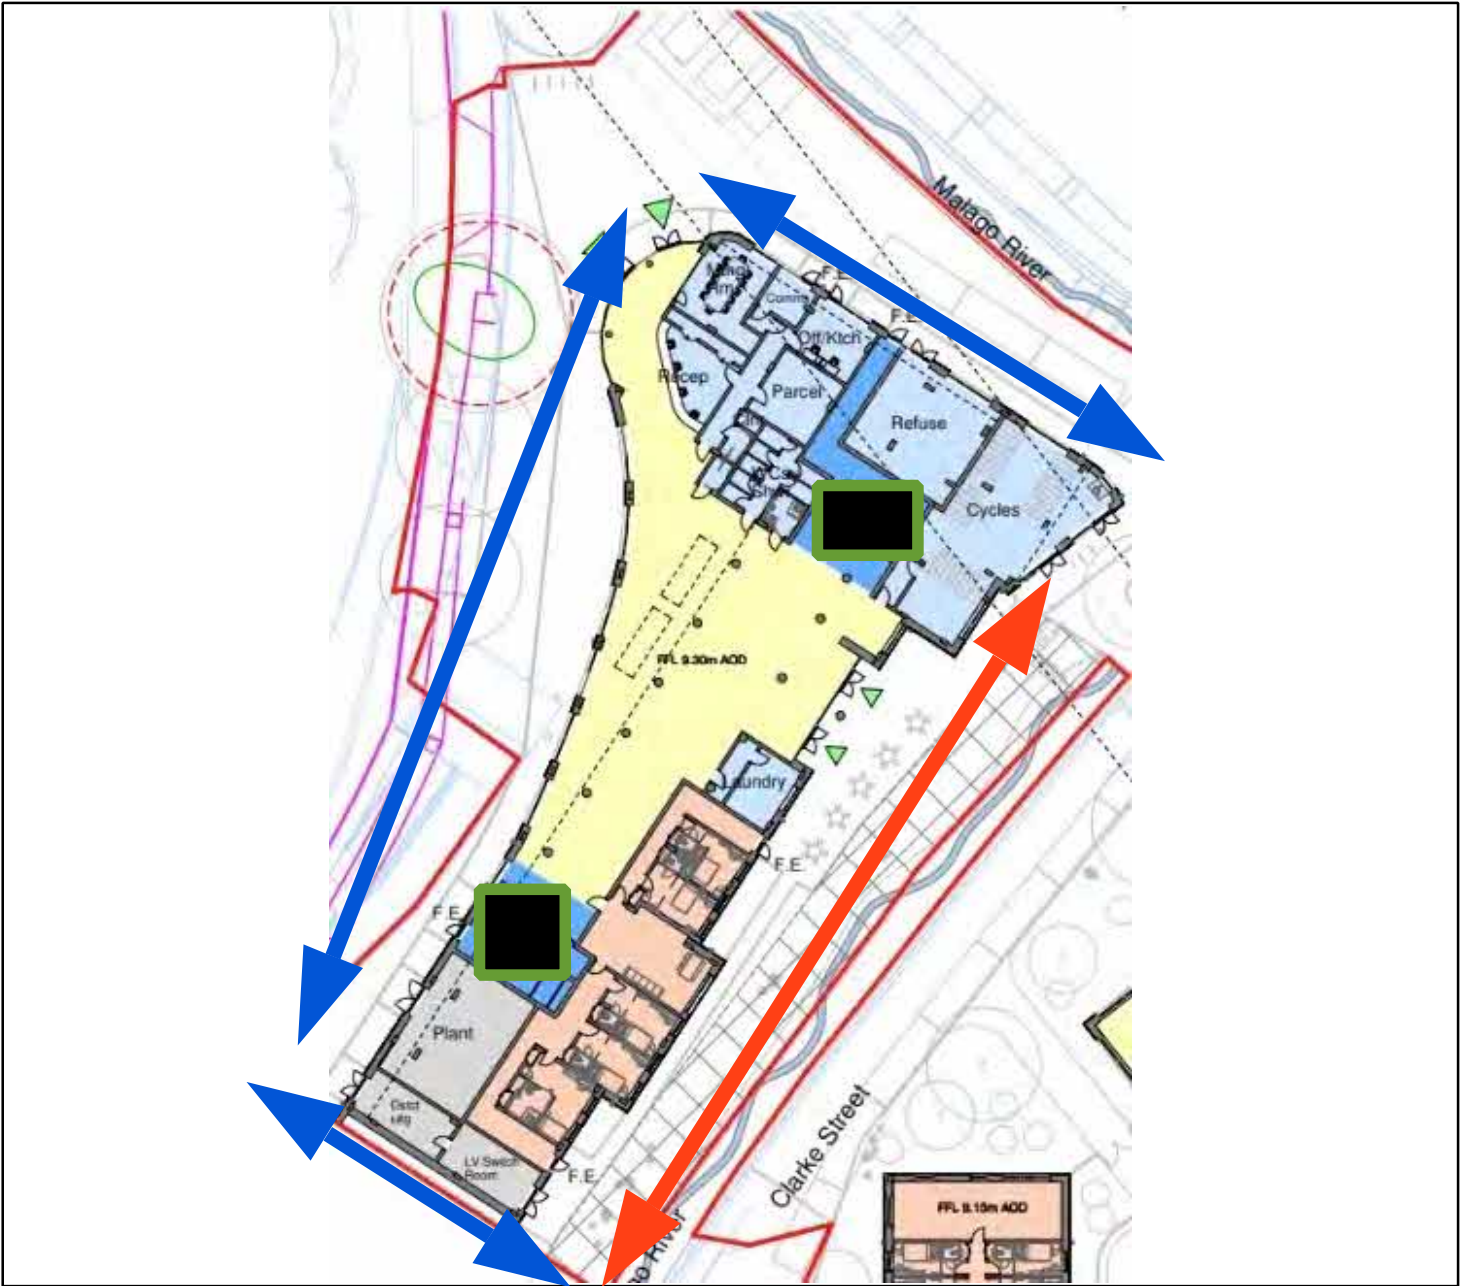
The perimeters highlighted in blue and lift pits highlighted in green have been

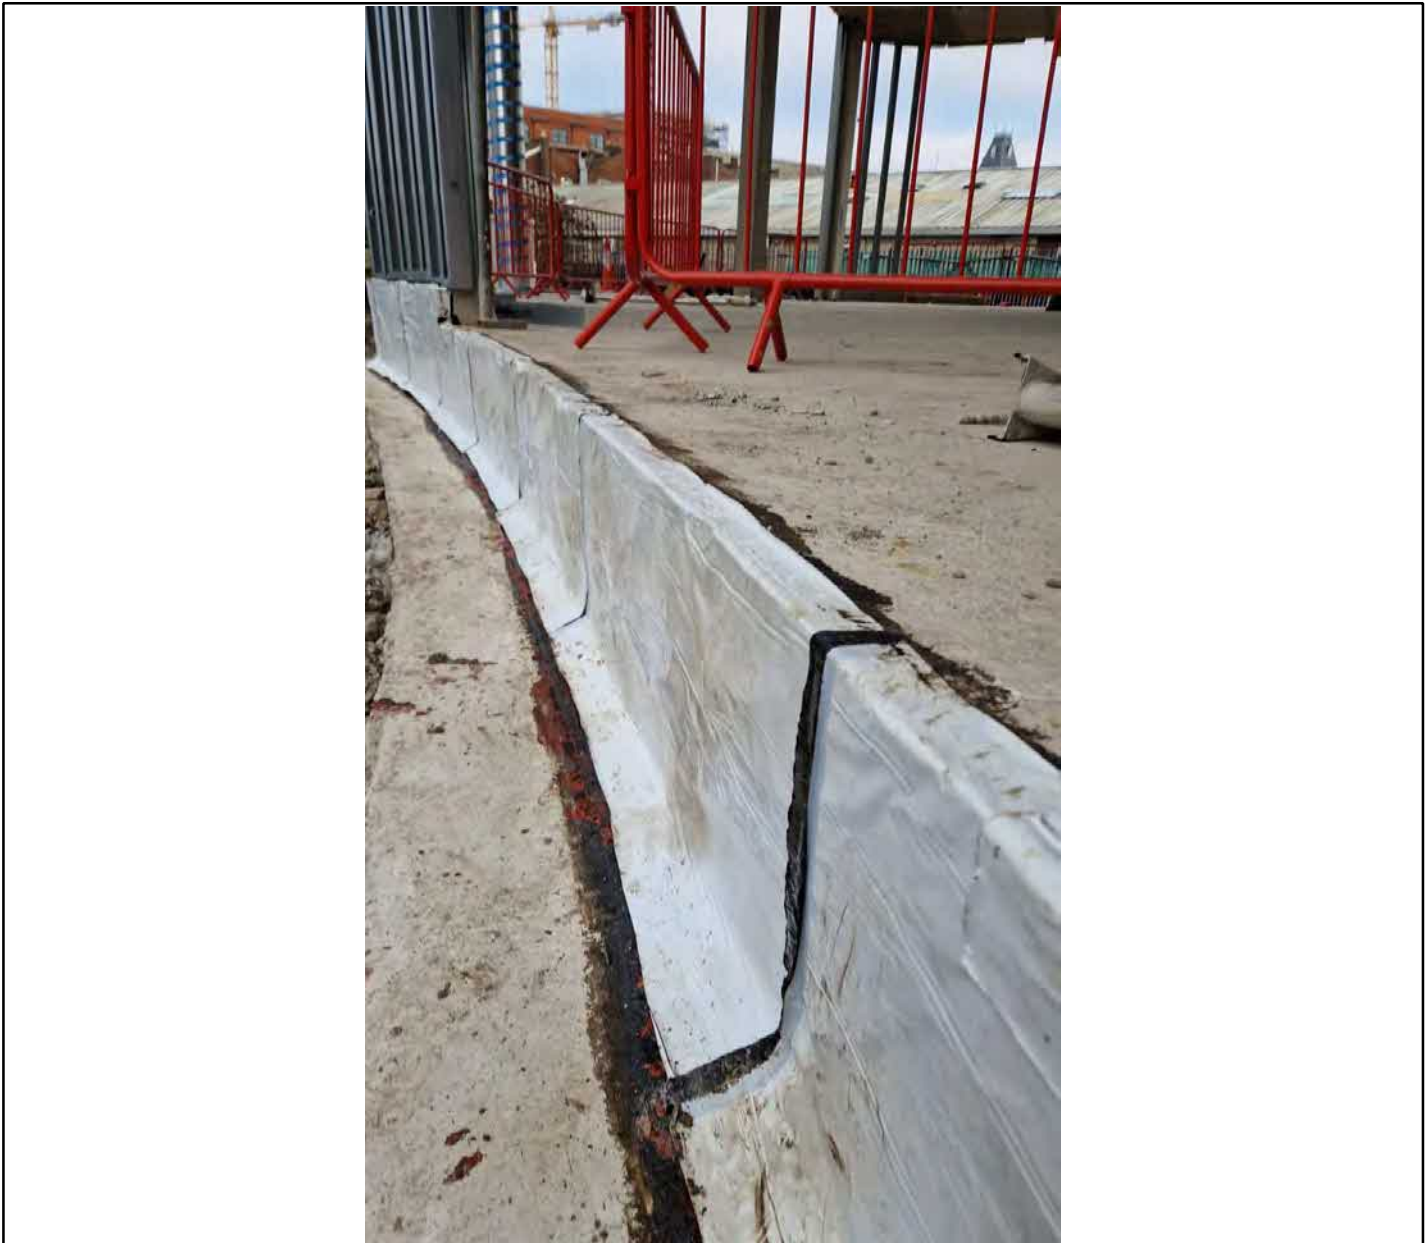
The photograph above shows an overview of a section of the Block A perimeters

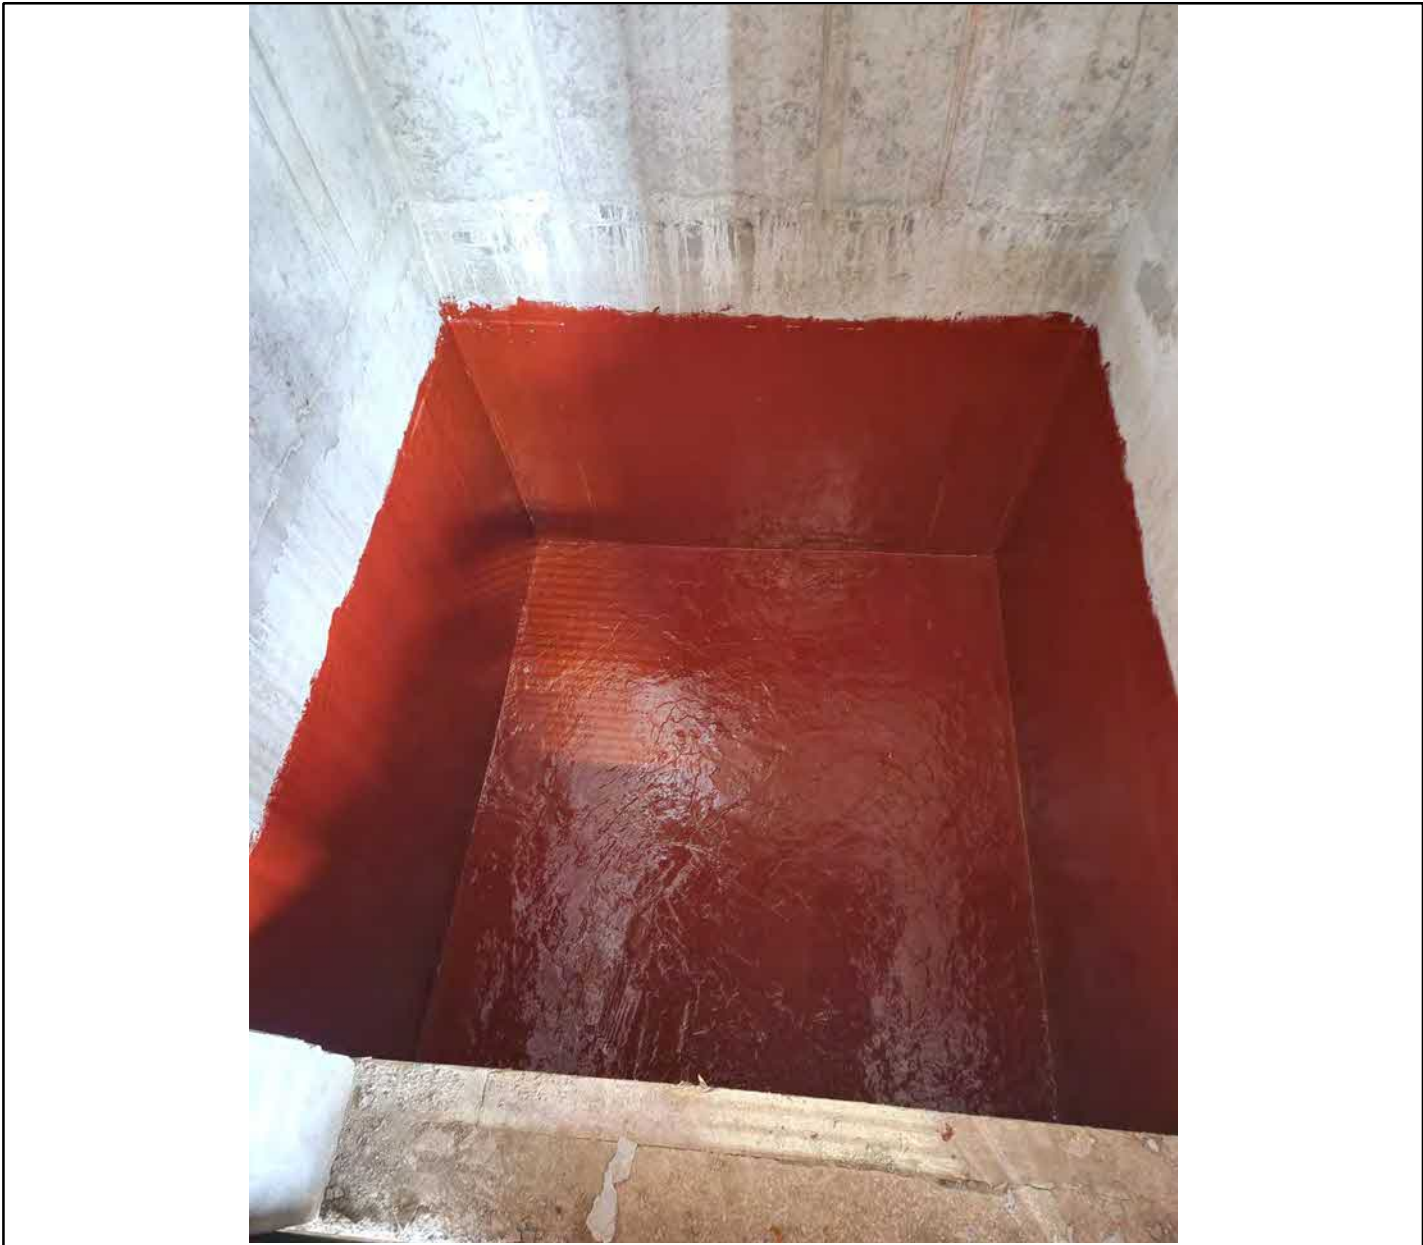
The photograph above shows one of the four lift pits which have been

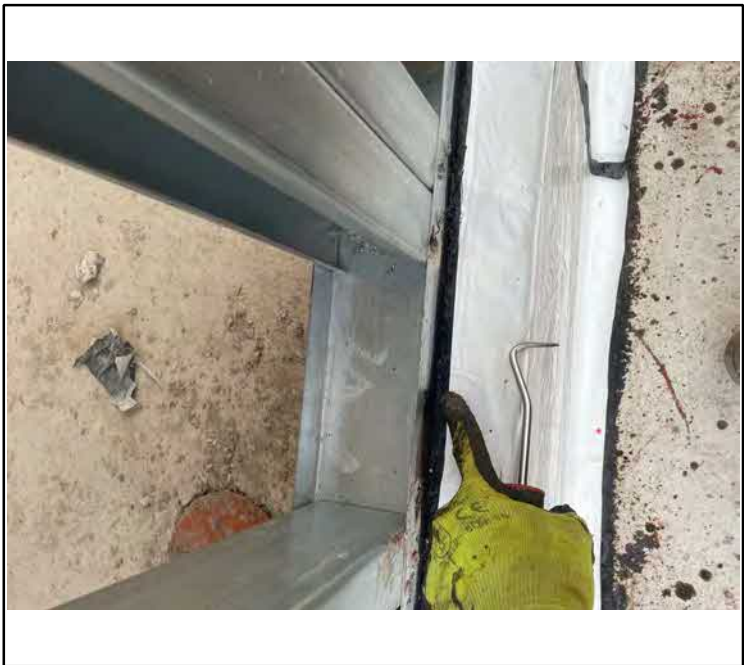
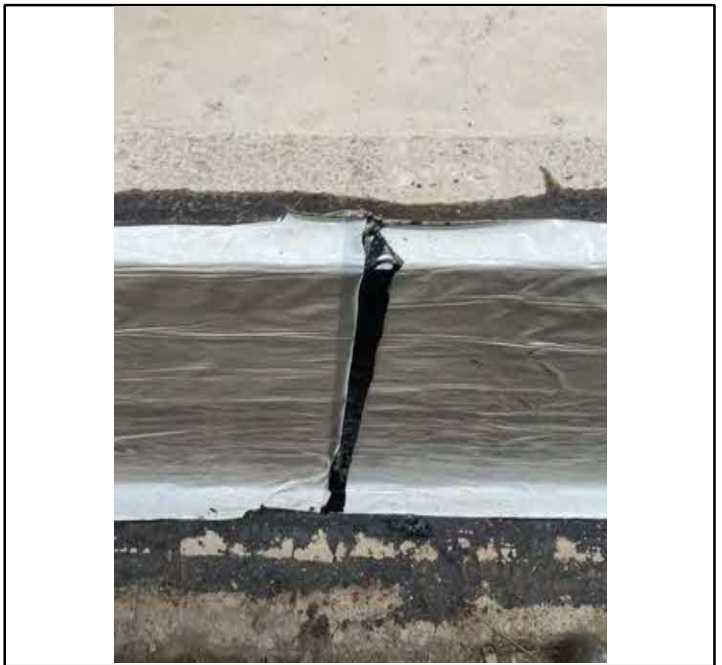
LOCATION/GRID LINE: Block A - Perimeters 100%.

The first photograph below shows the installers have first primed the concrete, this has been applied to aid in the adherence of the FIS Hydroprufe 8000 self adhesive membrane.

Once dry the FIS Hydroprufe 8000 has been installed and the installers have achieved

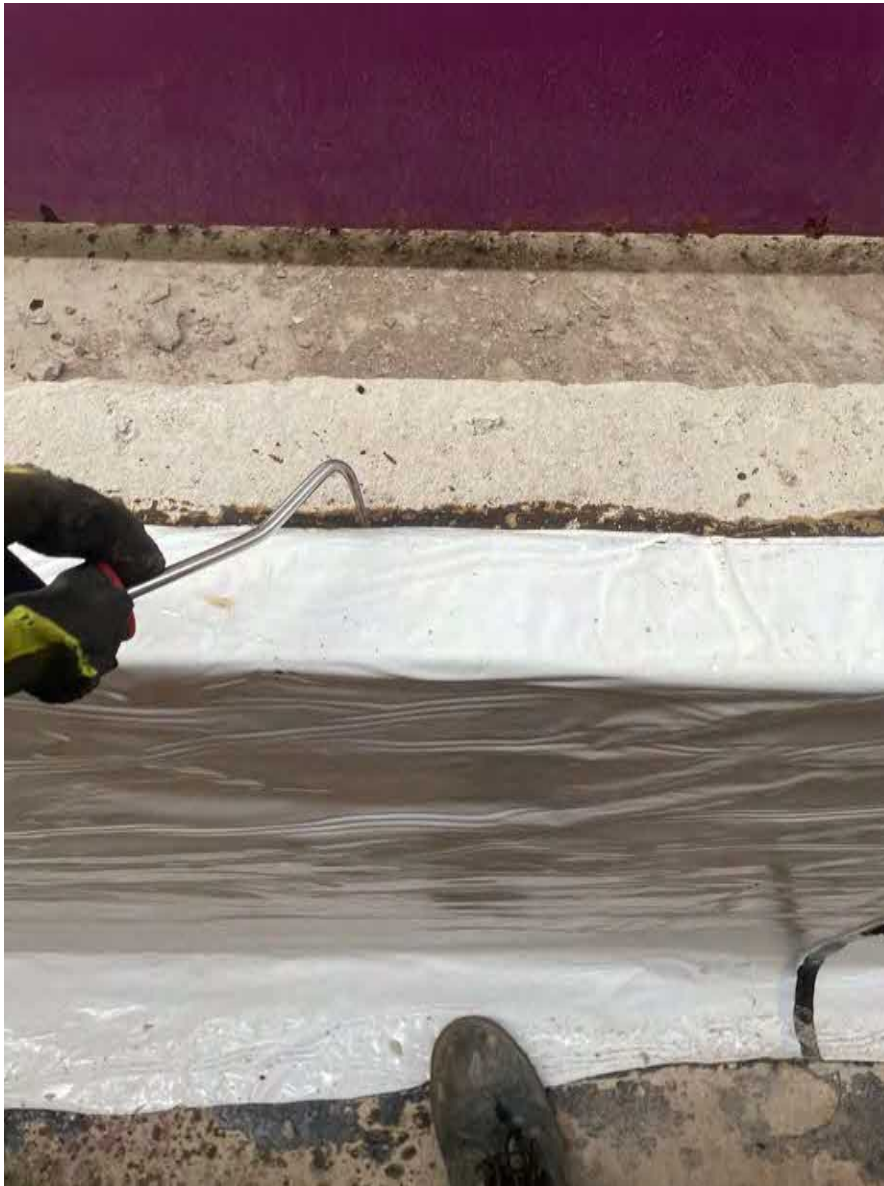
The photograph above shows a pick and probe test carried out to the seal achieved between the FIS Hydroprufe 8000 self adhesive membrane and the primed concrete slab and up stands. No faults or defects were identified during this visit.

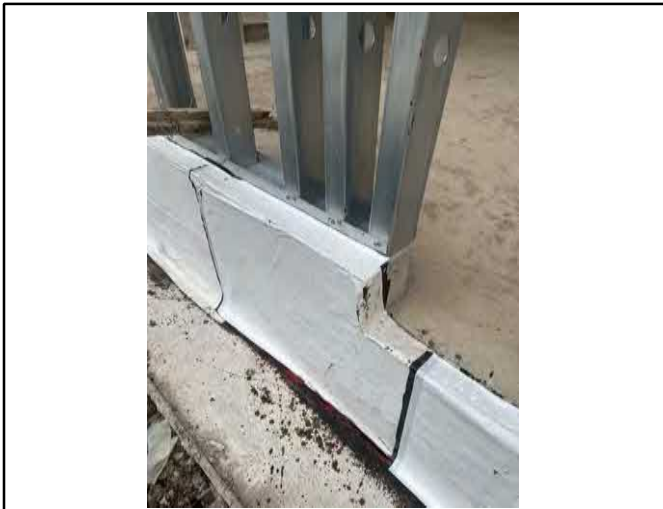
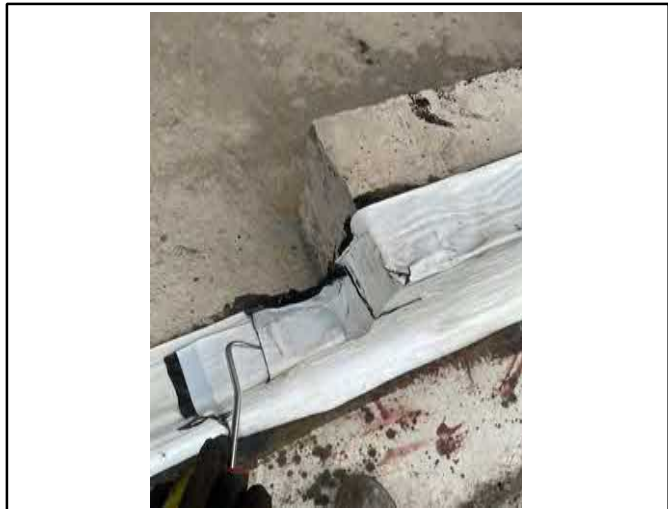
LOCATION/GRID LINE: Block A - Perimeters 100%.

The two photographs below shows examples of sealed corner details which have been sealed. As with the flat edges of the concrete slab and up stands the installers have first primed the corners.

Next a gas blow torch has been used to ensure a strong and consistent seal has been achieved. The second photograph above shows a pick and probe test carried out to sealed corner.

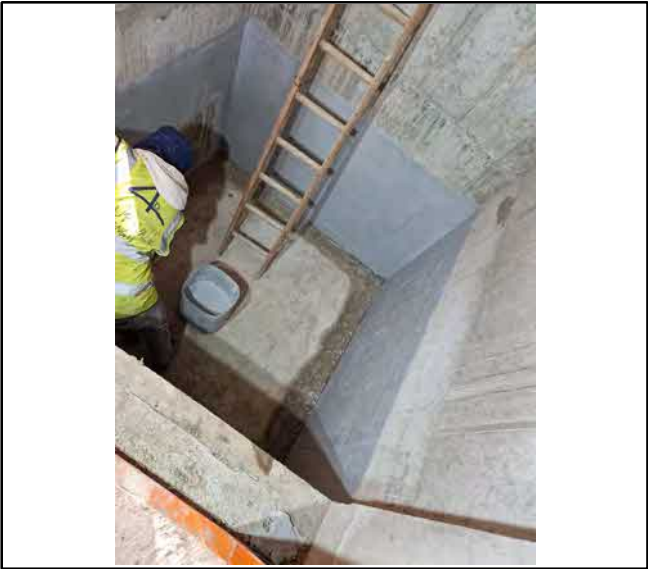
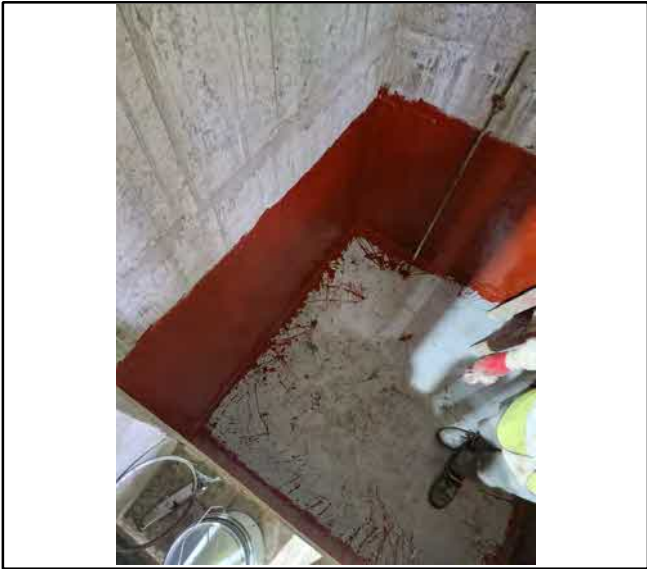
LOCATION/GRID LINE: Block A - Lift Pits.

The first photograph below shows the installers have first applied the FIS Hydroseal FX. Once dry the installers have then applied the FIS Hydroprufe liquid gas barrier to the lift pit.

All four lift pits have been sealed as per the FIS design and manufacturers specification. The installers have achieved a sufficient and consistent coverage of the FX and LG.

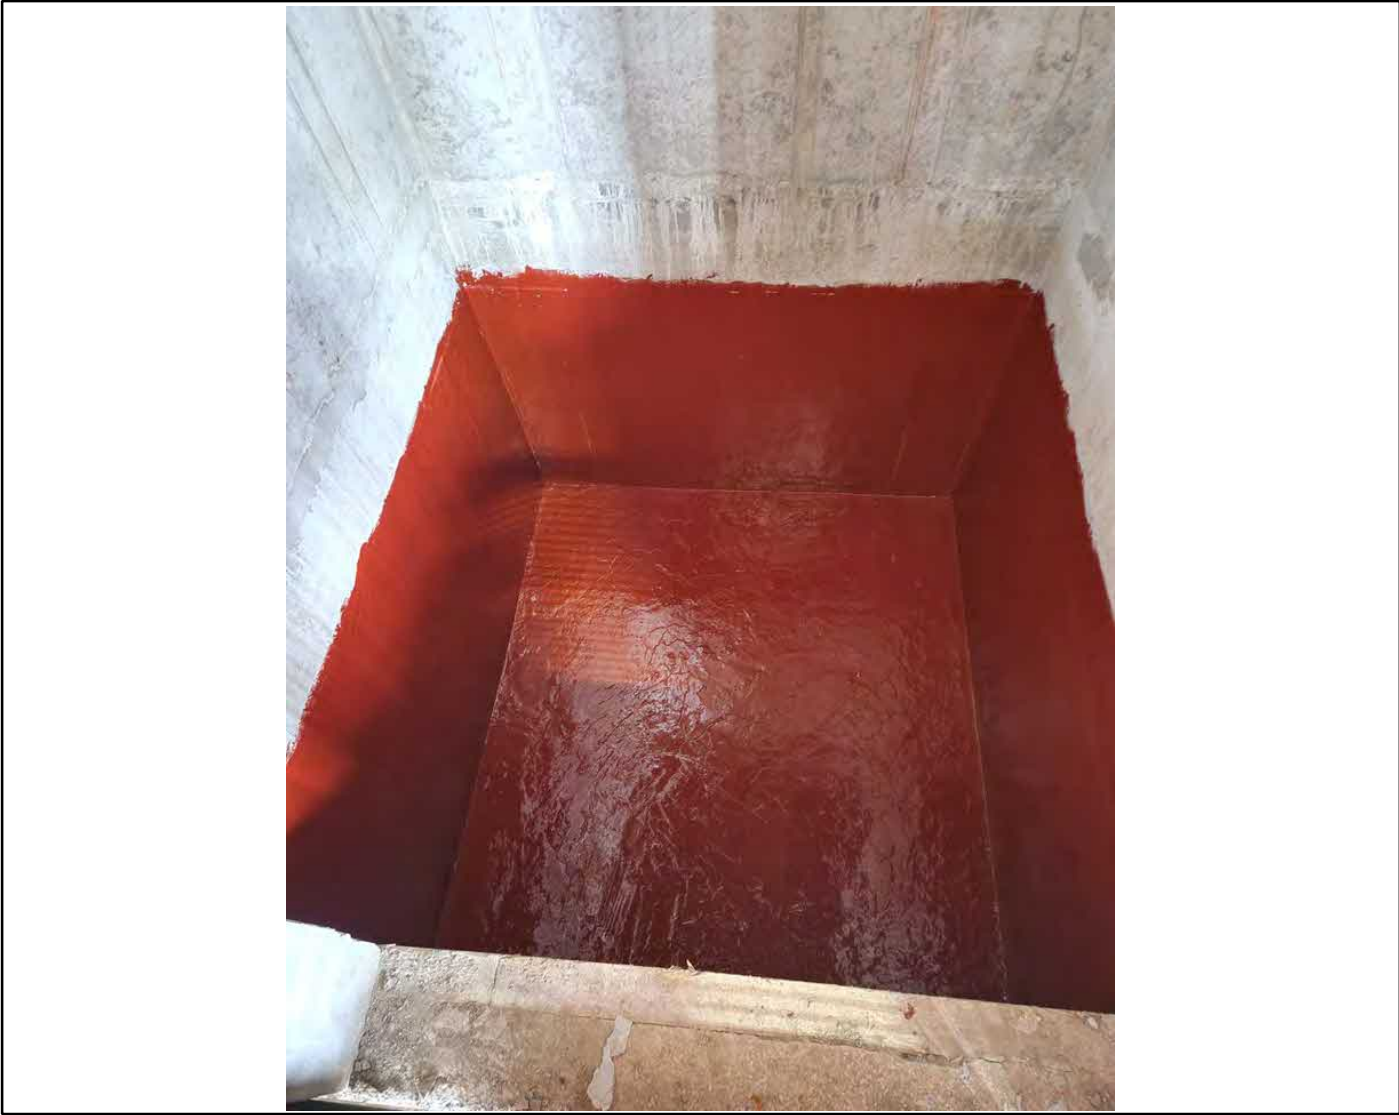
The photograph above shows an overview of one of the completed sealed lift

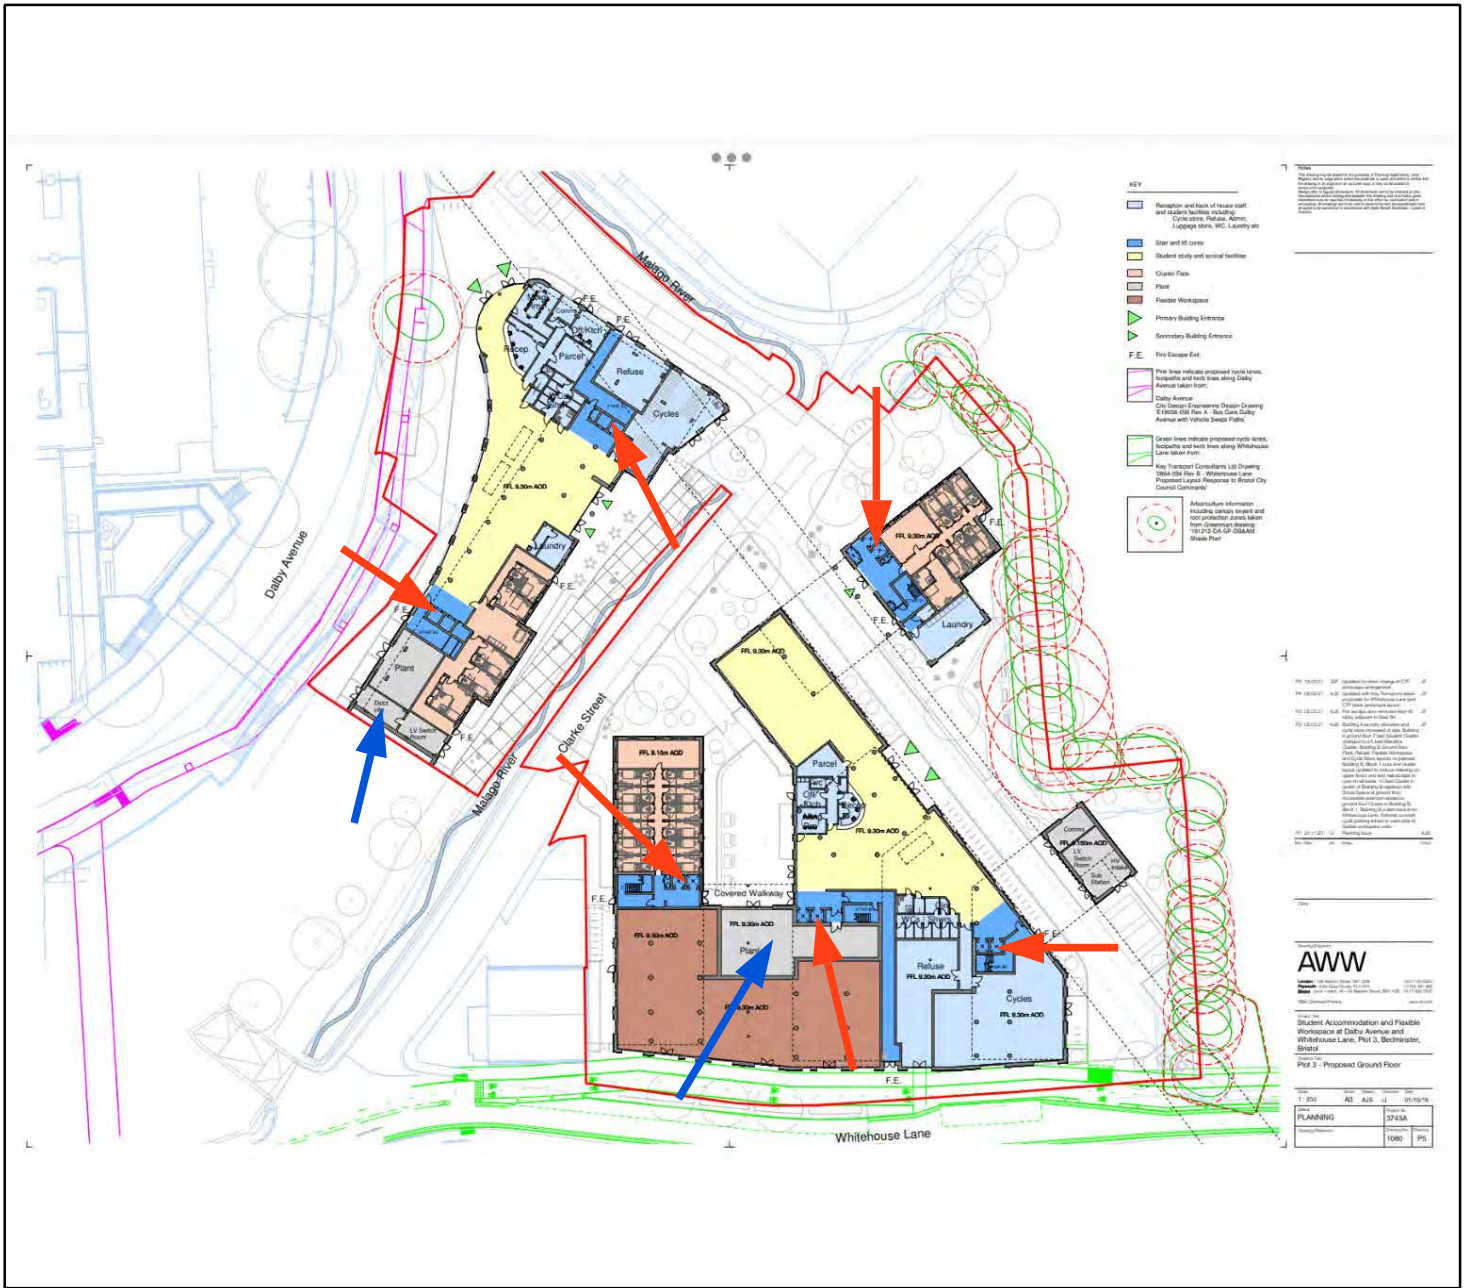
All perimeters of Block A and B have now been signed off. Lift pits annotated in red
