GEOSHIELD Verification Report

PROJECT REFERENCE: GEO102776

REPORT NUMBER: 015 REPORT DATE: 31/01/2023

PROJECT: Dalby Avenue

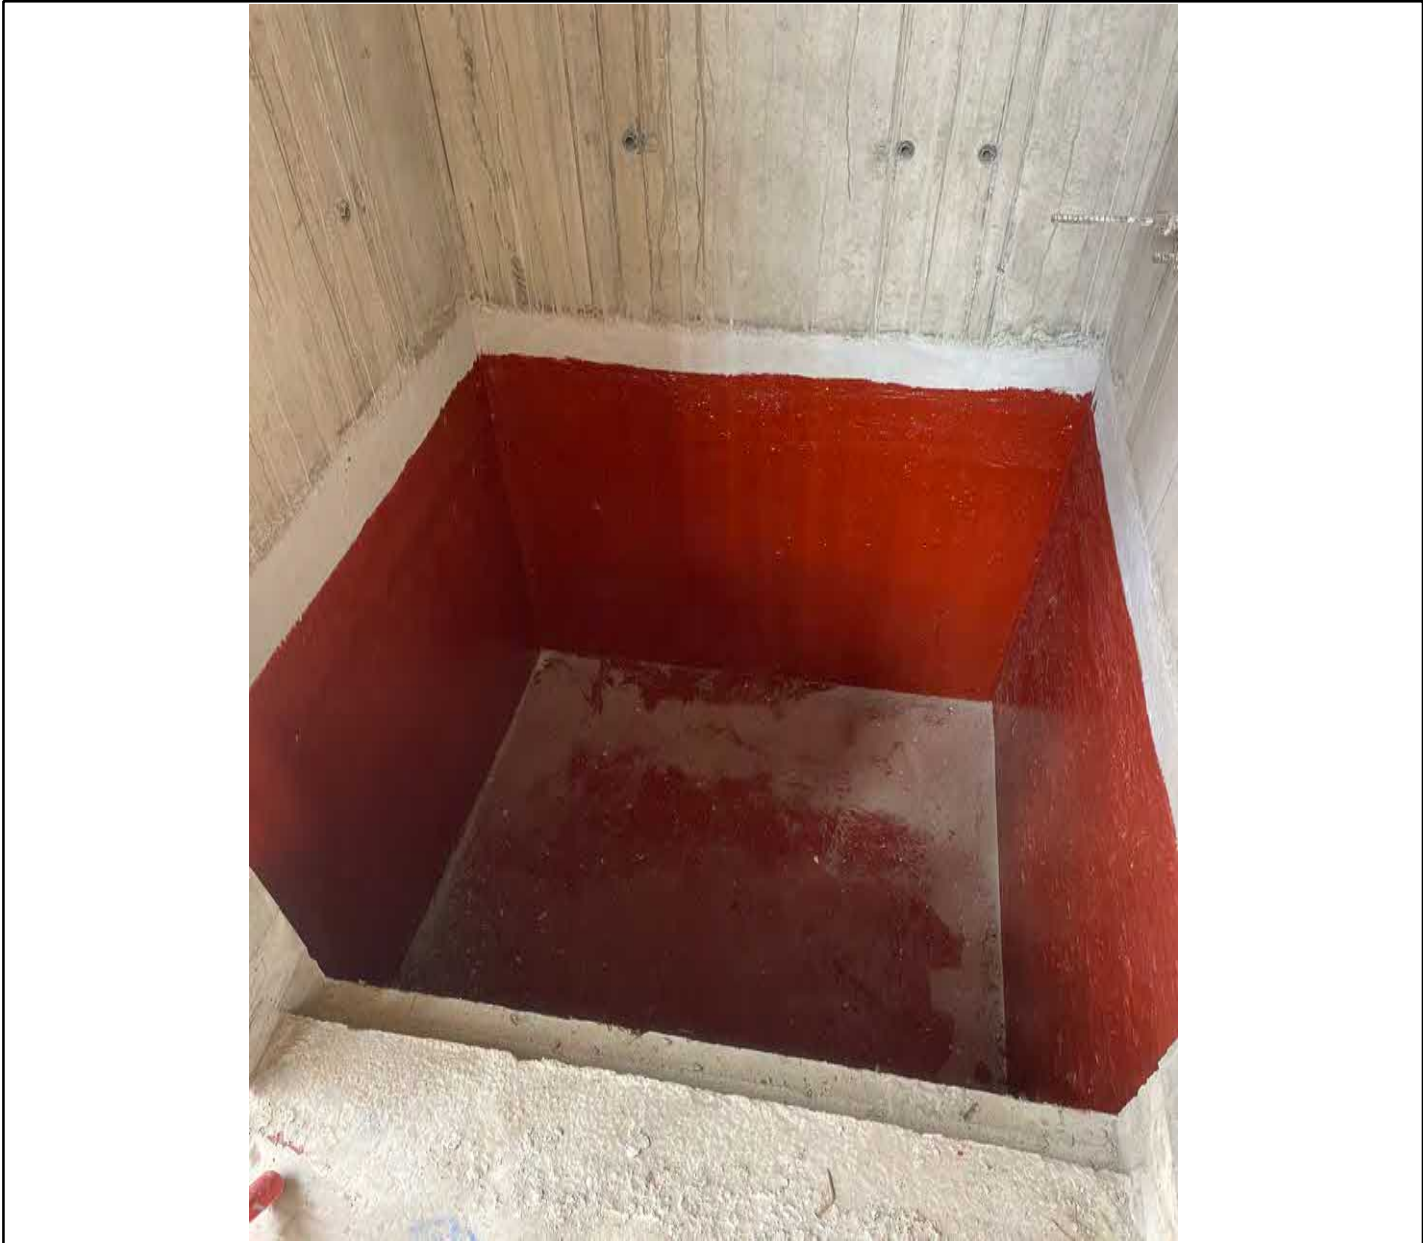
Overview photograph of sealed lift pit using Hydroseal FX and Hydroprufe

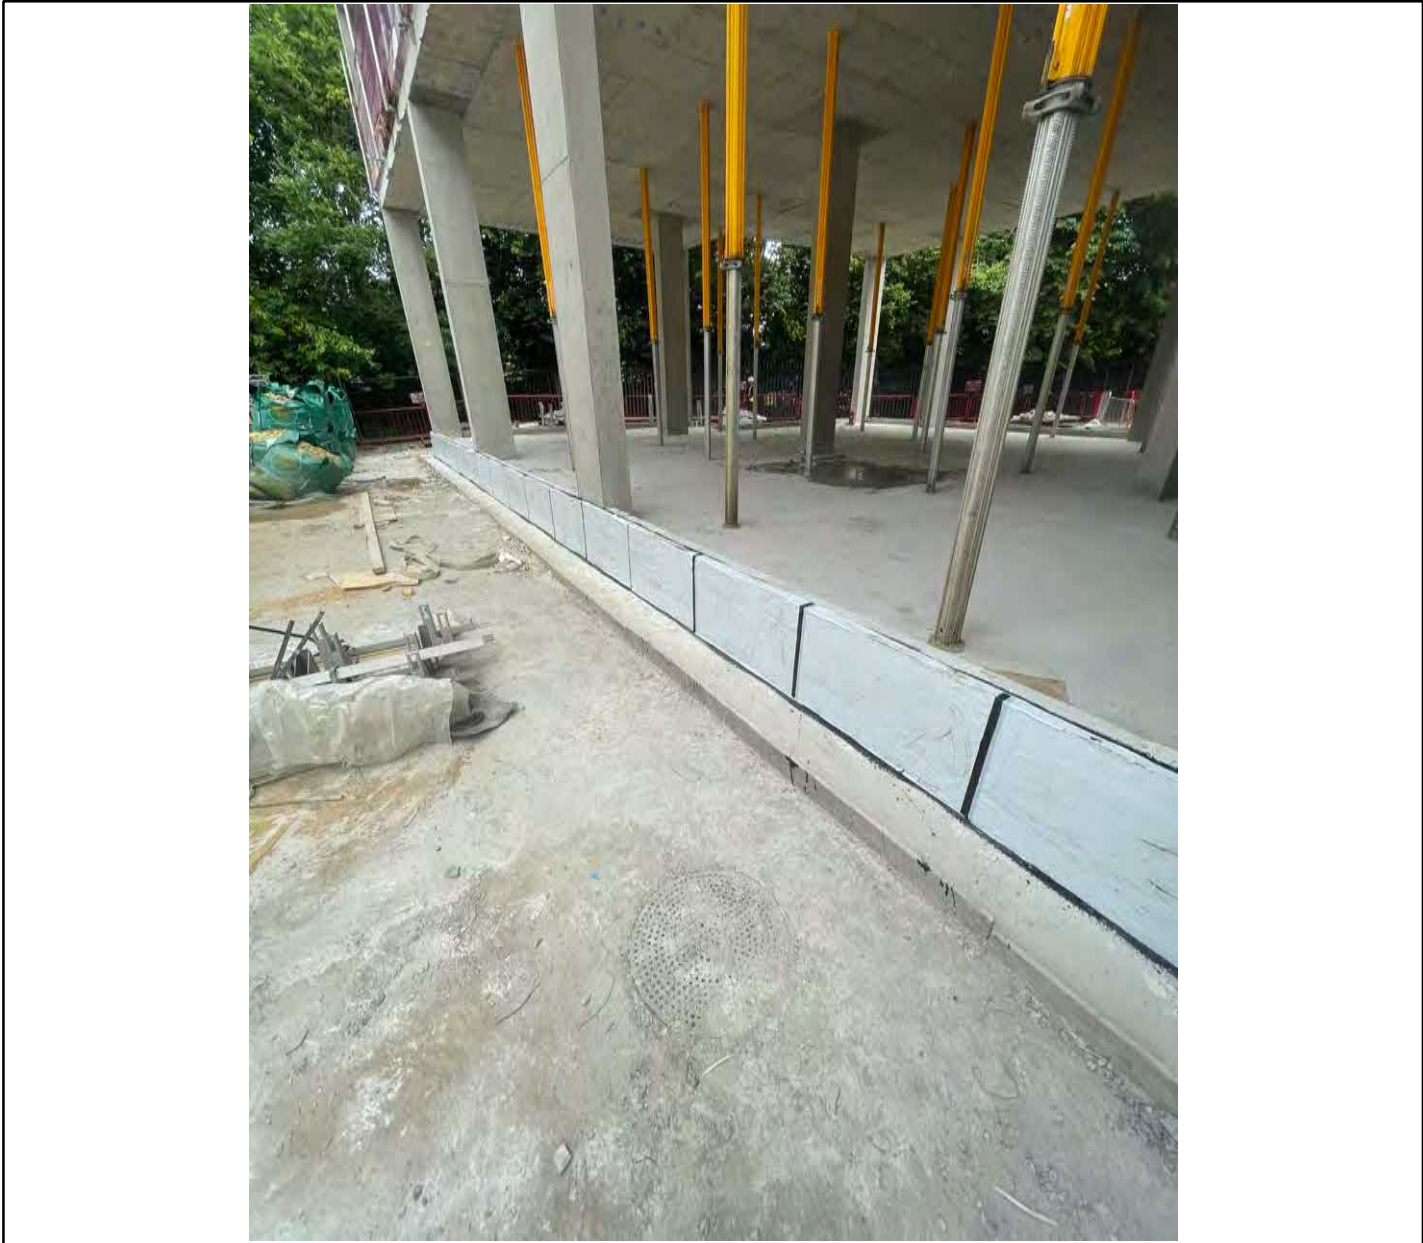
Overview of perimeter termination using Hydroprufe 8000 self adhesive

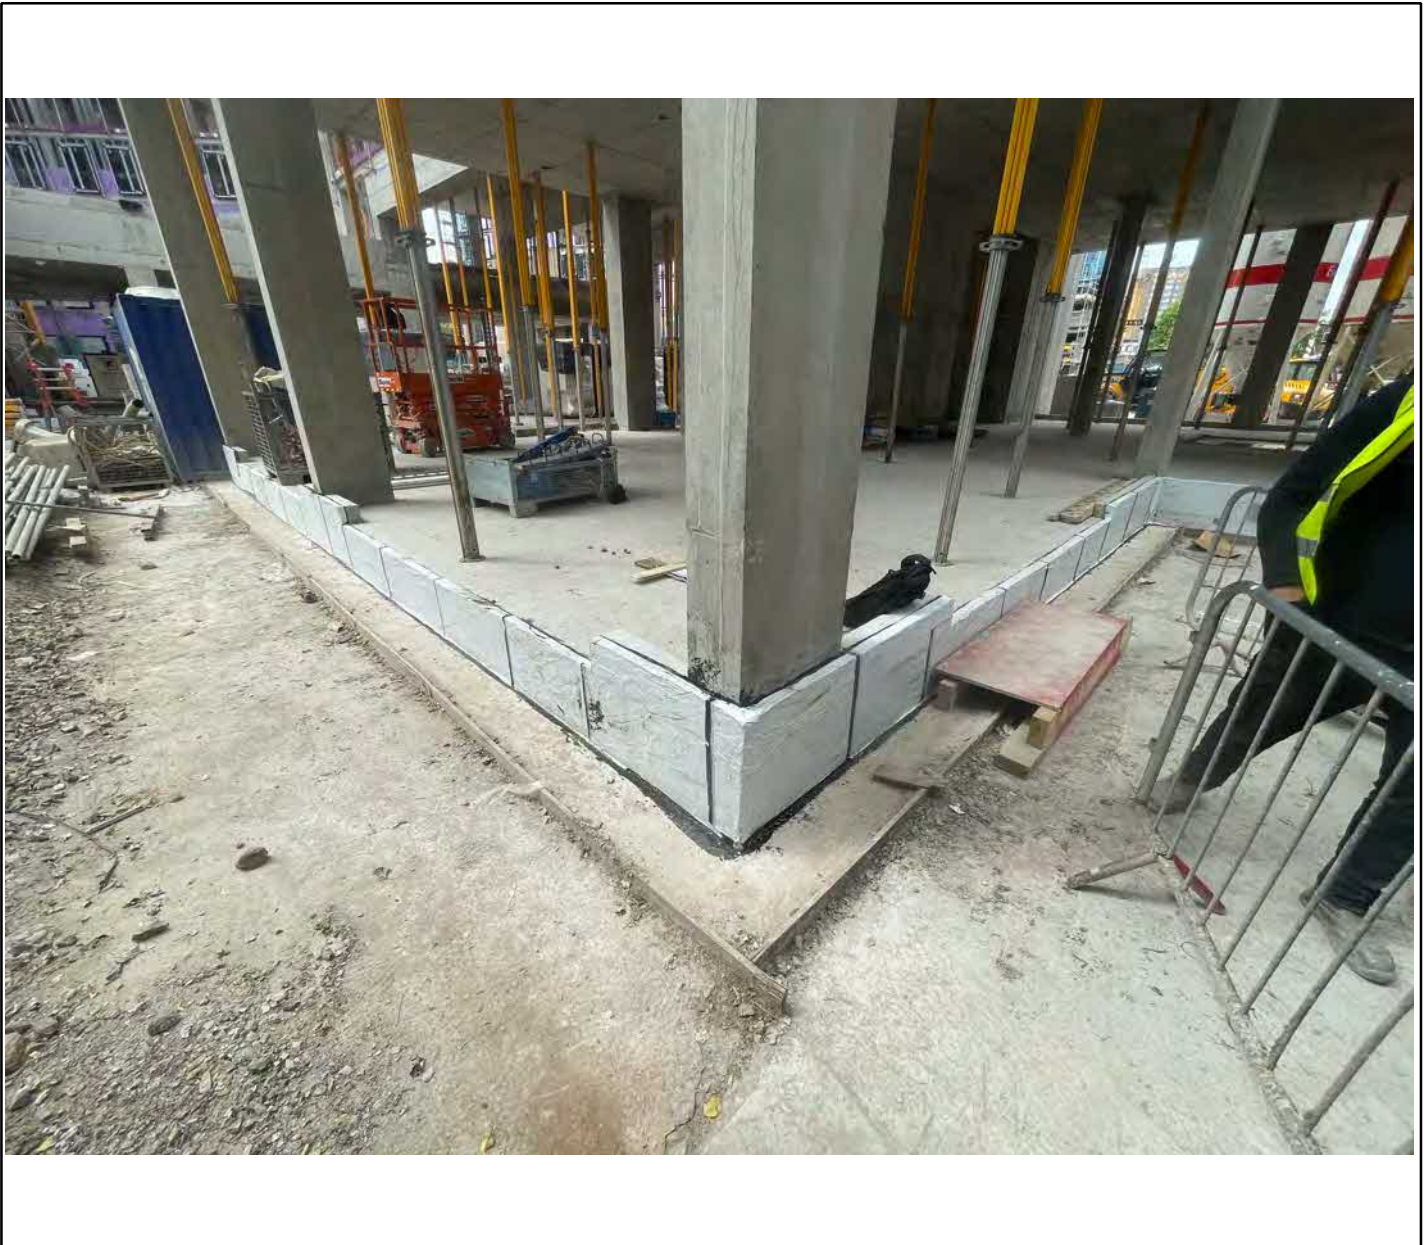
Additional overview photograph of perimeter termination verified and signed

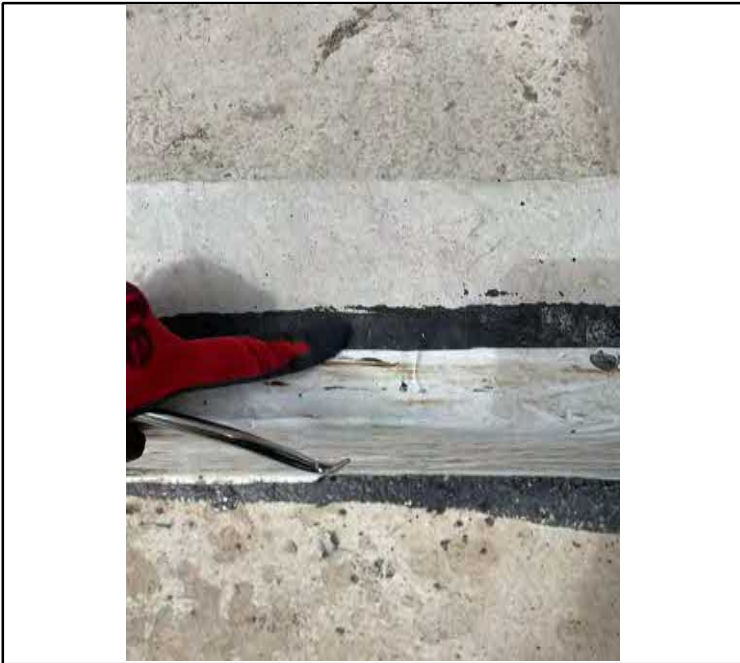
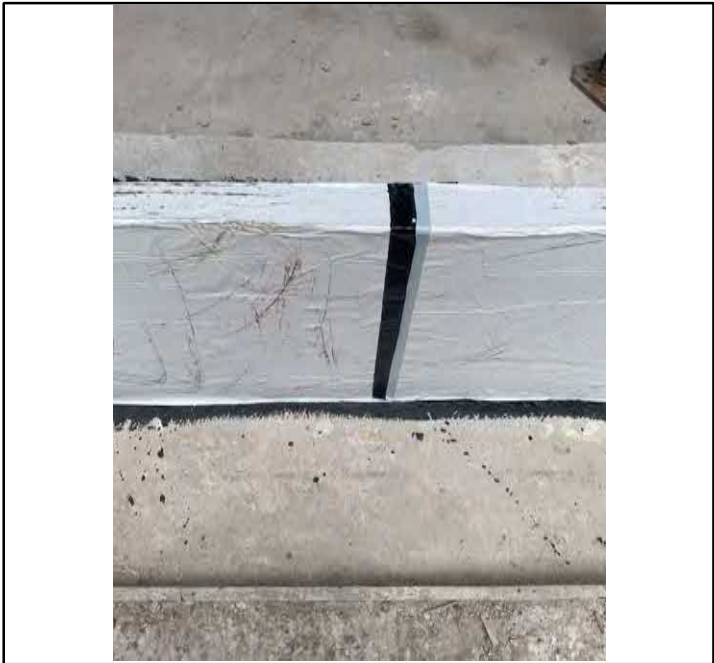
The first photograph below shows the installers have first primed the perimeters of the slab and upstands. Next the Hydroprufe 8000 self adhesive membrane has been adhered to the primed perimeters to terminate the previously applied membrane.

Heat has been applied to aid in the adherence of the Hydroprufe 8000. The second

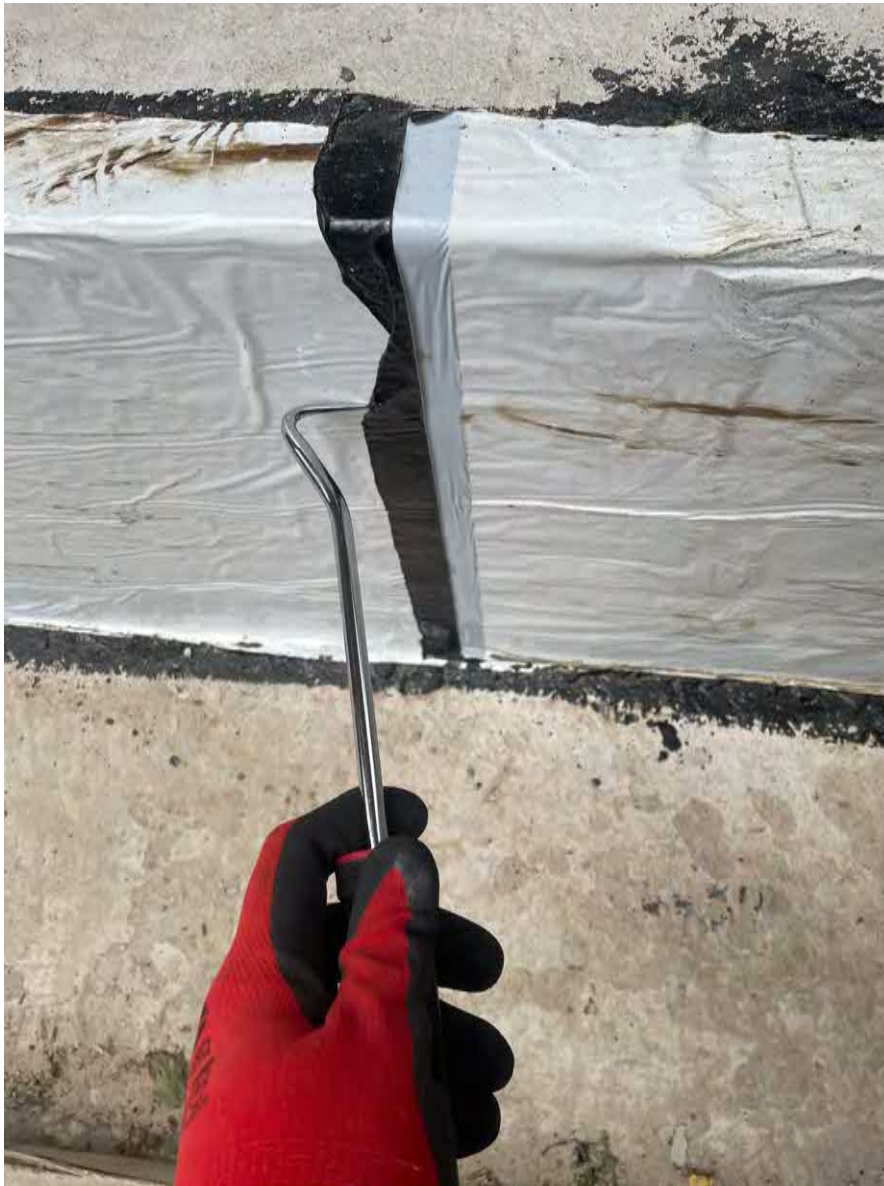
The photograph above shows a pick and probe test carried out to a sealed lap of the Hydroprufe 8000 self adhesive membrane. The installers have achieved a strong seal. Any faults or defects that were identified during this visit or previous visits have been rectified. Verified in accordance with CIRIA 735.

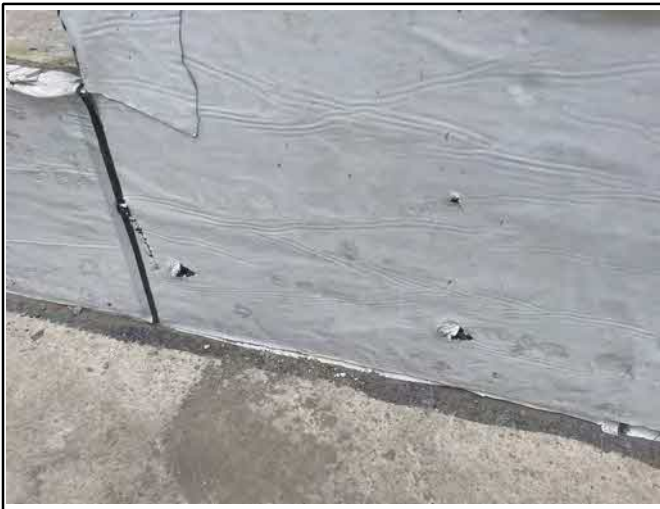
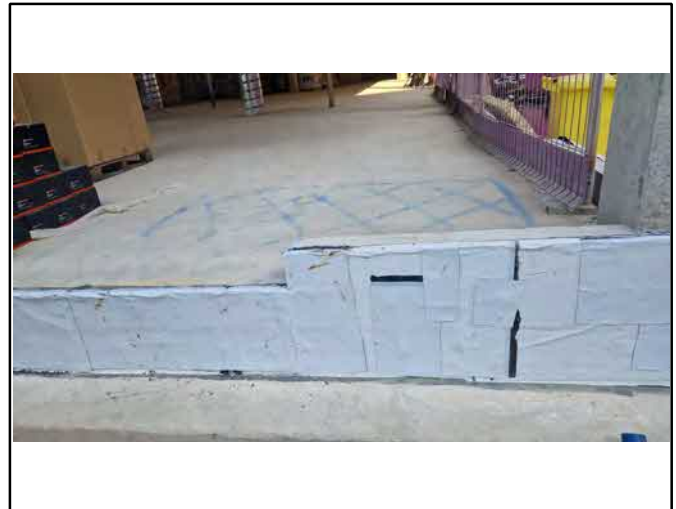
The first photograph below shows examples of damage which was identified when inspecting the Block B perimeters. Any holes identified in the newly installed or previously installed and verified Perimeters have now been patch repaired.

To carry out each patch repair. The installer have first cleaned the Hydroprufe 8000 self adhesive membrane of any dust or debris before applying an additional patch of the Hydroprufe 8000. A gas blow torch has been used to aid in the adherence of the self adhesive membrane.

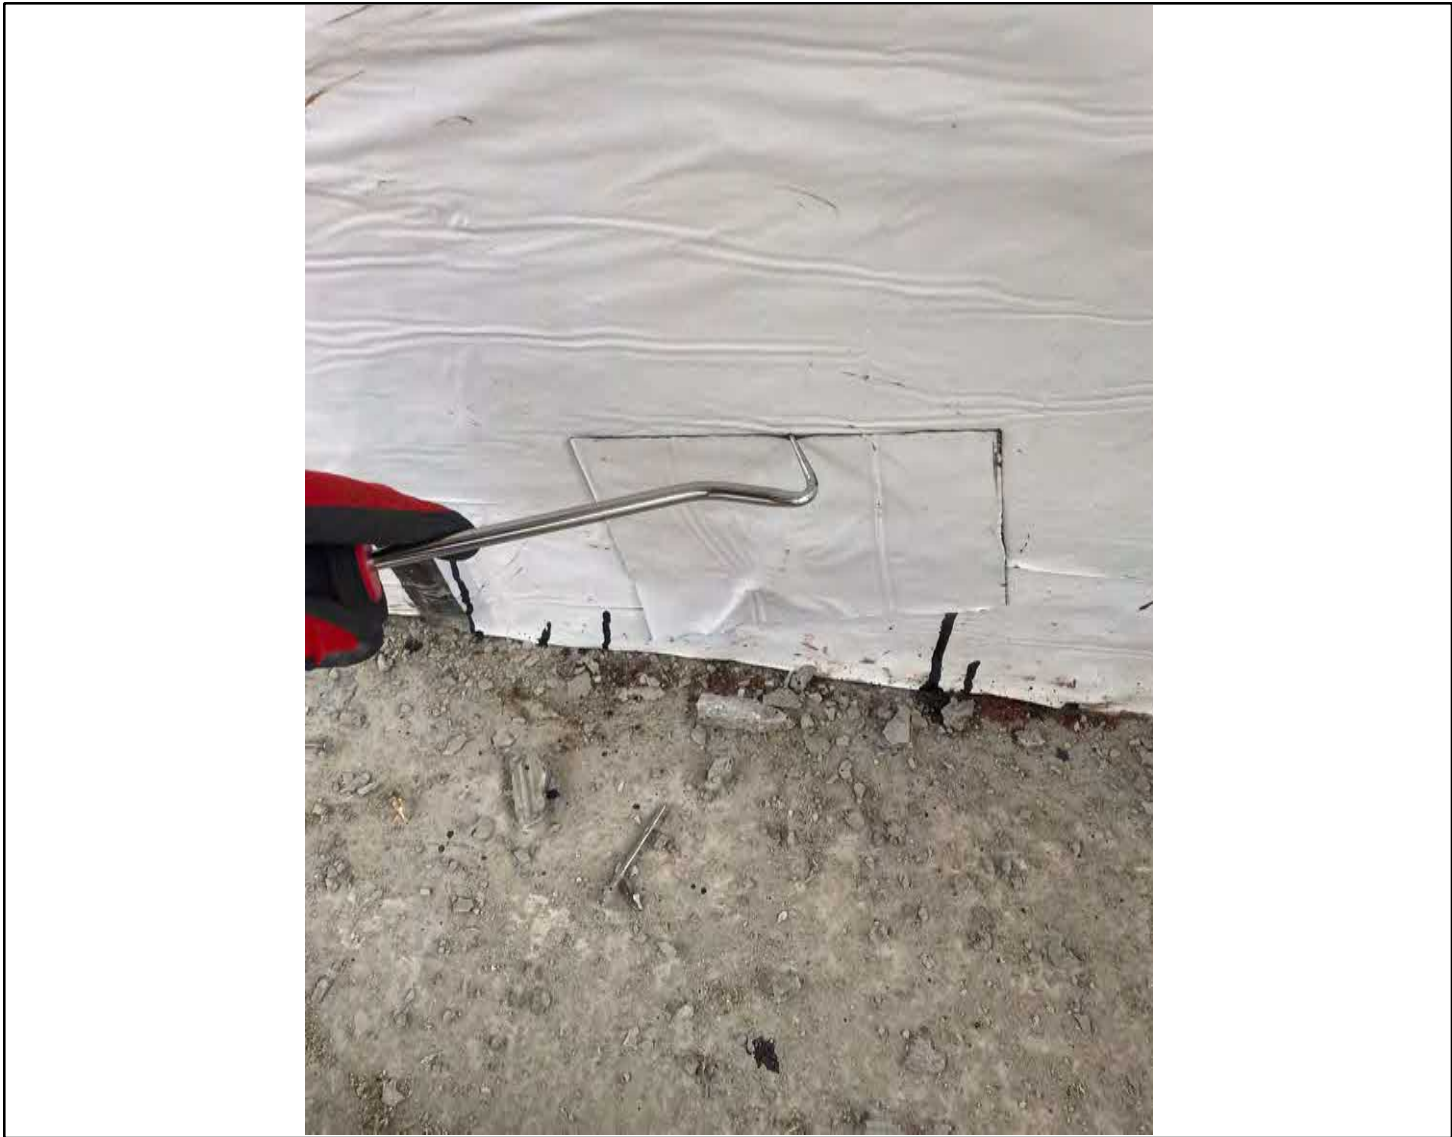
The photograph above shows a pick and probe test carried out to a sealed patch

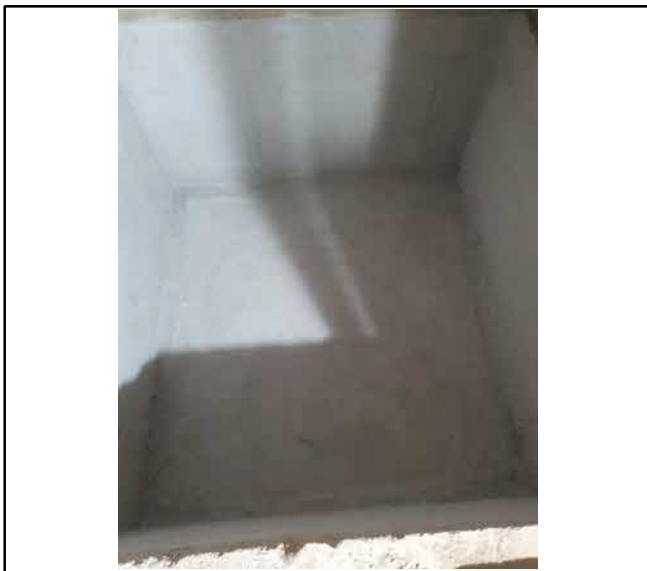
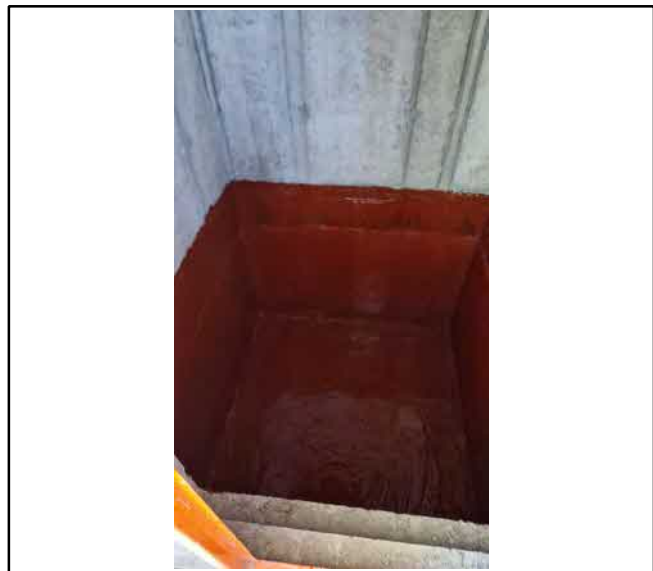
All lift pits and district heating pits have been sealed as per the FIS design. The installers have first cleaned the pits and ensured they are dry. Next Hydroseal FX has been applied as shown in the first photograph below.

Once allowed to dry the installers have then applied the Hydroprufe LG.

The installers have achieved full coverage with no gaps. The pits have then been

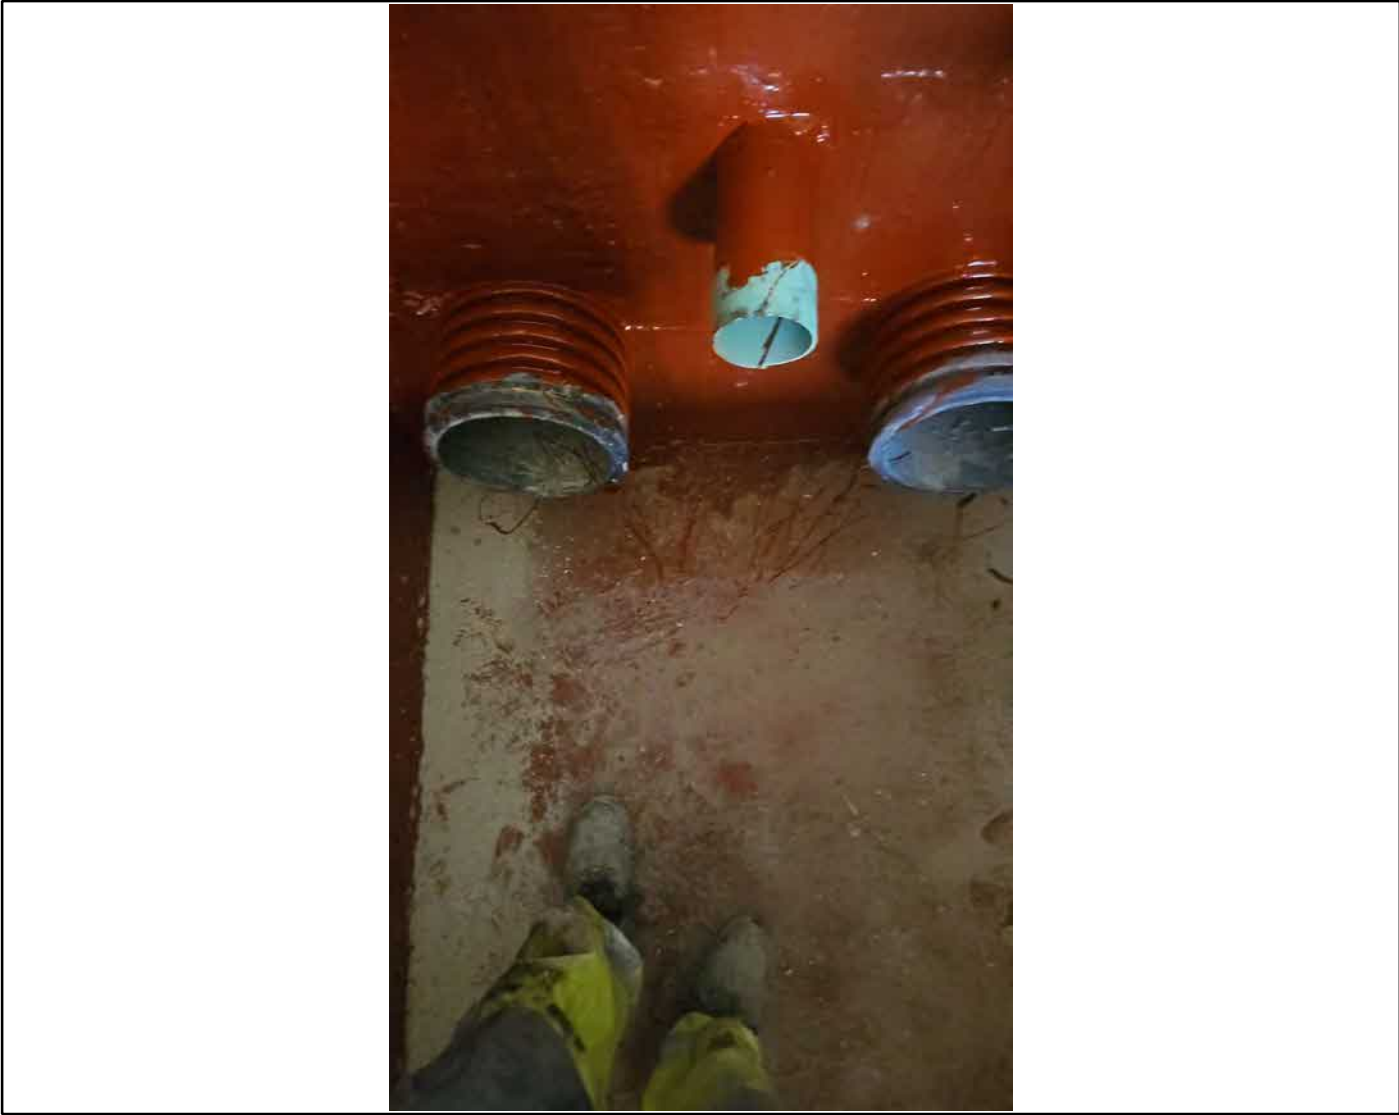
Pipes within the district heating pits have also been sealed by extending the

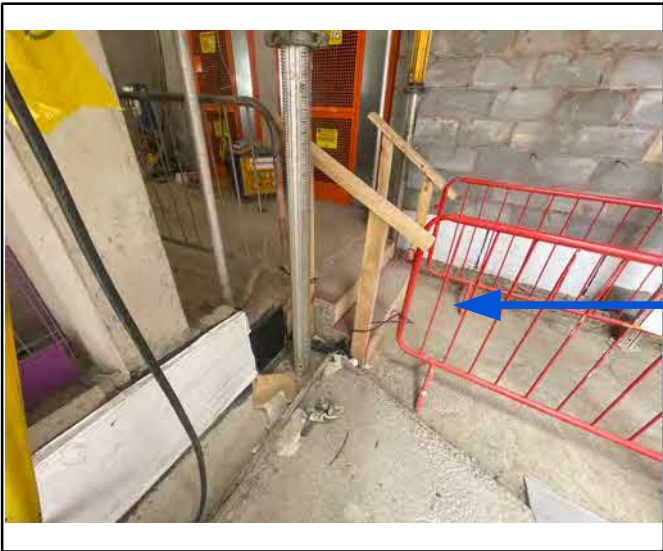
Area behind stairs was not sealed.

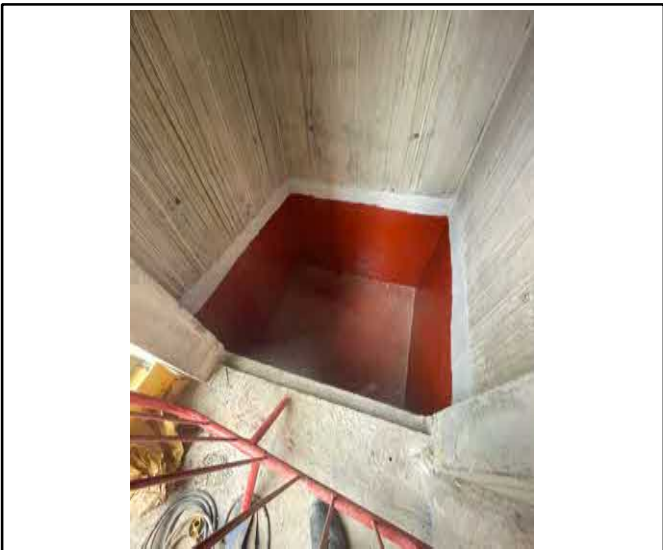
Additional overview photograph of

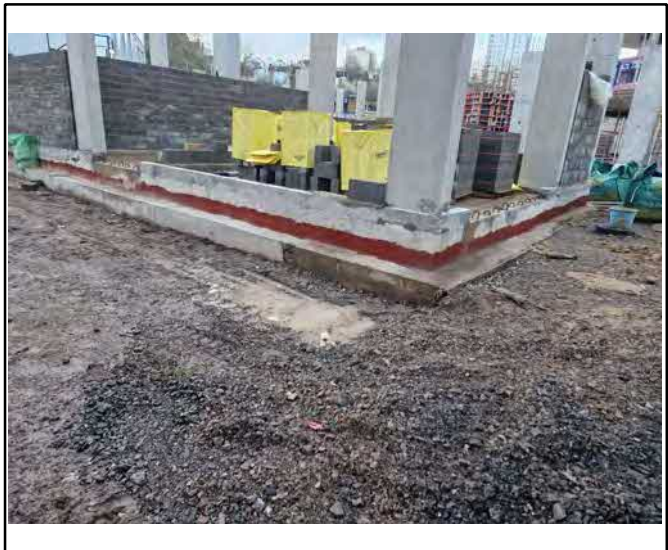
Perimeters prior to being terminated.

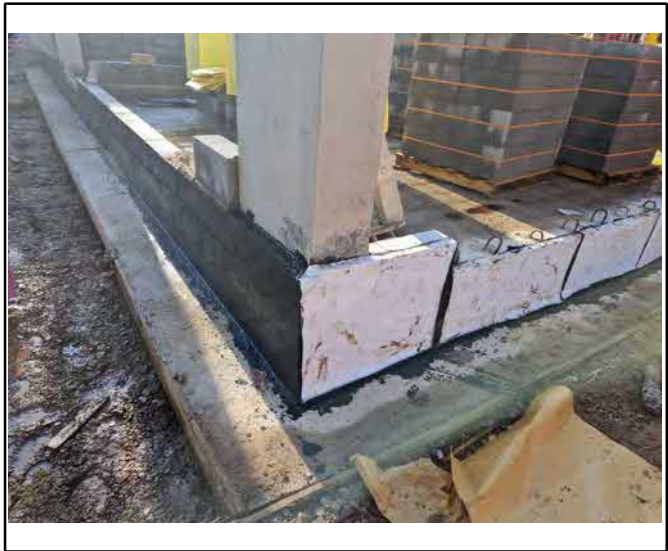
Primer applied prior to Hydroprufe

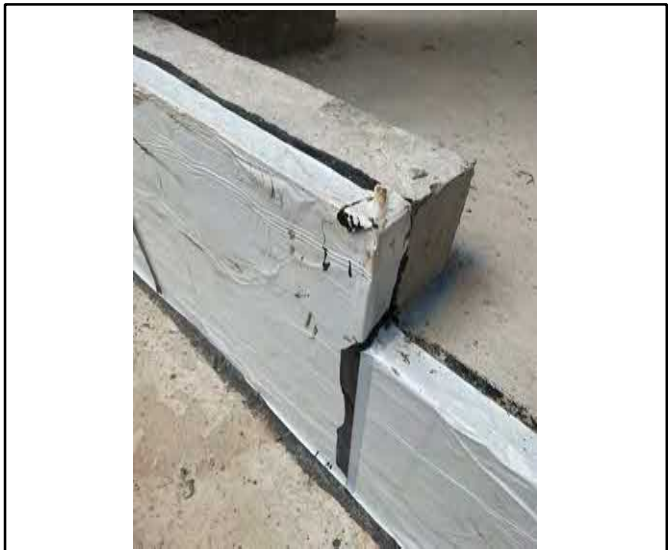
Sealed corner/door threshold.
