## Tree Condition Assessment for St Agnes Gardens, Bristol

6<sup>th</sup> February 2024

Land adjacent St Agnes Gardens  
Bristol  
BS4 2DQ

StAgnes\_TCA\_022023

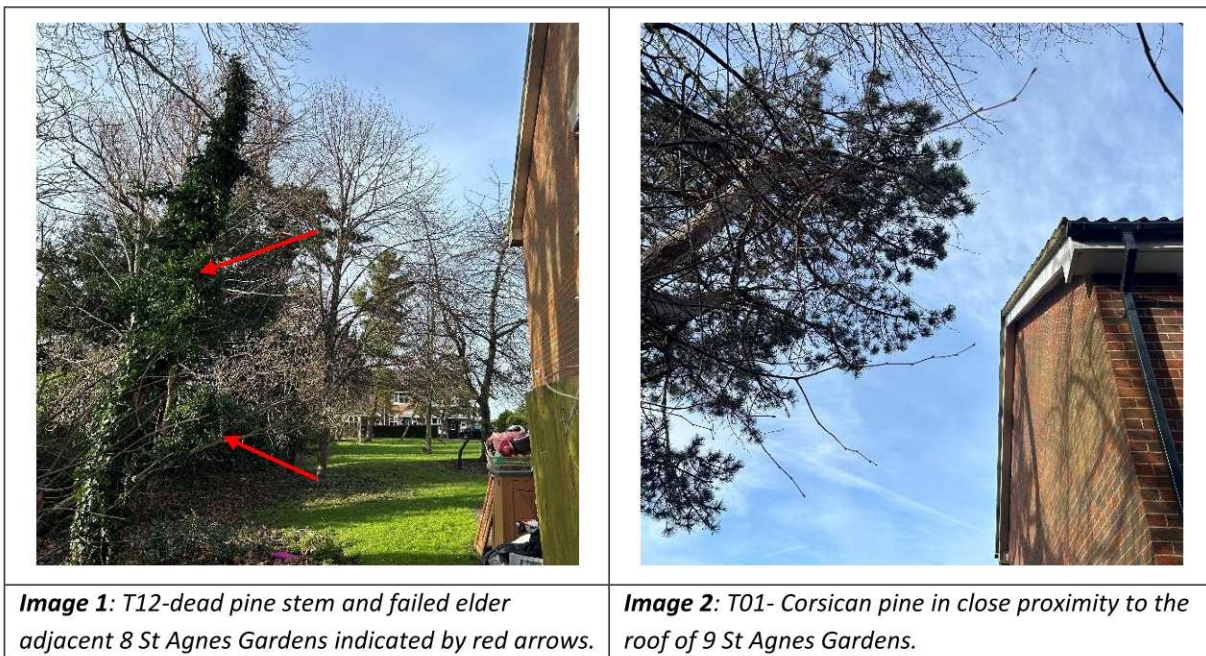
- 6.2 T12 is a small dead ivy-covered pine stem (image 1) with a weight bias towards the west elevation of number 8 St Agnes Gardens, it has a high likelihood of failure but is unlikely to cause damage to the building due to the relatively small size and poses a low risk of causing injury due to relatively low frequency of use of the target area<sup>4</sup> of the tree. T12 is the only tree recorded in the interest of risk mitigation. There is also a small elder 4 metres to the north-west of T12 that has partially failed. Both trees should be removed.

- 6.3 One Corsican pine (T01-tagged 630) has been recommended for minor crown pruning as it has branches growing within 1 metre of the roof of number 9 St Agnes Gardens (image 2) which can lead to structural damage and can facilitate pest (squirrel) ingress to the property.

- 7.2 As a minimum I recommend that T12 is removed along with the failed elder 4m to the north-west, the pine (T01) is reduced to allow 3 metres clearance from the roof of number 9 St Agnes Gardens and the epicormic growth is removed from the base of trees 02 and 11. The works to trees 01, 02 and 11 must be the subject of a TPO application to BCC, the works to tree 12 and the adjacent elder do not require consent from BCC.

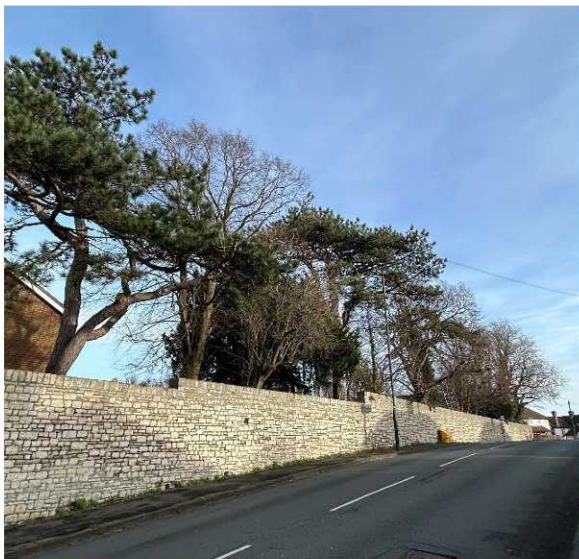
- 6.5 The trees subject of the TPO are generally in good health and condition. Many have clearly had crown reduction and crown lifting works with good clearance over Redcatch Road (image 3), with 1-2 years regrowth from the pruning wounds, which is consistent with a tree work application to BCC in October 2021 (ref: 21/05414/VP). None of the TPO trees had a defect that could lead to a foreseeable failure and no works are recommended in the interest of risk mitigation.

**Image 3:** Good crown clearance over Redcatch Road.

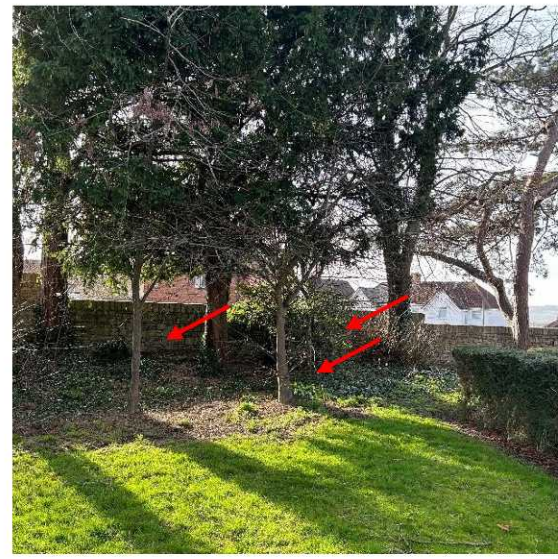
- 6.7 There are 3 young lime trees planted below the crown spread of T03 (a mature yew) and have developed severely suppressed crown forms as a result (image 4). The lime do not pose a risk and will not adversely impact T03 but will never develop a good crown form. The pro-active removal of the lime should be considered, there is potential that with care, the youngest lime to the north could be transplanted.

**Image 4:** Young limes suppressed by the canopy of mature yew indicated by red arrows.

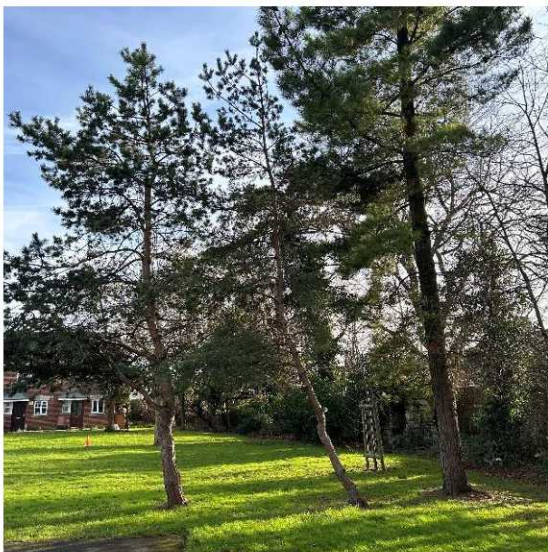
- 6.9 There are three pine planted within the open space to the east of tree 04 (image 5), a local resident expressed concern regarding the height of the west tree and the suitability of the trees for their location. I measured the height of the west pine (Monterey pine) as 16m tall and found no issues with the form or condition that could lead to a foreseeable failure. It should be noted that the pine has the capacity to reach a significantly larger size. There is a young pine in the centre of the three trees that is developing poor crown form due to suppression from the other two pines and it would be reasonable to remove this tree in the interest of good long term management to the benefit of the two adjacent pine.

**Image 5:** Row of 3 pine in public open space with the middle tree developing poor form.

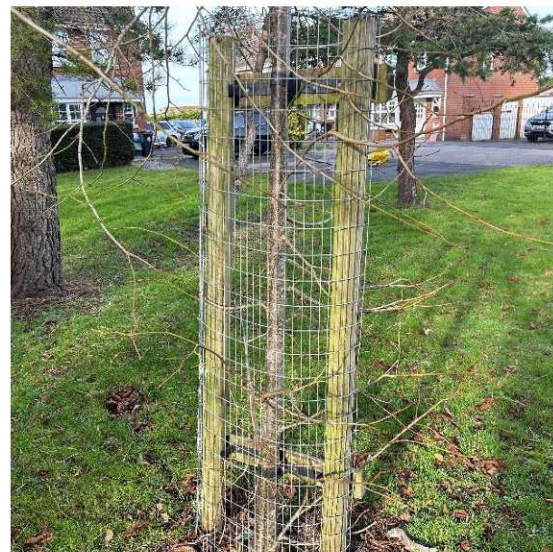
- 6.10 A young lime was noted in a tree shelter adjacent to the three pine, the young tree had two tree ties that were tight and in need of adjustment, if not adjusted they are likely to cause irreversible stem damage during the 2024 growing season.

**Image 6:** Newly planted lime with tree ties in need of adjustment.
