Job No. 22384

BROOK END FARM,
ISLAND VIEW,
BROOK END,
COTTERED, HERTFORDSHIRE
SG9 9QR

REPORT
ON
STRUCTURAL INSPECTION

Re : Structural Inspection of Existing Precast Concrete Portal Frame Barn at Island View, Brook End, Cottered, Herts SG9 9QR.

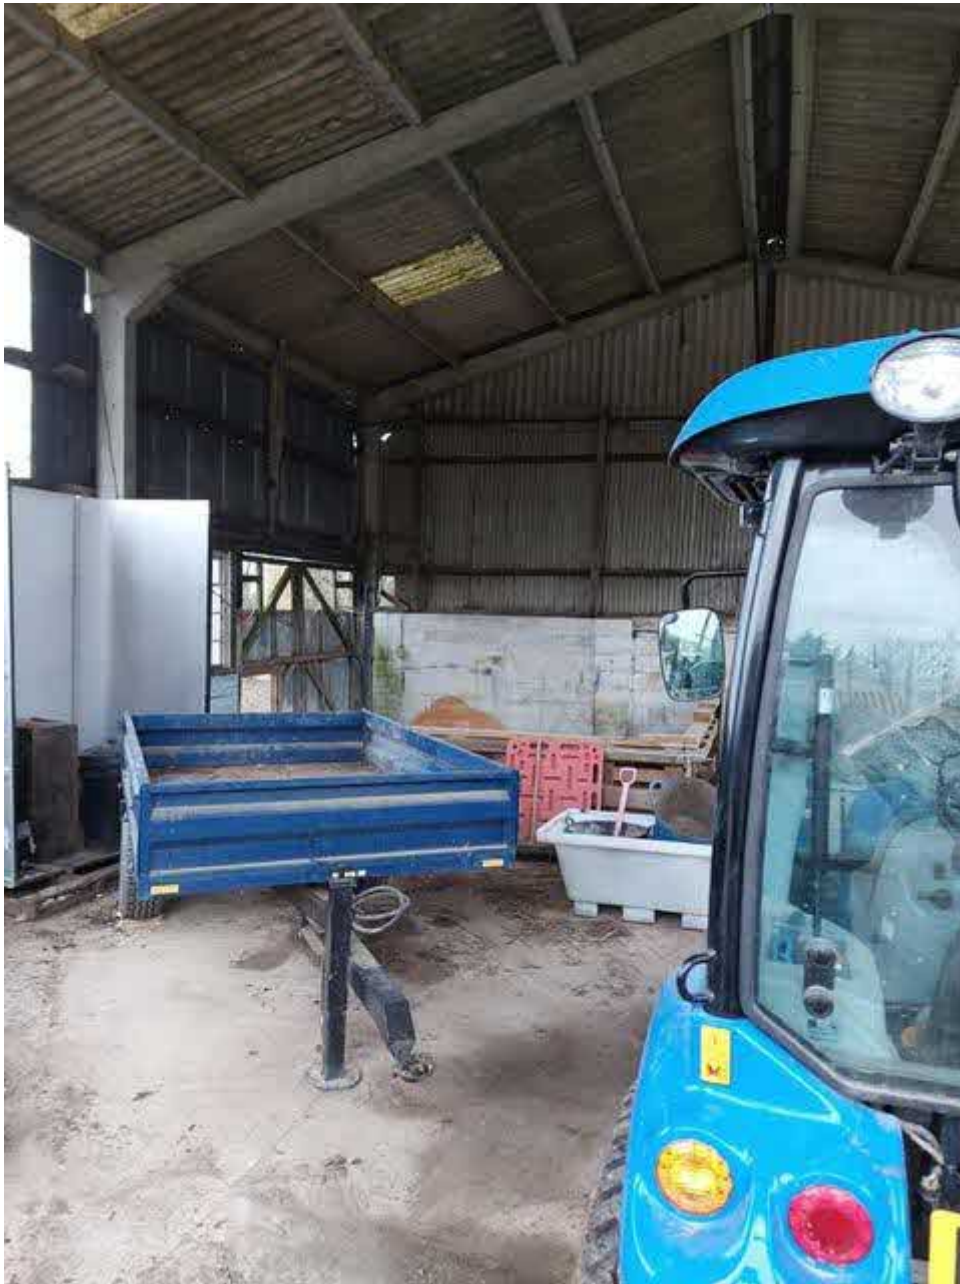
Existing Barn

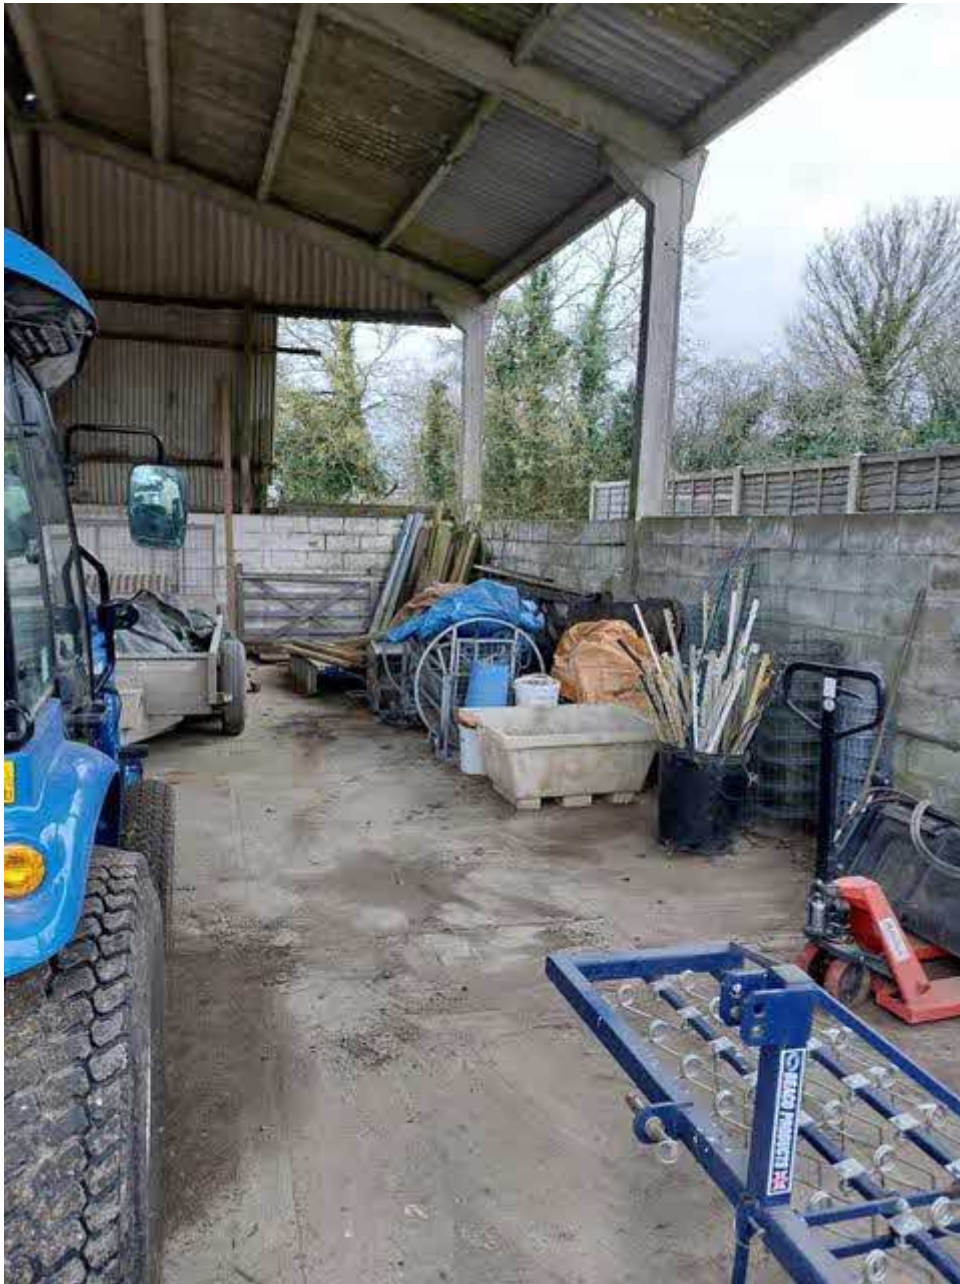
Existing Barn

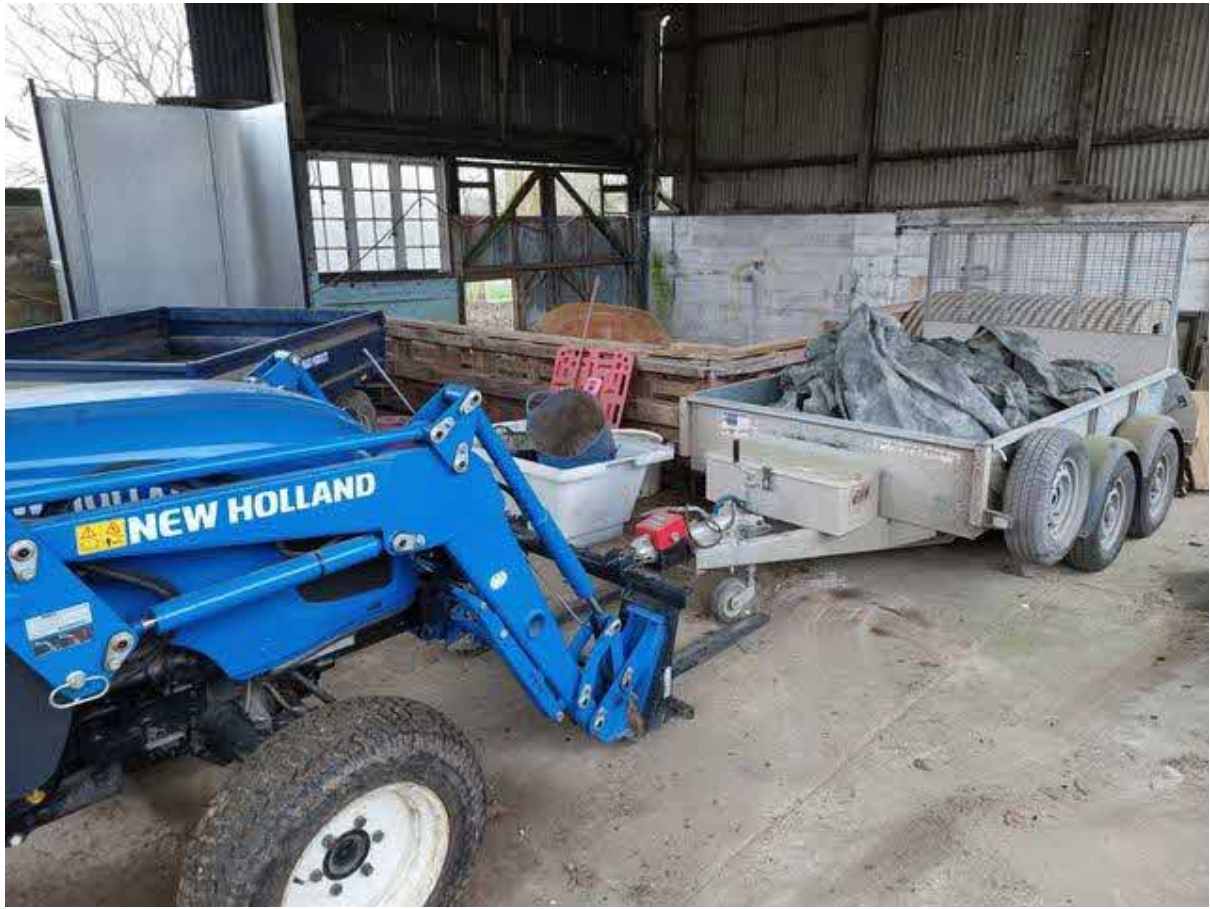
Existing Barn

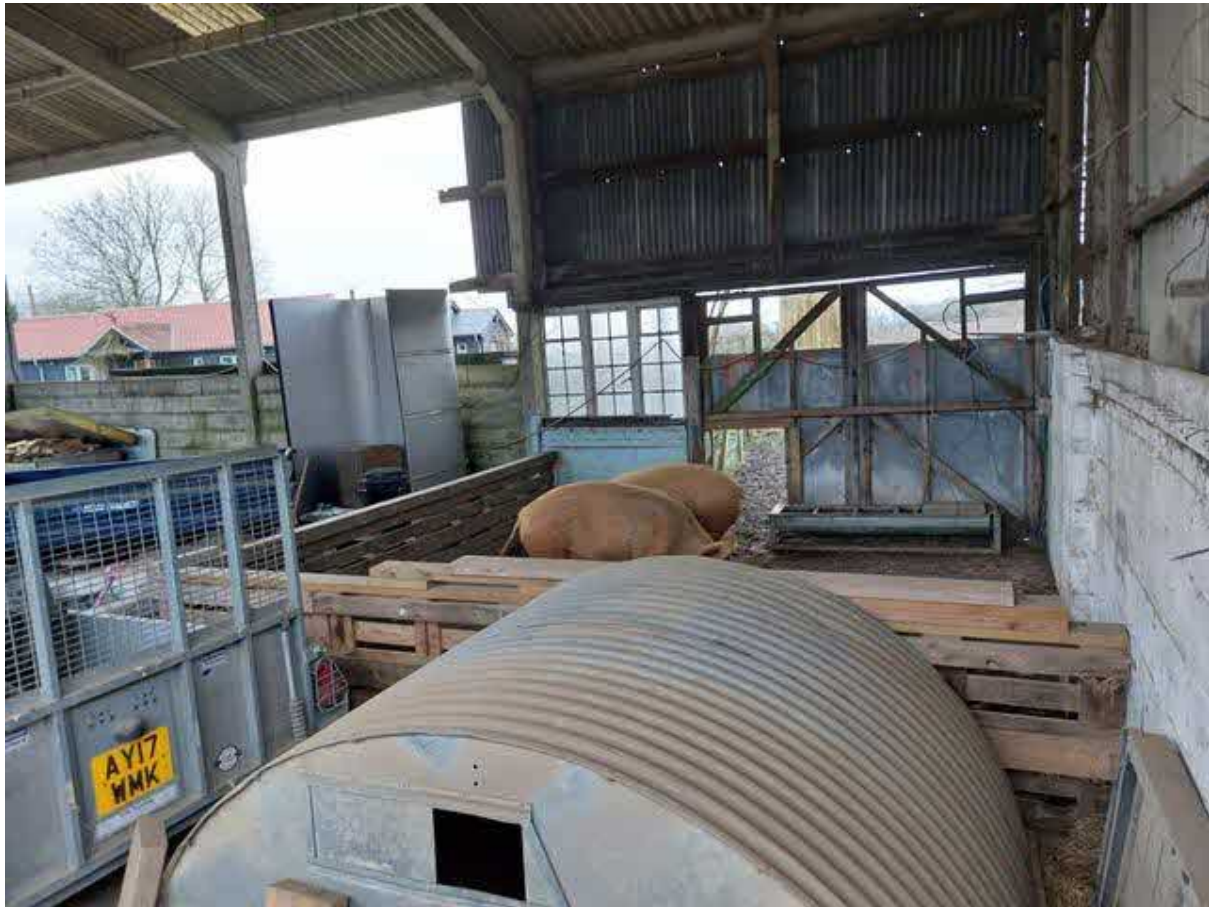
Existing Barn
