Contaminated Land Phase One Desk Study for proposed residential development at 767 Market Street, Whitworth, Rochdale, OL12 8LS.

Prepared for

James Campbell Associates Ltd,
173 Rochdale Road,
Firgrove,
Rochdale,
OL16 3BN

October 2022

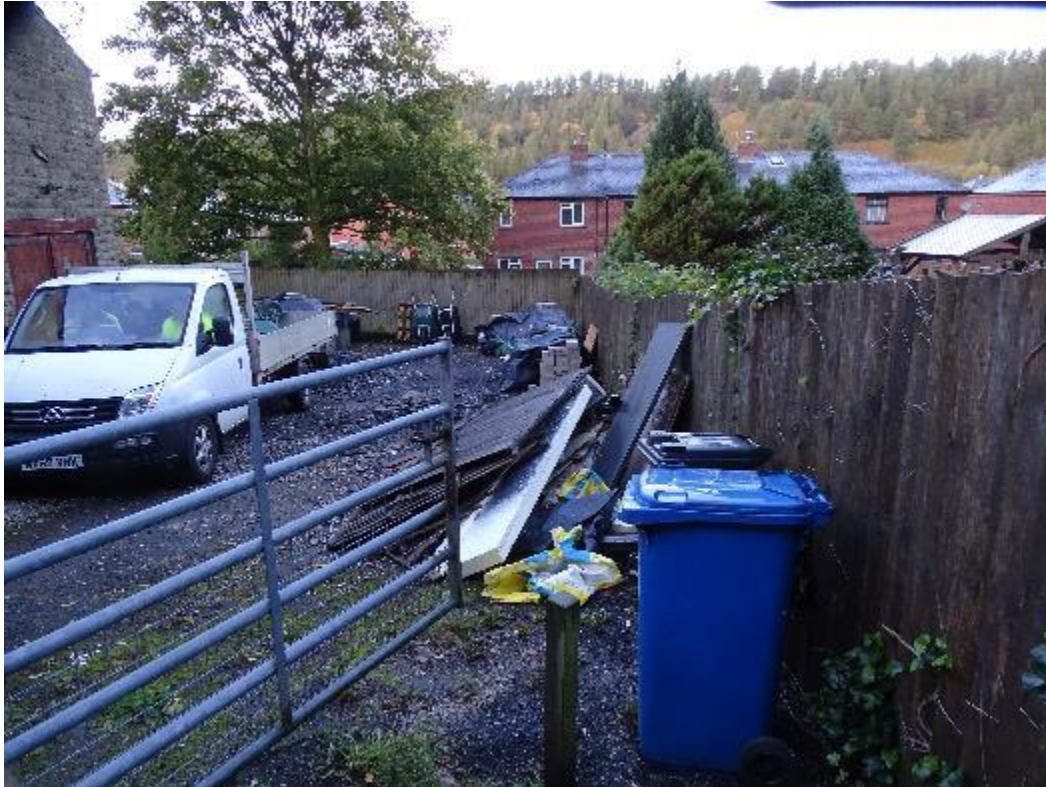
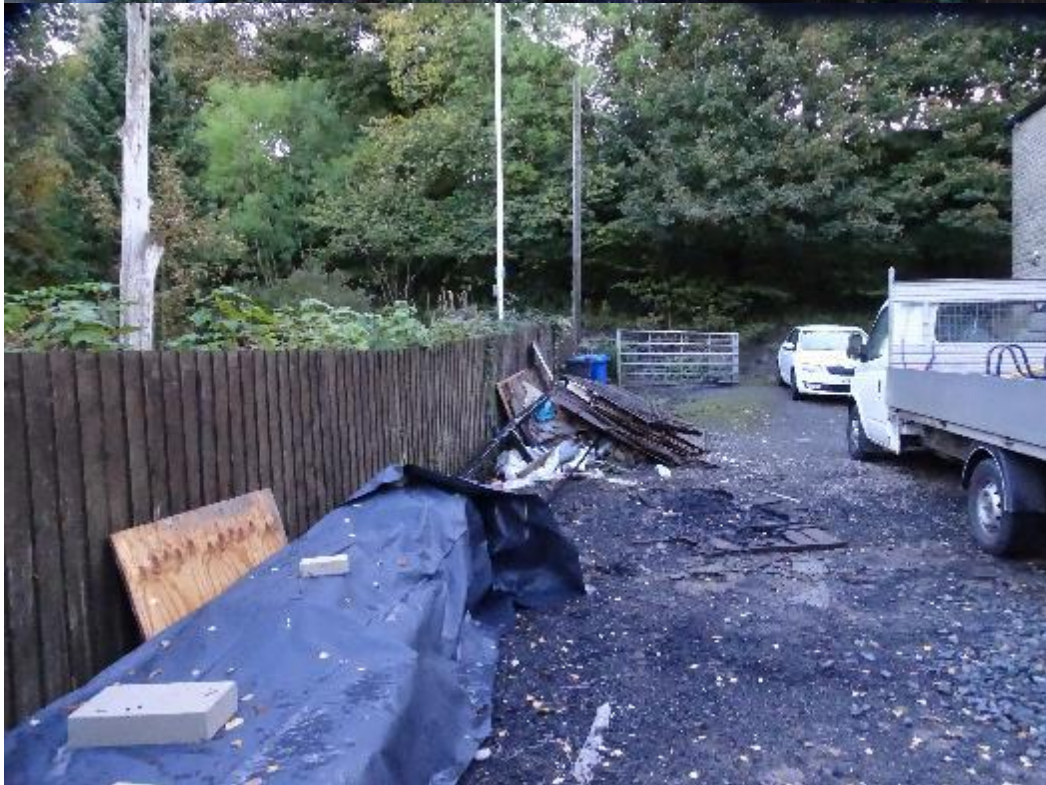
Access to the site from the main road

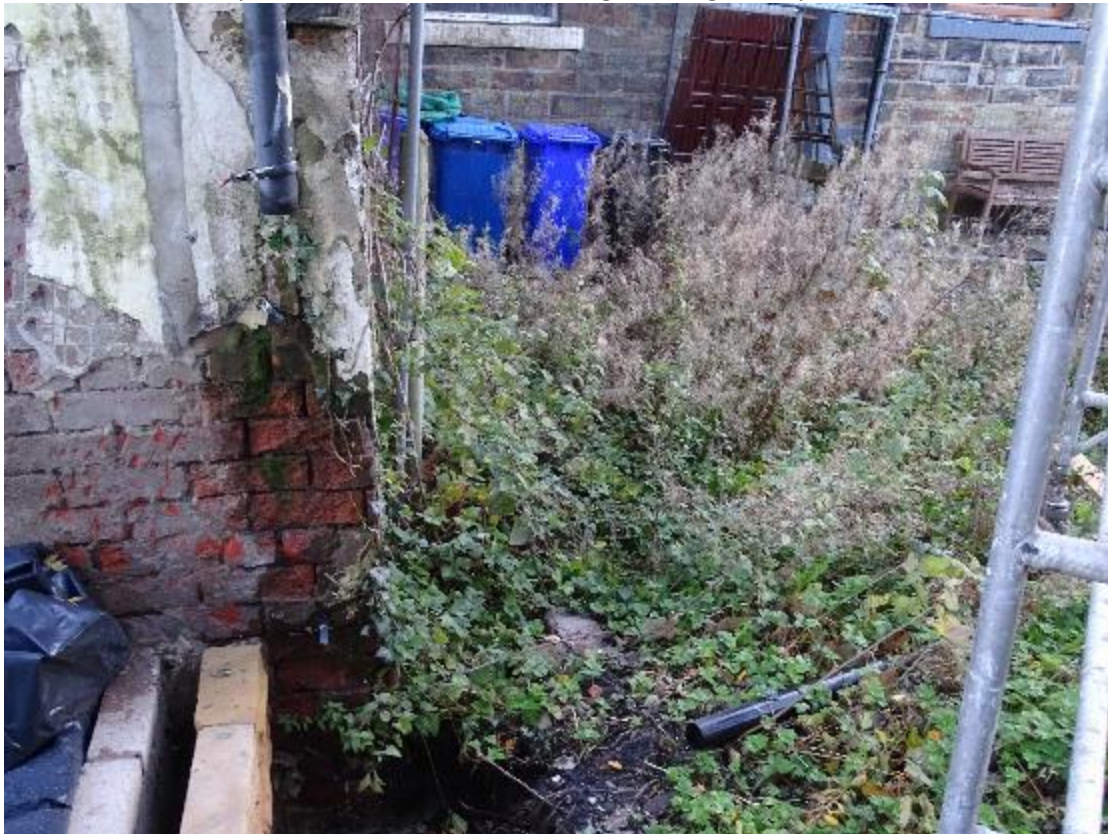
No signs of contamination, discoloration or olfactory evidence, dead or dying vegetation were seen during the walkover.

The rear "Garden", plus a trench that has been dug showing the topsoil.

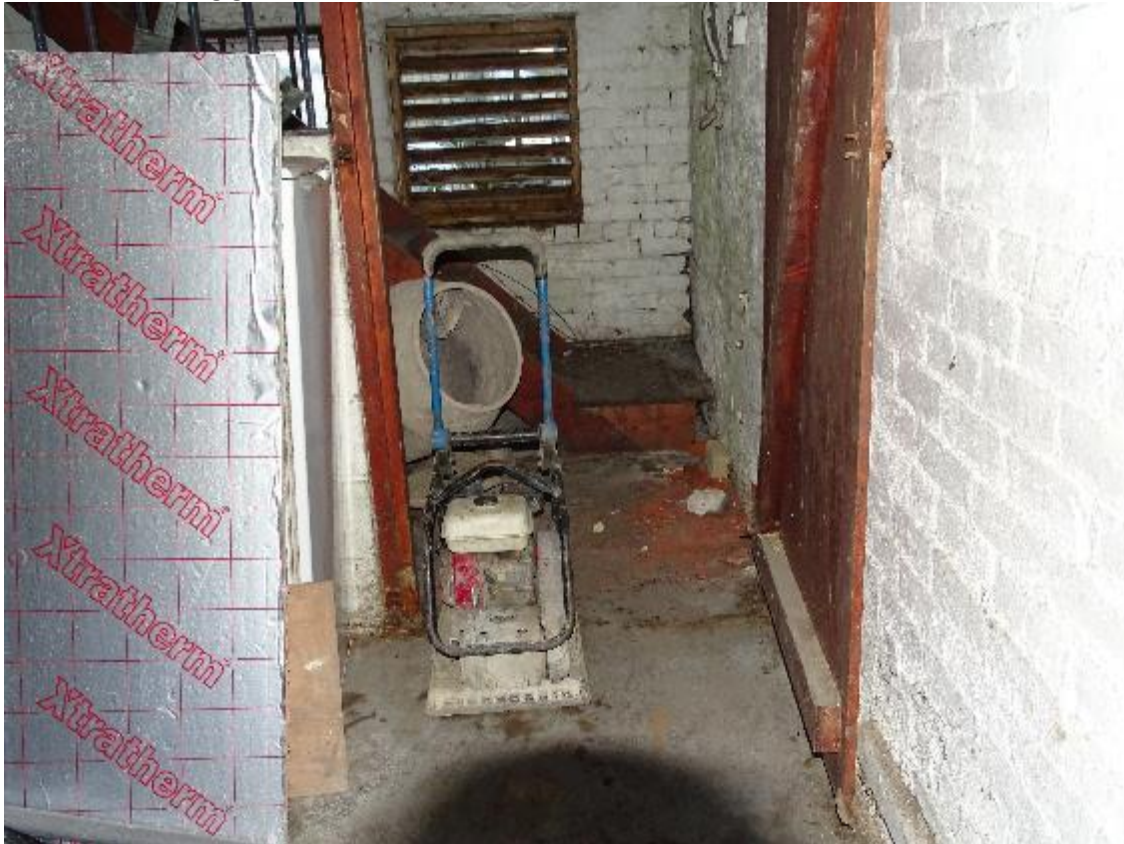
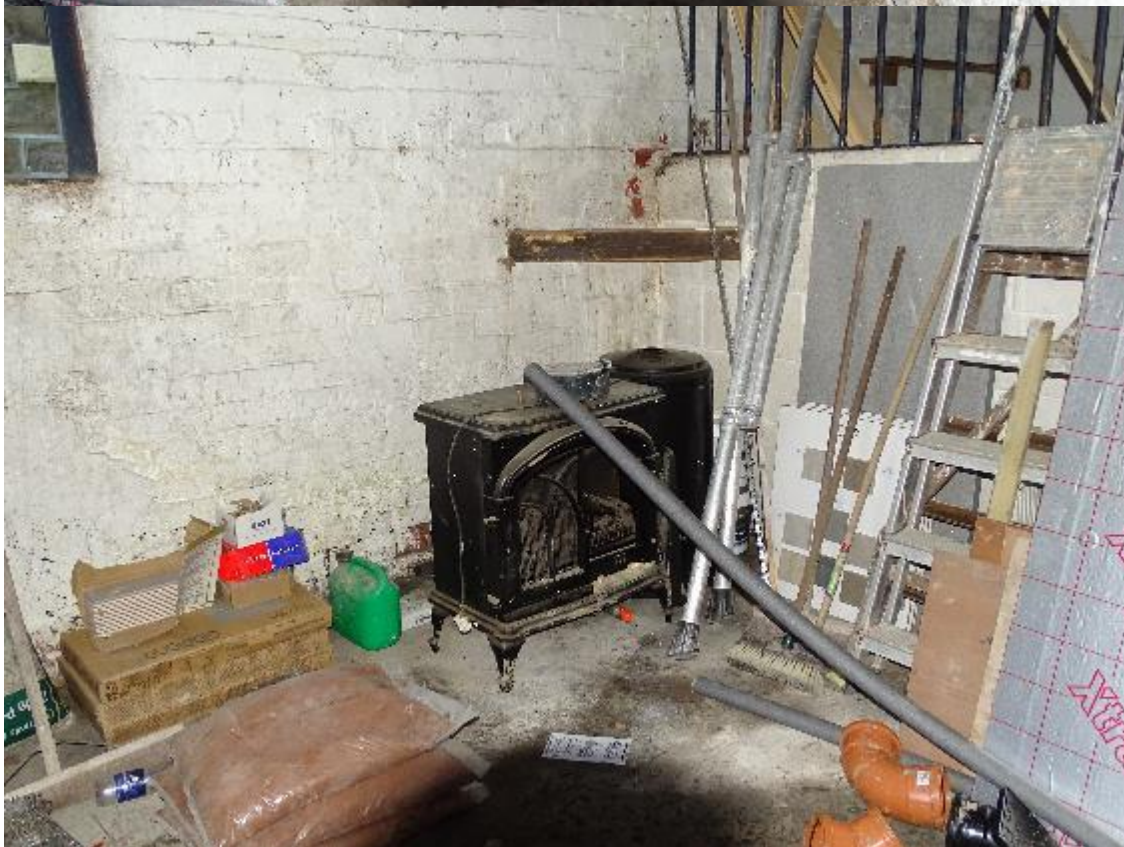
In the centre is the stable block to be converted. This is a two-storey building with a slate roof and floor. The flooring is to be replaced as part of the conversion.

Inside the building ground floor

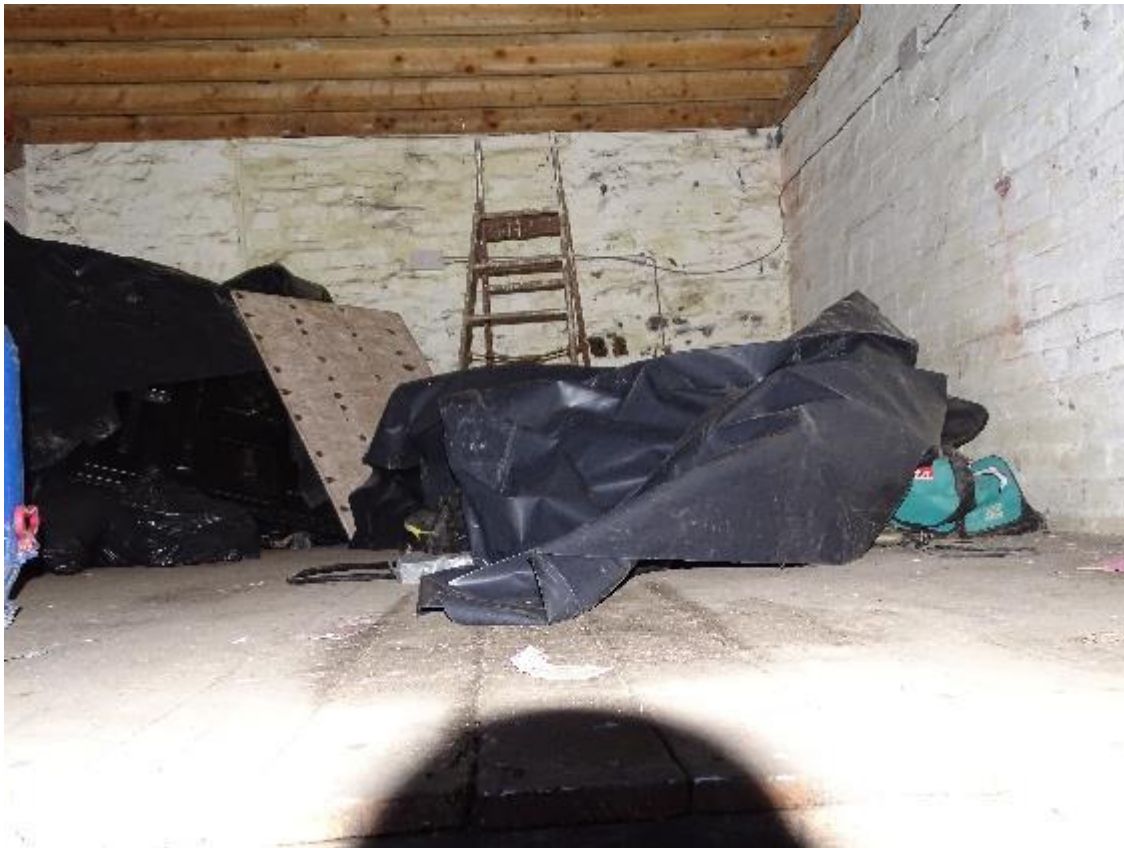
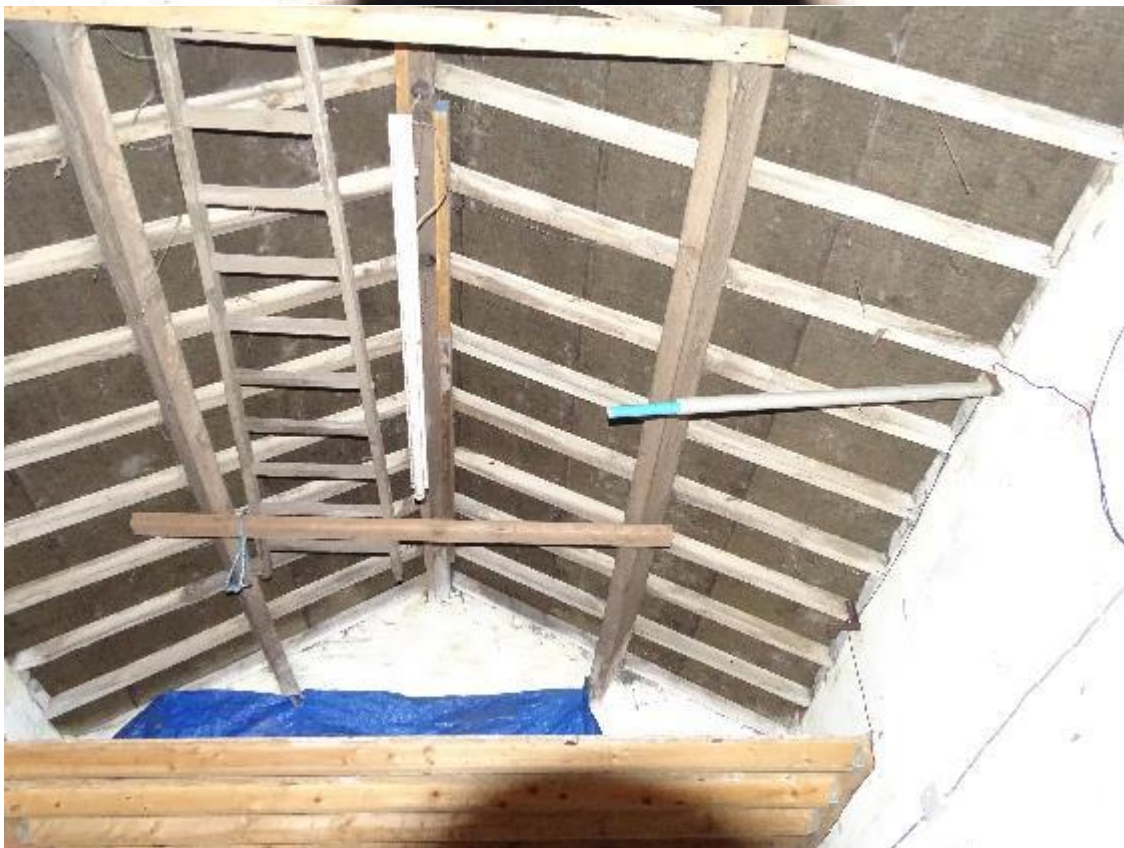
First floor
