Date: 29 November 2023

Our Ref: 1000/2649/DL

39 SANDSIDE, SCARBOROUGH – BUILDING CONDITION REPORT AND REPAIR / DEVELOPMENT APPRAISAL

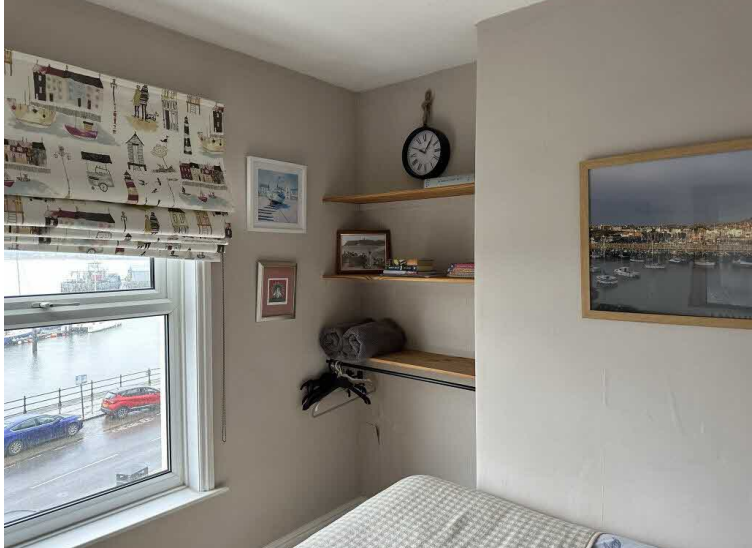
<p>3. General view within bedroom of the apartment. View defective wallpaper which is caused by water ingress / dampness. Such issues are present throughout the property.</p>

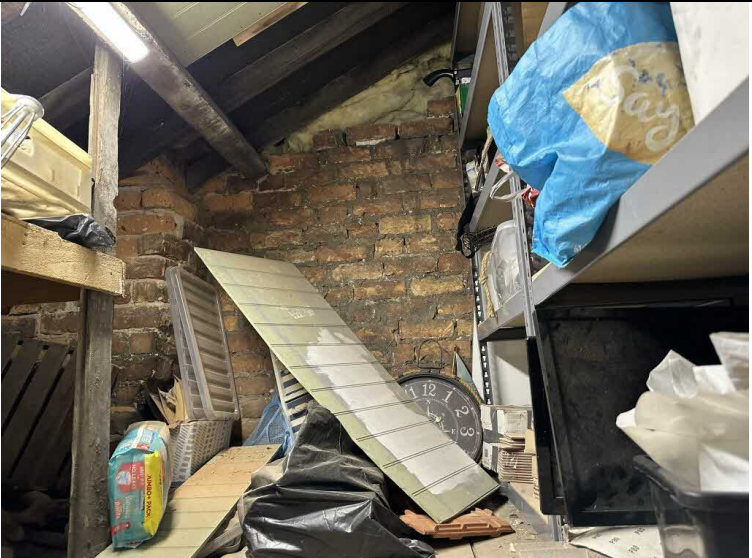
4. View within the roof space of the damp timbers, damaged brickwork and lack of appropriate fire stopping material.

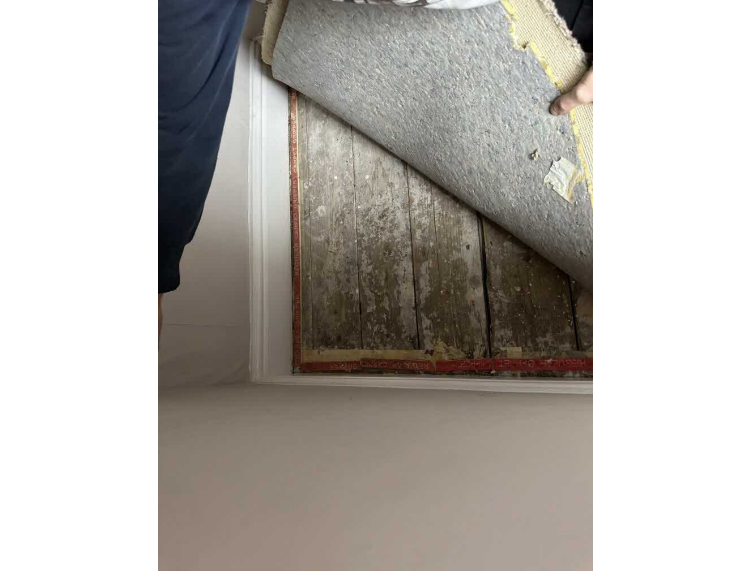
5. View of the timber suspended floor which is damp to touch.

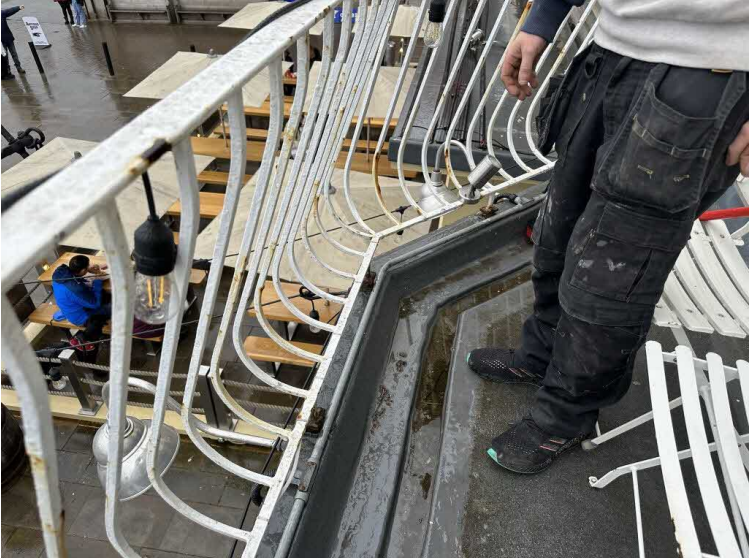
6. View of deck to the balcony areas. The deck is saturated and is structurally in poor condition with deflection noted.

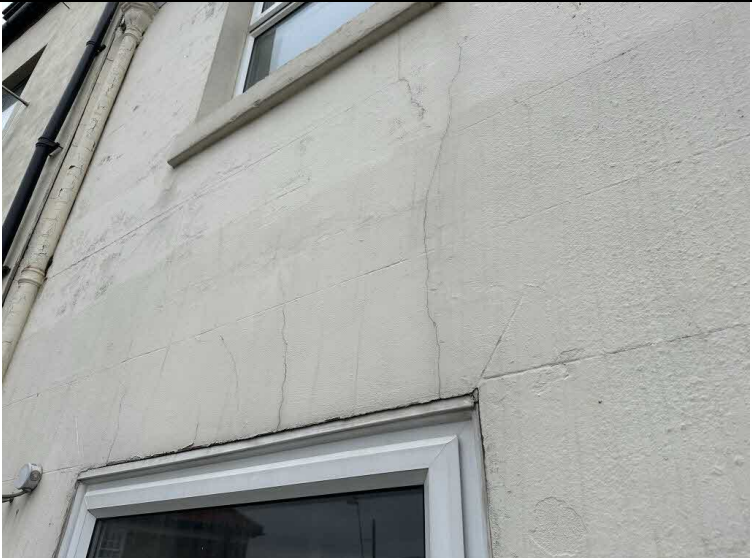
- **Structural Issue 1 - Widespread structural movement including bulging and out of line wall surfaces with rotated lintels.**
- **Structural Issue 2 – Collapsed Elements** – We have concerns surrounding the potential for partial structural collapse, having opened up the structure. Within the bar area to the ground floor, we removed a single ceiling tile to assess the structure above. When the ceiling tile was displaced, a large chunk of masonry fell from the packing around the structural timber. This appears to be a widespread issue, having inspected the ceiling voids as far as is reasonably possible.

7. View of cracking above window heads and bulging walls.

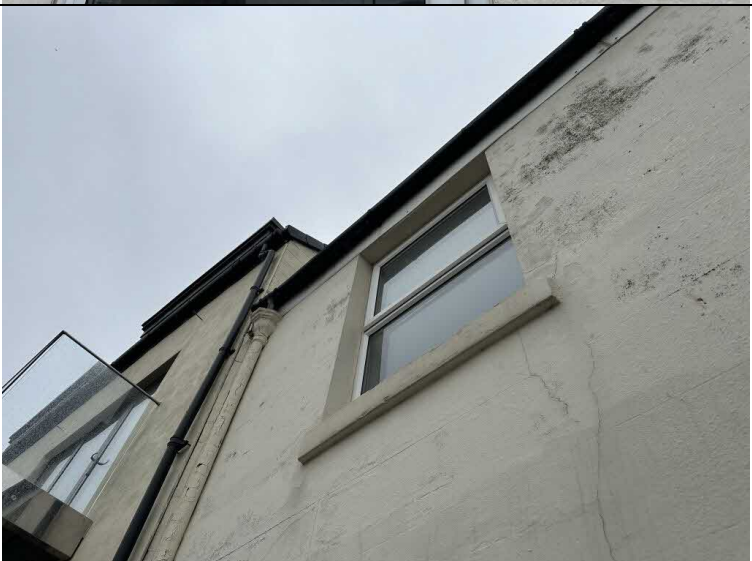
8. View of spalling render due to exposed coastal location.

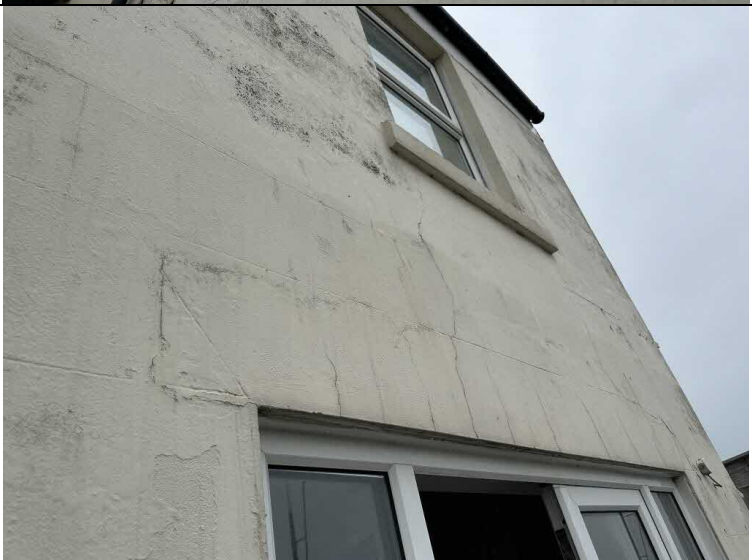
9. View of cracking between floor levels.

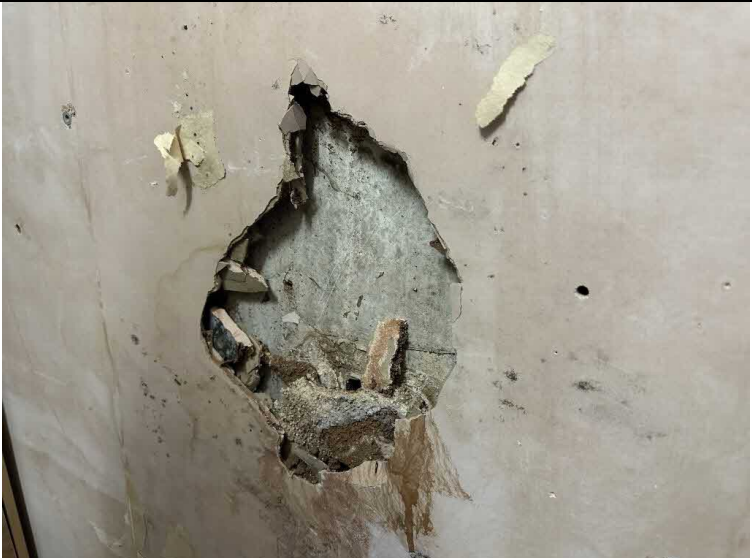
10. View of damaged plasterwork within the bar areas which have de-bonded with the substrate below due to dampness and movement.

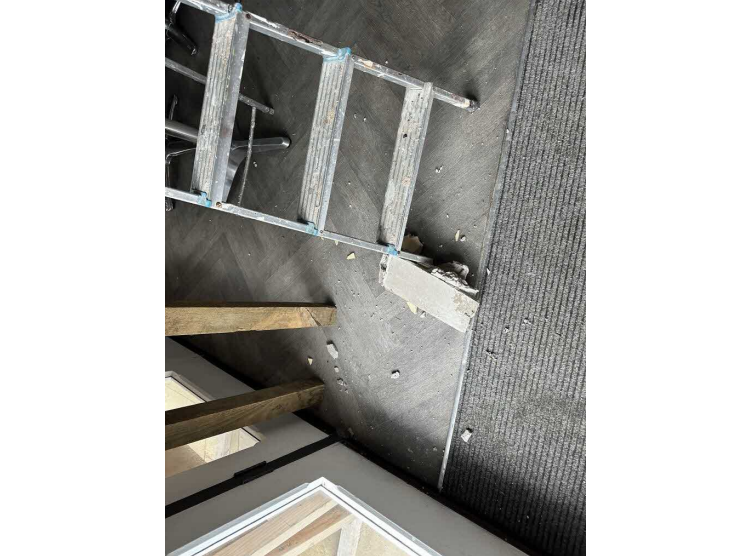
- **Structural Issue 5 - Masonry Defects** - Significantly deteriorated masonry which has decayed in areas to a powdered composition. Large sections of the masonry will require rebuilding as part of any planned renovation works to the existing building.

11. View of masonry that fell out when undertaking an inspection of the areas above the suspended ceiling.

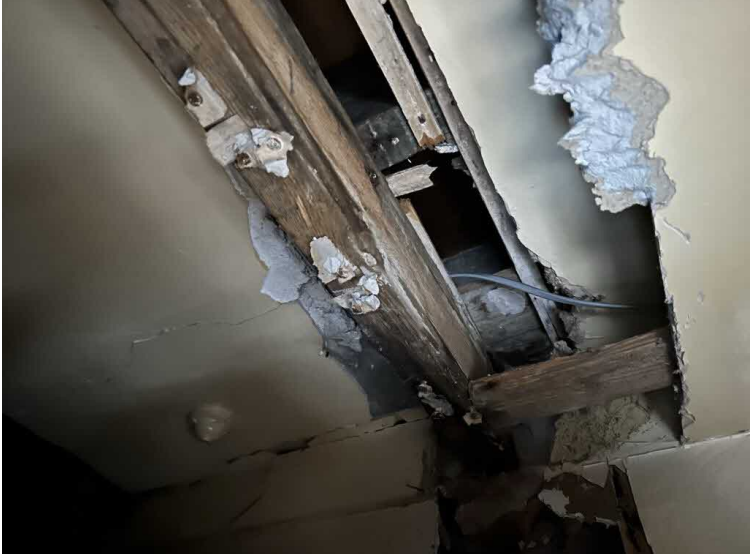
- **Structural Issue 4 - Timber Defects** - Severely decayed built in timbers in the form of beams, lintels, floor joists and roofing timbers. The majority of the timbers that we surveyed were damp and had signs of infestation. As such, structural timber replacements are likely to be required.

12. View of damp and rotated structural timbers to the floor structure above the ground floor.
