# TOPPING ENGINEERS

## STRUCTURAL INSPECTION REPORT

39 Sandside, Scarborough

**DOCUMENT REF:**  
23365-SIR-001

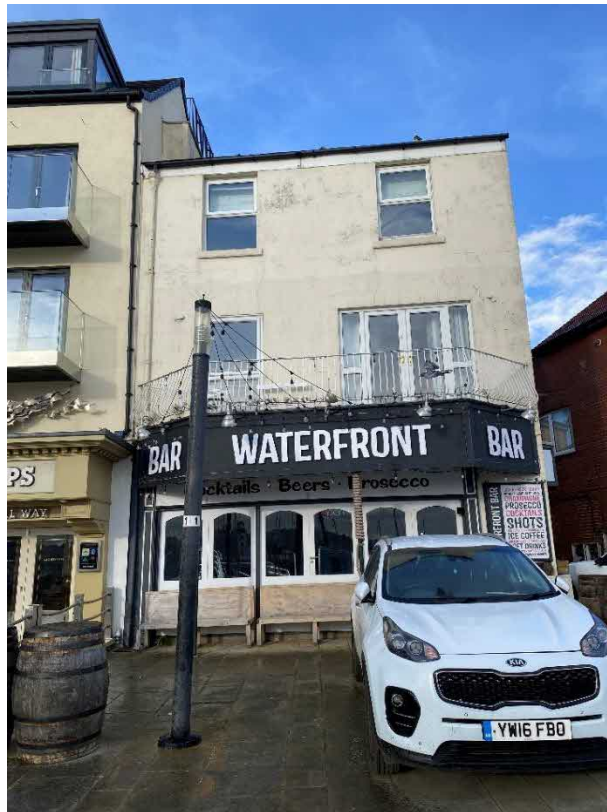
Front Elevation

The building has suffered significant structural movement. When facing the front of the building there is a gap of approximately 50mm diminishing to zero against the neighbouring building (the Anchor Restaurant). The gap has been filled. The rear elevation shows less severe movement, but similar movement is visible. The gable wall shows tension cracks to the southeast corner. The window heads on the front elevation have rotated significantly. In the worst case the rotation is approx. 40mm in 1 metre. The movement of the building indicates substantial settlement toward the south corner. Because the building is rendered and painted the vertical alignment of horizontal bed joints in the brickwork is not visible & this is often used as a key indicator of structural movement. Consequently the movement is not as obvious as a building without the render finish.

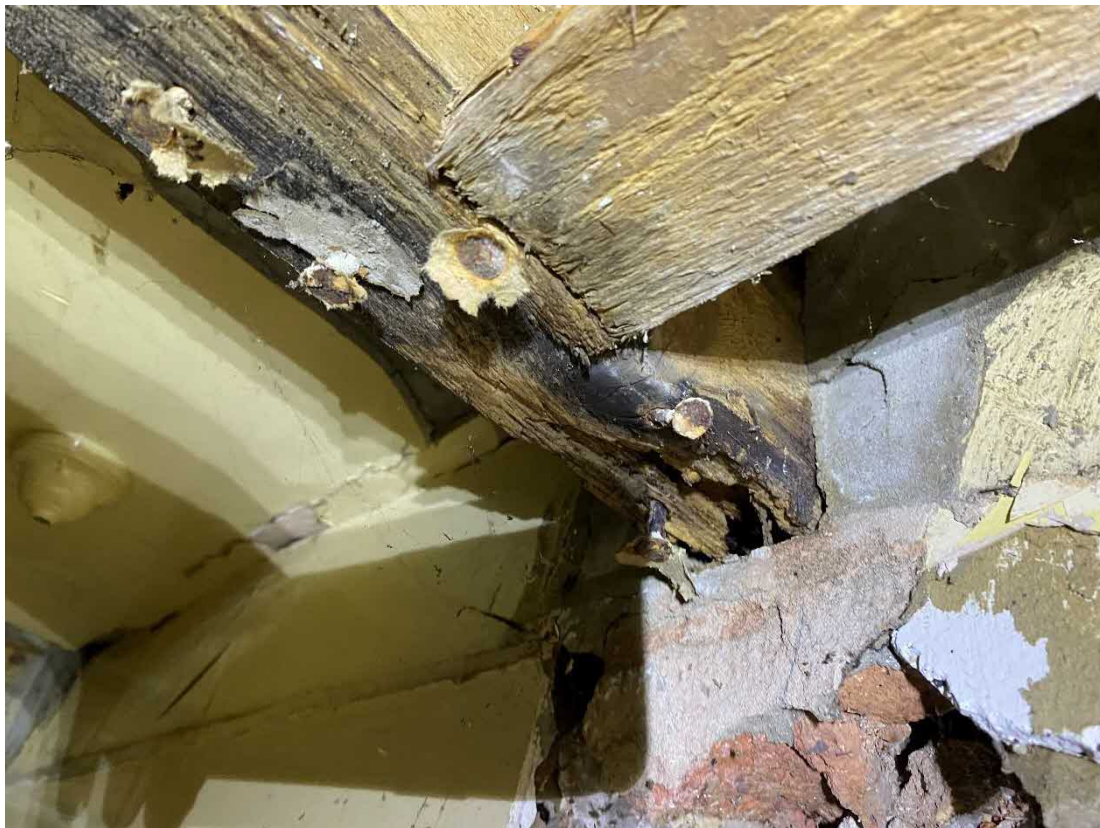
The cantilevered balcony has deflected approximately 50mm away from the railings and is in an unsafe condition. Where the ceiling void is visible in the bar at ground floor there are two layers of ceiling. The upper ceiling has partially collapsed onto the lower ceiling within the void and there is evidence of timber fungal decay on the south elevation wall.

Rotten Timber in Ceiling

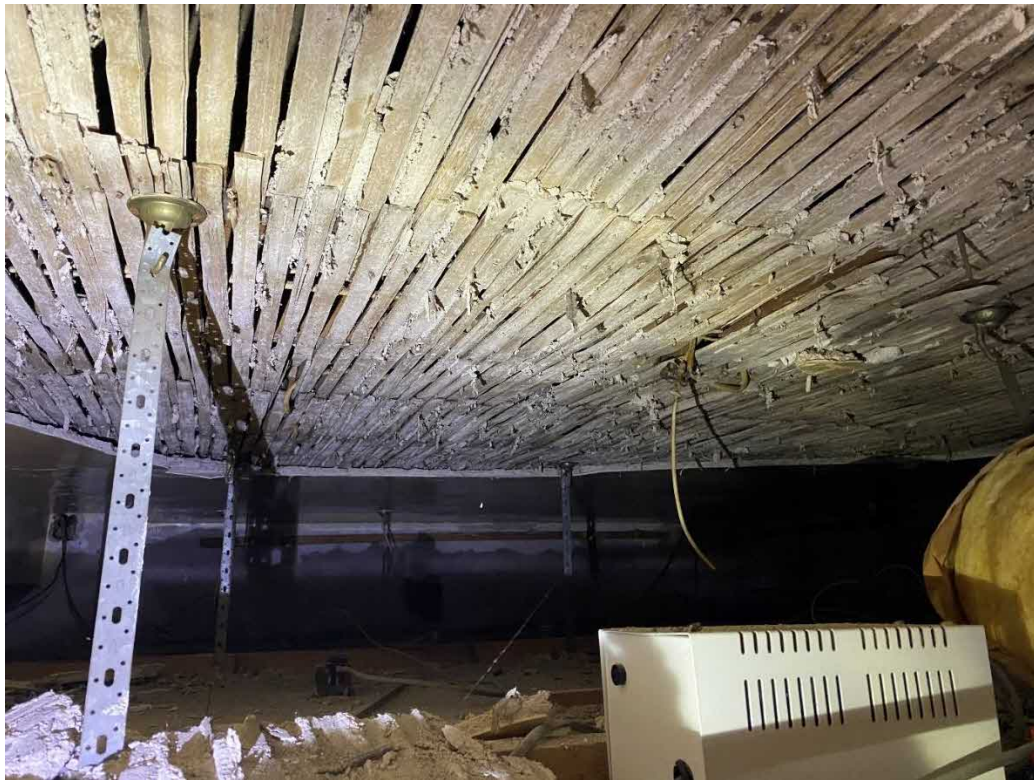
Internal view of ceiling void

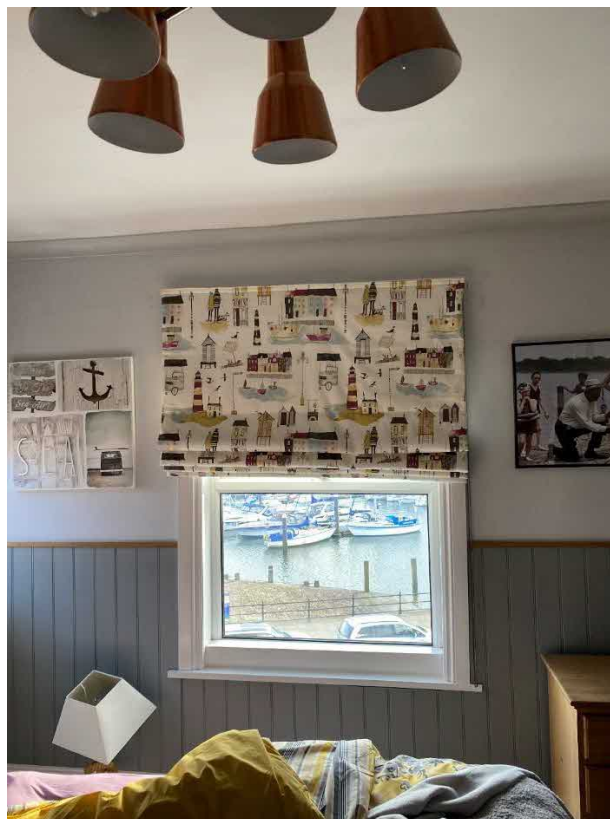
Movement at Window Head. Rotation from left to right

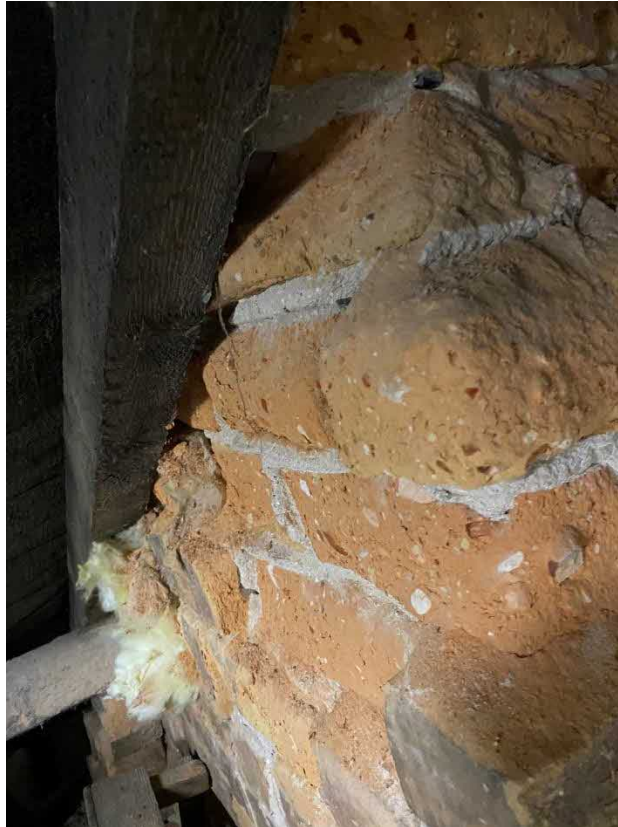
Internally the brickwork is exposed in the loft space and has perished to powder in places.

Severely Eroded Brickwork in Roof Space
