# Addendum Arboricultural Report

## Subsidence Damage Investigation at:

164 Hampstead Way  
London  
NW11 7XD

CLIENT:	Claims Consortium Group
CLIENT REF:	244176
MWA REF:	SUB200818-7471Rev01
MWA CONSULTANT:	Andy Clark
REPORT DATE:	29/01/2024

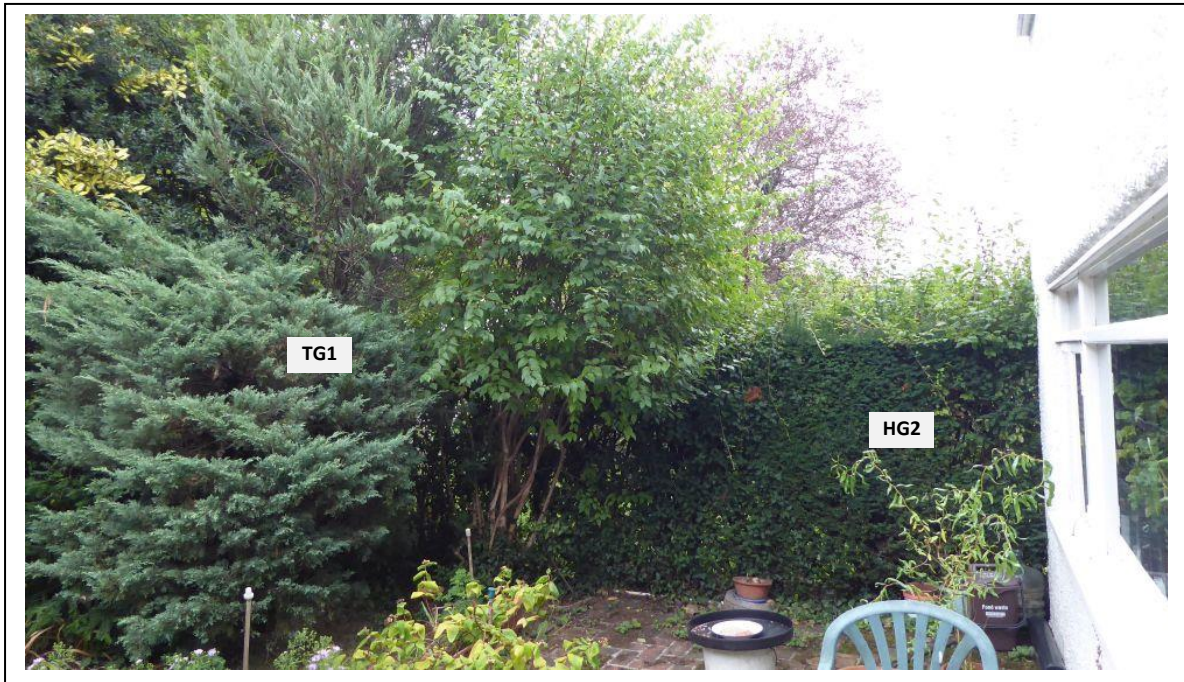
Irrespective of the identification of recovered root samples, our survey has identified vegetation within influencing distance of the building with a current potential to influence soil volumes below foundation level; the most significant of which in relation to the current damage are the nearby hedge and shrub groups, identified as HG1, HG2, SG1 and TG1.

View of TG1 group to left of frame and HG2 hedgerow beyond

Recommendation		Remove (fell) all within 5.5m of the building to near ground level and remove any regrowth as it emerges [herbicide translocation risk].					
HG2	Mixed species hedgerow group of mostly Yew and Holly	2.5	50 Ms *	1.0	0.3 *	Younger than Property	Third Party 162 Hampstead Way NW11 7XD
Management history		Subject to past management/pruning - appears regularly trimmed.					
Recommendation		Remove (fell) all within 3.5m of the building to near ground level and remove any regrowth as it emerges [herbicide translocation risk].

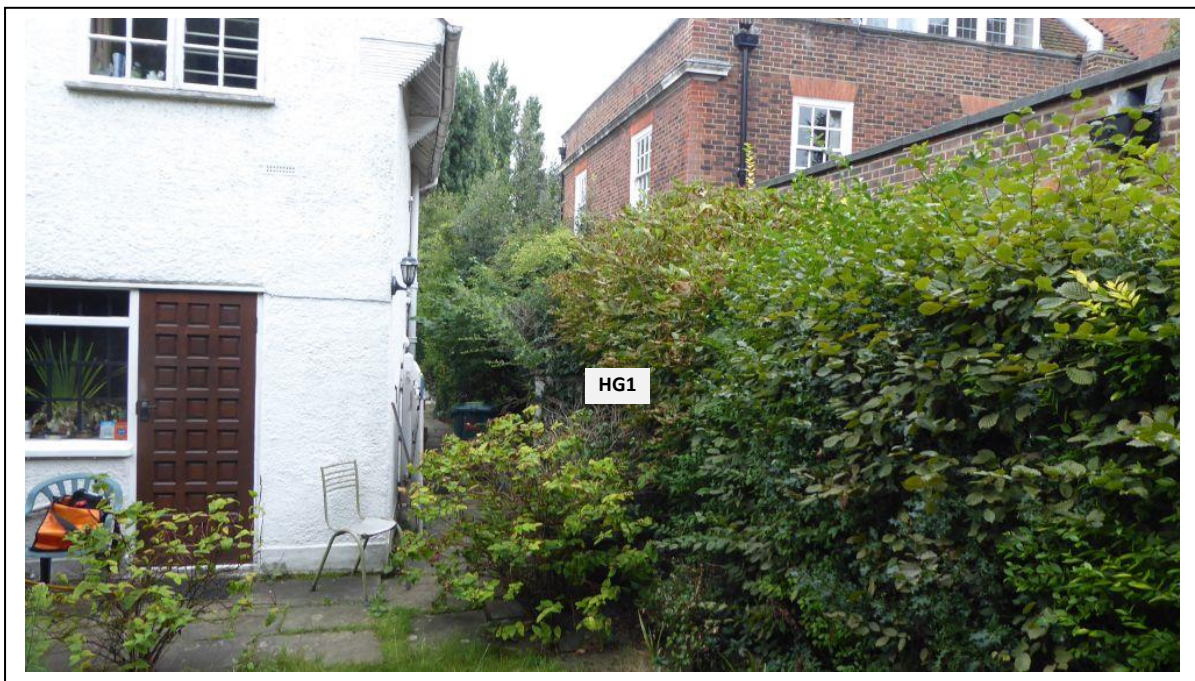
The Oleaceae spp. roots and the probably Philadelphus spp. roots will be from the various related shrubs around the property gardens. The Platanus spp. roots will be from the T3 London Plane. The Aesculus spp. roots will be from the Horse Chestnut stem within HG1 hedgerow.

Works were carried out in April 2023 to reduce the height of HG1 hedgerow to 2.0m, however the ongoing movement recorded over the following months demonstrates that reduction has not restored stability to the building and so further works are required.

View from property rear of HG1 hedgerow group

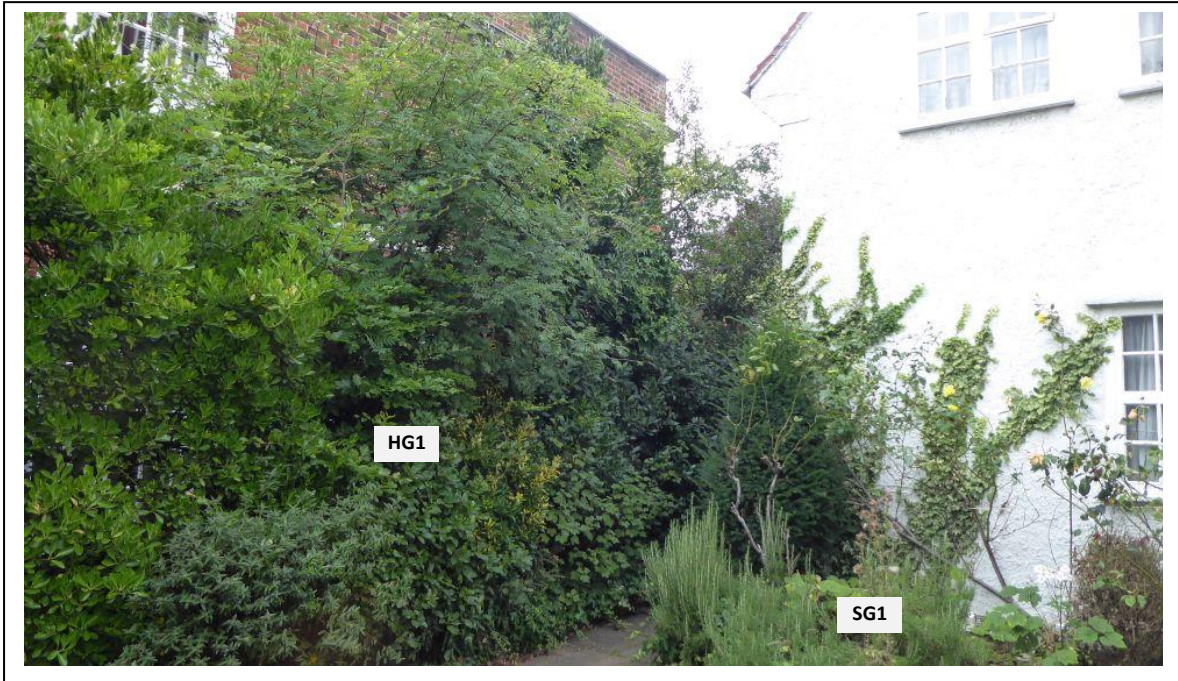
View from property frontage of HG1 group to left of frame and SG1 group to foreground

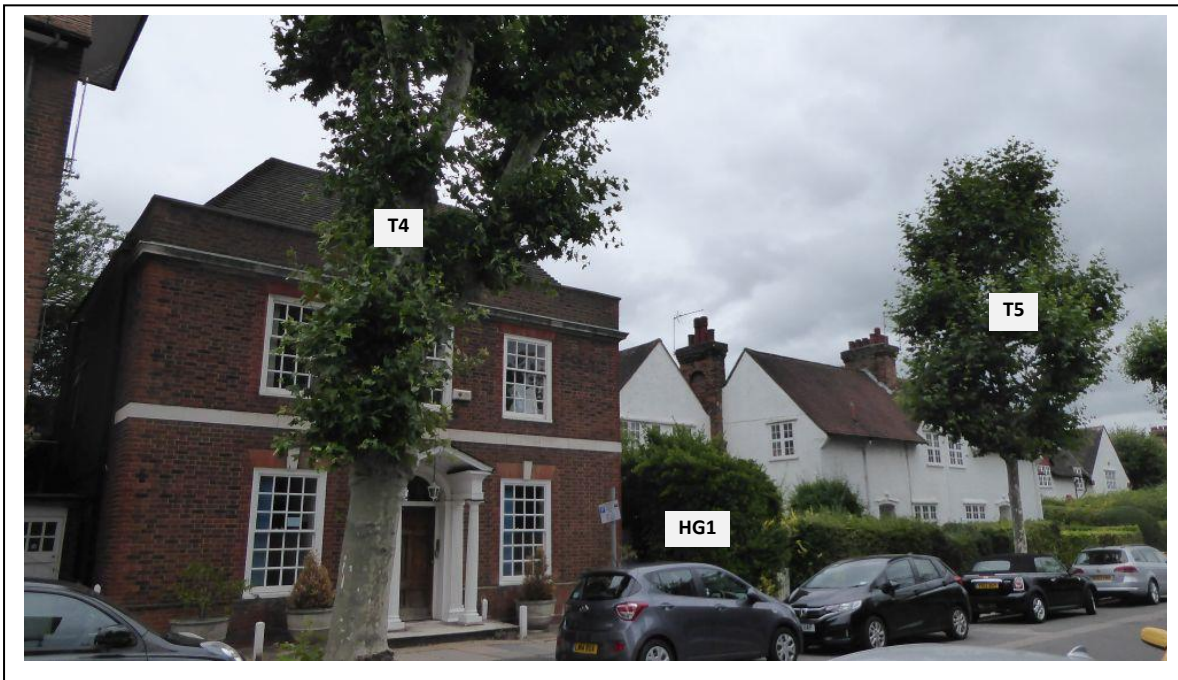
Overview of T4 and T5 London Planes with HG1 group visible to centre frame
