**SITE INVESTIGATION REPORT**

**S20074**

164 HAMPSTEAD WAY, LONDON, NW11 7XD

**S20074 Report 1**

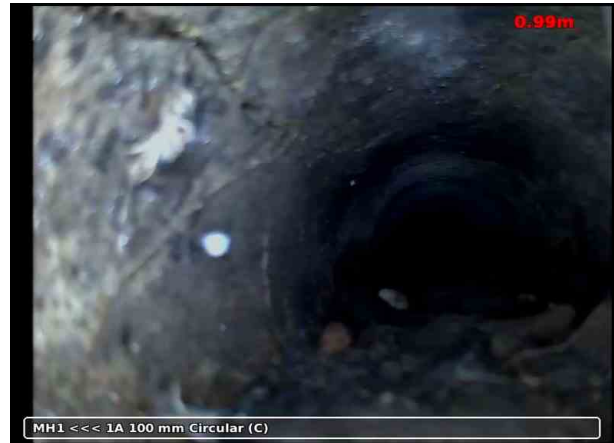
2, 00:00:24, 0.99 m  
Fracture, longitudinal at 10 o'clock

Town or Village:	London	Inspection Direction:	Upstream	Upstream Node:	A
Road:	164 Hamsteead Way	Inspected Length:	5.70 m	Upstream Pipe Depth:	0.000 m
Location:	Other (state in comments)	Total Length:	5.70 m	Downstream Node:	MH1
Surface Type:		Joint Length:	0.00 m	Downstream Pipe Depth:	0.900 m
Use:	Other	Pipe Shape:	Circular		
Type of Pipe:	Gravity drain/sewer	Dia/Height:	100 mm		
Year Constructed:		Pipe Material:	Vitrified clay pipe (i.e. all clayware)		
Flow Control:	No flow control	Lining Type:	No Lining		
Inspection Purpose:	Sample survey to determine asset condition	Lining Material:	No Lining		
Comments:	Large section of debris and silt / Cracks in line				
Recommendations:	Establish if 'live' / High pressure water jet and CIPP patch line defects if 'live'

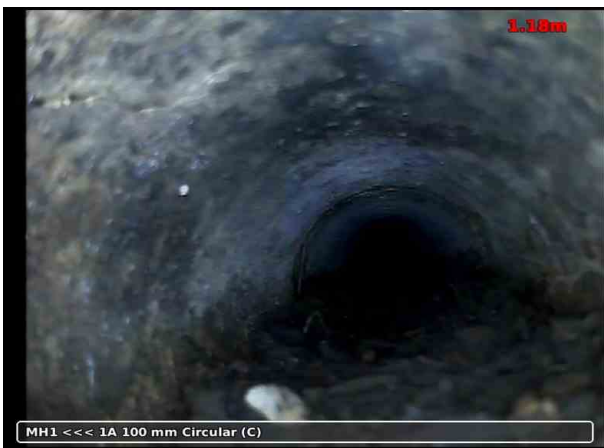
3, 00:00:26, 1.18 m  
Settled deposits, hard or compacted, 40% cross-sectional area loss, start

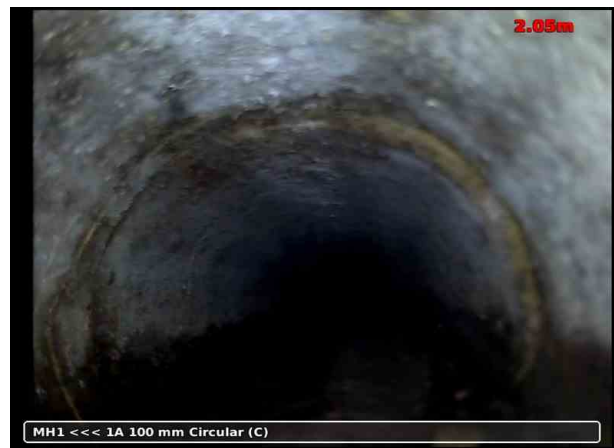
4, 00:00:41, 2.05 m  
Crack, circumferential from 7 o'clock to 11 o'clock

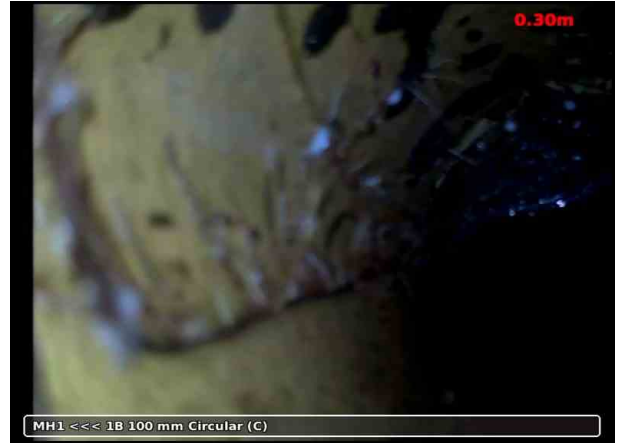
2, 00:00:15, 0.30 m  
Roots, fine at joint

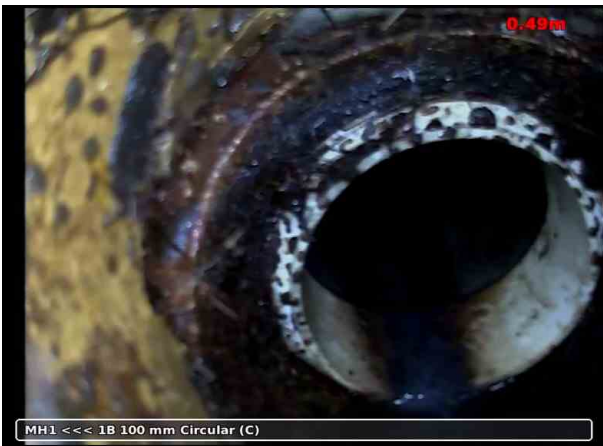
3, 00:00:21, 0.49 m  
Roots, fine at joint

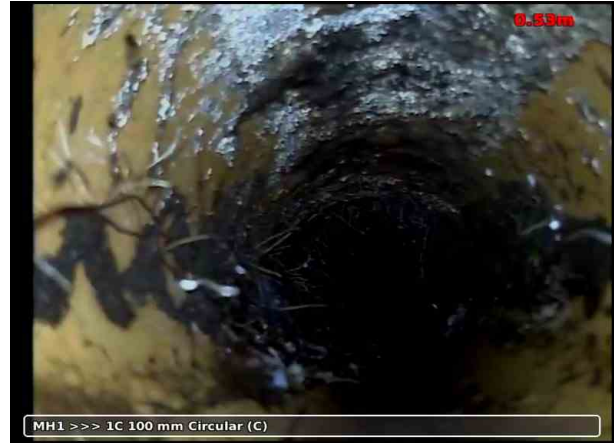
The rear manhole (MH1) downstream to MH2, was found to be suffering from heavy root ingress and a partially collapsed pipe adjacent to its entry into MH2.

2, 00:00:18, 0.53 m  
Roots, tap, start

Town or Village:	London	Inspection Direction:	Downstream	Upstream Node:	MH1
Road:	164 Hamsteead Way	Inspected Length:	4.75 m	Upstream Pipe Depth:	
Location:	Under a permanent building	Total Length:	4.94 m	Downstream Node:	MH2
Surface Type:		Joint Length:	0.00 m	Downstream Pipe Depth:	
Use:	Combined	Pipe Shape:	Circular		
Type of Pipe:	Gravity drain/sewer	Dia/Height:	100 mm		
Year Constructed:		Pipe Material:	Vitrified clay pipe (i.e. all clayware)		
Flow Control:	No flow control	Lining Type:	No Lining		
Inspection Purpose:	Sample survey to determine asset condition	Lining Material:	No Lining		
Comments:	Mass roots and partially collapsed line				
Recommendations:	Excavate and renew

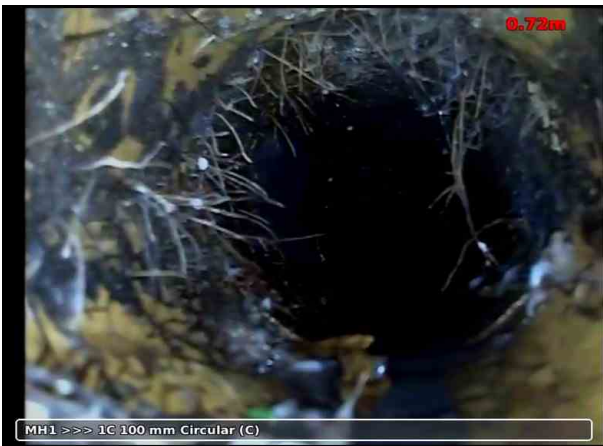
3, 00:00:20, 0.72 m  
Roots, mass at joint, 10% cross-sectional area loss

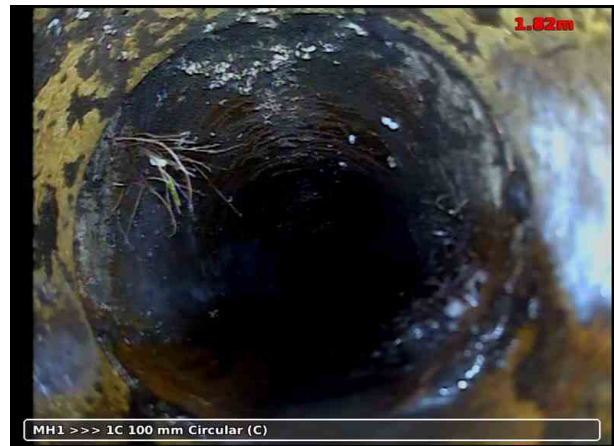
4, 00:00:34, 1.82 m  
Roots, fine at joint

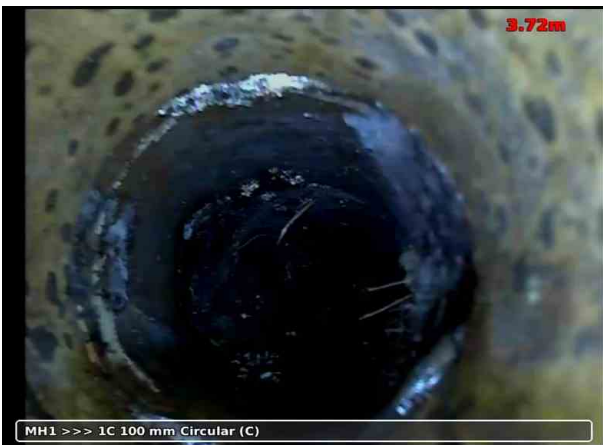
5, 00:00:52, 3.72 m  
Crack, circumferential at joint from 8 o'clock to 4 o'clock

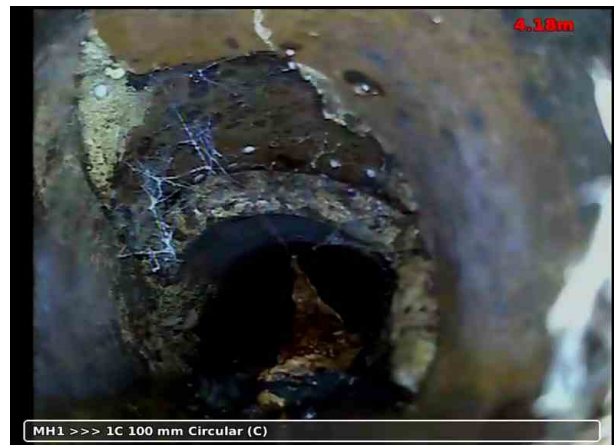
6, 00:00:59, 4.18 m  
Collapsed drain or sewer

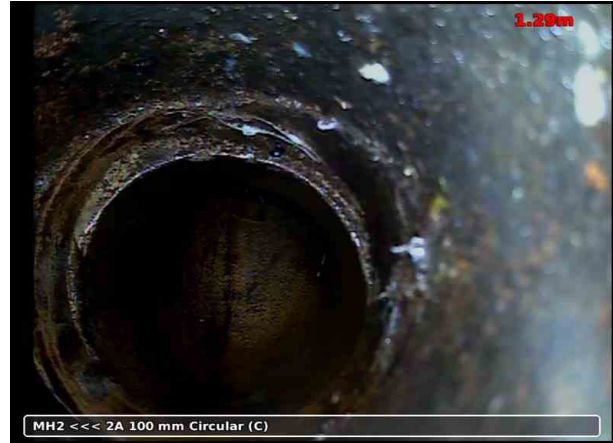
2, 00:00:22, 1.29 m  
Fracture, circumferential from 12 o'clock to 12 o'clock

<b>Town or Village:</b>	London	<b>Inspection Direction:</b>	Upstream	<b>Upstream Node:</b>	SVP
<b>Road:</b>	164 Hamsteead Way	<b>Inspected Length:</b>	1.79 m	<b>Upstream Pipe Depth:</b>	0.000 m
<b>Location:</b>	Under a permanent building	<b>Total Length:</b>	1.90 m	<b>Downstream Node:</b>	MH2
<b>Surface Type:</b>		<b>Joint Length:</b>	0.00 m	<b>Downstream Pipe Depth:</b>	1.200 m
<b>Use:</b>	Combined	<b>Pipe Shape:</b>	Circular	<b>Dia/Height:</b>	100 mm
<b>Type of Pipe:</b>	Gravity drain/sewer	<b>Pipe Material:</b>	Vitrified clay pipe (i.e. all clayware)	<b>Lining Type:</b>	No Lining
<b>Year Constructed:</b>		<b>Lining Material:</b>	No Lining		
<b>Flow Control:</b>	No flow control				
<b>Inspection Purpose:</b>	Sample survey to determine asset condition				
<b>Comments:</b>	Fracture adjacent to rest bend				
<b>Recommendations:</b>	CIPP patch line

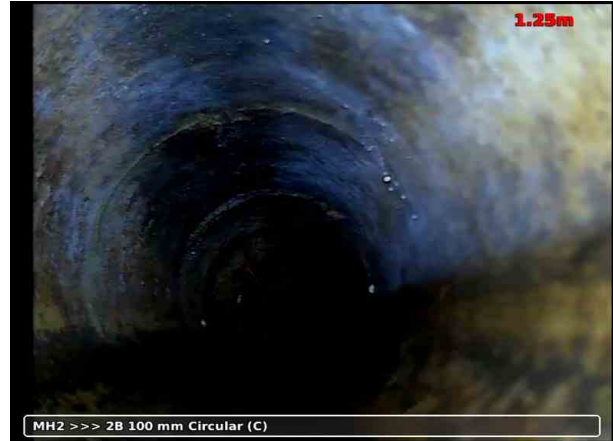
<table><tr> <td style="width: 10%;">0.00</td> <td style="width: 10%;">MH</td> <td style="width: 40%;">Start node type, manhole, reference number: MH2</td> <td style="width: 10%;">00:00:02</td> <td style="width: 10%;"></td> <td style="width: 10%;"></td> <td style="width: 10%;"></td> </tr><tr> <td>1.25</td> <td>CC</td> <td>Crack, circumferential from 8 o'clock to 2 o'clock</td> <td>00:00:23</td> <td>2</td> <td>2</td> <td></td> </tr></table>

2, 00:00:23, 1.25 m  
Crack, circumferential from 8 o'clock to 2 o'clock

Town or Village:	London	Inspection Direction:	Downstream	Upstream Node:	MH2
Road:	164 Hamsteead Way	Inspected Length:	7.90 m	Upstream Pipe Depth:	1.200 m
Location:	Under a permanent building	Total Length:	7.90 m	Downstream Node:	MAIN SEWER
Surface Type:		Joint Length:	0.00 m	Downstream Pipe Depth:	0.000 m
Use:	Combined	Pipe Shape:	Circular		
Type of Pipe:	Gravity drain/sewer	Dia/Height:	100 mm		
Year Constructed:		Pipe Material:	Vitrified clay pipe (i.e. all clayware)		
Flow Control:	No flow control	Lining Type:	No Lining		
Inspection Purpose:	Sample survey to determine asset condition	Lining Material:	No Lining		
Comments:	Multiple defects				
Recommendations:	HPWJ / CIPP line / Excavate and renew SWG and junction

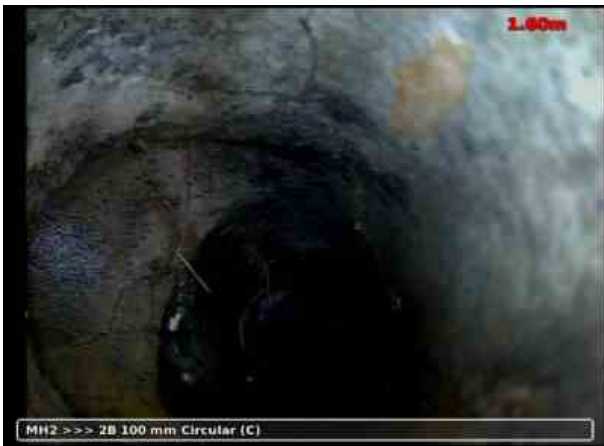
<table><tr> <td style="width: 10%;">0.00</td> <td style="width: 10%;">MH</td> <td style="width: 40%;">Start node type, manhole, reference number: MH2</td> <td style="width: 10%;">00:00:02</td> <td style="width: 10%;"></td> <td style="width: 10%;"></td> <td style="width: 10%;"></td> </tr><tr> <td>1.60</td> <td>CC</td> <td>Crack, circumferential from 12 o'clock to 12 o'clock: Crack in junction from SWG</td> <td>00:00:31</td> <td></td> <td>2</td> <td></td> </tr></table>

3, 00:00:31, 1.60 m  
Junction at 9 o'clock, diameter: 100mm, Junction to SWG

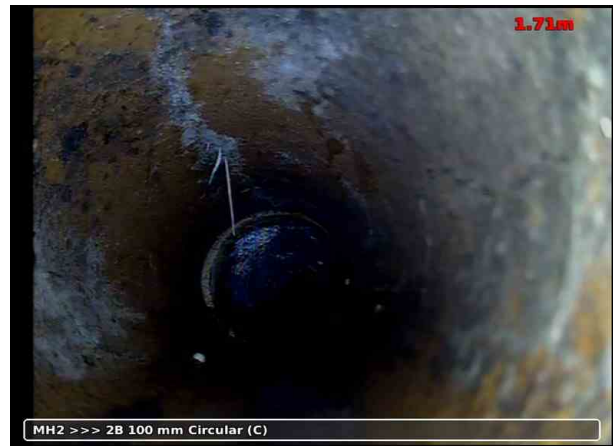
<table><tr> <td style="width: 10%;">0.00</td> <td style="width: 10%;">MH</td> <td style="width: 40%;">Start node type, manhole, reference number: MH2</td> <td style="width: 10%;">00:00:02</td> <td style="width: 10%;"></td> <td style="width: 10%;"></td> <td style="width: 10%;"></td> </tr><tr> <td>1.71</td> <td>S01</td> <td>CL Crack, longitudinal at 11 o'clock, start: Fine root ingress through crack</td> <td>00:00:41</td> <td>4</td> <td>2</td> <td></td> </tr></table>

4, 00:00:41, 1.71 m  
Crack, longitudinal at 11 o'clock, start, Fine root ingress through crack

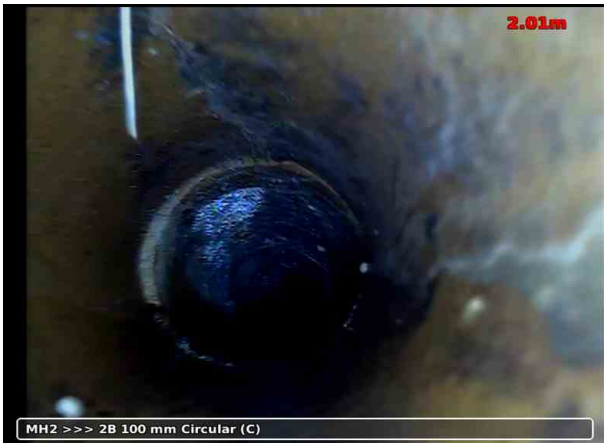
5, 00:00:42, 2.01 m  
Joint displaced, medium

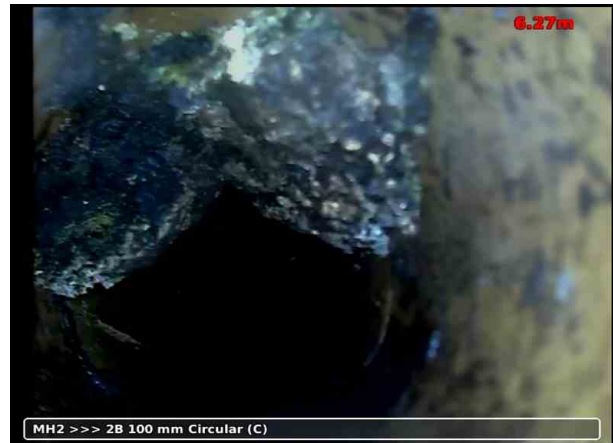
6, 00:01:16, 6.23 m  
Attached deposits, other at 12 o'clock, 20% cross-sectional area loss, Grease
