## **Preliminary Report**

**[REDACTED]**  
164 Hampstead Way  
London  
NW11 7XD

**Reported Peril: Subsidence**

**Date of Report: 18<sup>th</sup> August 2020**

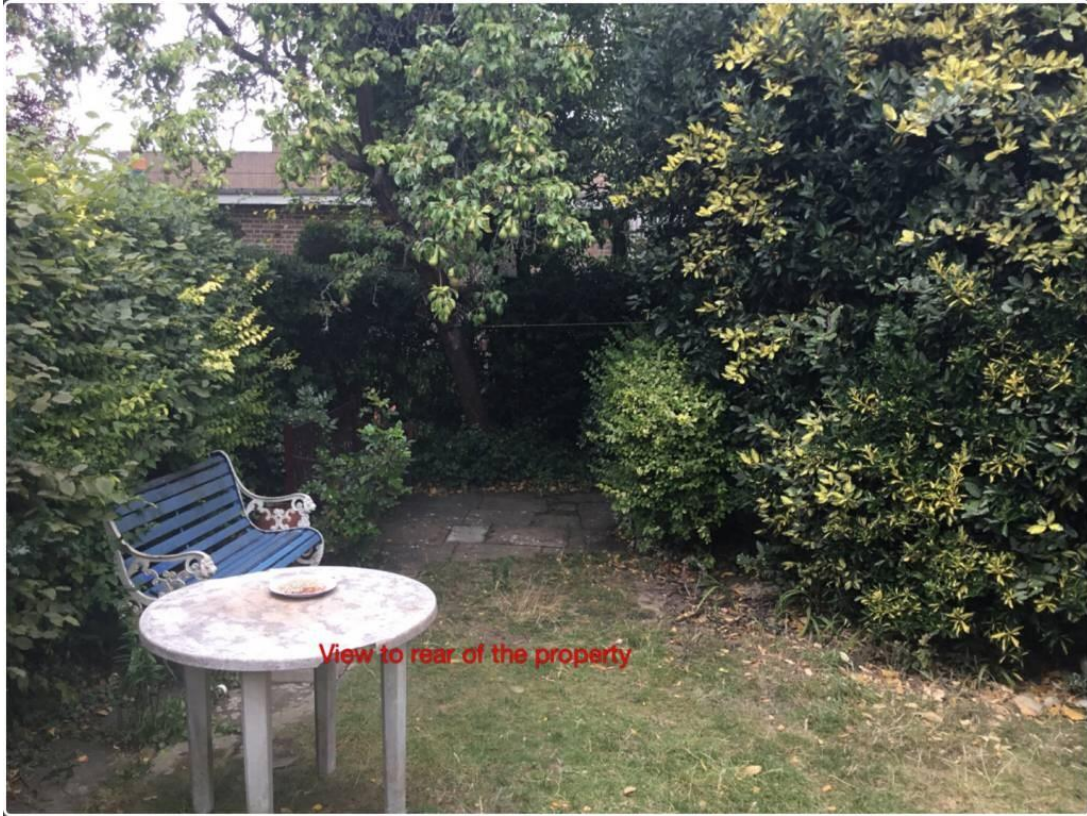
Vegetation to rear

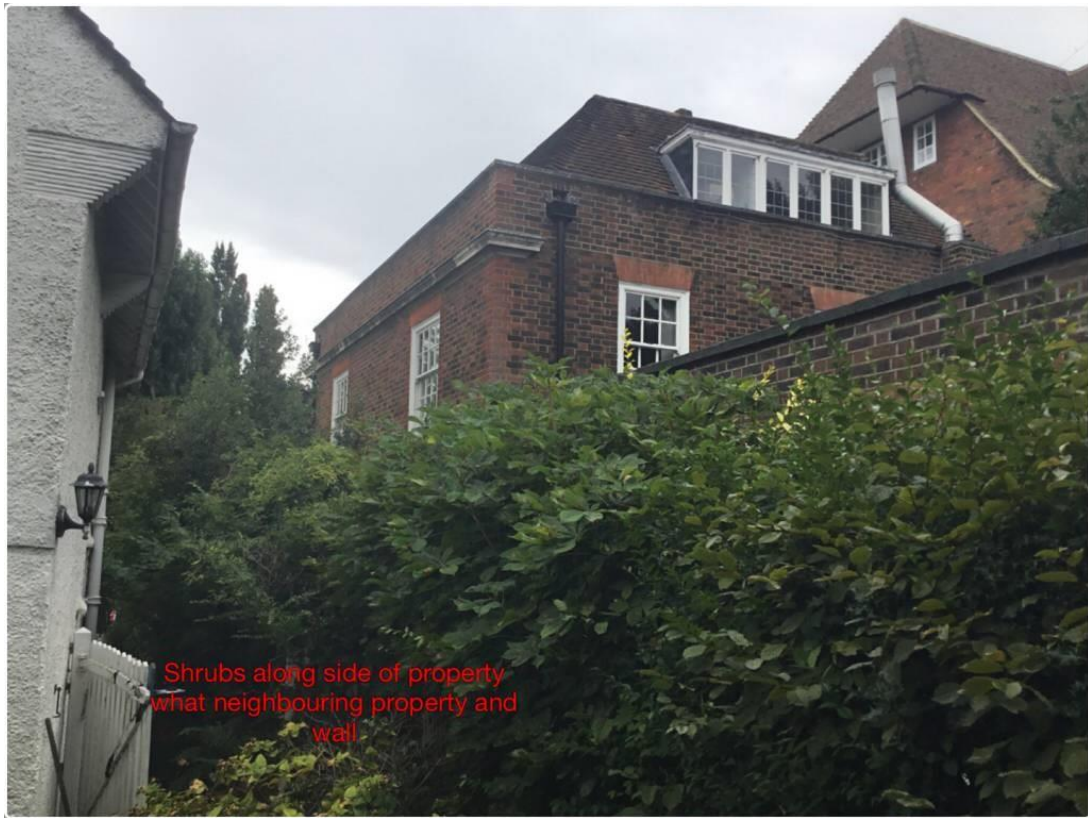
Vegetation to Rear Left

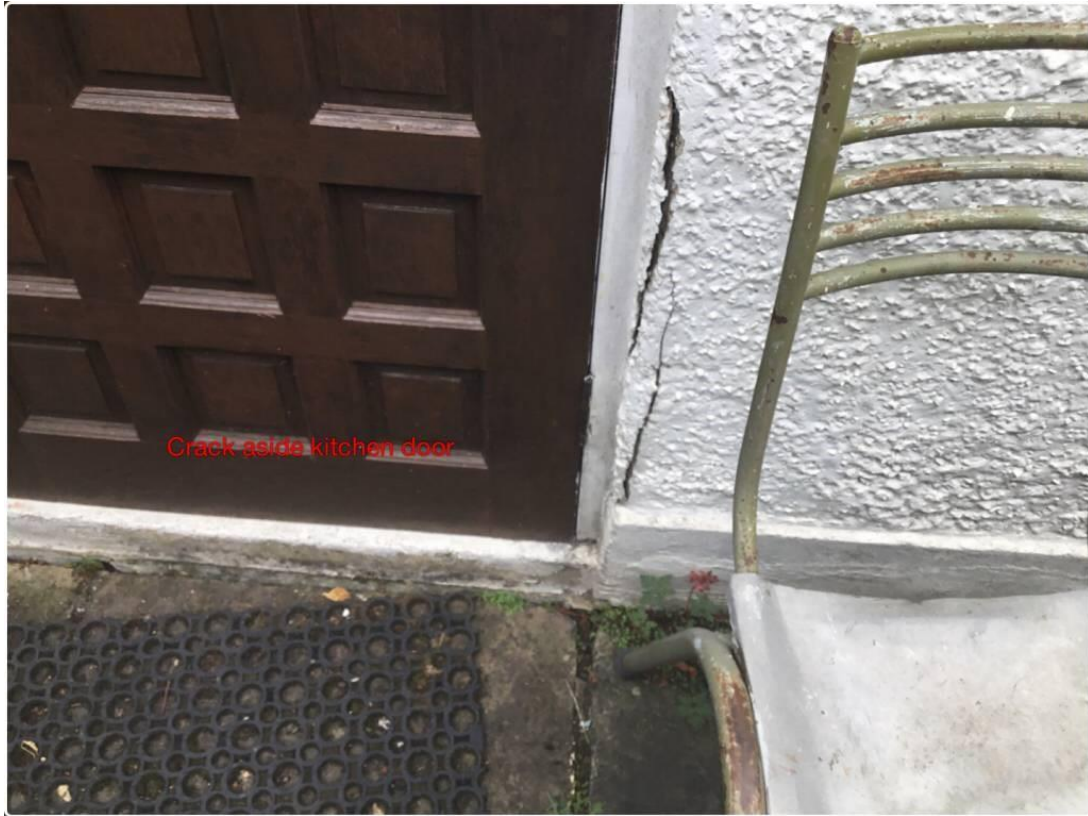
Damage Adjacent to kitchen door - Rear

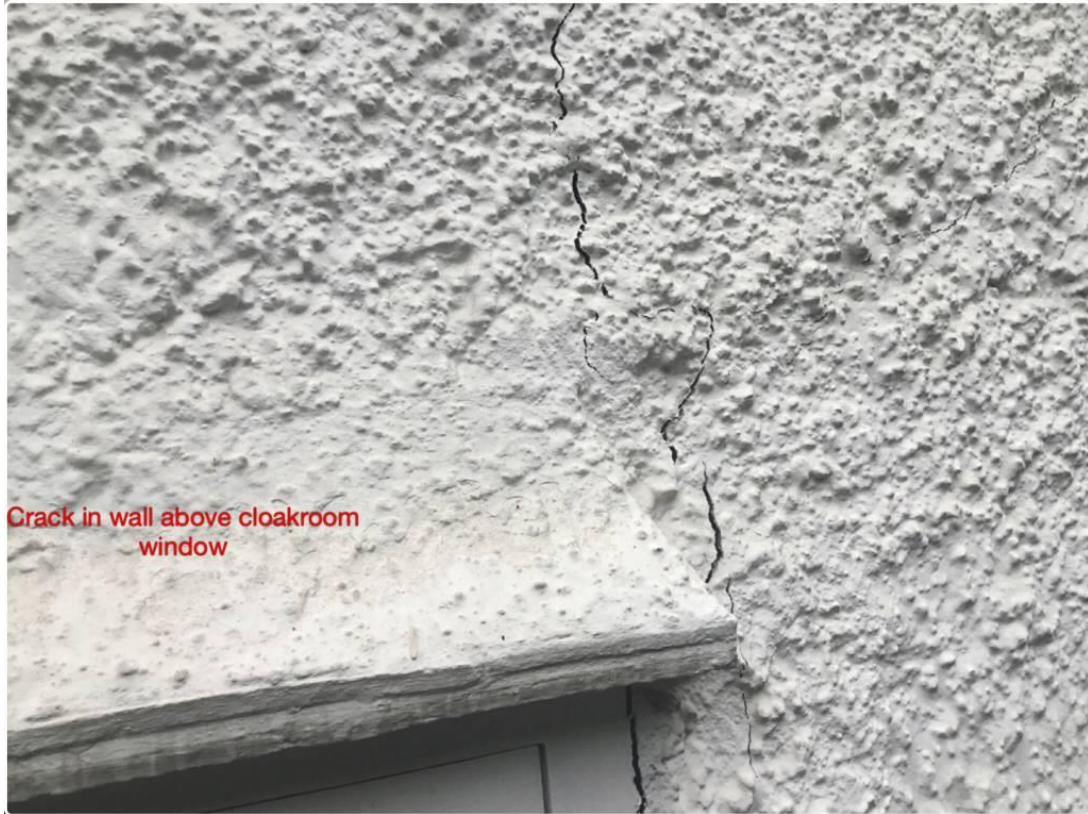
Left Flank

**Room wall damage:** Cracks in the side wall at the cloakroom window, one of which runs up the building to the roof.

Crack in wall above cloakroom window

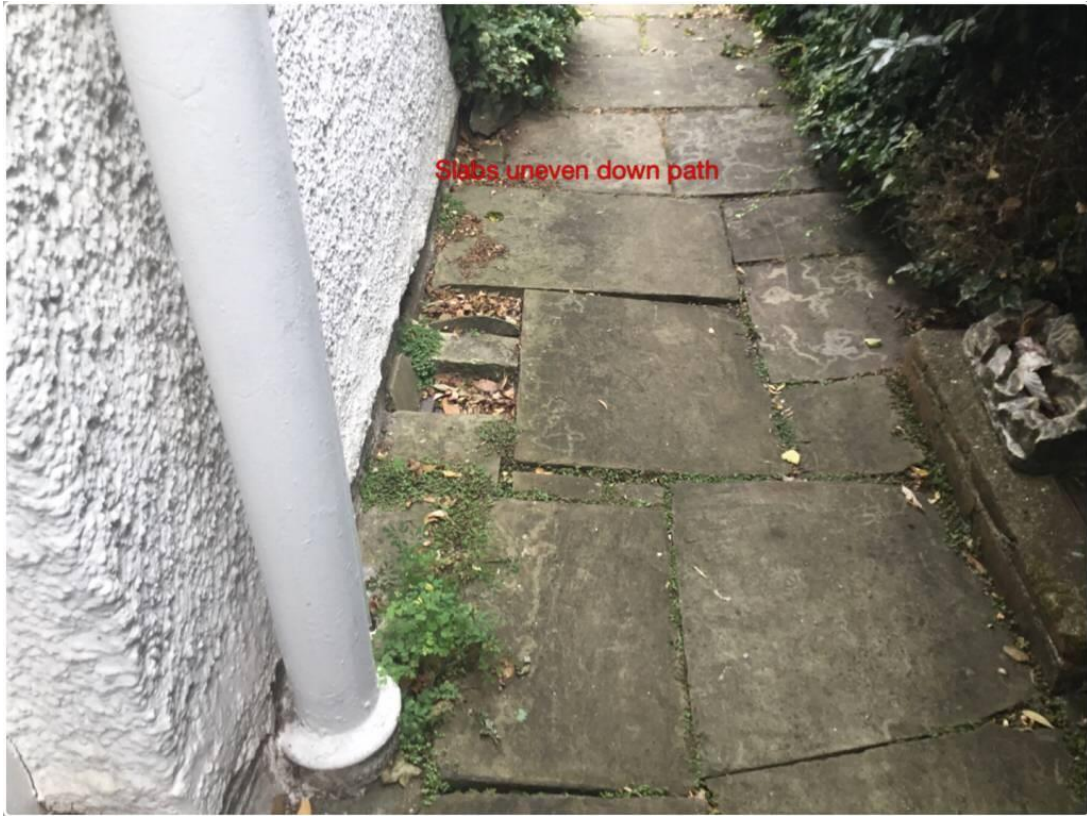
**Room floor damage:** There is a narrow path down the side of the house and the paving slabs are not level. There is a gap showing along the rear side and the rear of the property. It was noted that there is line of sunken earth across the front garden.

We also noted that the paving around the property had dropped by varying degrees which would appear to have occurred over a significant period of time and will predate the inception of the policy.

Long term settlement of paving

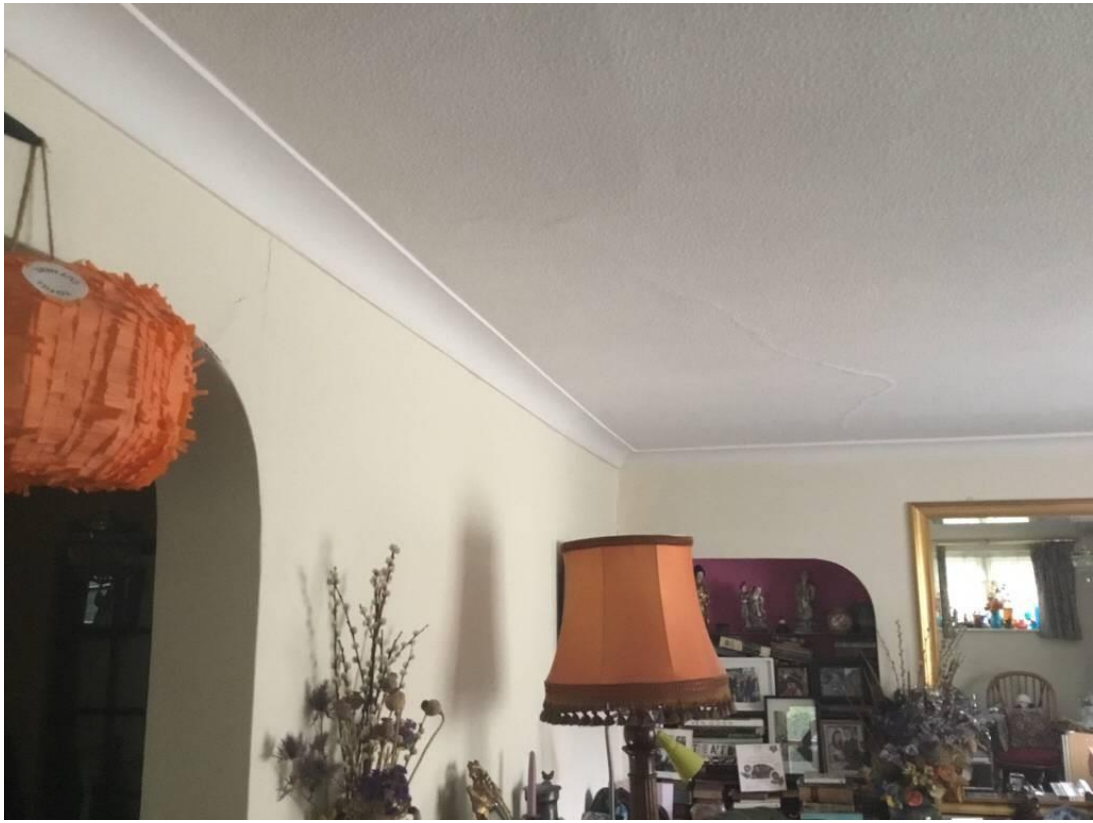
Lounge/Dining

**Room wall damage:** Cracks along the external wall and ceiling abutment which runs round at the same abutment of the internal wall between the dining room and kitchen. Kitchen was not inspected as the policyholder was using the door to socially distance themselves from the surveyor.

**Room wall damage:** There is a crack along the wall/ceiling abutment from the external wall along the internal supporting wall and across the lined ceiling.

**Room ceiling damage:** Crack across the ceiling from the internal wall.

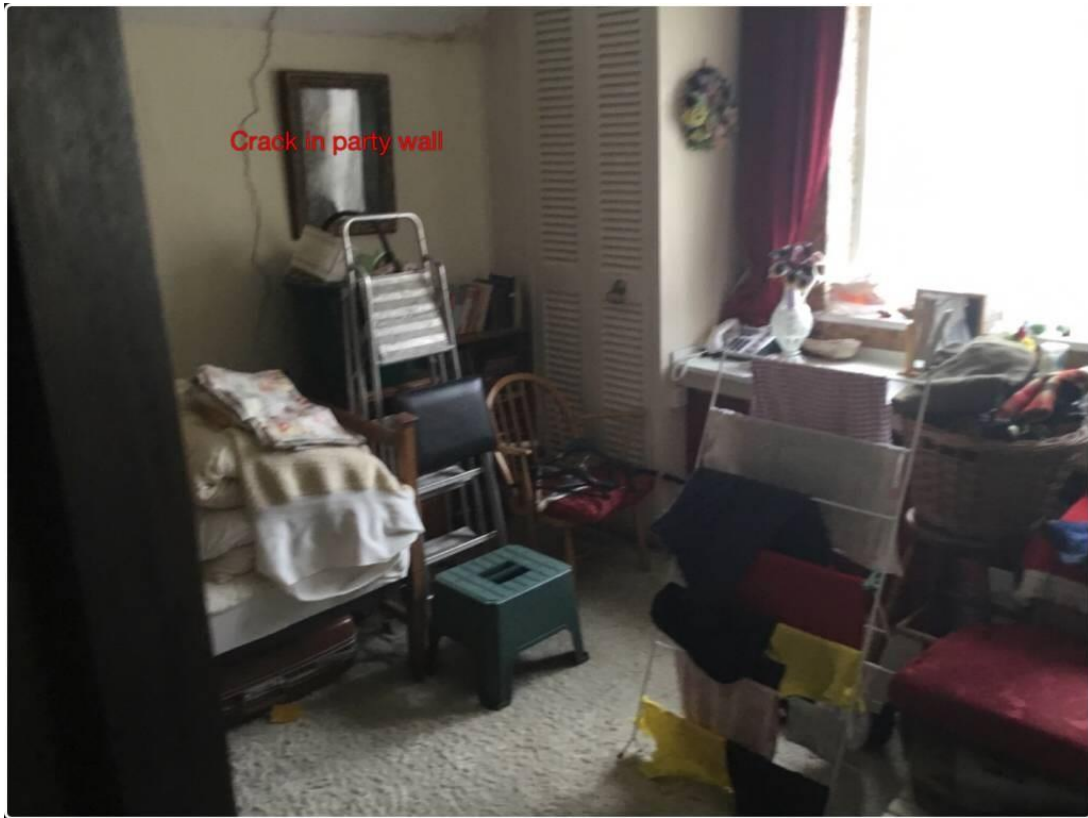
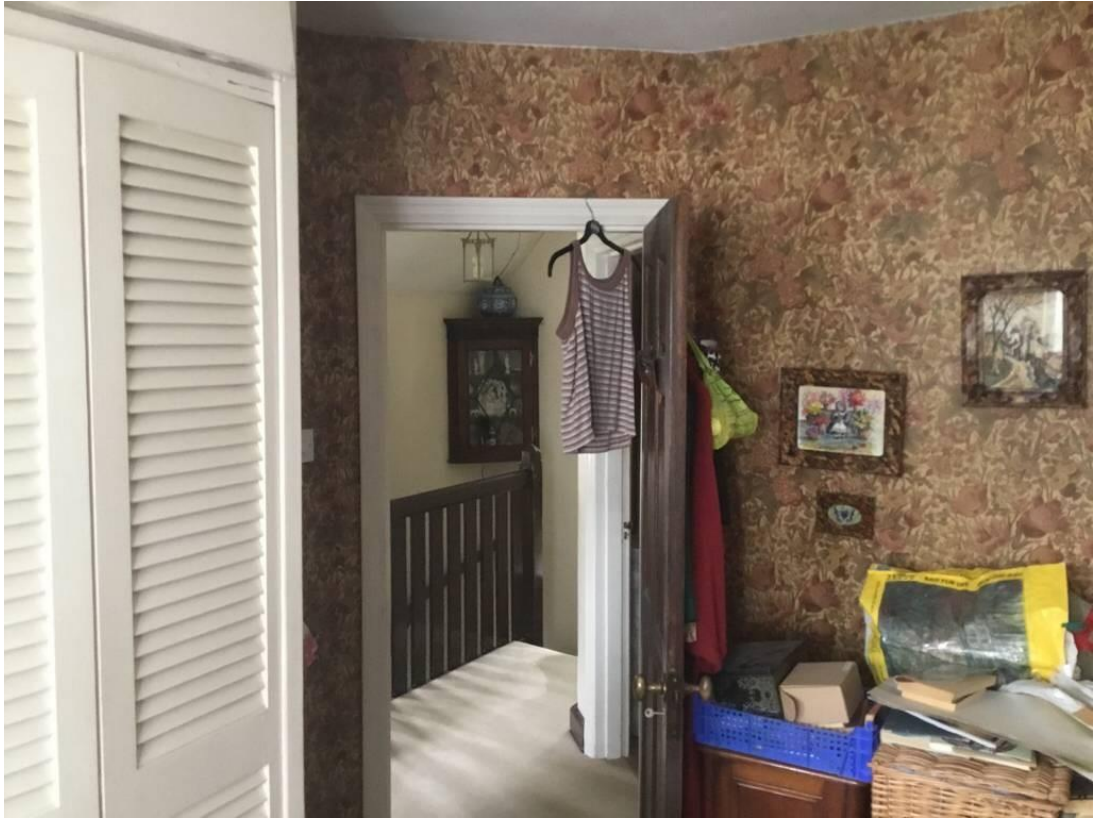
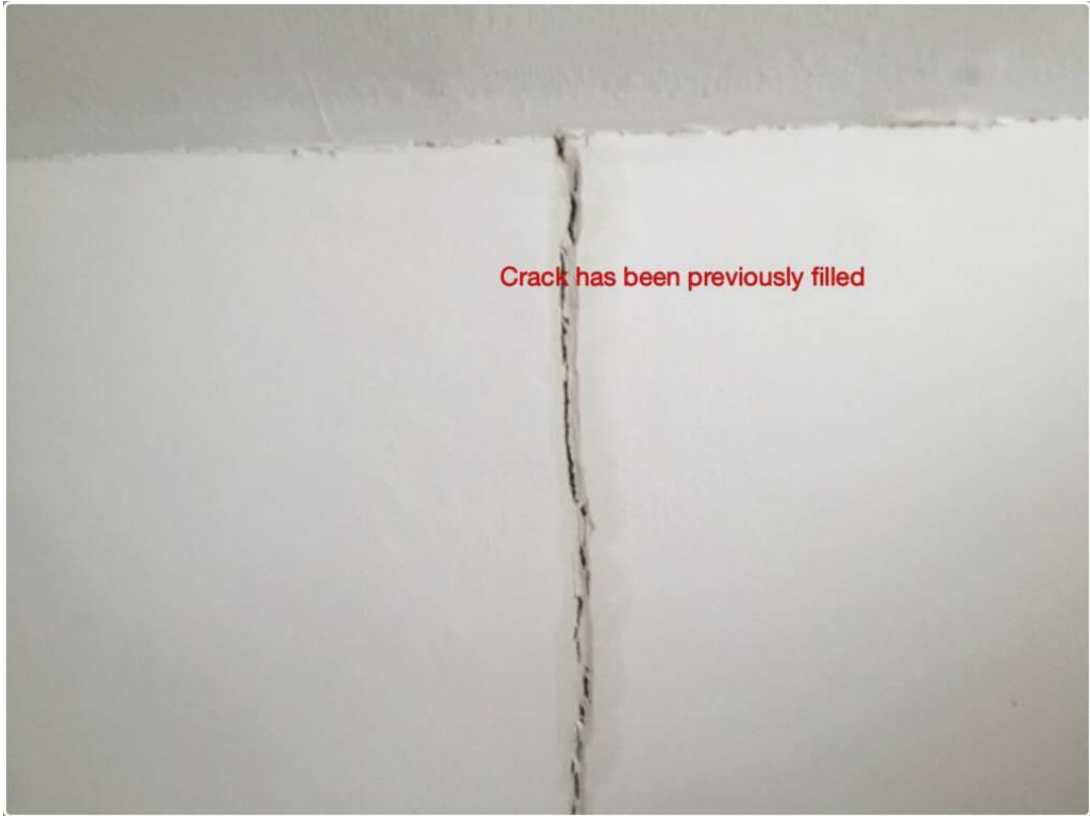
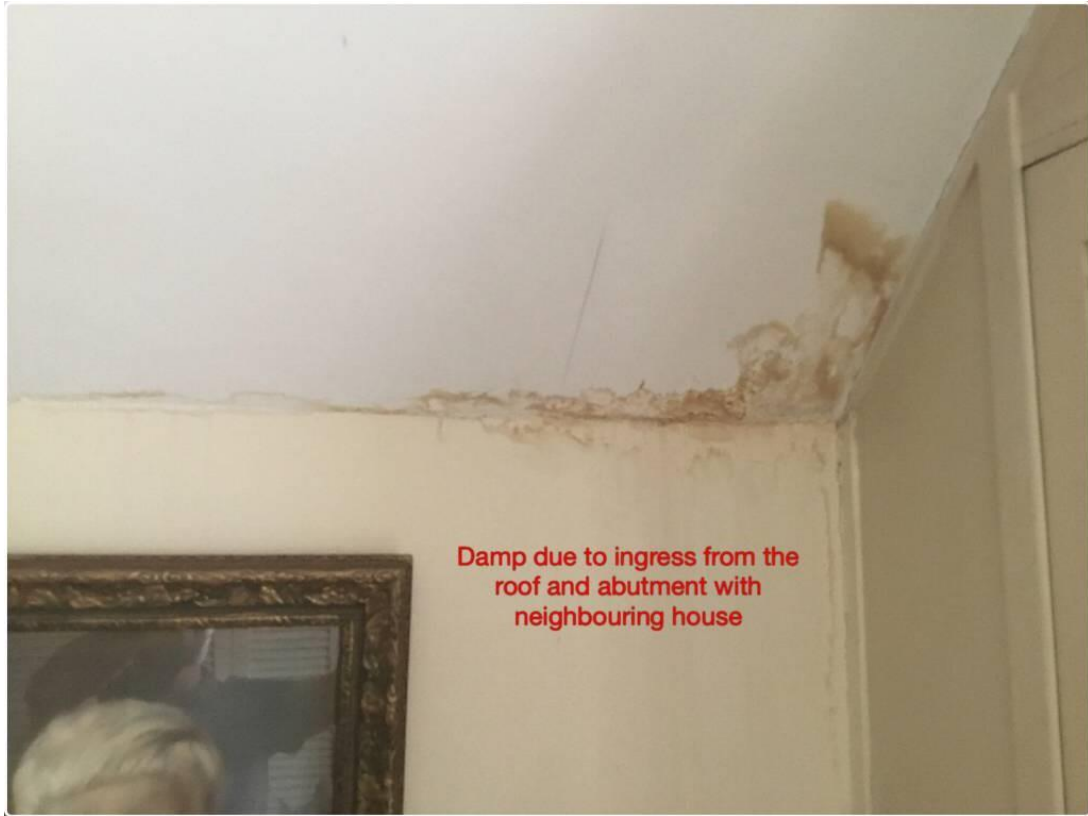
Front bedroom

**Room wall damage:** Vertical crack on the party wall. The crack has been filled historically but has opened up again.

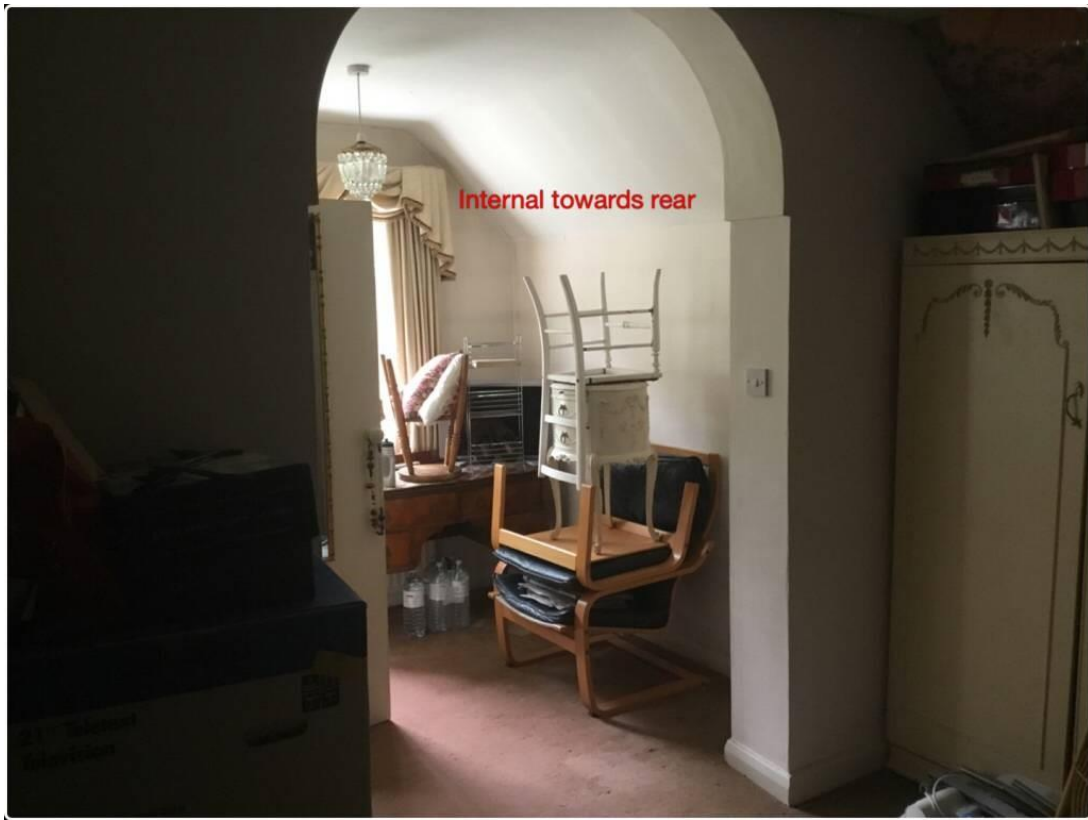
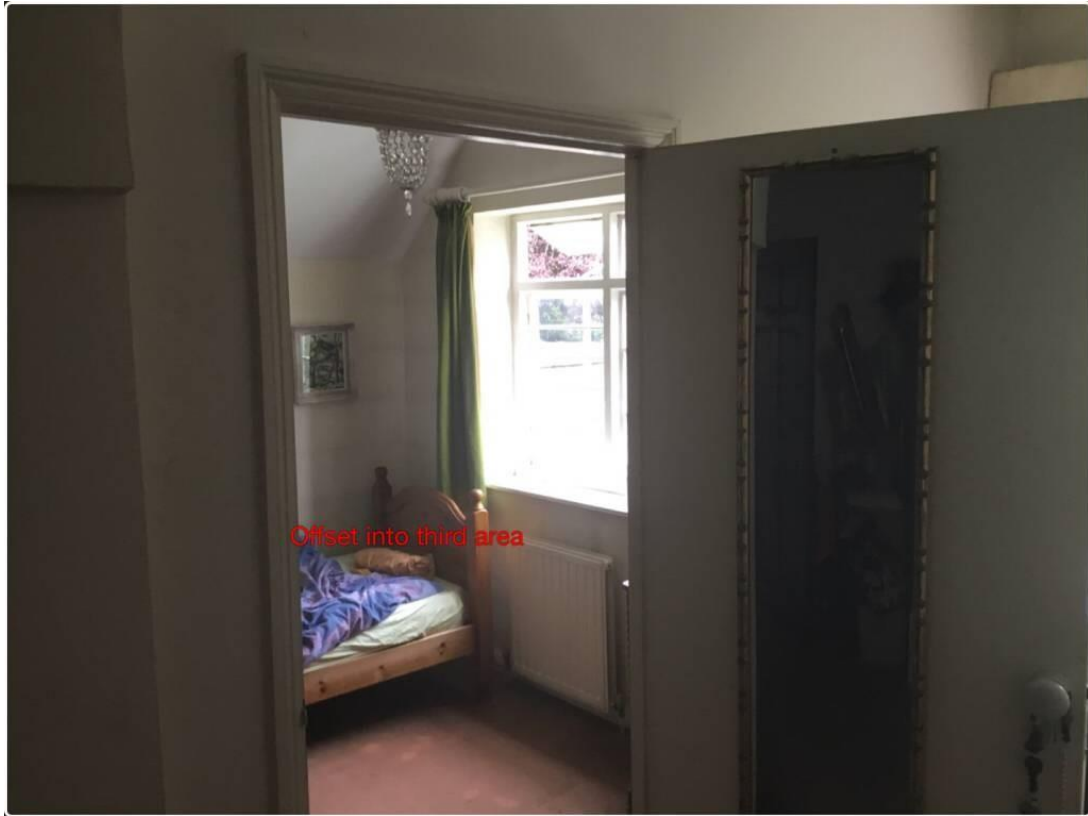
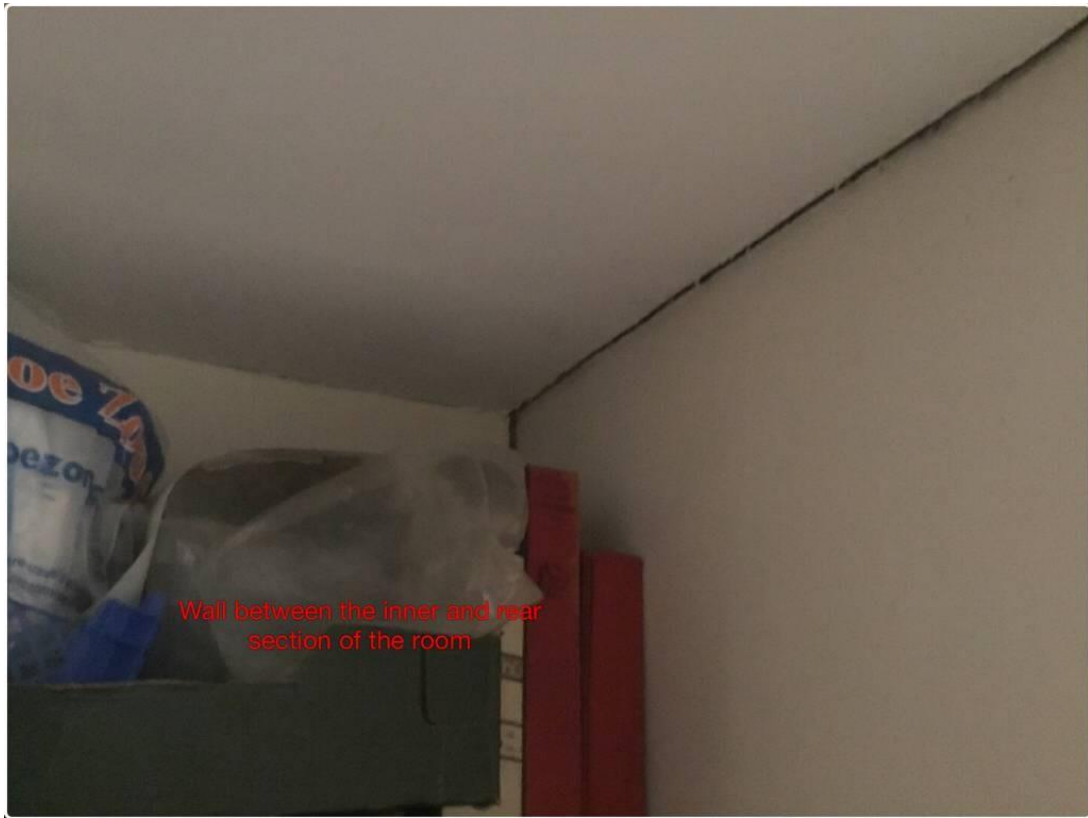
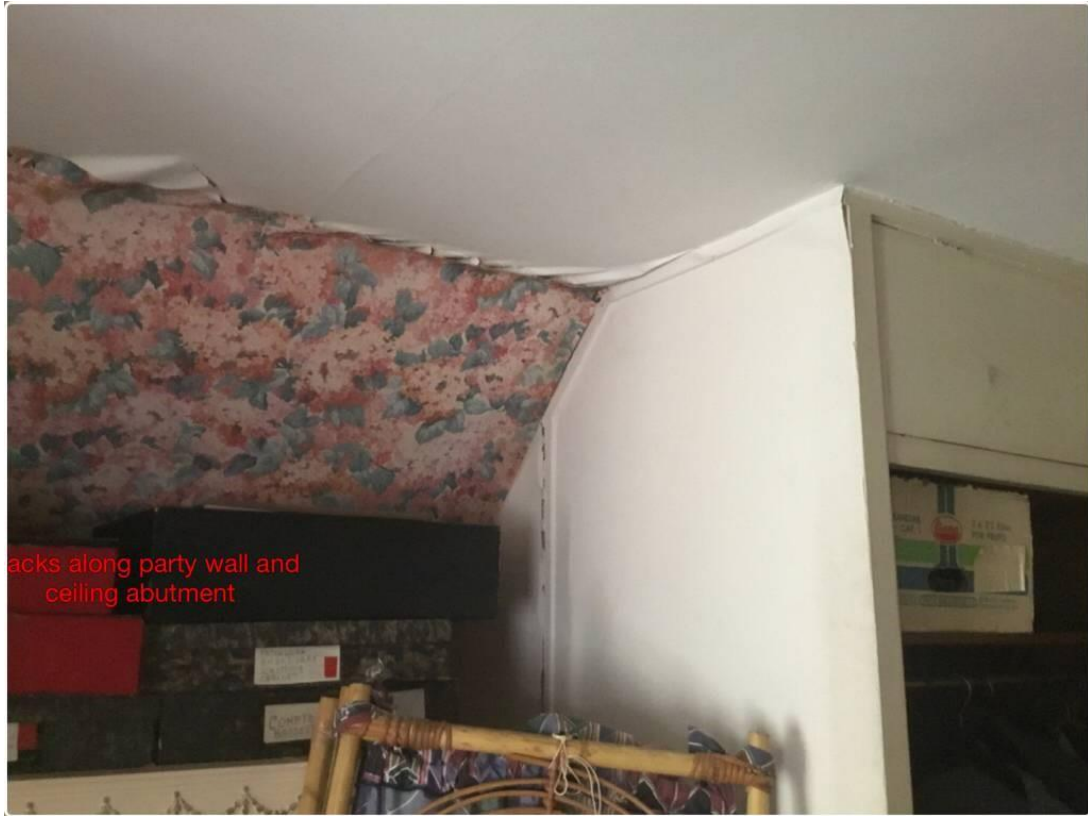
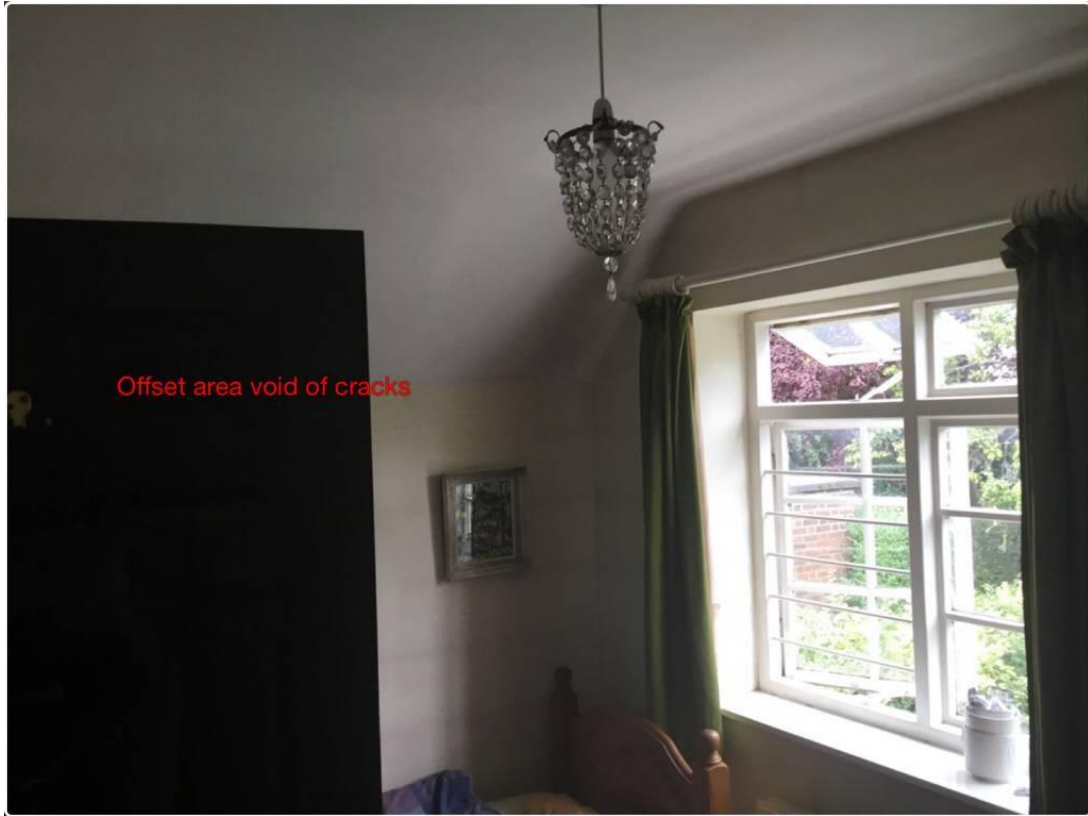
Bedroom (Open plan over three rooms to the rear)

**Room floor damage:** The room is over two rooms with a third off to the rear left. The customer thinks the house was extended backwards sometime in the history of the property. The cracks are at the wall between the inner room and the two to the rear. The floors in the rear areas have a lot of spring when walked across. The floor in the inner room is sound.

**Room wall damage:** Cracks along the solid wall and ceiling abutment between the inner room and the rear room, there is plaster on the floor where the gap has recently opened up slightly. The crack returns around the party wall at ceiling height.

**Other significant damage:** Further investigation may be required to check floor joists.

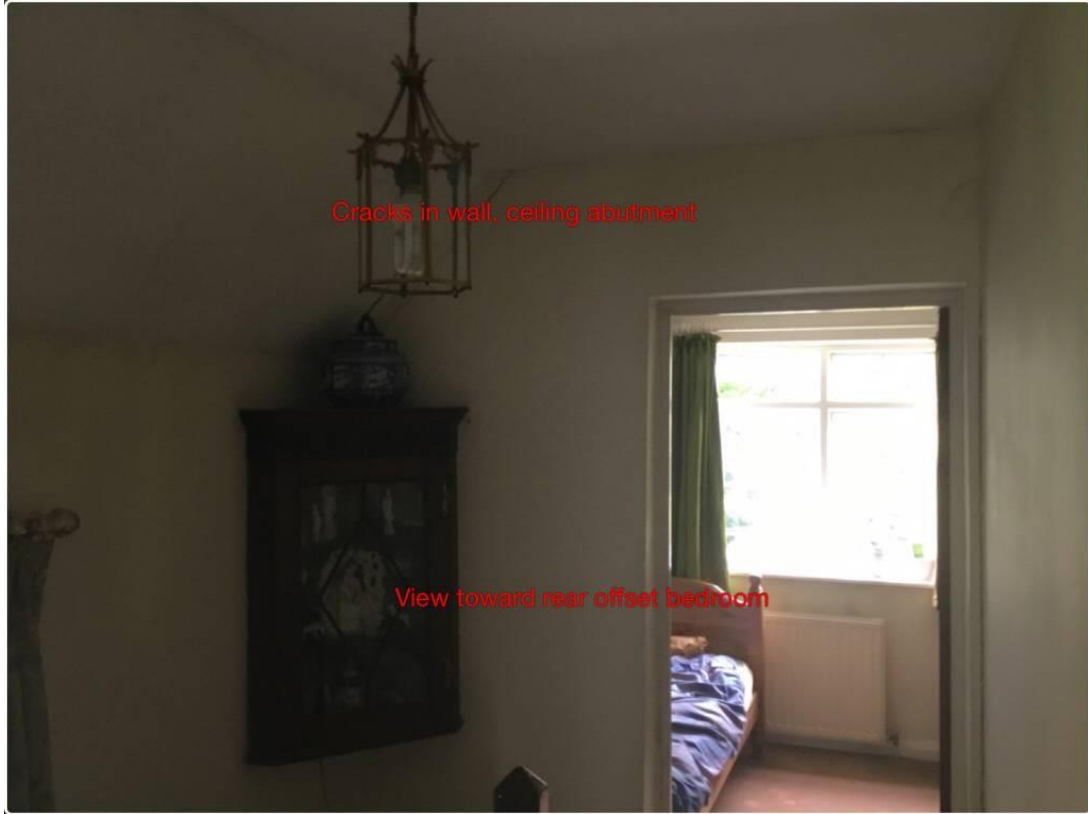
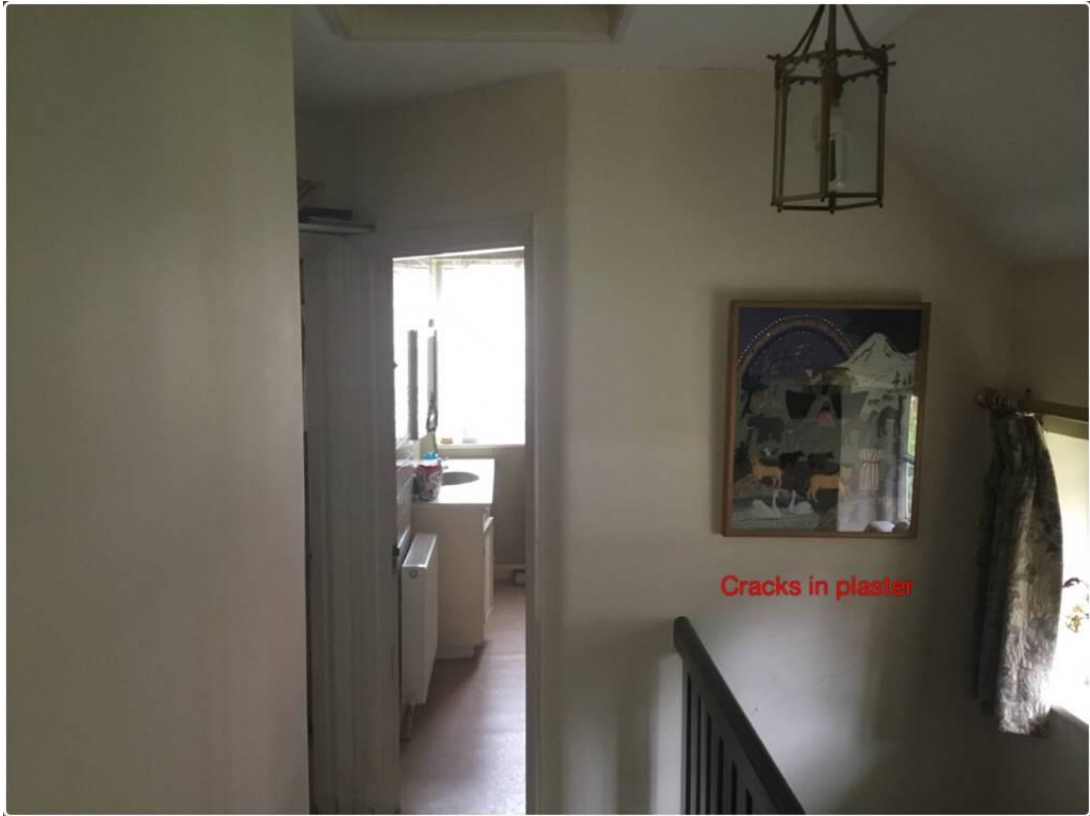
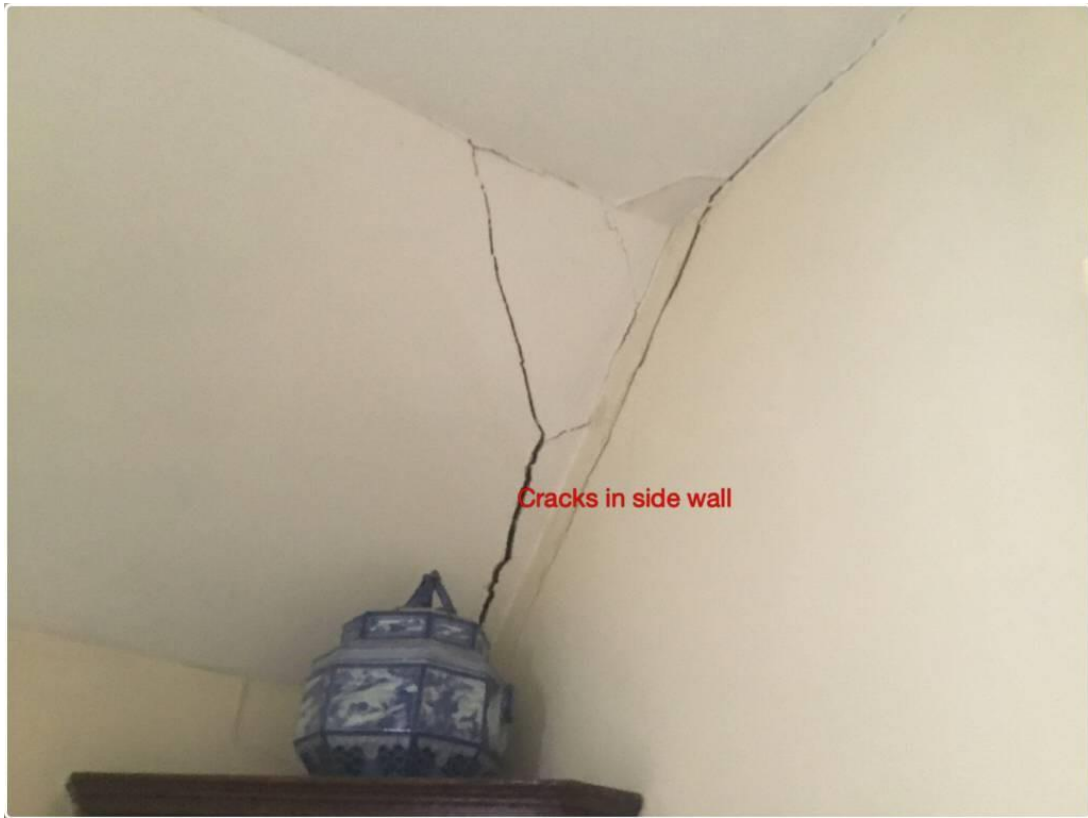
Landing to rear

**Room wall damage:** Cracks are all on the external wall of the stairs.

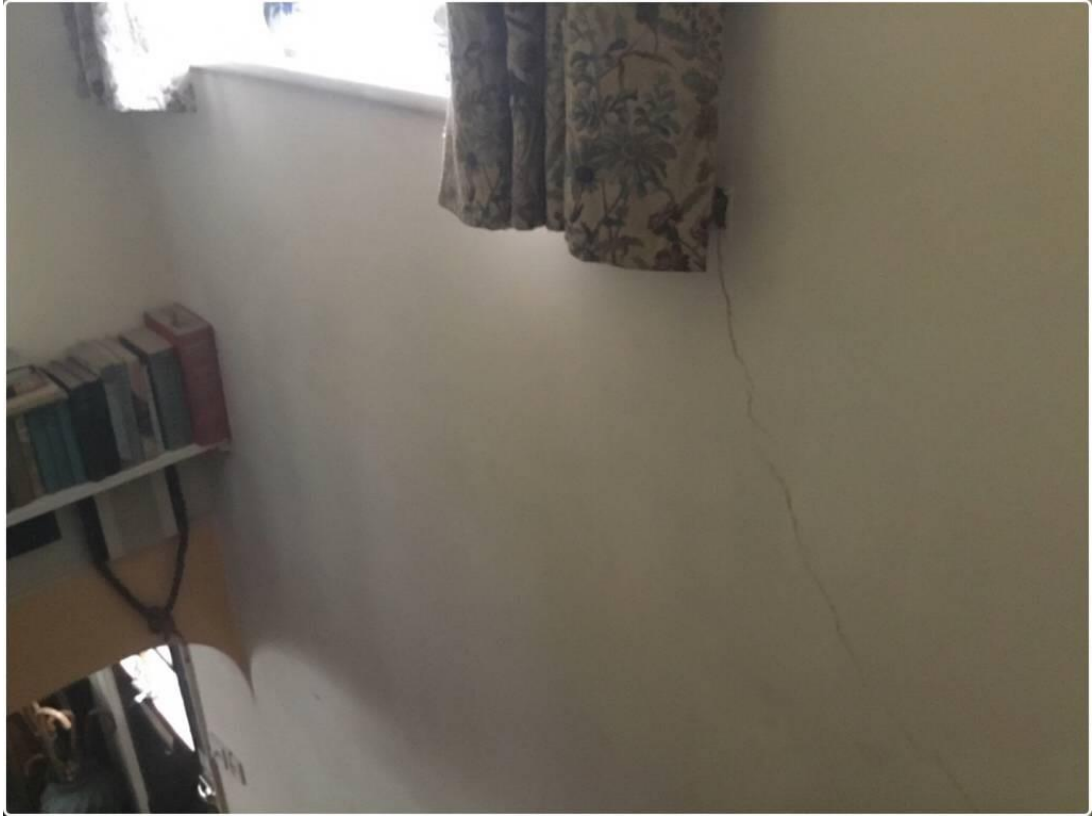
Stair well to left hand side

**Room wall damage:** Cracks across the external wall. There is a gap between the staircase and the wall. Cracks are at the bottom, middle and top of the stairs. The stairs are open plan with the living room.
