Our Ref: 23518/JL/PLA

Date: 19 January 2024

**Re: Lallows Boatyard, 3 Medina Road, Cowes**

We visited the above property, at your request, on 6<sup>th</sup> December 2023 to undertake a structural assessment of the rear right hand side structure of the site.

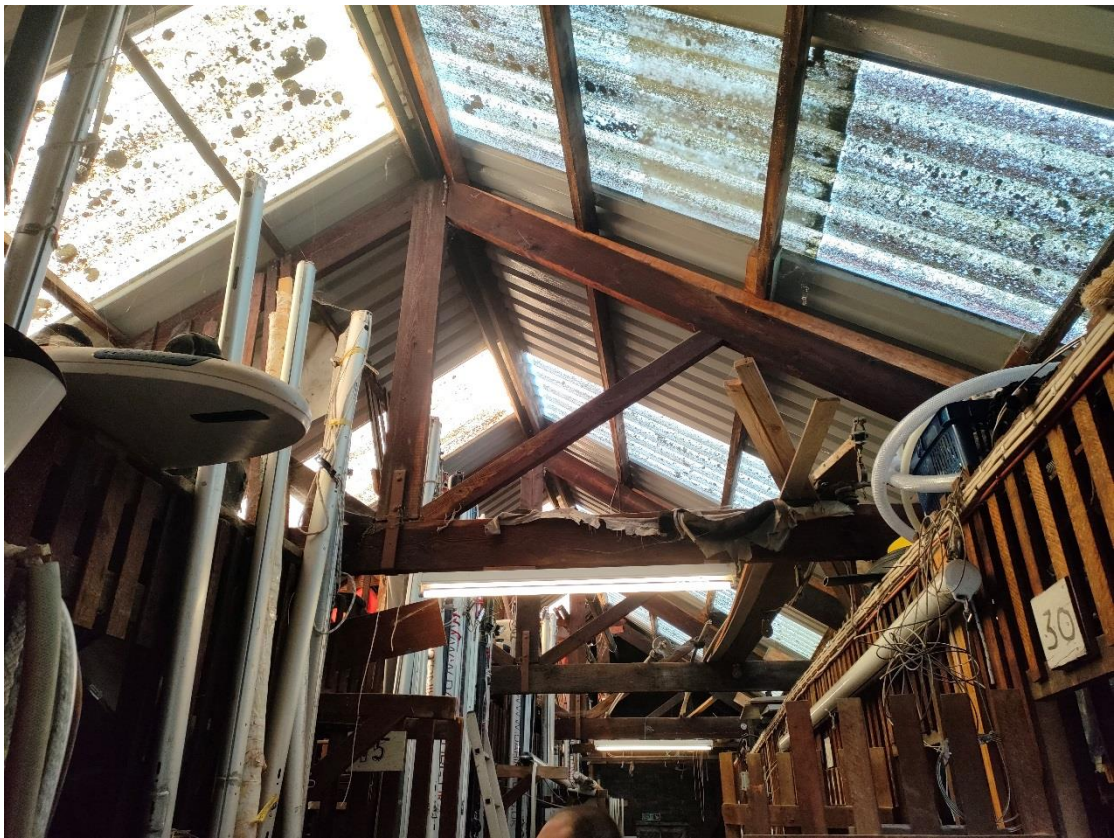
Image 2 shows a general view to the underside of the roof structure.

**Image 2** Upper floor, view on roof structure.

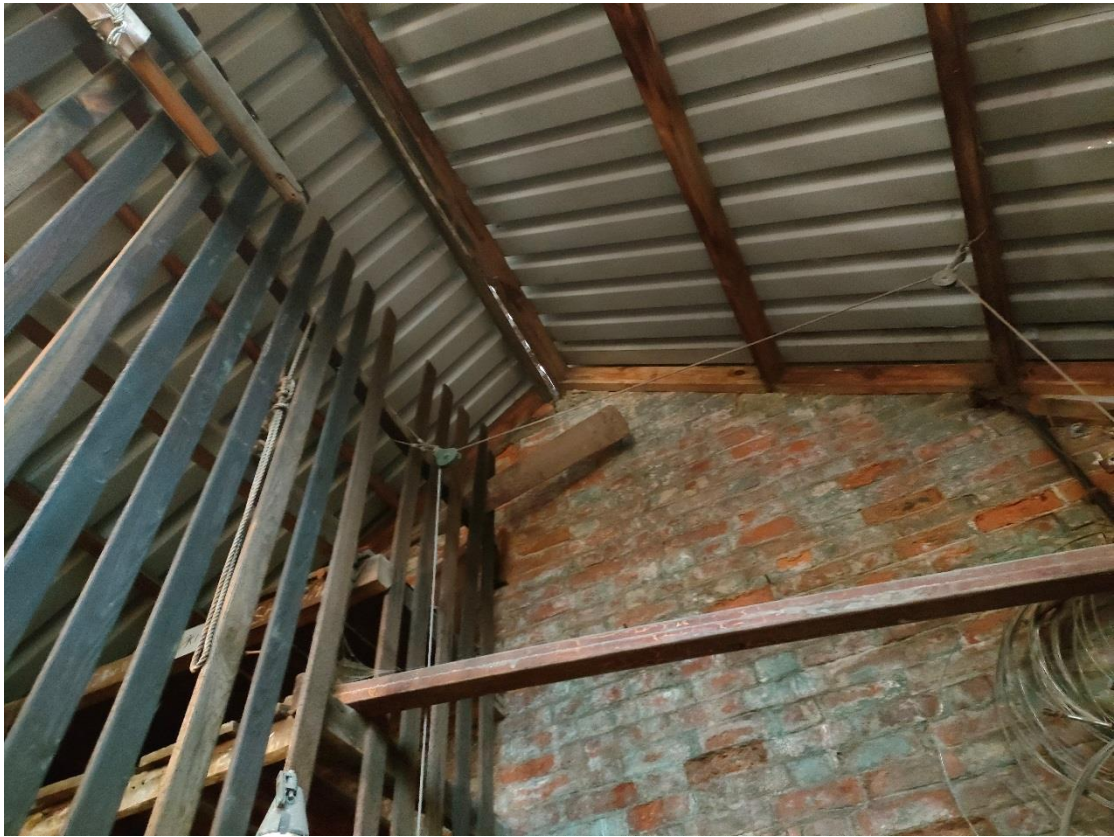
Image 3 shows a view on the gable wall with spalled bricks and minor cracking.

**Image 3** Upper floor, view on gable wall.

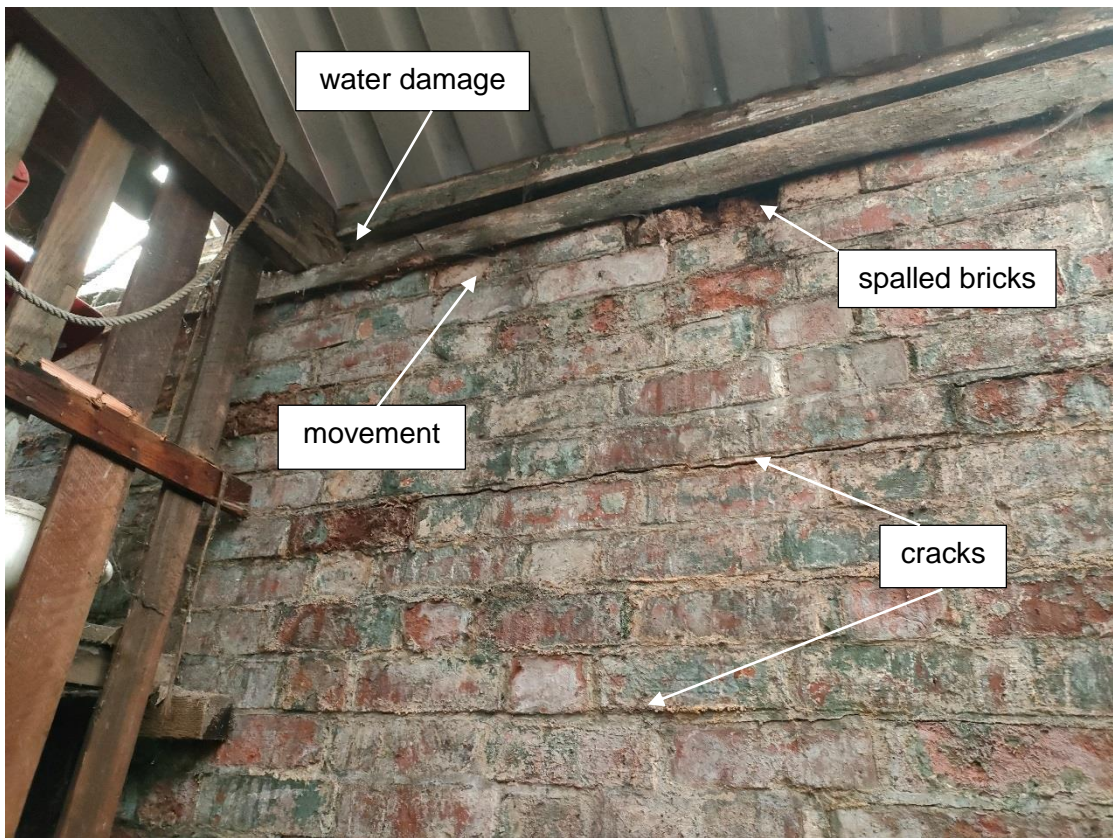
Image 4 shows the wall plate. Damage noted was horizontal cracking to the masonry and significantly spalled bricks. A movement outwards of the bricks directly under the plate can also be noted.

**Image 4** Upper floor, view at wall plate.

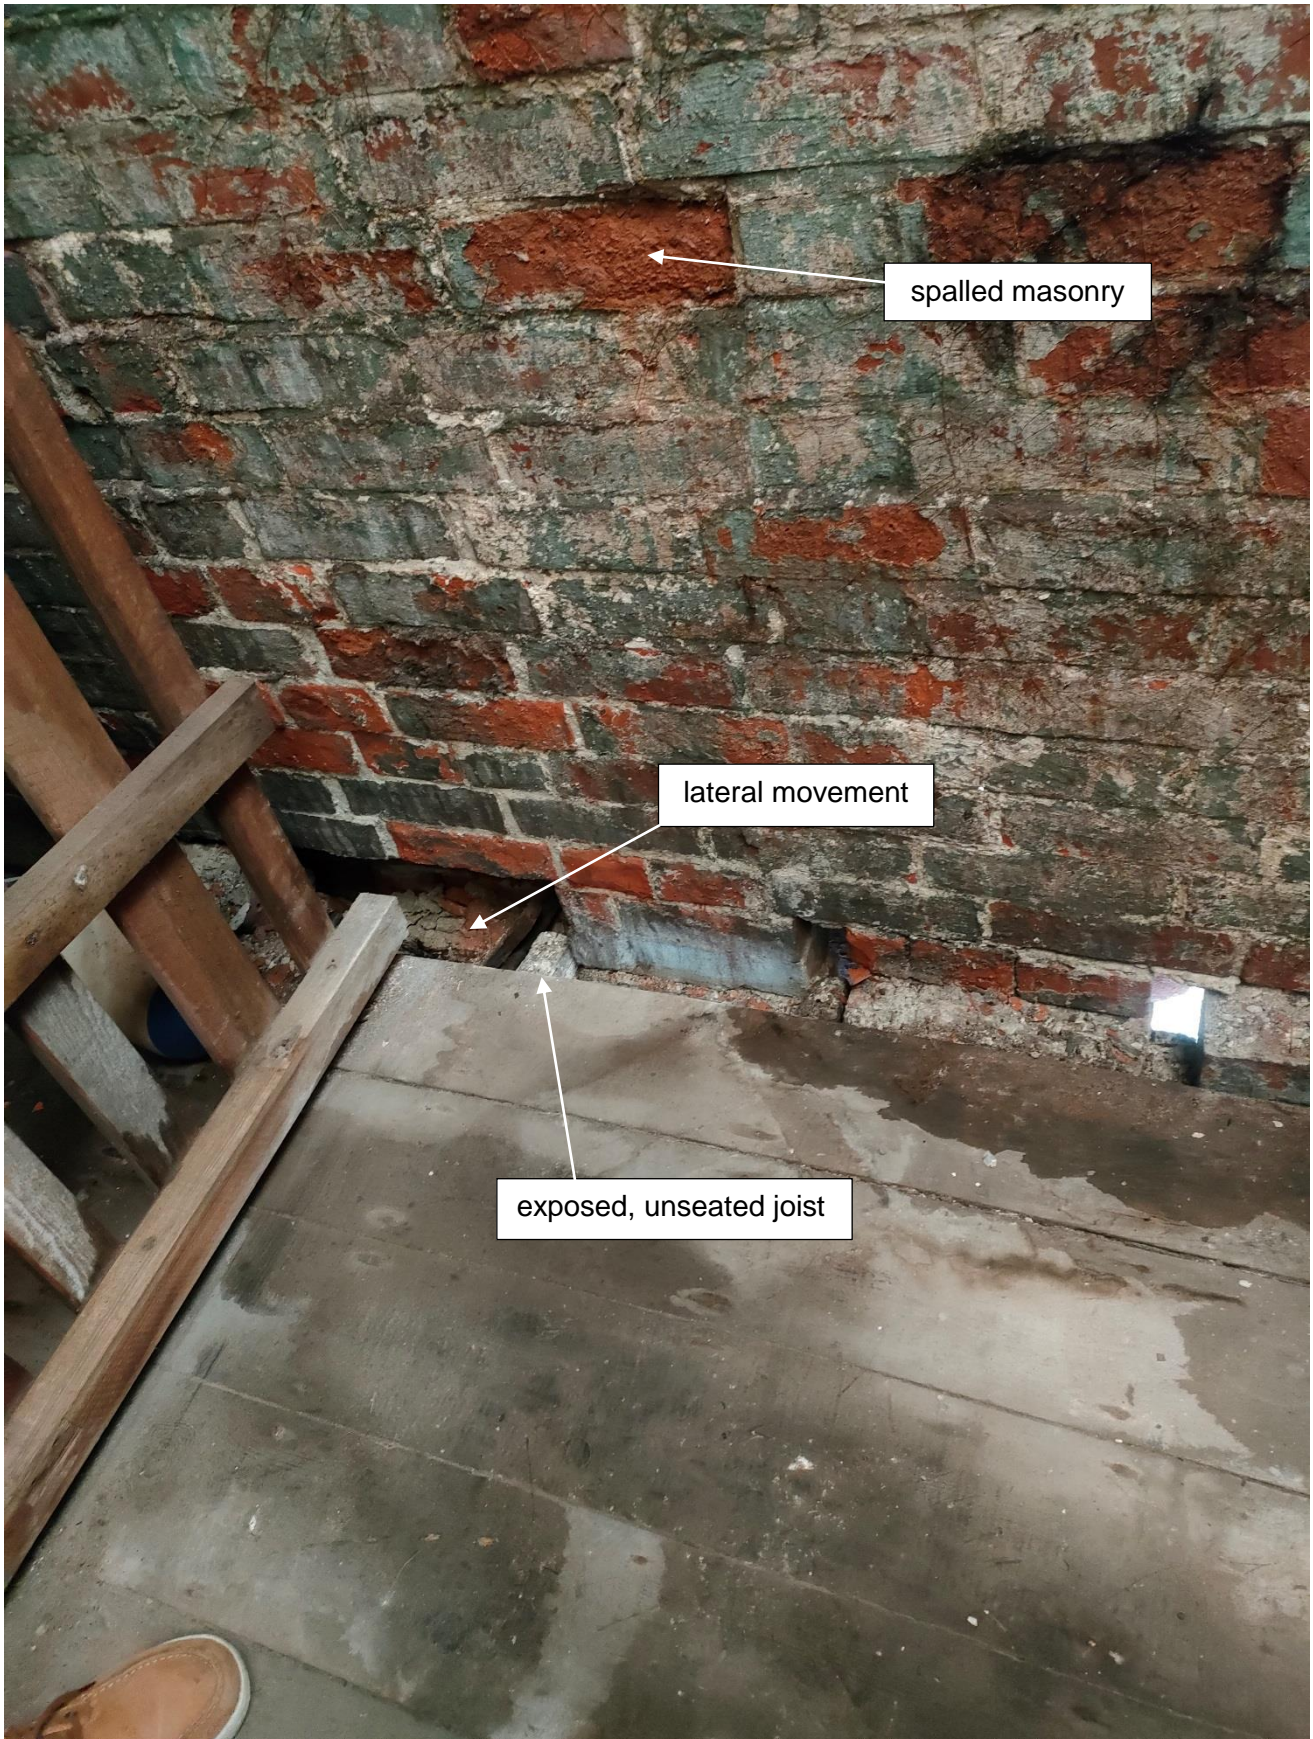
Images 5 and 6 show the masonry wall at upper floor level. There are areas of damp and cracking to the brickwork. A lateral movement to the masonry can also be noted with Image 5 showing unseated floor joists.

Significant structural distress was noted to the structure. The large bow in the masonry to the right hand side elevation has caused the upper floor joists to become unseated and require temporary support. This has also meant the elevation wall does not have a mid-height support. The bow has also caused movement to the roof structure, noted as lateral movement to the wall plate and distortion to the ridge. The most likely cause for this movement is a settlement of the foundations along the slipway.

**Image 5** Upper floor, lateral movement at floor level.

The wall cannot be 'pushed back' into a vertical position so will require replacement. Similarly the floor joists will also require replacement. These works can only be undertaken when a new run of foundations has been dug and cast along the elevation. Similarly the roof will require significant repair and areas of replacement.

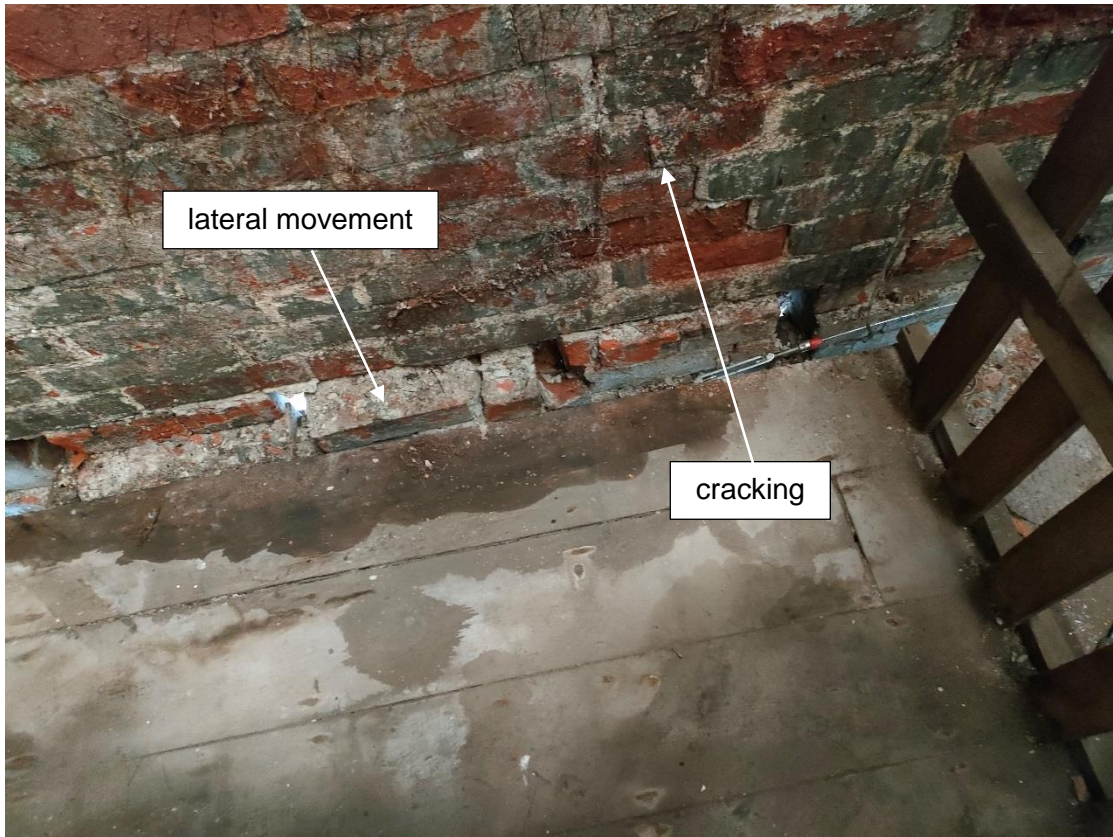
**Image 6** Upper floor, lateral movement at floor level.

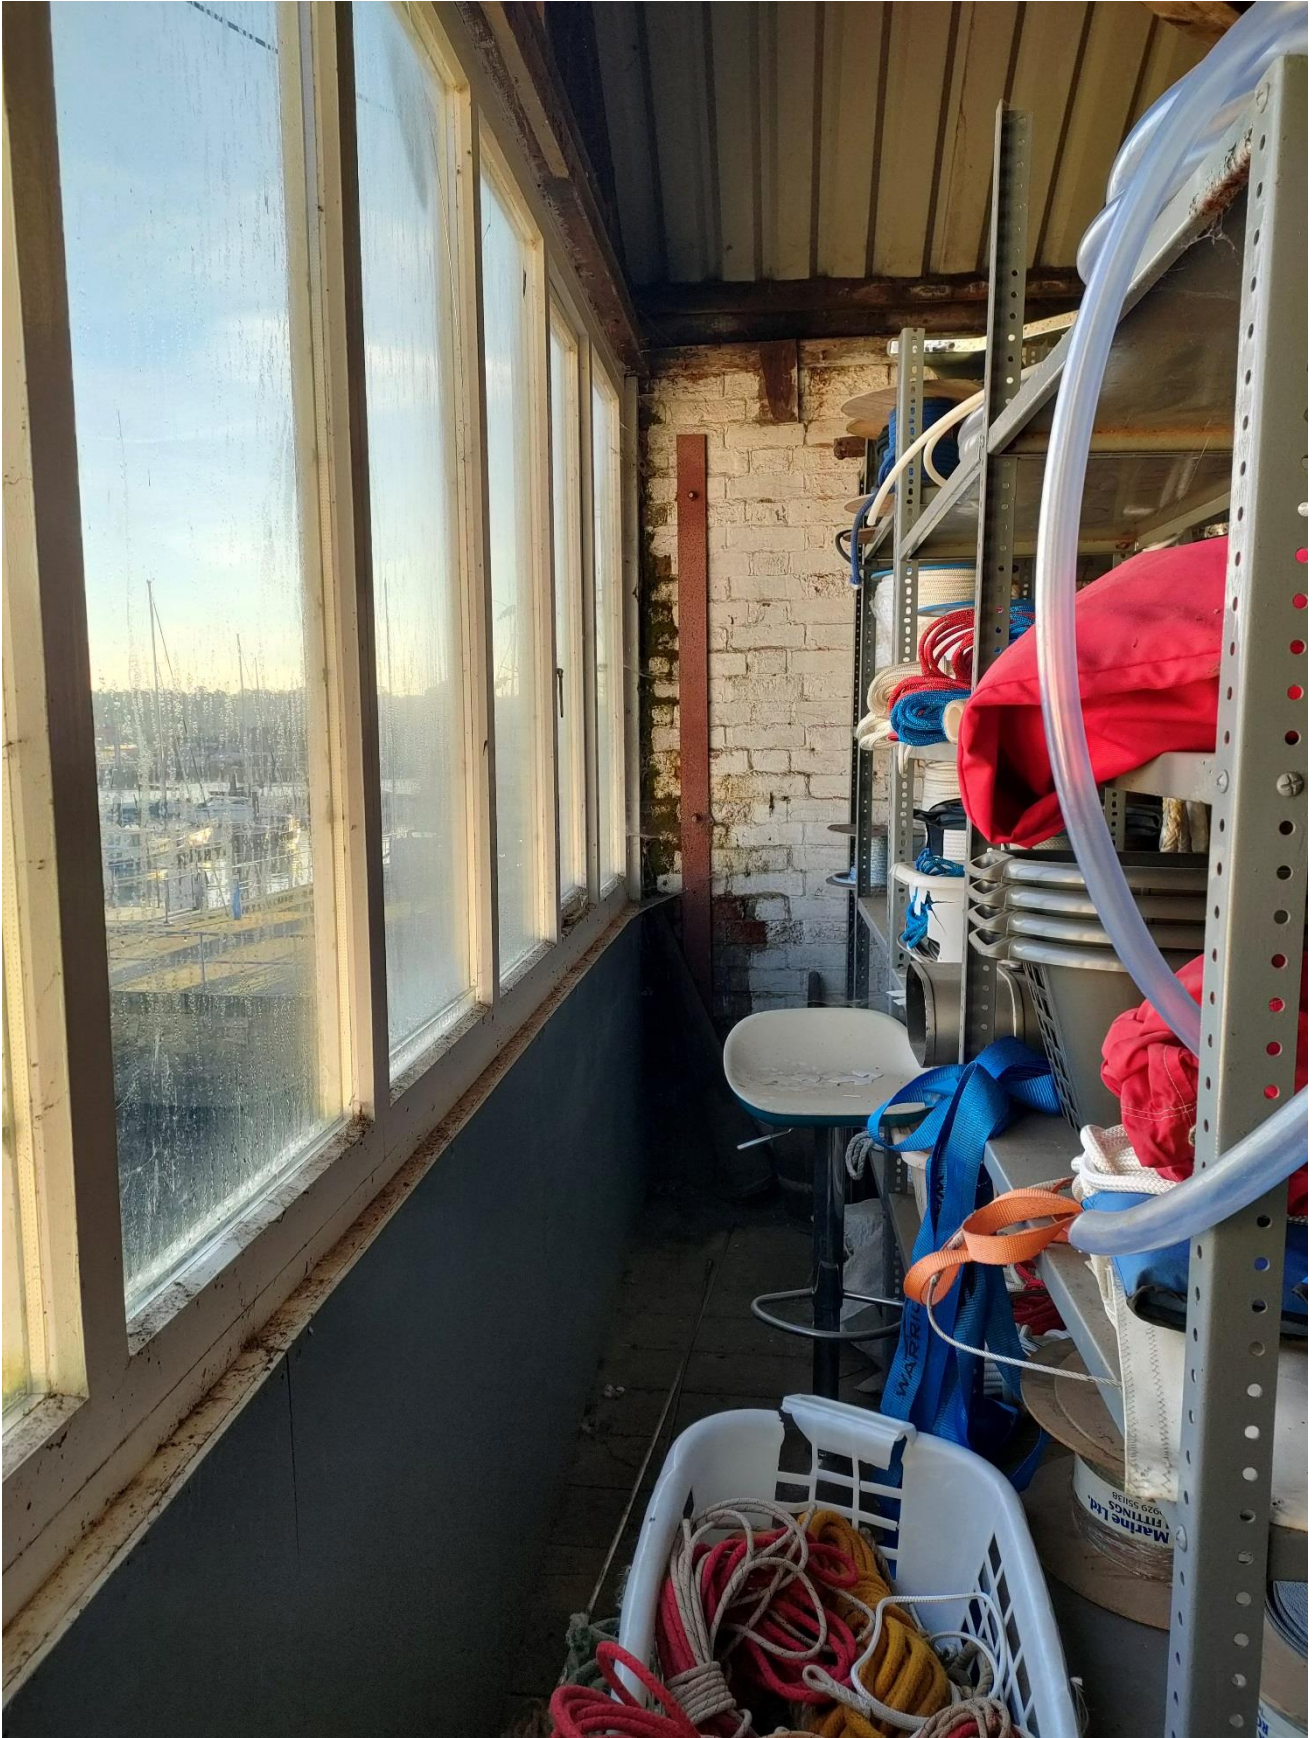
To the rear elevation a steel strapping plate has been installed to re-support the masonry, refer to Image 7.

**Image 7** Upper floor, rear – steel strapping.

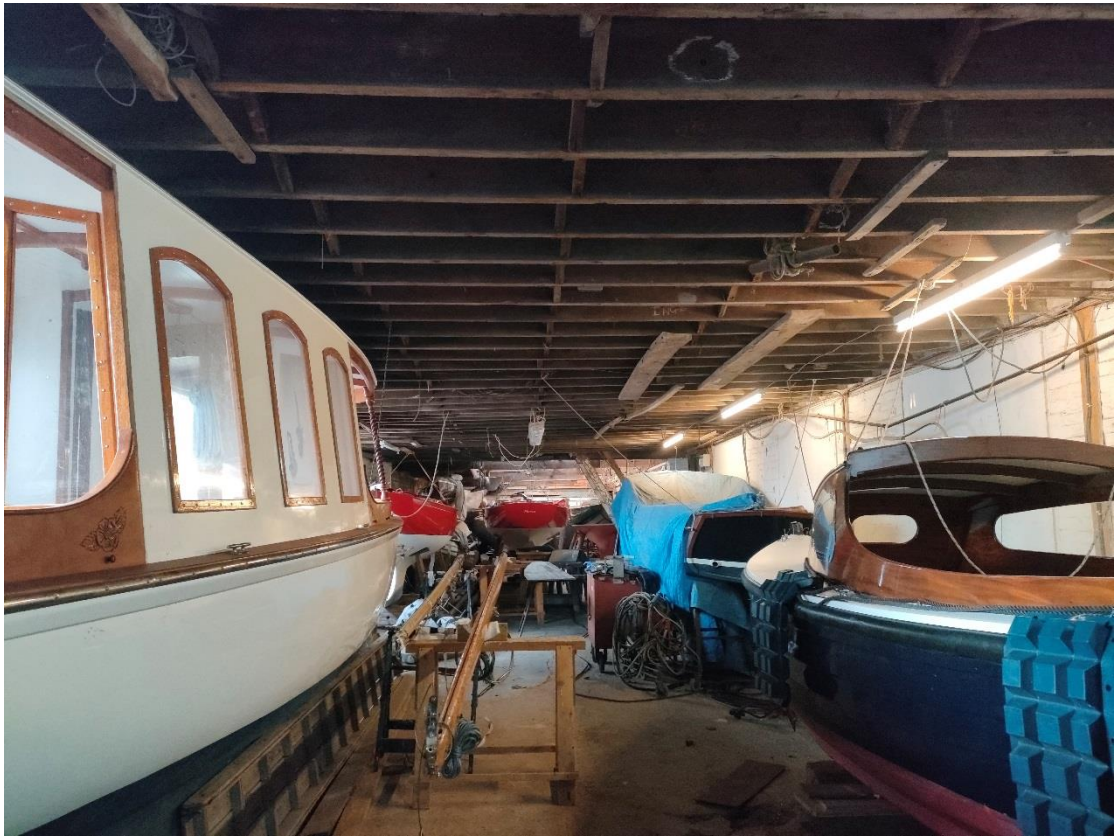
Image 8 shows a general view at ground level. Windows are located on the long elevations.

**Image 8** Ground floor, general view.

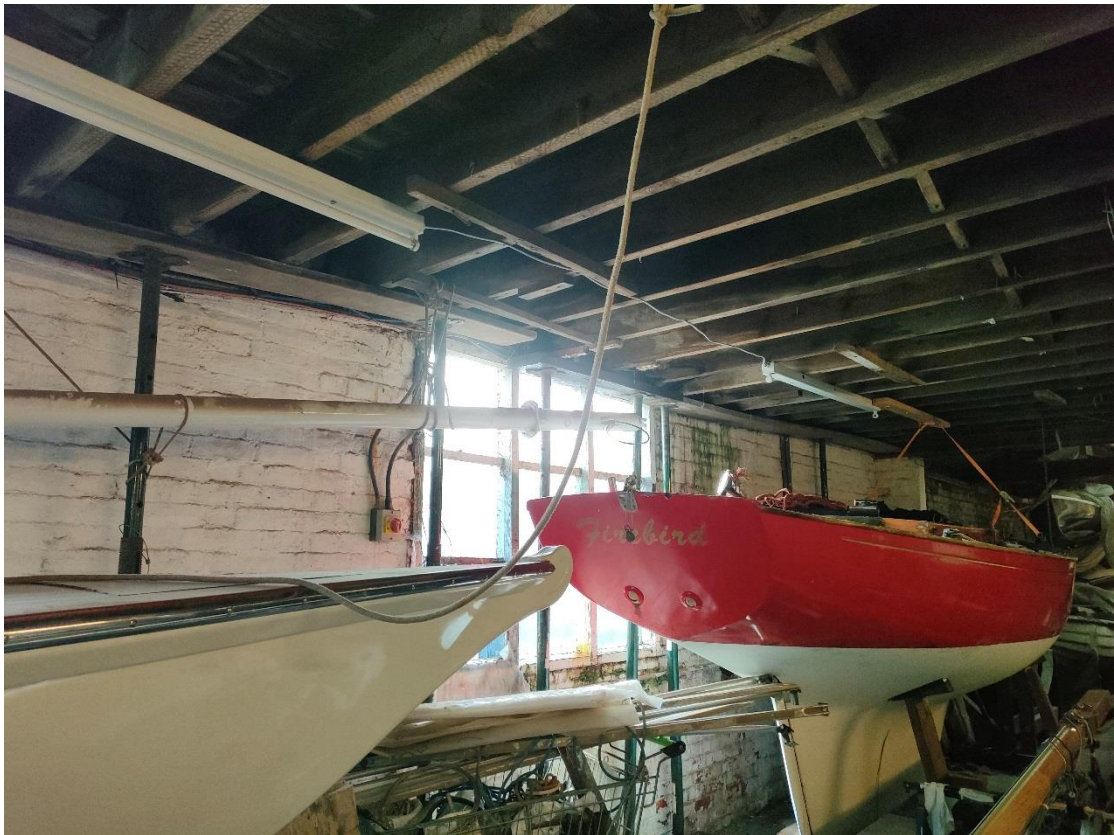
The lateral movement of the external long elevation wall has caused the floor joists to become unseated and their ends are propped, refer to Image 9. Deflection of floor joists can be seen clearly in this image.

**Image 9** Ground floor, propped floor joists.

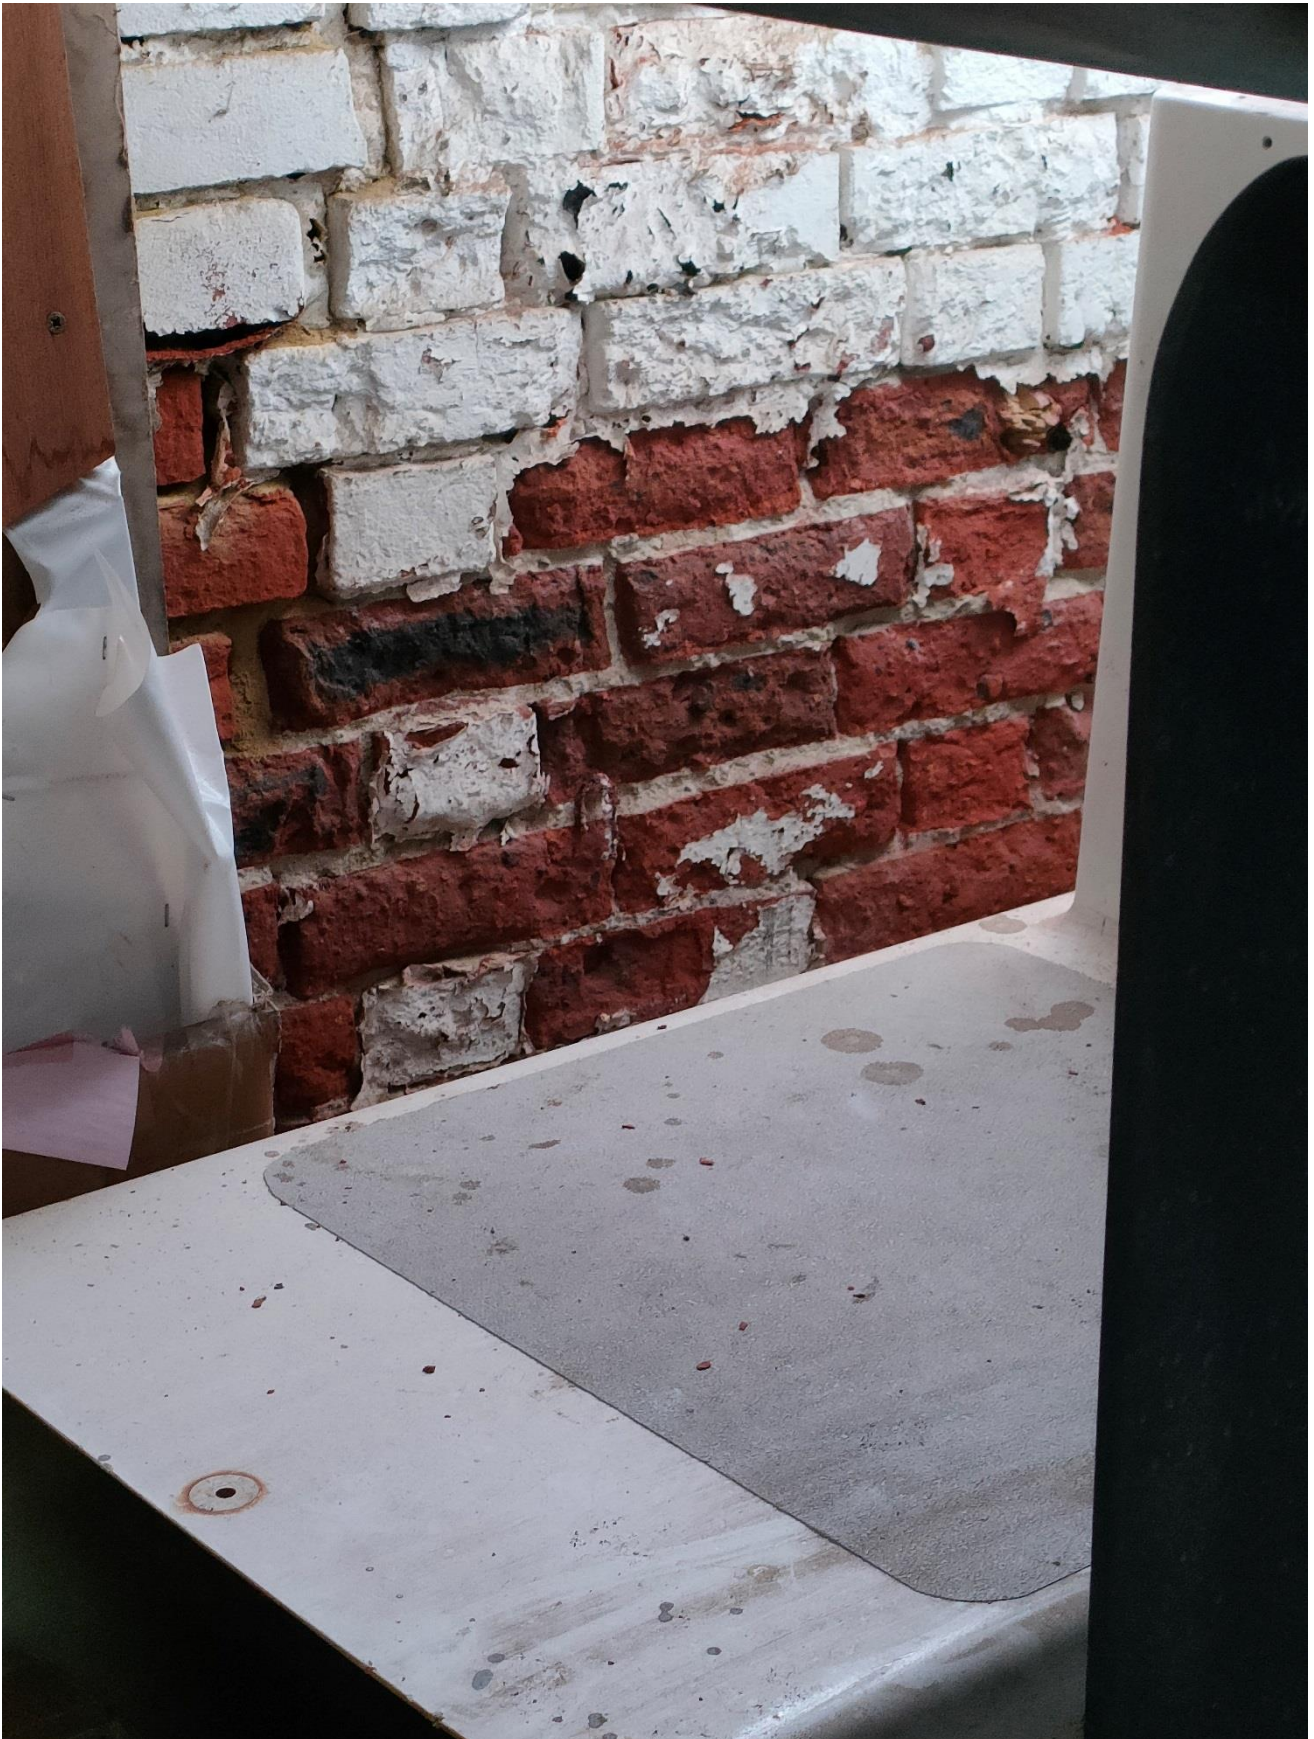
The brickwork at ground floor level is in a poor condition. Spalled masonry, cracking and historical movement can be seen. Refer to Images 10 and 11.

**Image 10** Ground floor – spalled masonry and historical movement.

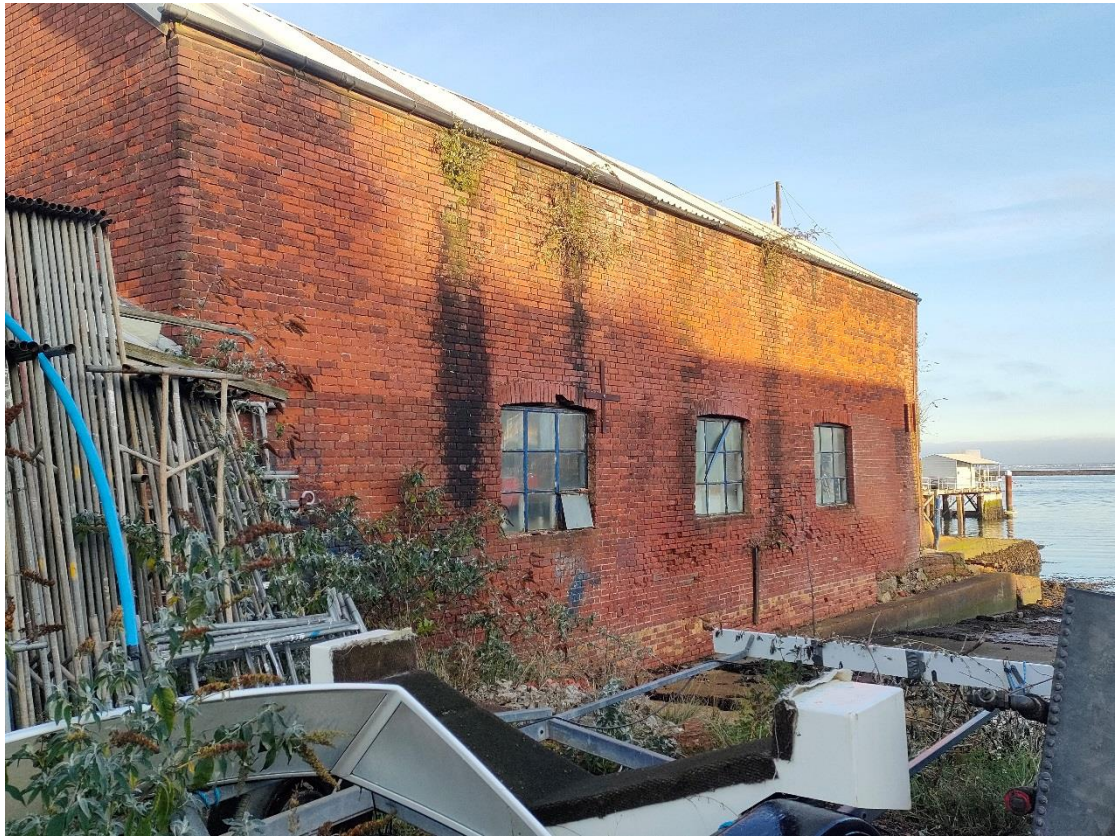
**Image 12** Right hand side elevation.

The right hand side elevation runs alongside the slipway, refer to Image 12, and the left hand side elevation has been roofed and forms part of the storage areas, refer to Image 13.

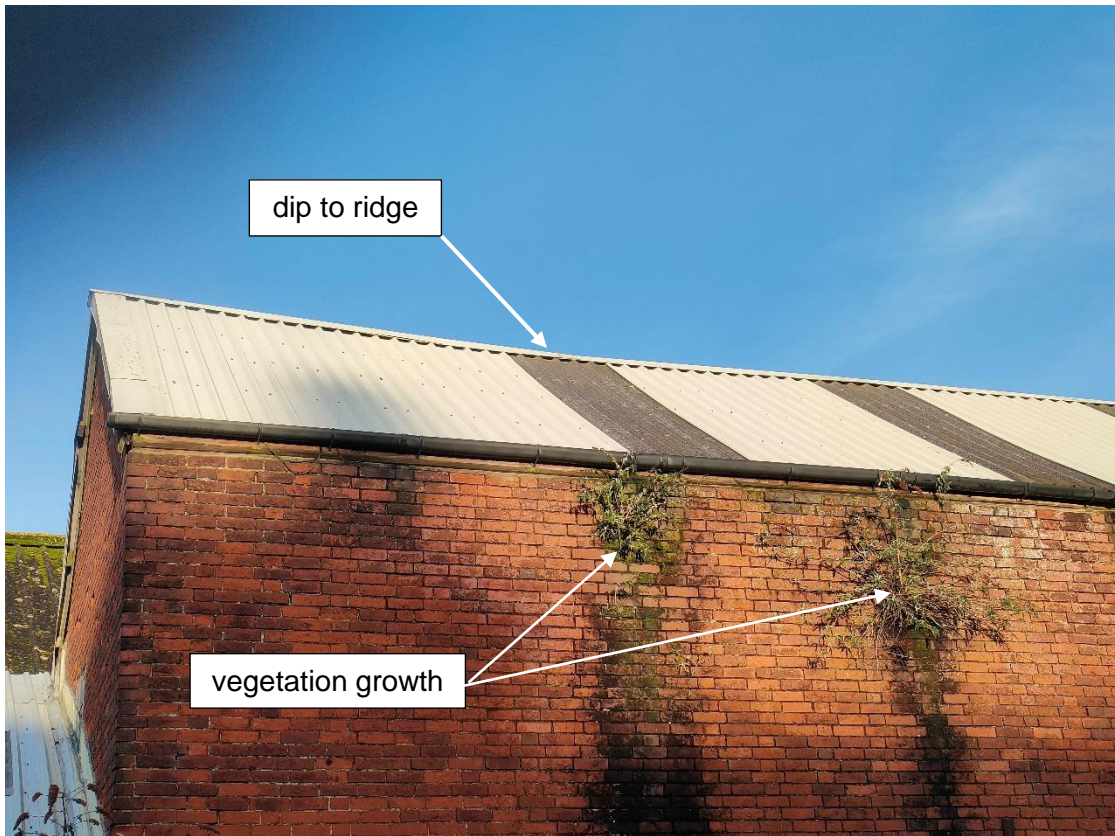
A significant dip can be seen to the ridge line, refer to Image 14.

**Image 14** Profiled sheet roof – dip to ridge.

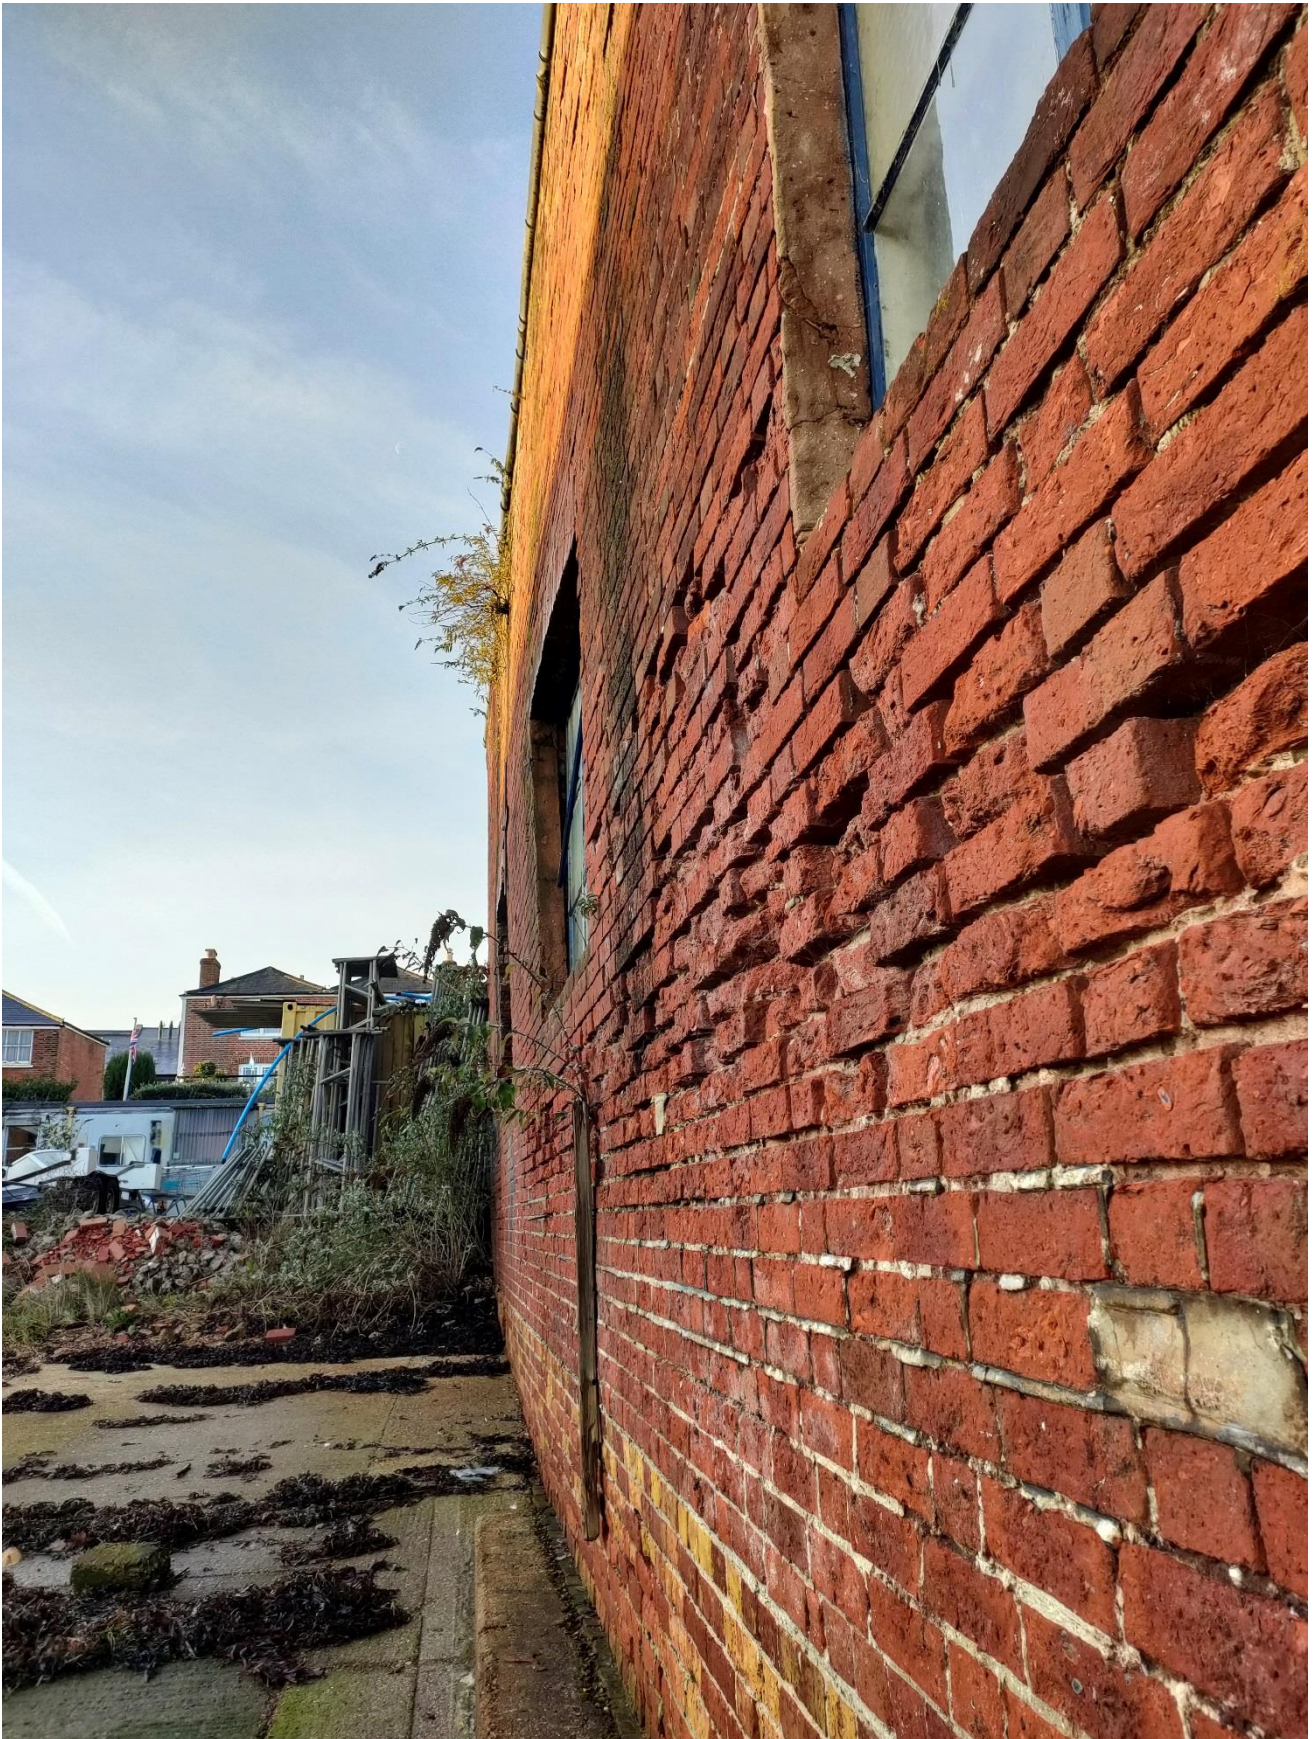
The masonry to the right hand side elevation exhibits the same bow seen internally. Large areas of brickwork are significantly spalled and vegetation is growing in the wall, refer to Images 15 and 16, Areas of lost mortar can also be noted, generally below the high tide water line.

**Image 15** View along right hand side elevation showing significant spalling and bow.

Very little of the original structure will remain after these works, and the Temporary Works will be costly. We therefore recommend that the safest and most cost effective solution is to demolish the existing building.

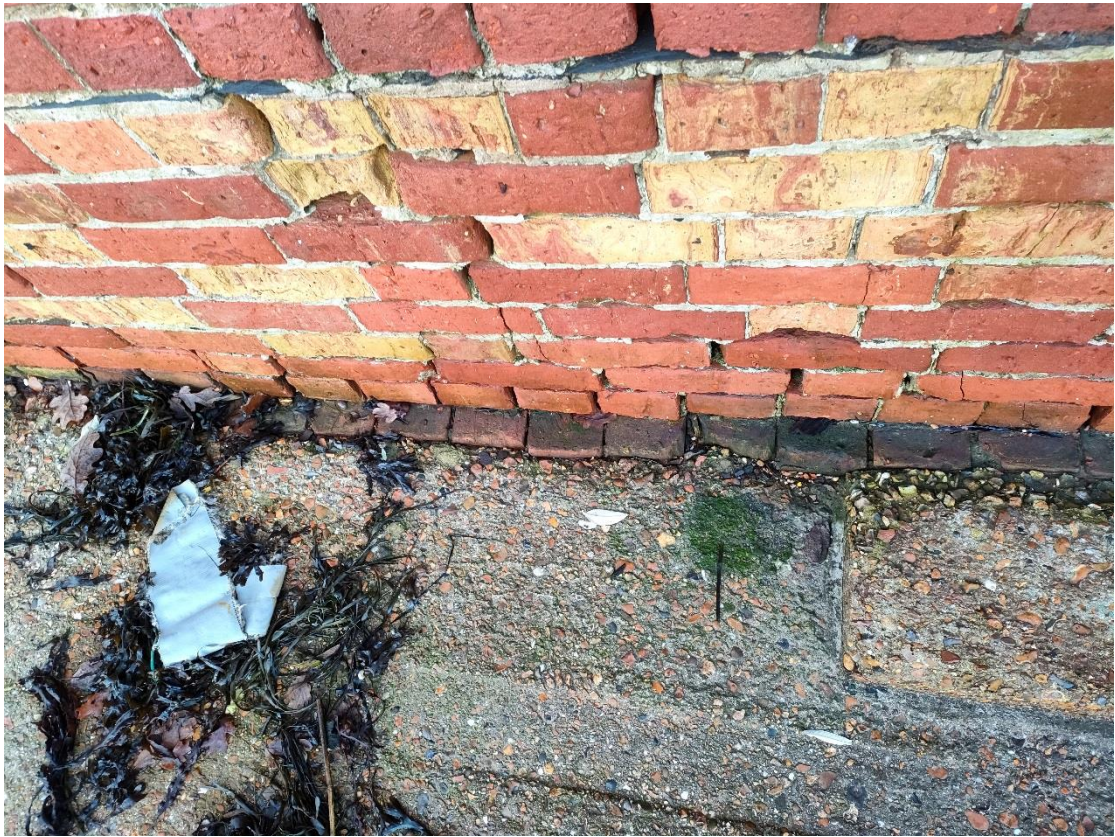
**Image 16** Right hand side elevation – spalled brickwork and loss of mortar.

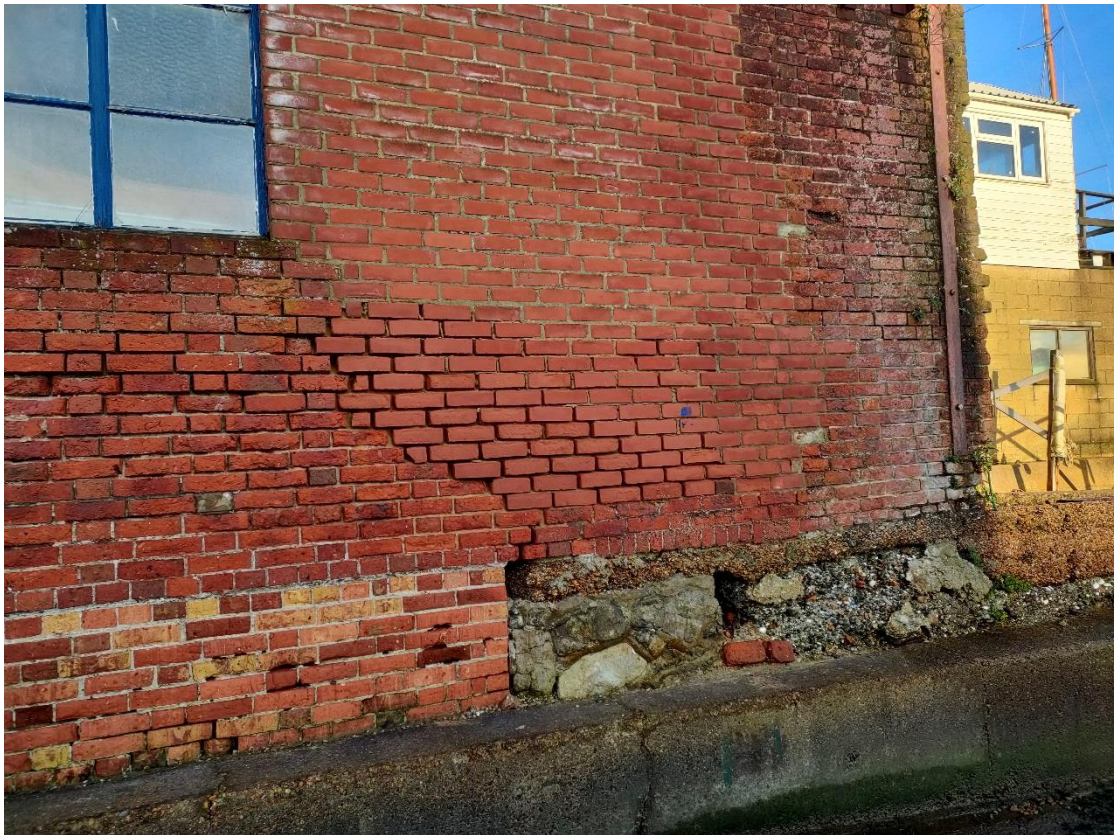
At the rear elevation the wall is founded on a mix of slabs and stone, refer to Image 17. There is also a steel strip which matches through to the internal strap, refer to Image 7. Image 17 also indicates diagonal cracking, spalled bricks, lateral movement and numerous areas of rebuilding/repointing.

**Image 17** Slab, stone and fill support to right hand side elevation wall to rear.

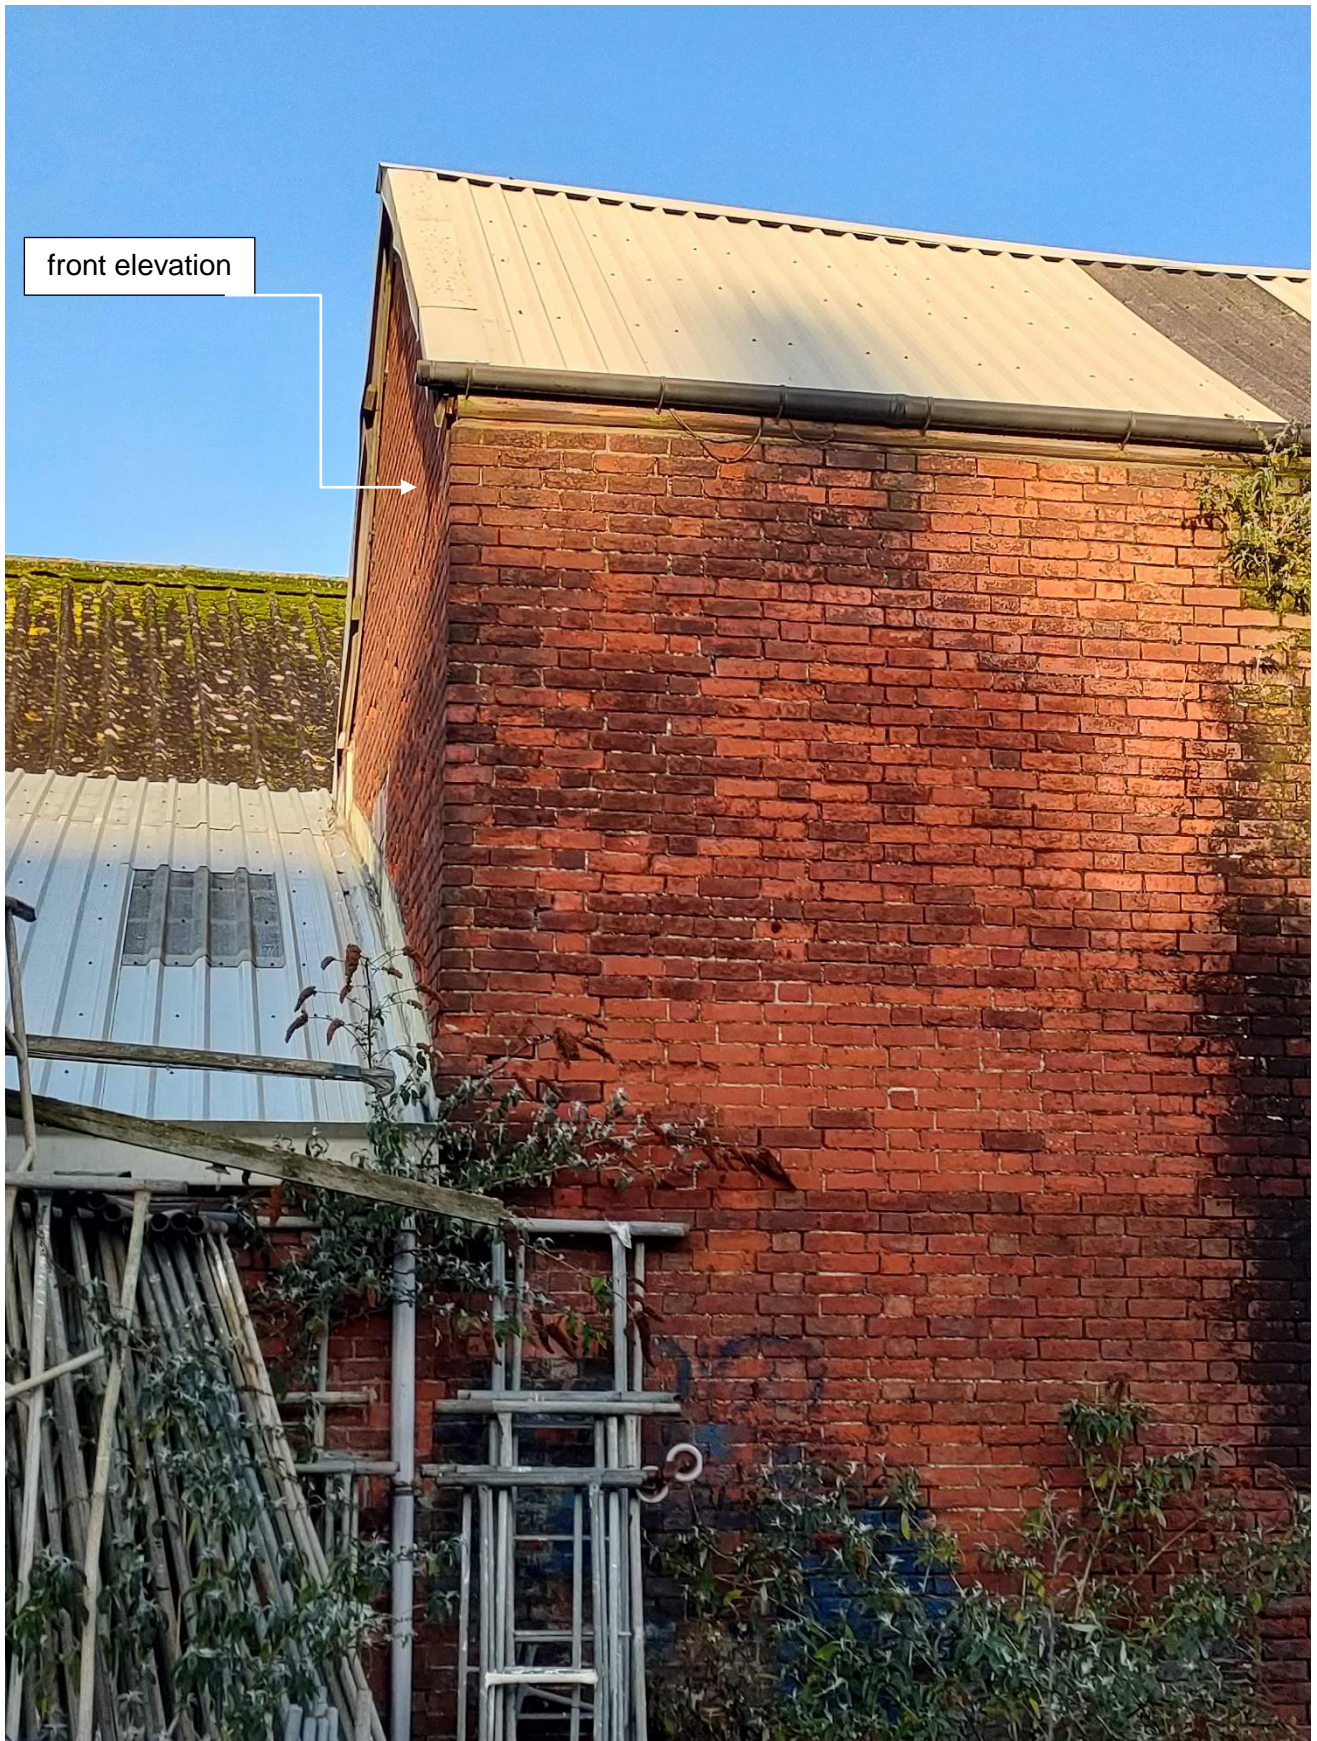
**Image 18** Front elevation.

The front elevation has limited access due to an adjoined building. The upper masonry shows signs of spalling and a potential bow inwards, refer to Image 18.
