SCHEDULE OF COMPLETED REPAIRS

**REPAIR ADDRESS: 90 HAYES LANE
BECKENHAM
KENT
BR3 6SP**

Insured: Mrs Caroline Millard
Reference: DLG-SN-22-004722

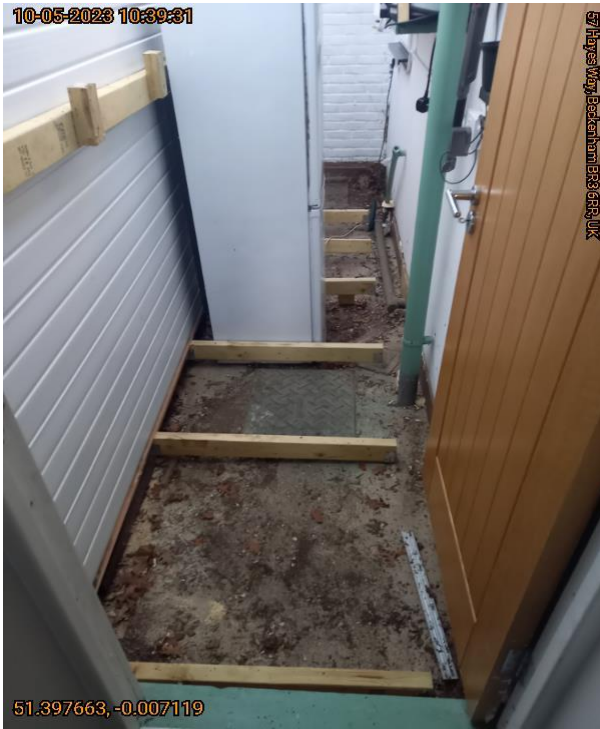
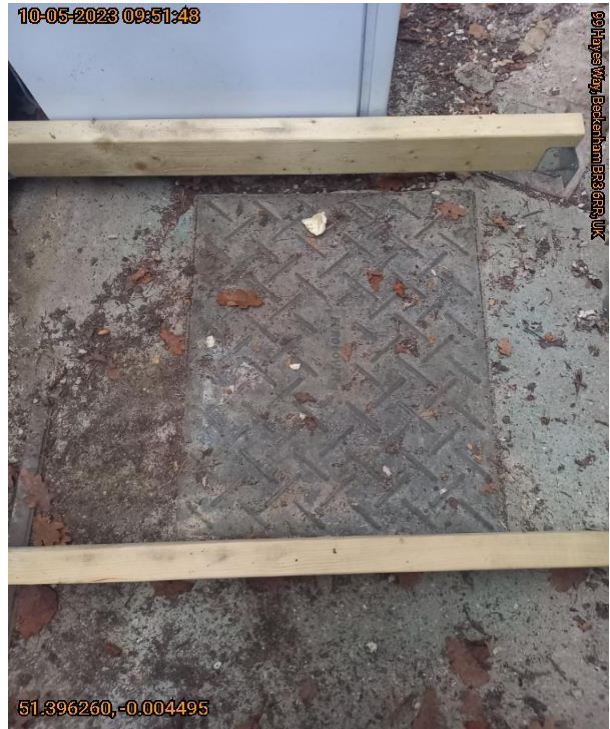
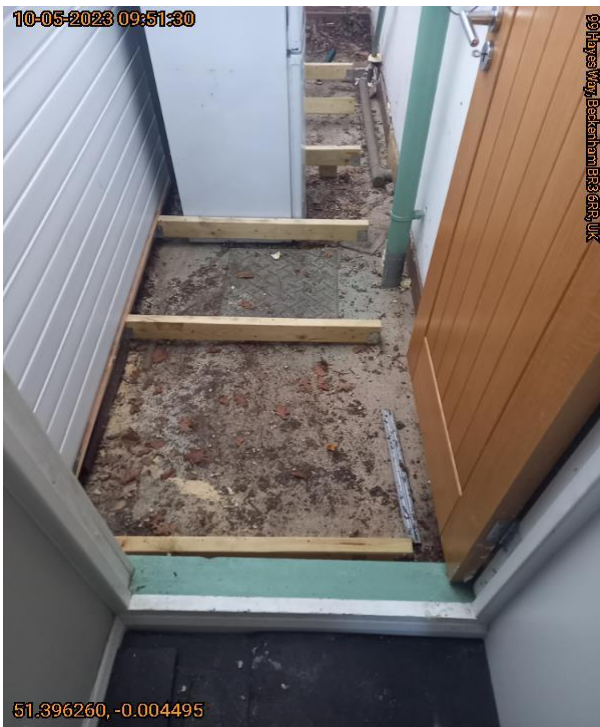
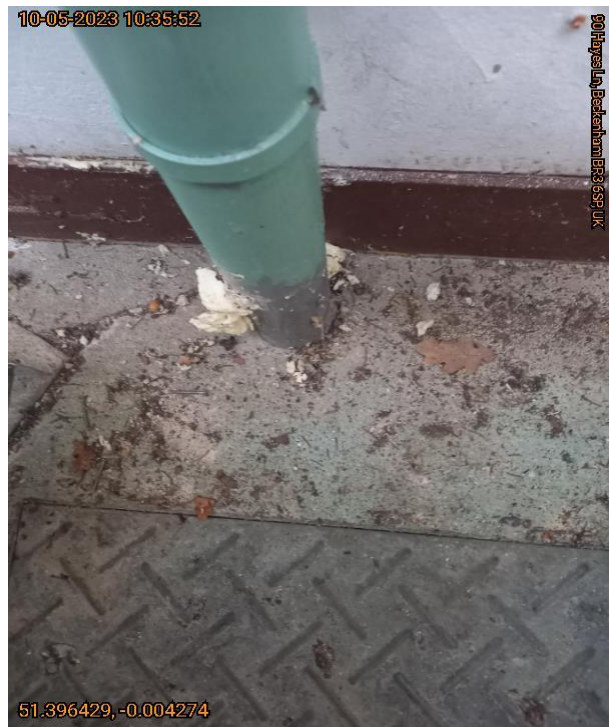
We completed high pressure water Jetting and installed 1m x 100mm patch liner to repair the run which goes upstream to the WC

The CCTV survey confirmed cracking on the restbend to the RWDP which is 75mm

To complete an internal excavation upstream of IC4 to remove and replace the restbend to RWDP2.
Backfill and reinstate leaving the area clean and tidy.
