# Engineers Report

**Risk Address** 90 Hayes Lane  
BECKENHAM  
Kent  
BR3 6SP

**360 Reference** DLG-SN-22-004722  
**Insurer Reference** 084239680  
**Policy Holder** Mrs Caroline Millard

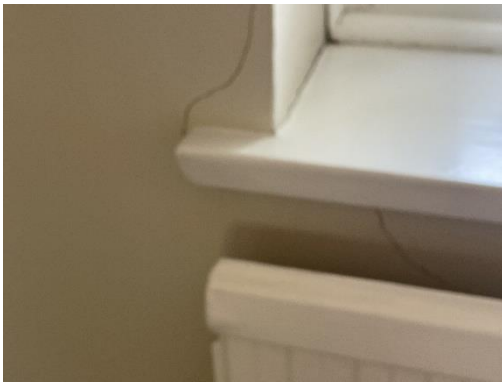
Diagonal / vertical cracking, up to approximately 3-4mm wide is evident around structural openings and to plaster finishes generally. Gaps between the wall & floor junctions has also been noted, circa 5-6mm in width, to the left-hand area of the property.

Picture 1: Internal cracking

It is common practice to categorise the damage in accordance with B.R.E. Digest 251 "Assessment of Damage in Low-Rise Buildings". In this case, the damage falls into Category 2 "Slight" as there is cracking up to approximately 5mm wide.

The cause of the localised subsidence, generally orientated towards the left, right & rear elevations of the property, appears to be clay shrinkage, exacerbated by the water demand of the nearby vegetation, to the rear of the risk address.

Following completion of the mitigation works described above, and a period to allow the ground to rehydrate, crack repairs and redecoration to the affected areas of the property can proceed. A repair schedule will be drawn up and agreed in due course.

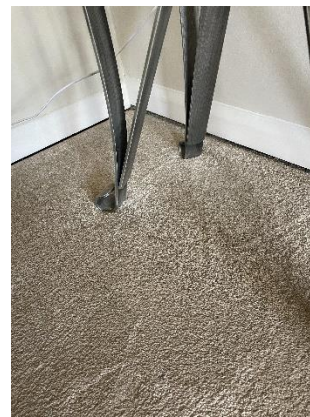
Picture 2: Gap between floor & skirting

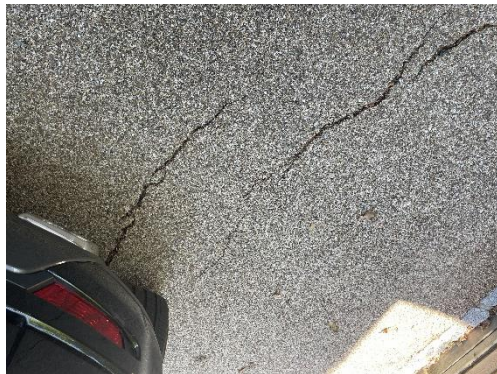
The internal damage is not generally reflected externally, however the external walls are rendered, We have noted damage in the form of tree root damage to the resin pathways around the property, externally.

Pictures 3 – Cracking to resin drive
