ARBORICULTURAL REPORT at 90 Hayes Lane Beckenham Kent BR3 6SP

Claim Number: DLG-SN-22-004722

JCA Ref: 18960/ChC

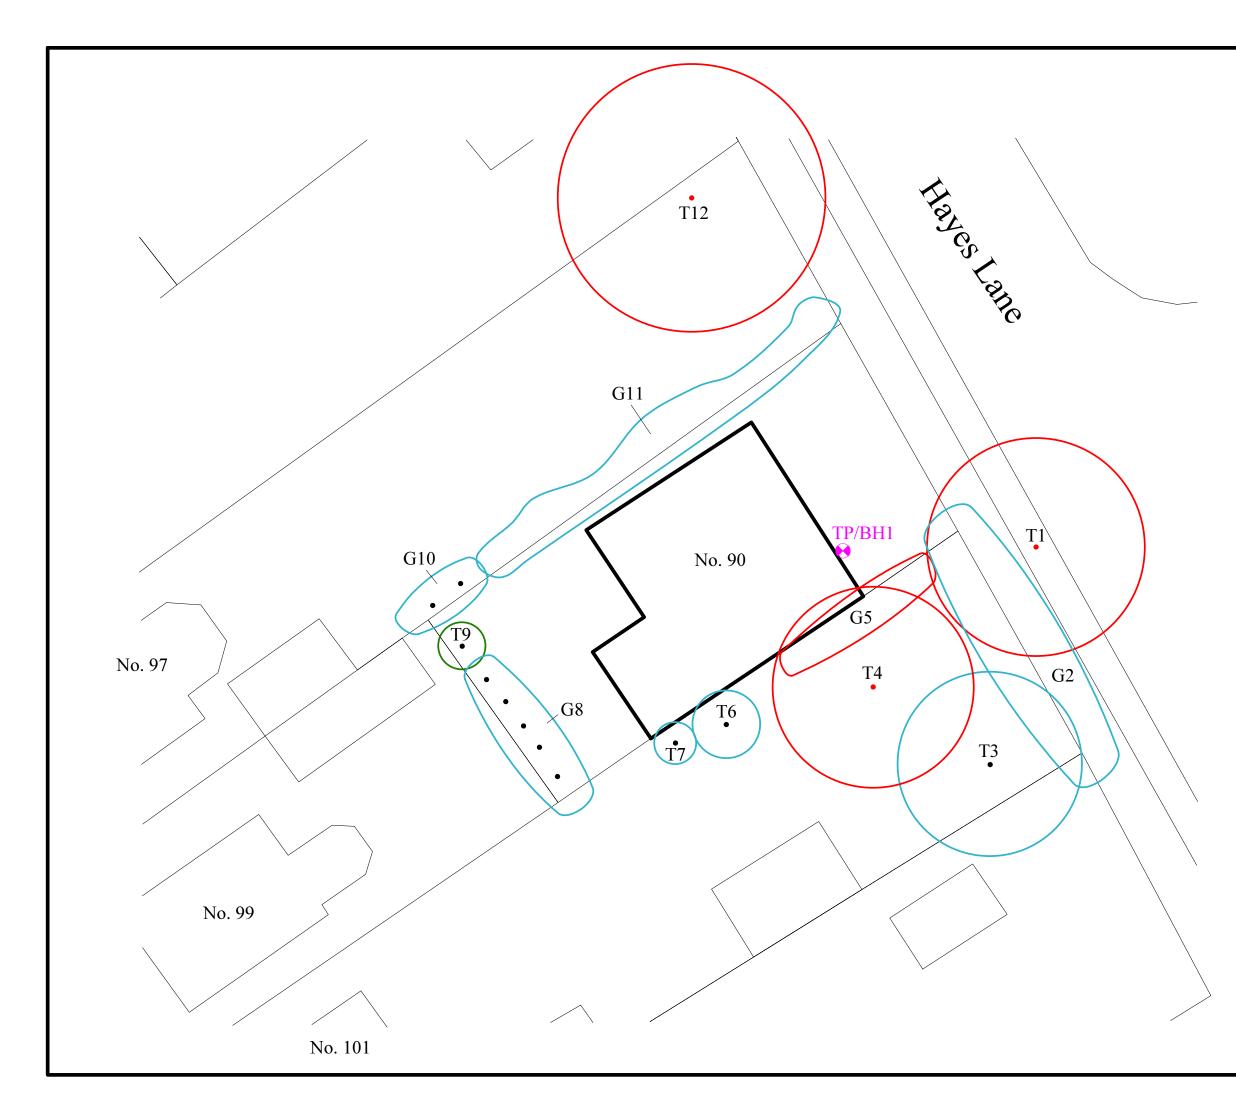
- 3.2.1 Please refer to the site plan at **Appendix 2** for an indication of the trial pit/borehole location.
- 3.2.2 **Trial pit/borehole 1** revealed a concrete/brick corbel foundation at a maximum depth of 1100mm below ground level.

- 5.1 Descriptions of the surveyed vegetation and all recommended work are detailed in the tables at **Appendix 1**.
- 5.2 Please refer to the site plan at **Appendix 2** for the locations of the vegetation surveyed and all the relevant site features.

- 6.3 We have therefore recommended that **T1**, **T4**, **G5** and **T12** be removed to ground level and that the stumps be treated to prevent regrowth.

- Monitoring of cracks indicating cyclical movement.
- 6.5 We consider the vegetation identified as G2, T3, T6, T7, G8, G10 and G11 to be of possible future concern to the subject property, if left unmanaged. We have therefore recommended that these items of vegetation be maintained at their current height and spread over the forthcoming years. These works are only recommended as a precaution and are not considered a priority to resolve the damage observed at the subject property.
- 6.6 We have summarised all our tree specific recommendations in **Section 7** and made general recommendations in **Section 8**. The effect of these recommendations should be to prevent further damage by reducing the moisture uptake close to the problem areas.
