8th February 2024

Oak tree at 38 Stoney Road, Bracknell, RG42 1YG

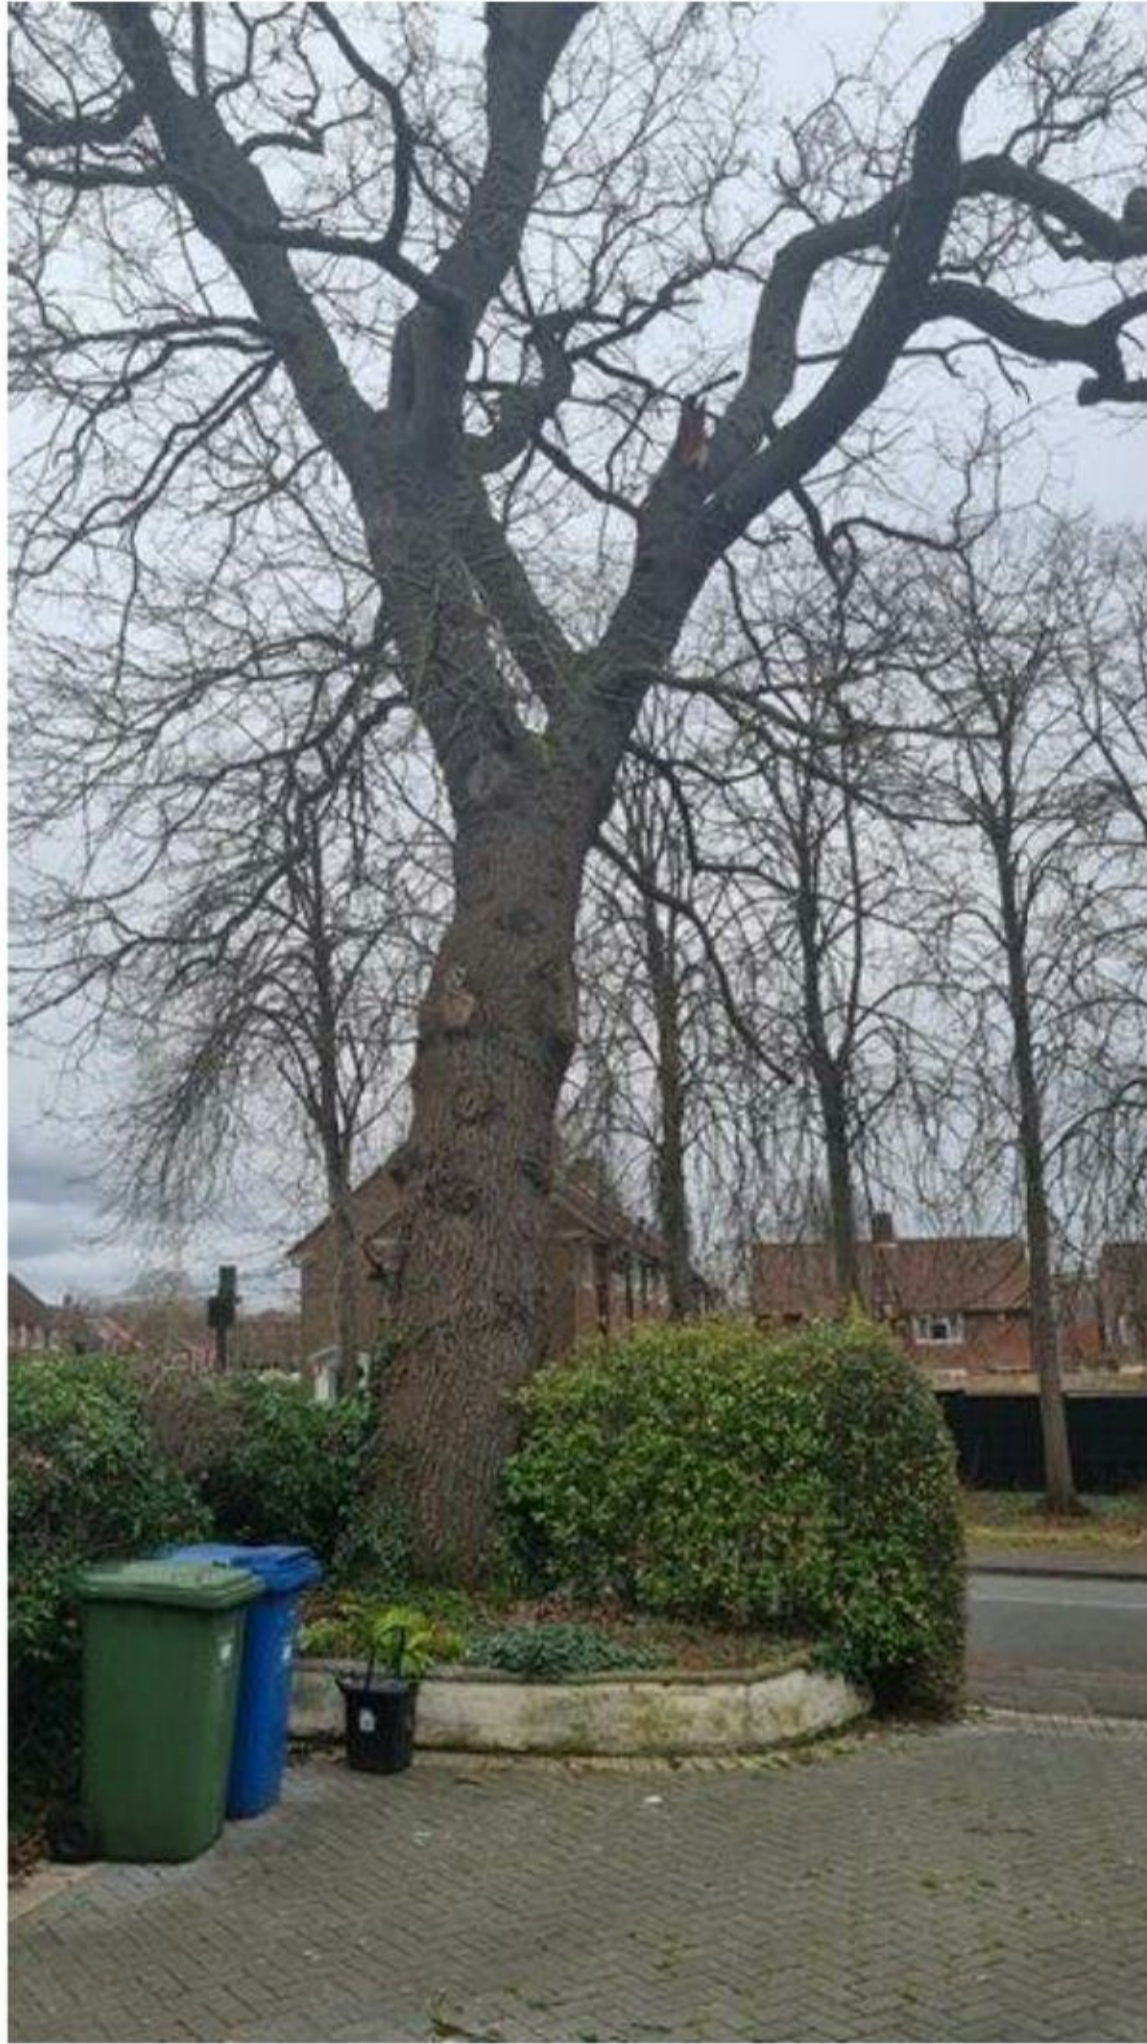
The main trunk has numerous wounds from historic branch removal which have calloused over. There is a vertical scar on the west of the trunk at the base. The main stem leans such that the tree is weighted towards the road. The trunk divides in two at 6m, with the southern and northern stems further dividing into three major limbs. See photos 1 & 2 below.

Photo 1: View of tree from within driveway

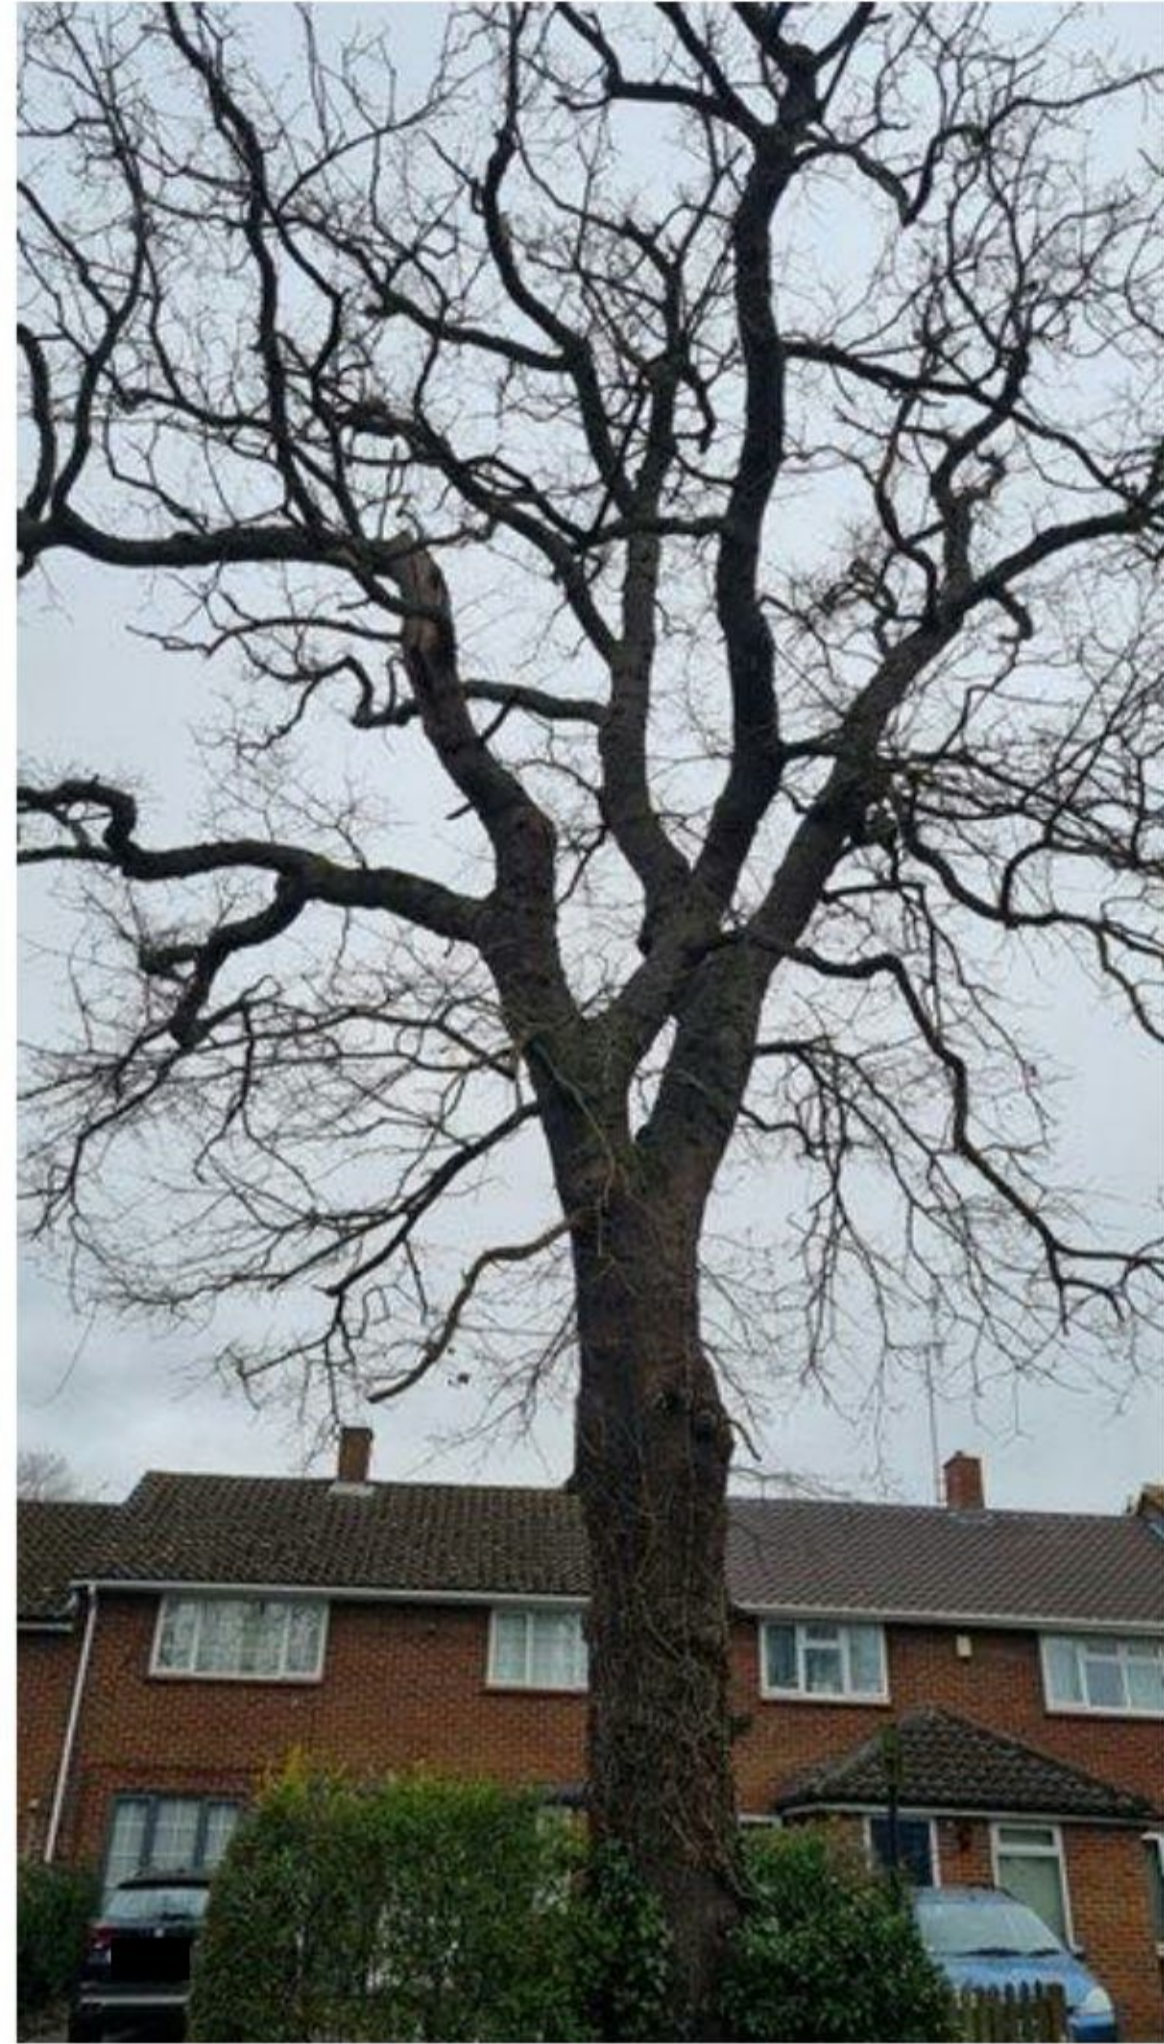
Photo 2: View of tree from road

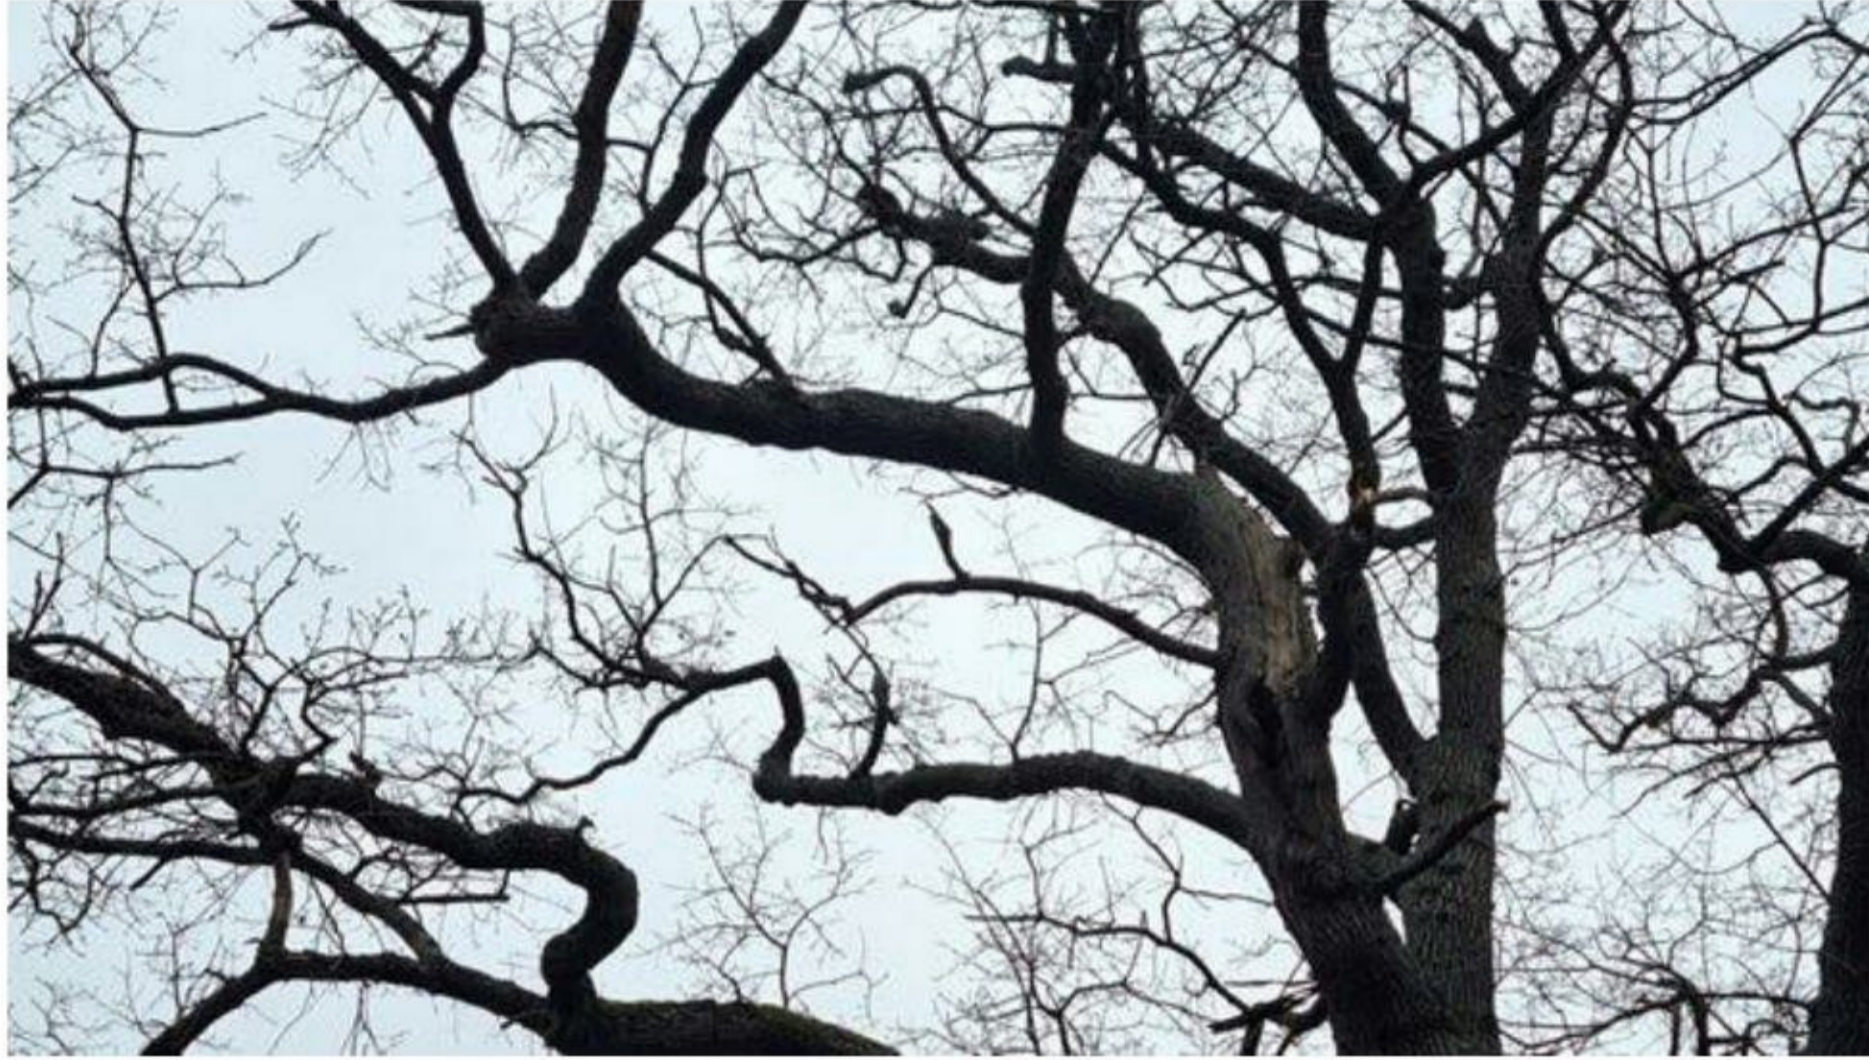
1. A major limb extending out to the southeast has a large area of exposed dead heartwood where an upright limb has been historically torn out. There is then a further wound below this, from a more recently torn out branch. Due to these wounds, the branches above these areas of damage are weak, with the likelihood of the major limbs snapping in high wind. The end of the branch has been reduced in the past, no doubt to reduce the sail area of the limb and reduce the risk of the limb snapping. **I would recommend the branches above the two wounds are reduced by 2 – 3m to suitable growth points to reduce the risk of the limbs failing at the weak area.** See Photos 3, 4 & 5 below.

Photo 3 limb at south east

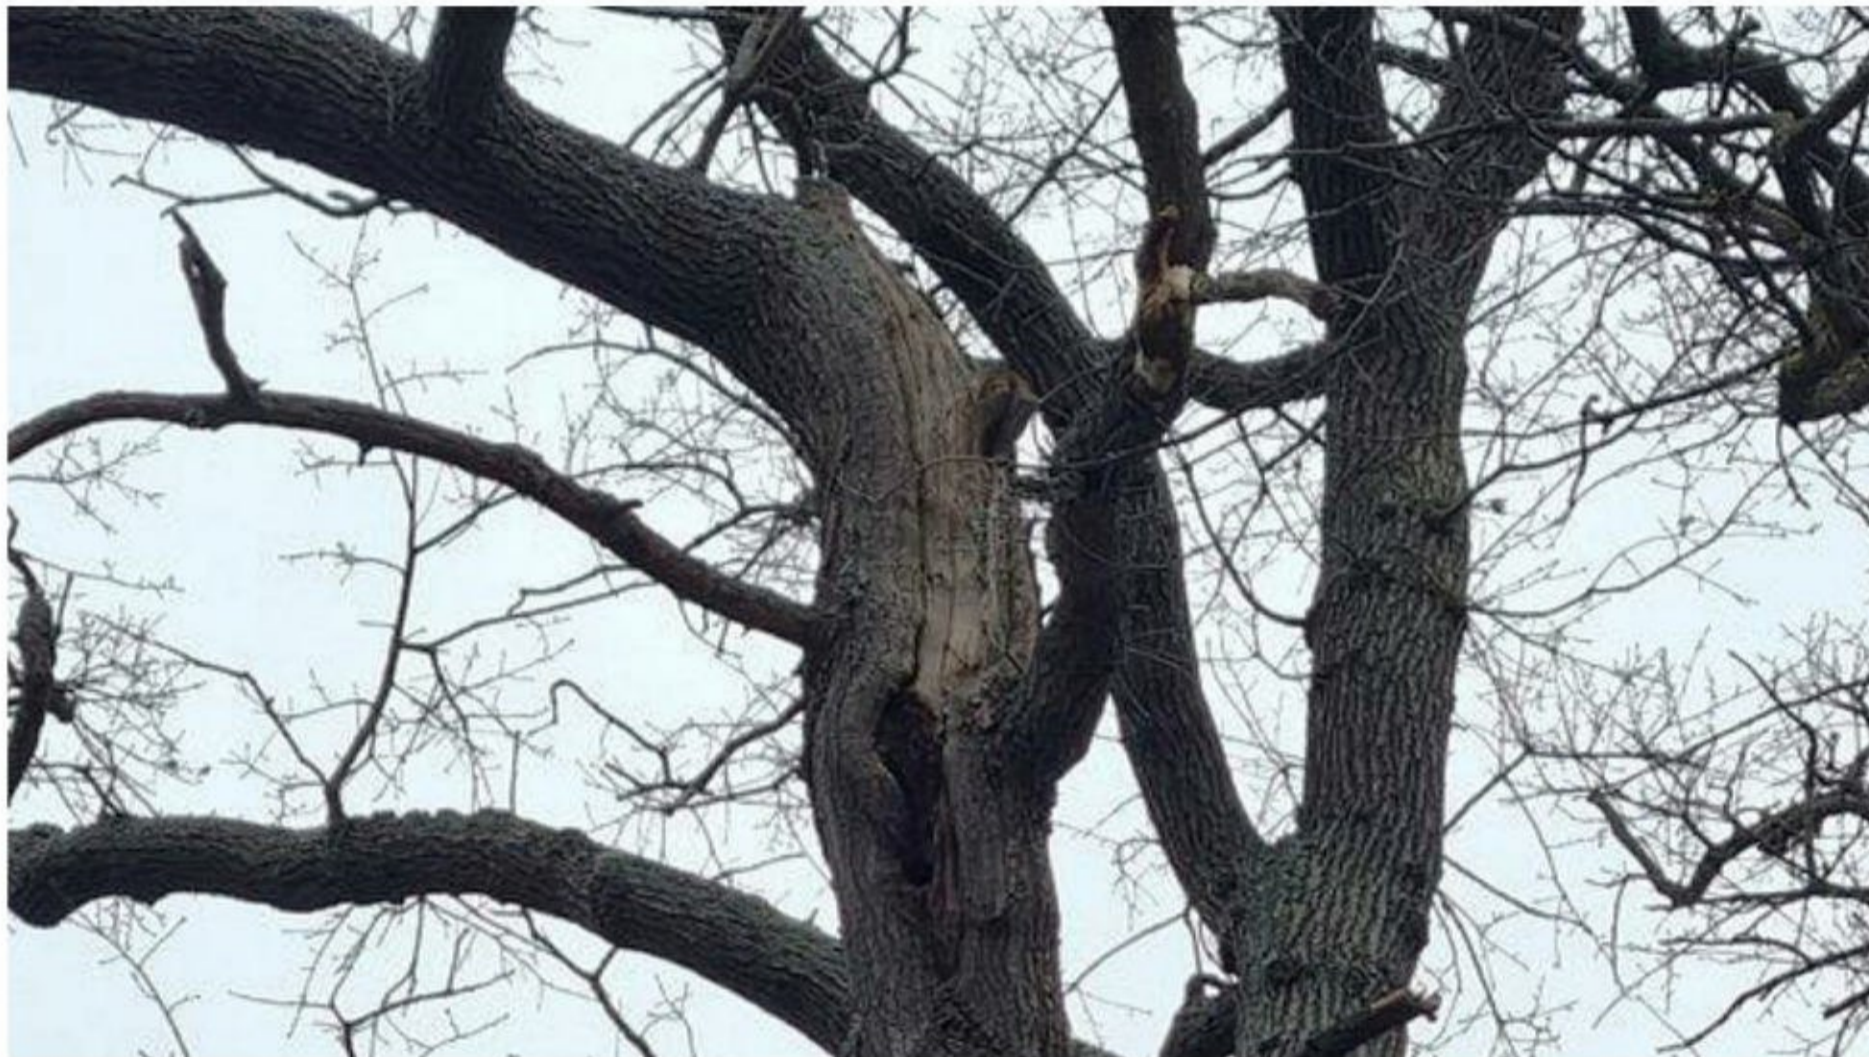
Photo 4 limb at south east area of weakness

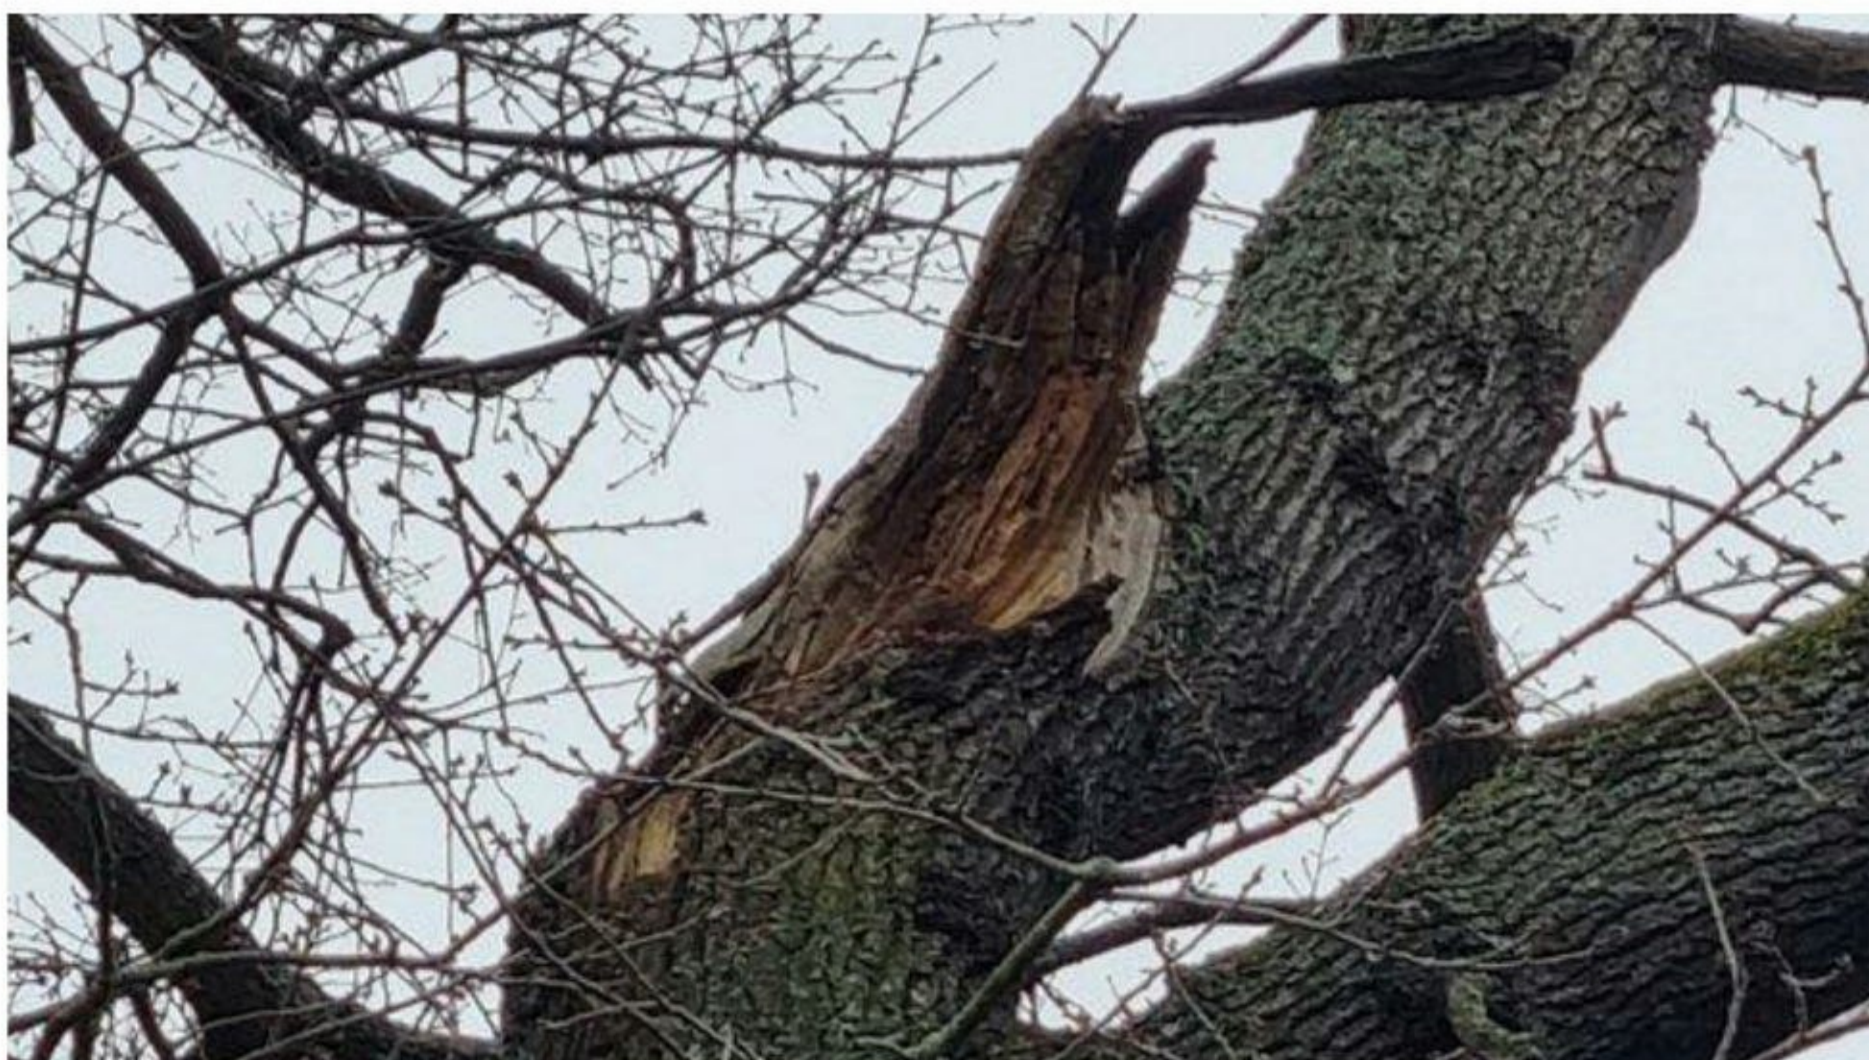
Photo 5 limb at south east. Torn out branch leaving area of weakness

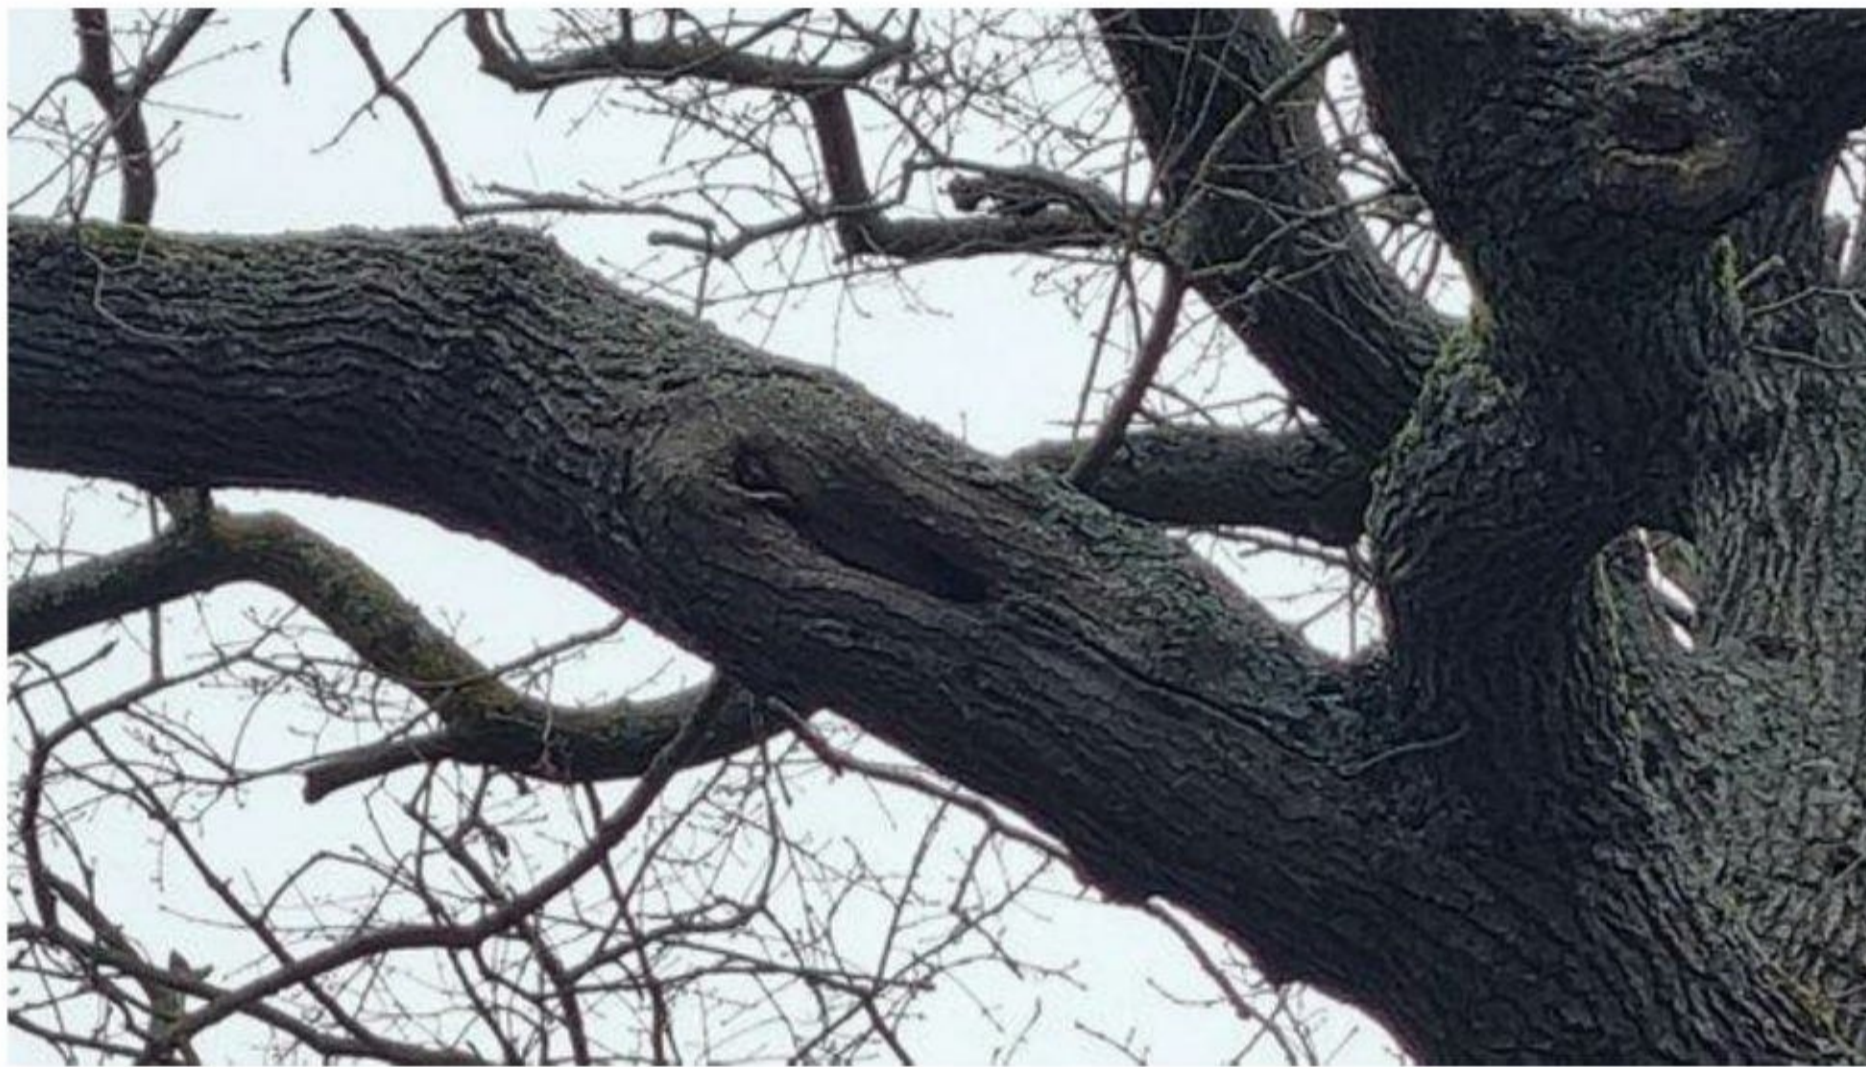
2. There is a 7m branch extending to the southwest over the driveway, which has a cavity near where it joins the tree from a historic tear out wound (Photo 6 below). The branch has been historically pruned back over the drive, no doubt to reduce the end weight of the branch, and then has since grown back (Photo7 below). There is the risk the branch will snap at the weak point in high wind. **I recommend that this branch is reduced by 2m to suitable growth points to reduce the risk of the branch snapping.**

Photo 6 cavity in branch extending over driveway

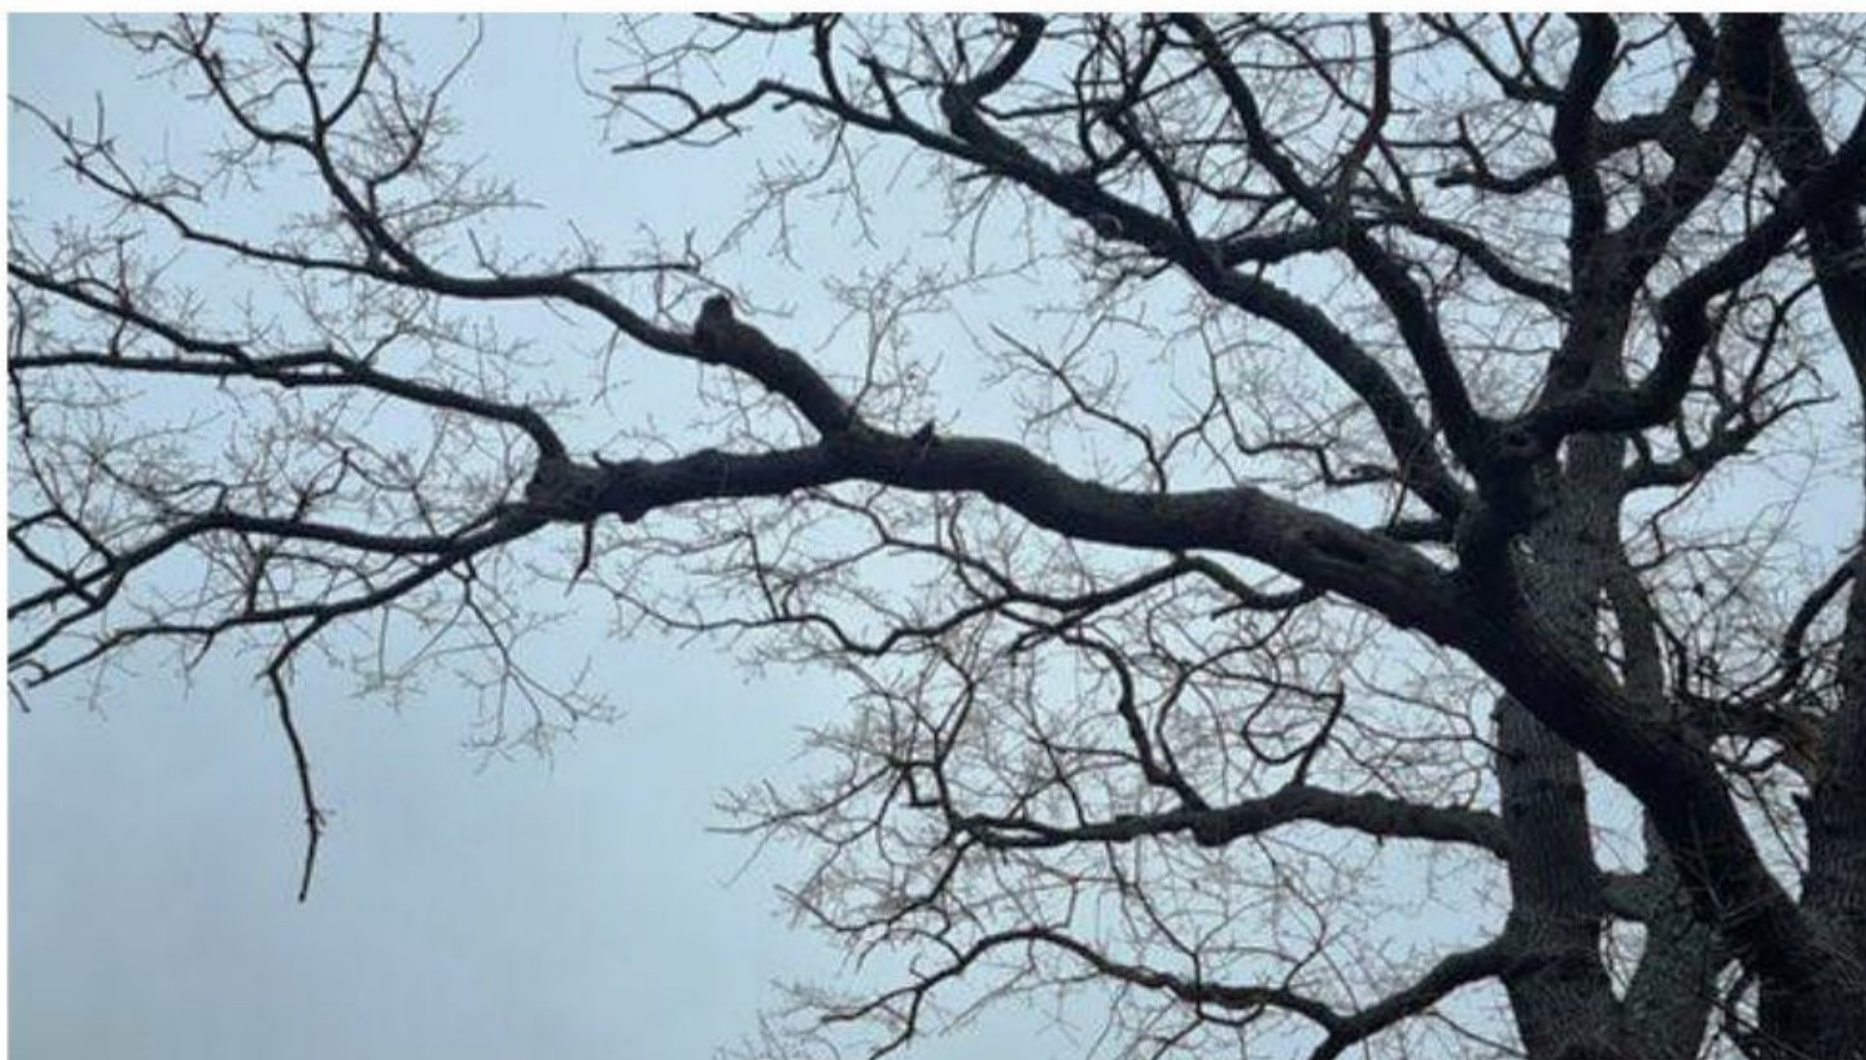
Photo 7 branch extending over driveway previously reduced

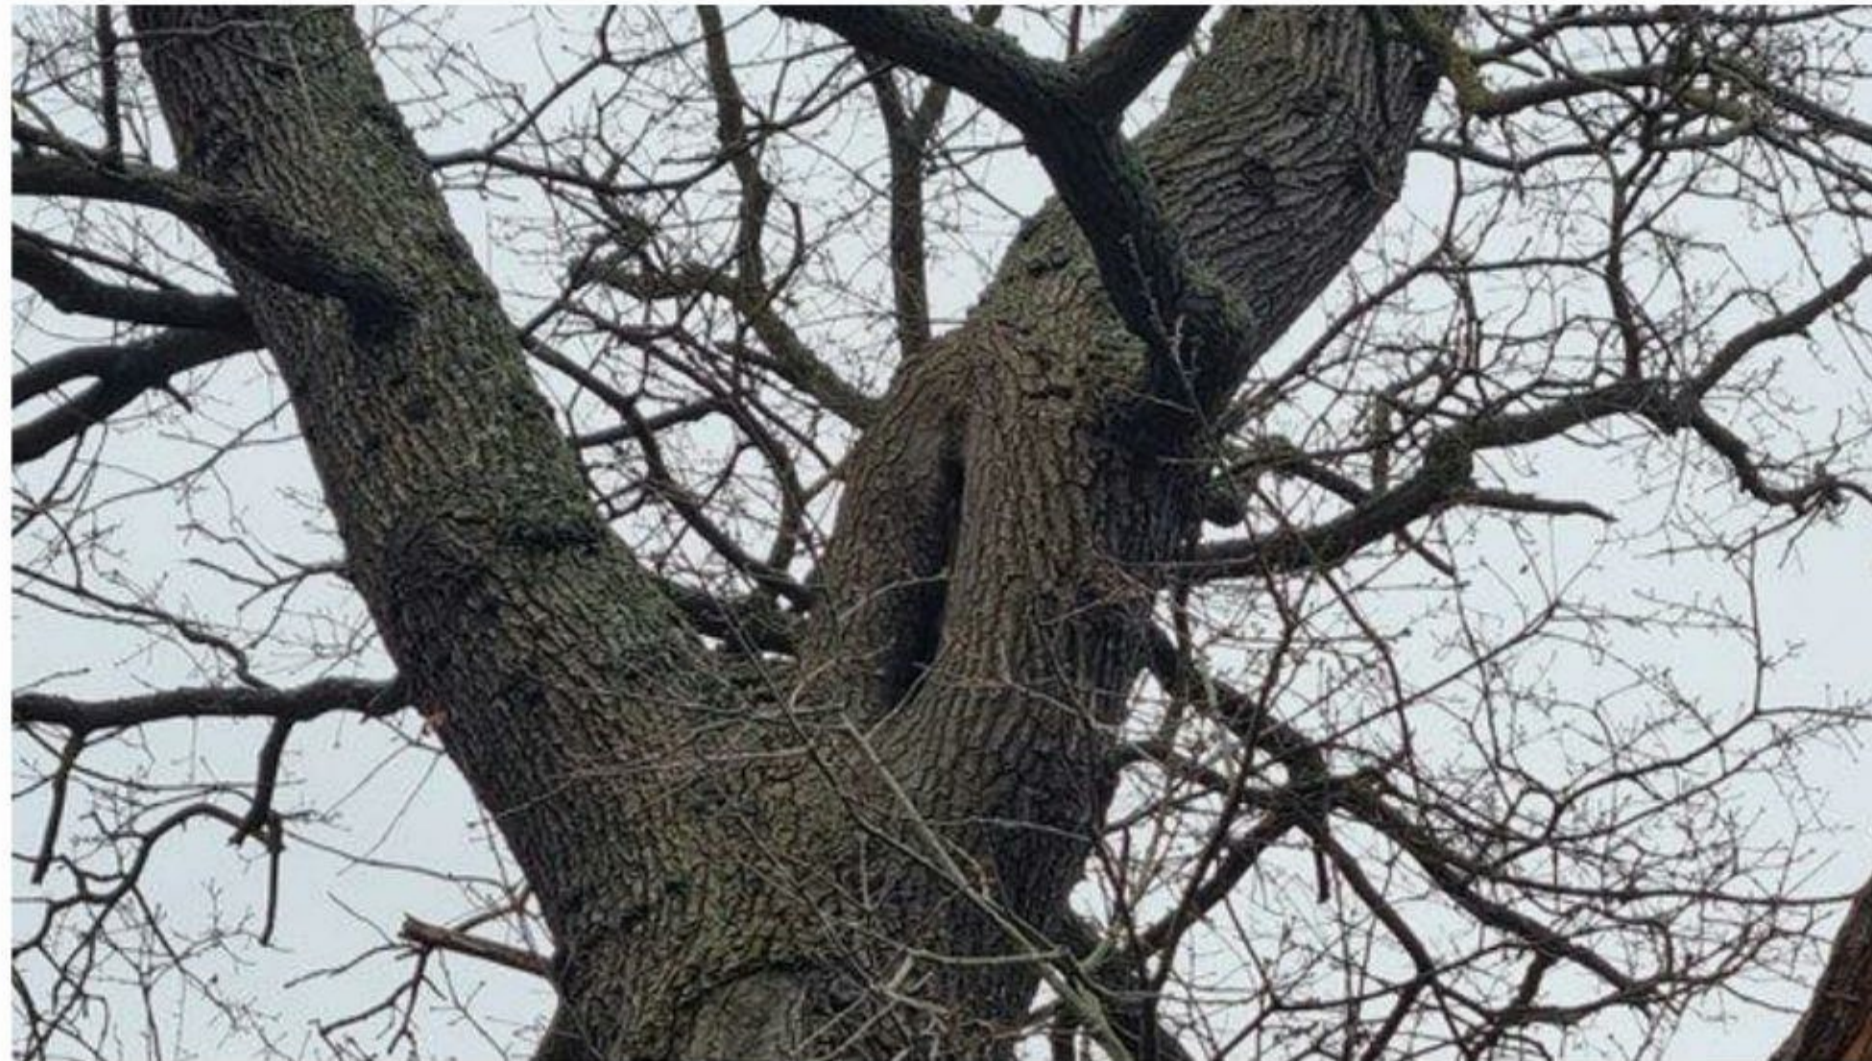
3. On the northern main limb at 10m there is a cavity in the main upright limb, approximately 50cm high and 5cm wide. The extent of the callousing would indicate that the cavity has been present for some years, however this also means that any decay present will have had time to develop, creating an area of weakness. From experience this species can be prone to snapping where such cavities are present. See photo 8 below. **I would recommend that the crown above this cavity is reduced by 2 – 3m to suitable growth points to reduce the risk of the limb snapping in high wind.**

Photo 7 showing cavity at 10m
