# ARBORICULTURAL REPORT

## TREE CONDITION SURVEY

CARRICK  
WARFIELD STREET  
WARFIELD  
BRACKNELL  
BERKSHIRE  
RG42 6AR

FEBRUARY 2024  
Ref: SCD 06318 / 2024

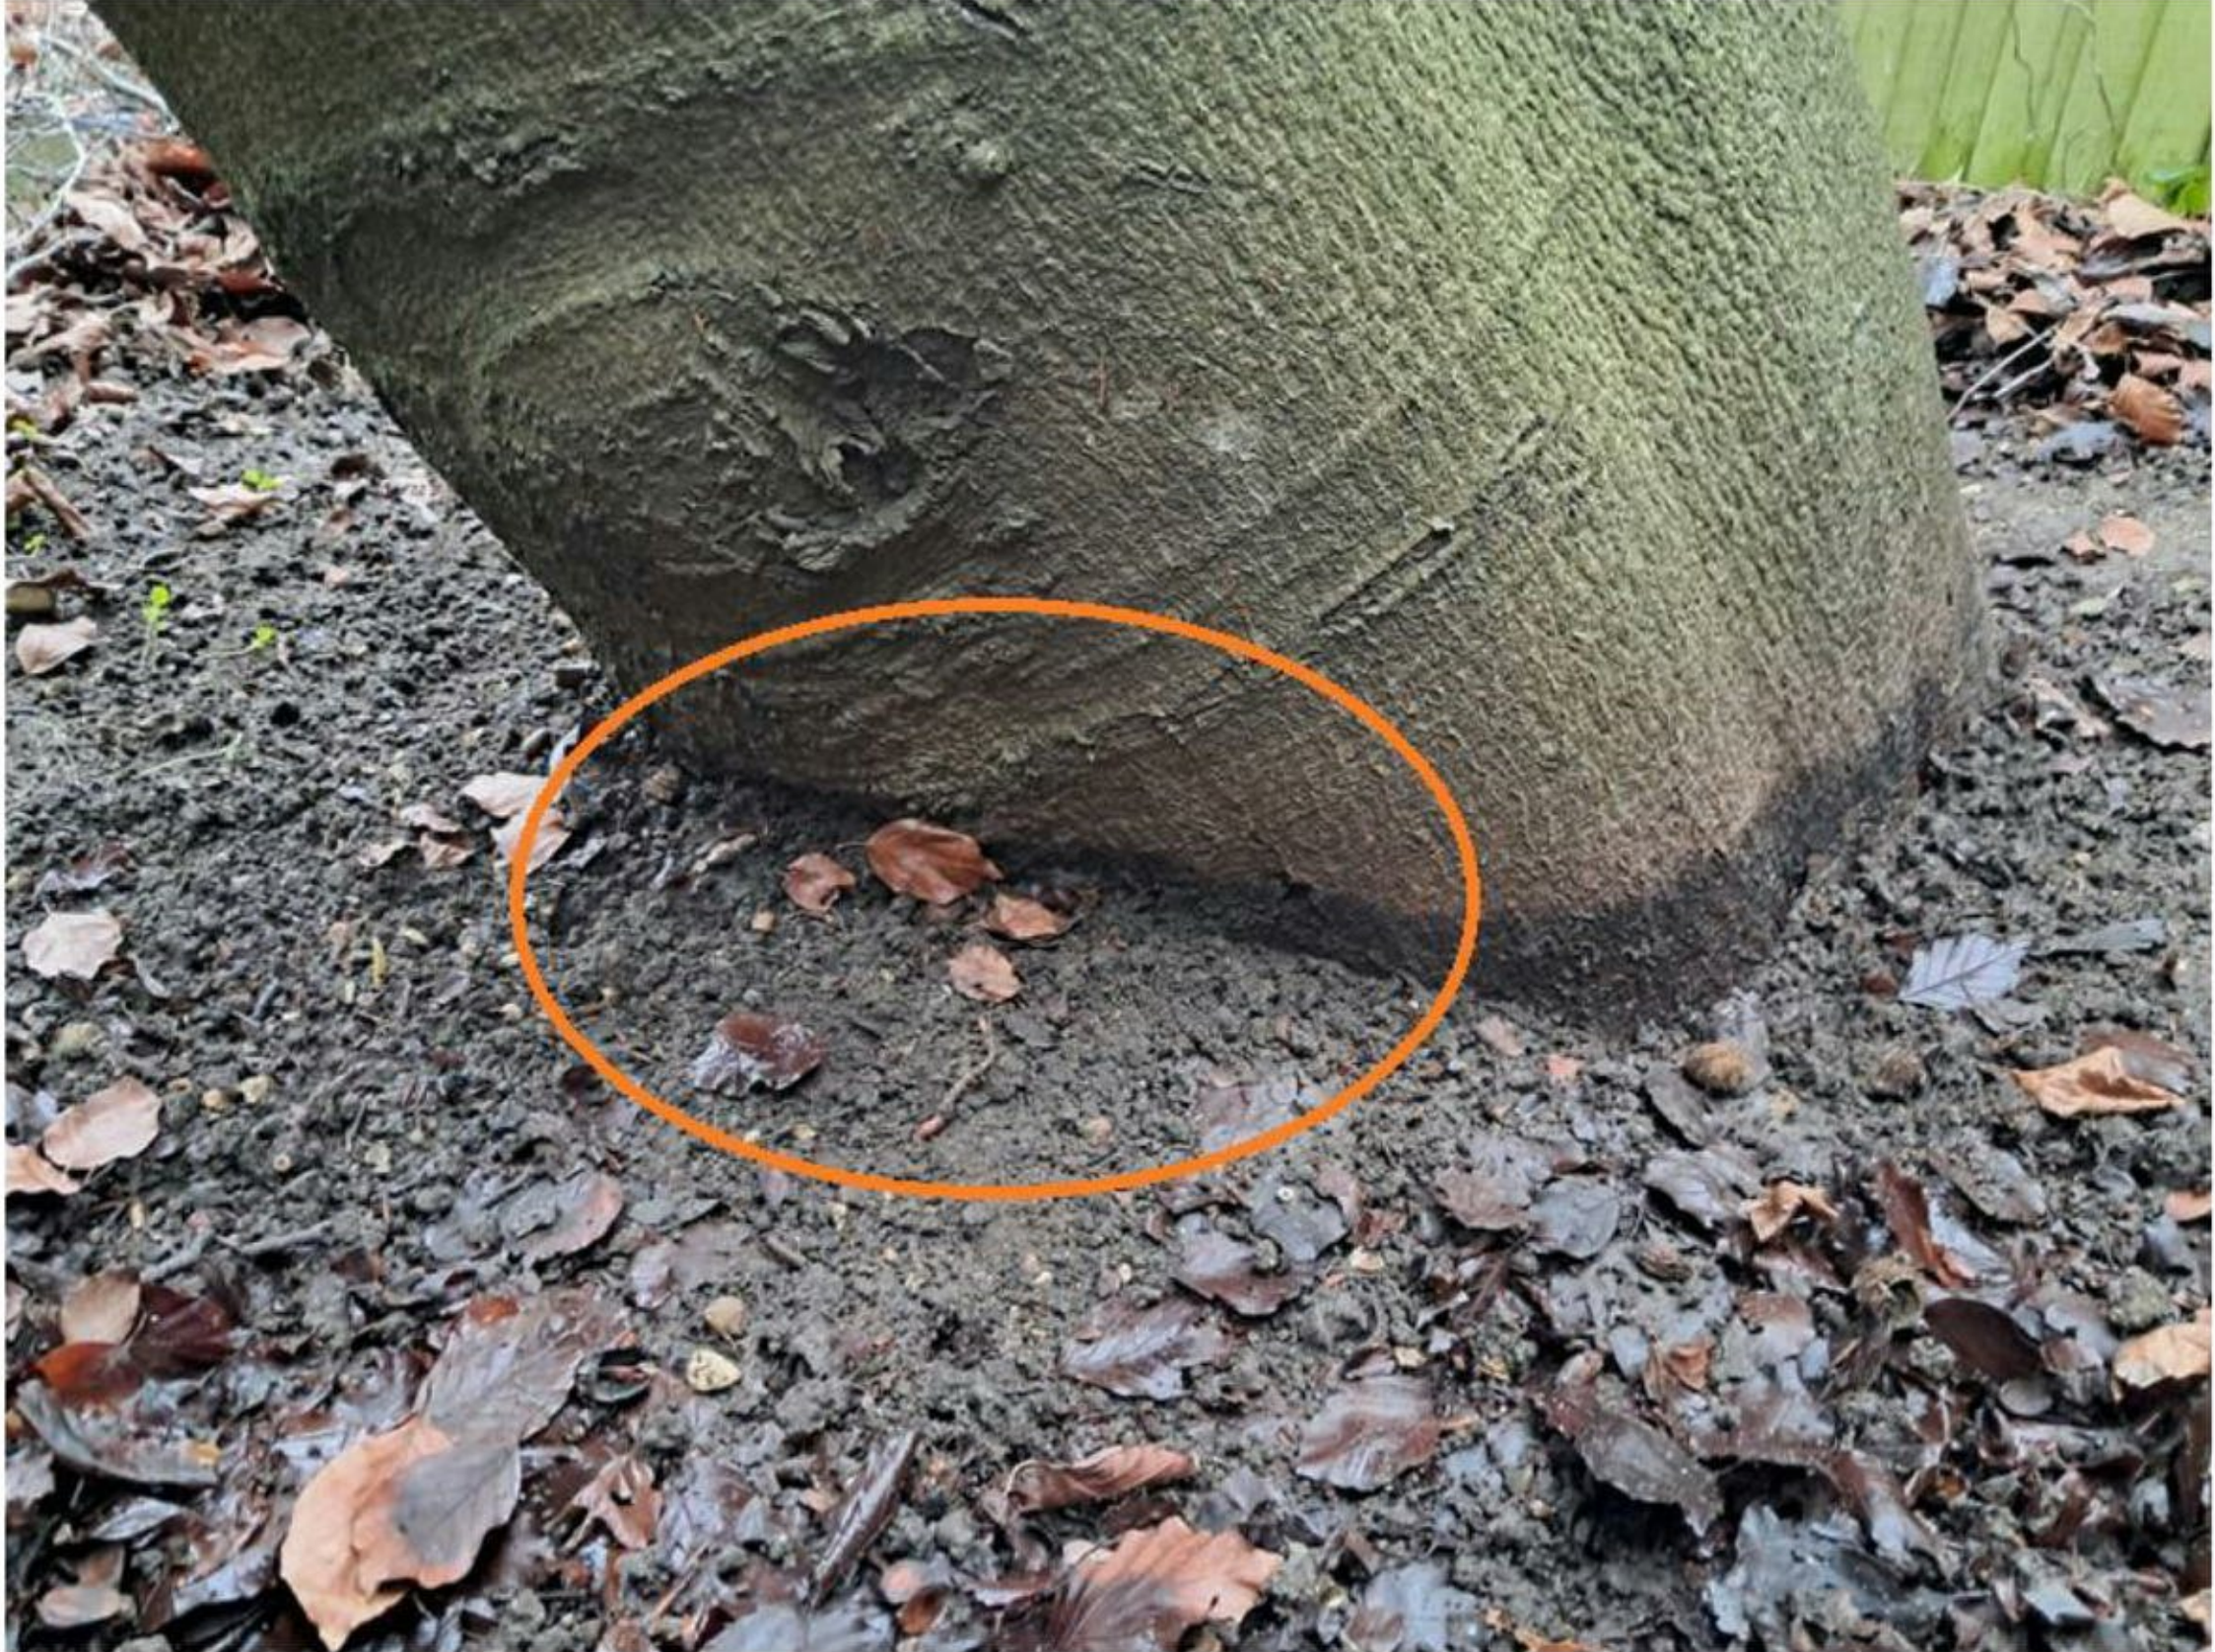
Photo 4 – Earth at base of tree being pushed into low mound on compression side of trunk.

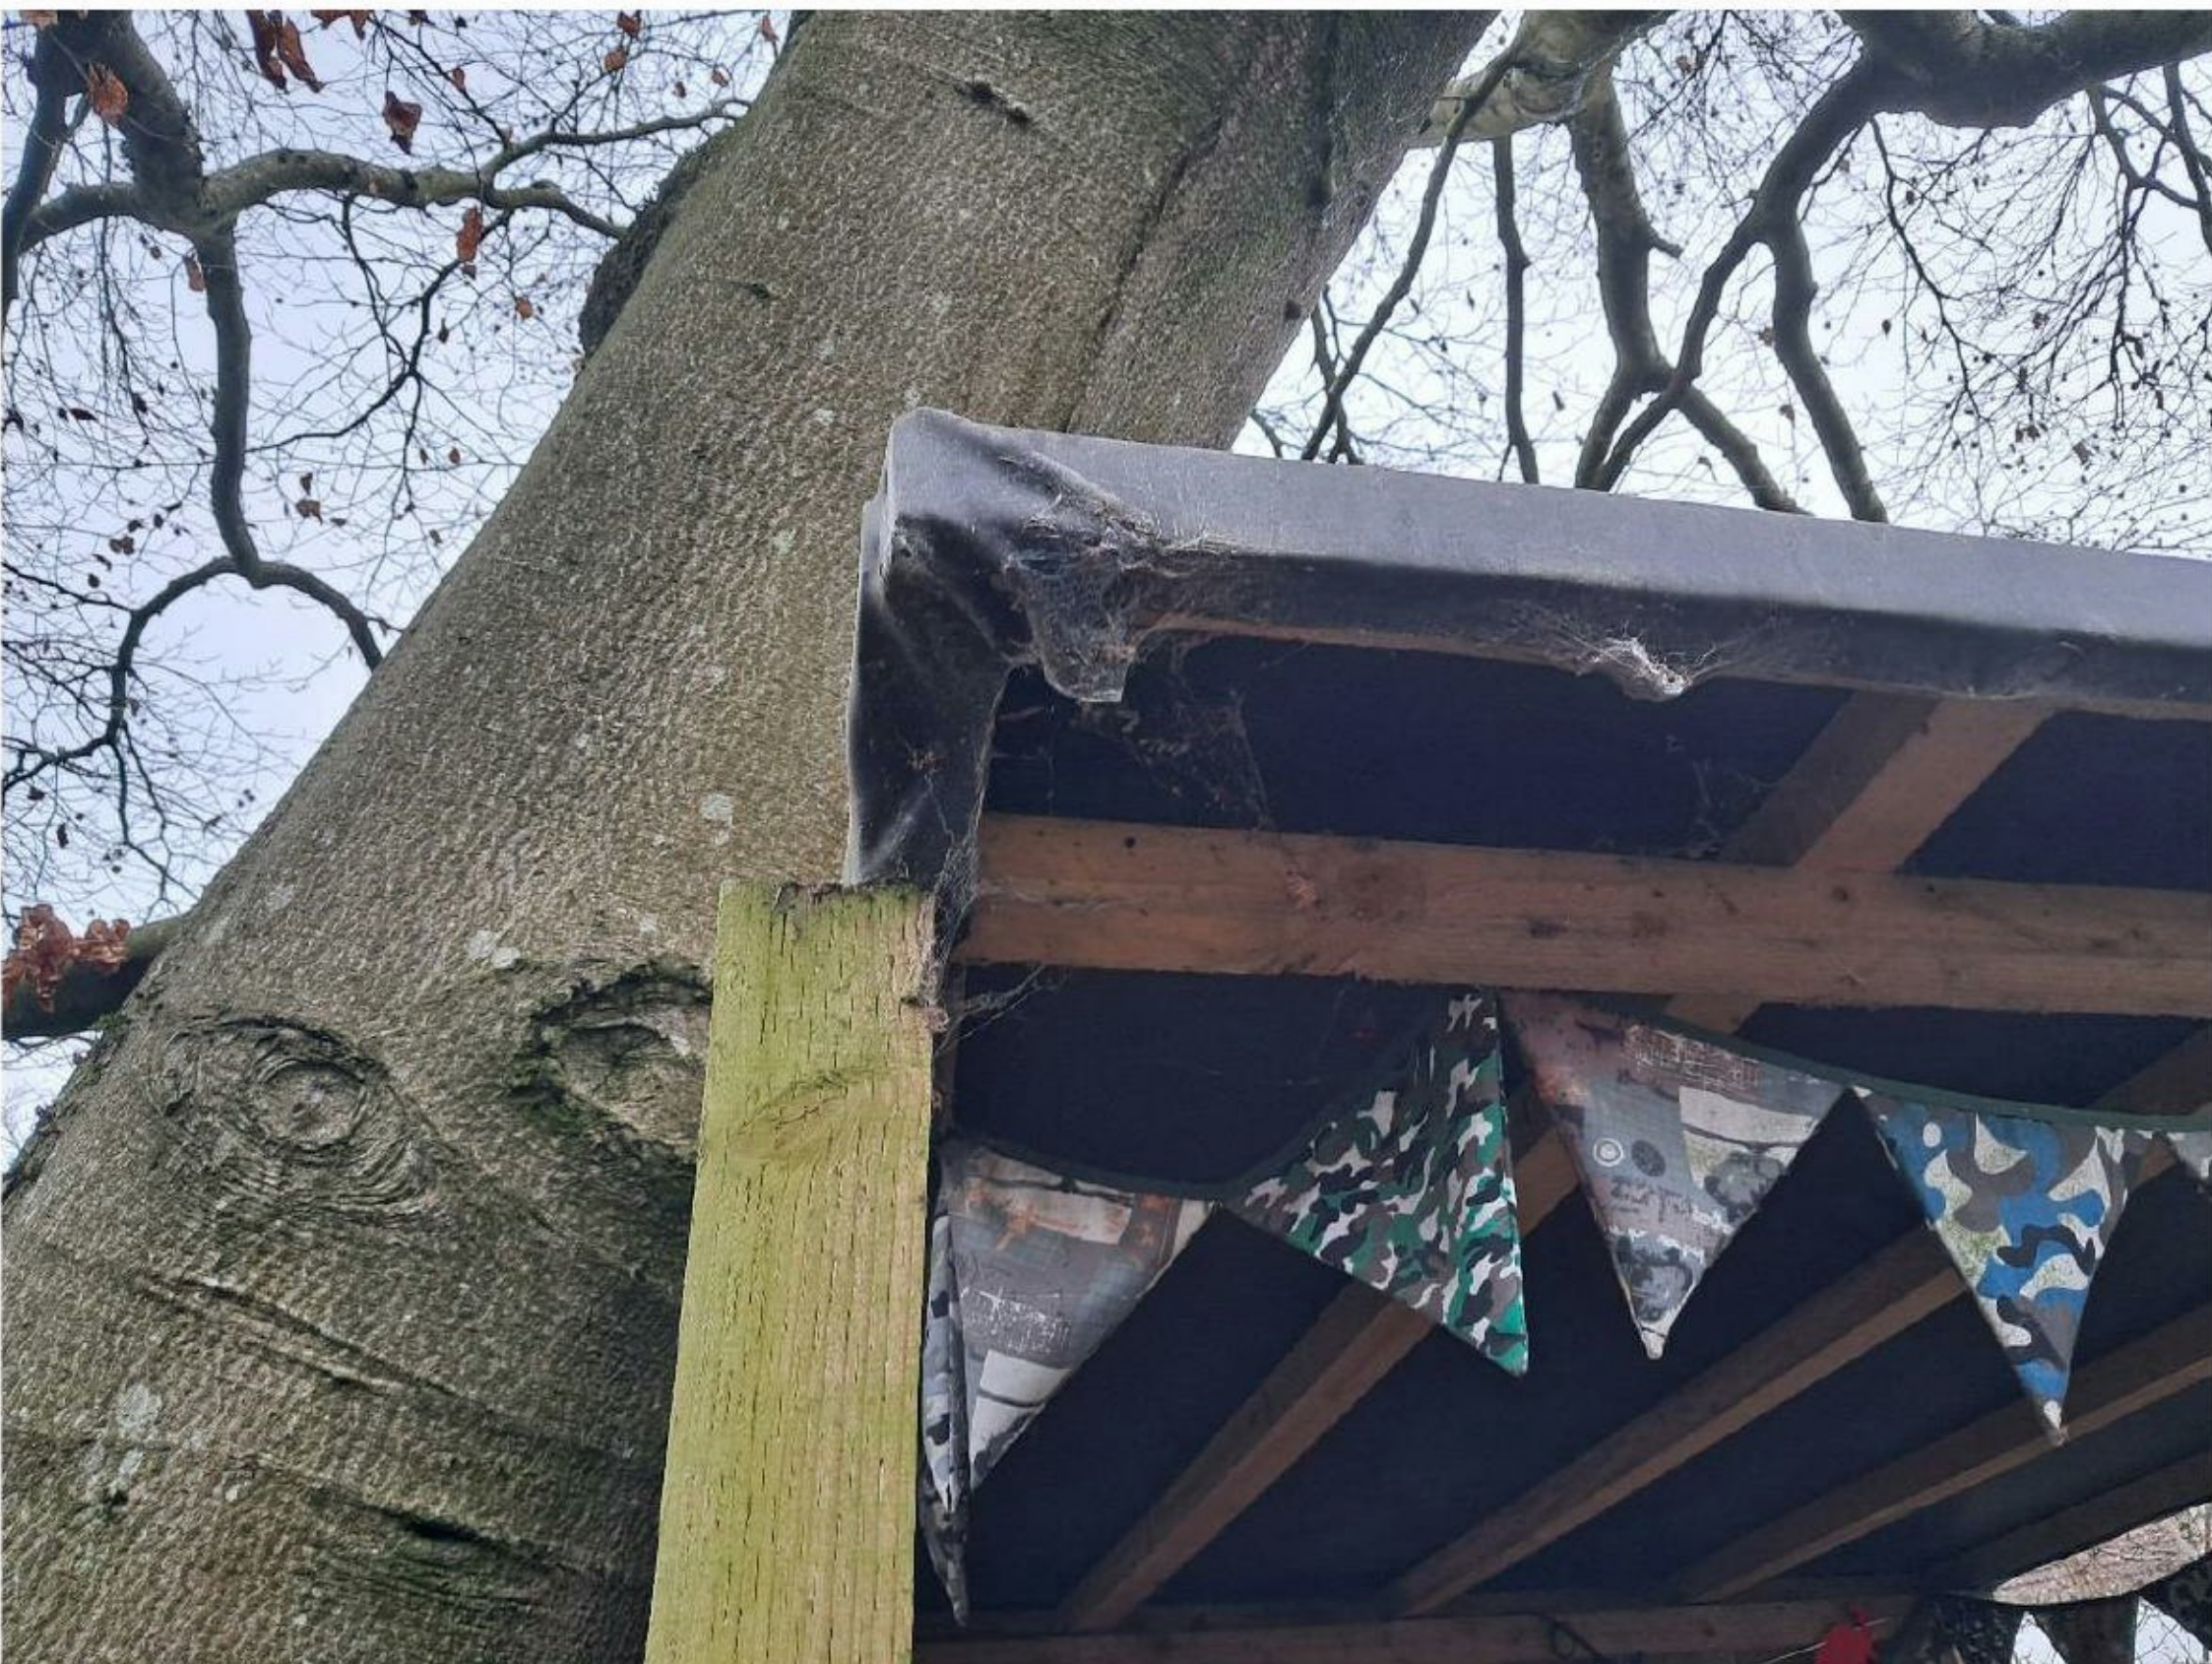
Photo 5 – Shifted roof of children's play fort.

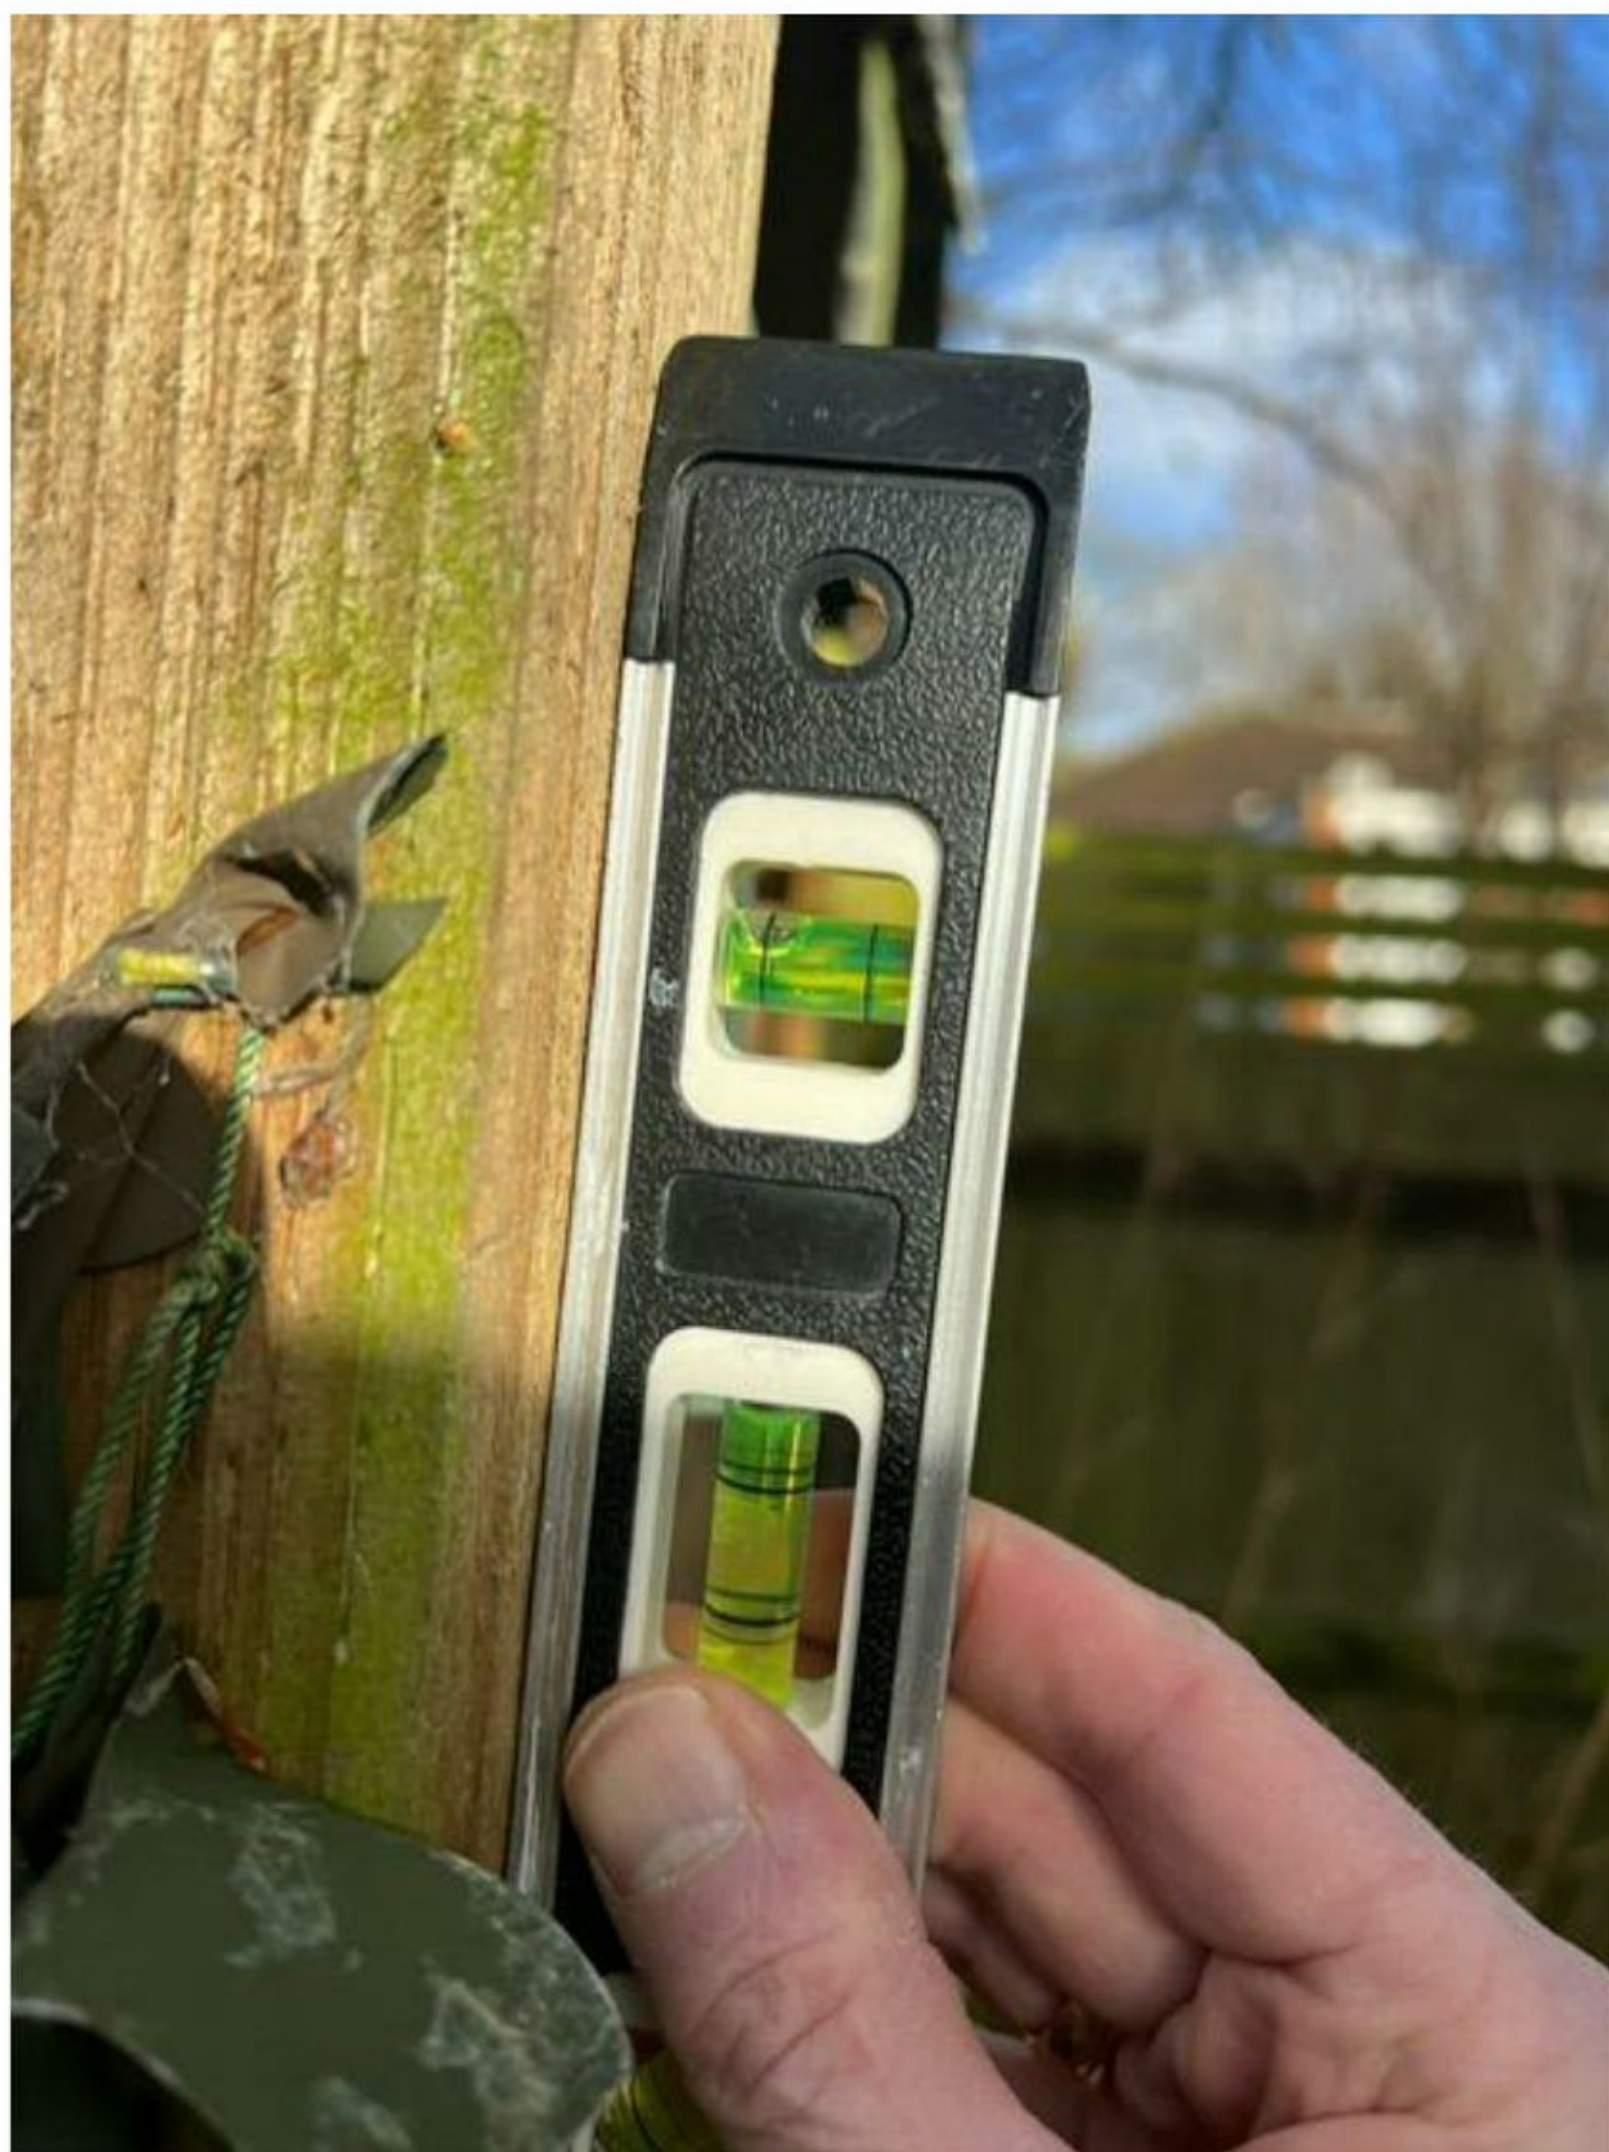
Photo 6 – Fort legs now leaning off centre.

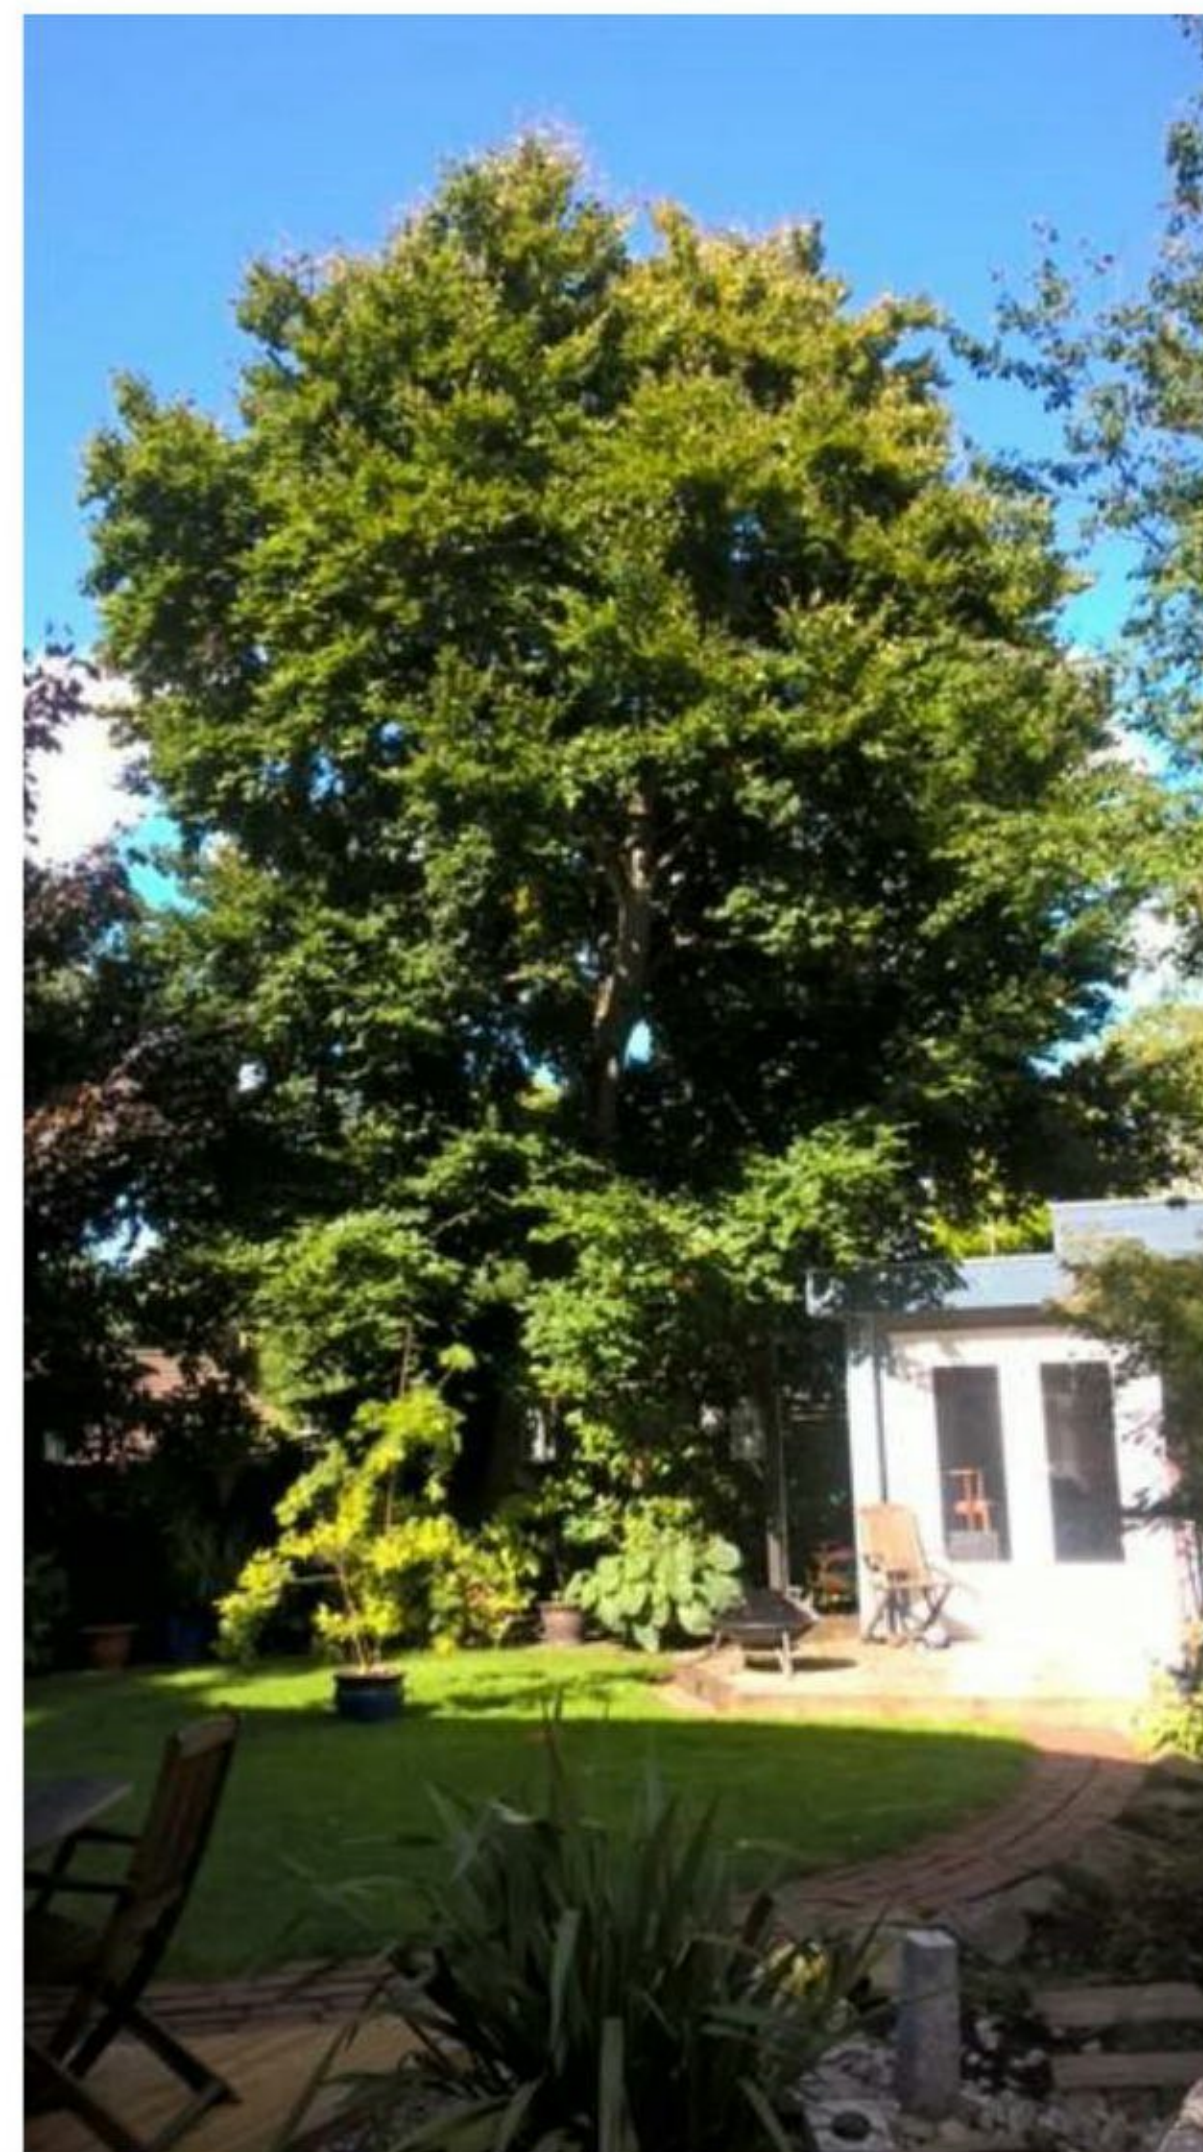
Photo 7 – Owner's photograph of Beech taken in 2017 – lean has now significantly increased.
