**BS5837:2012 Tree Survey
Arboricultural Impact Assessment
Arboricultural Method Statement**

**77 Main Street
Killearn
G63 9LF**

February 2024

Document Reference: 101009_BS

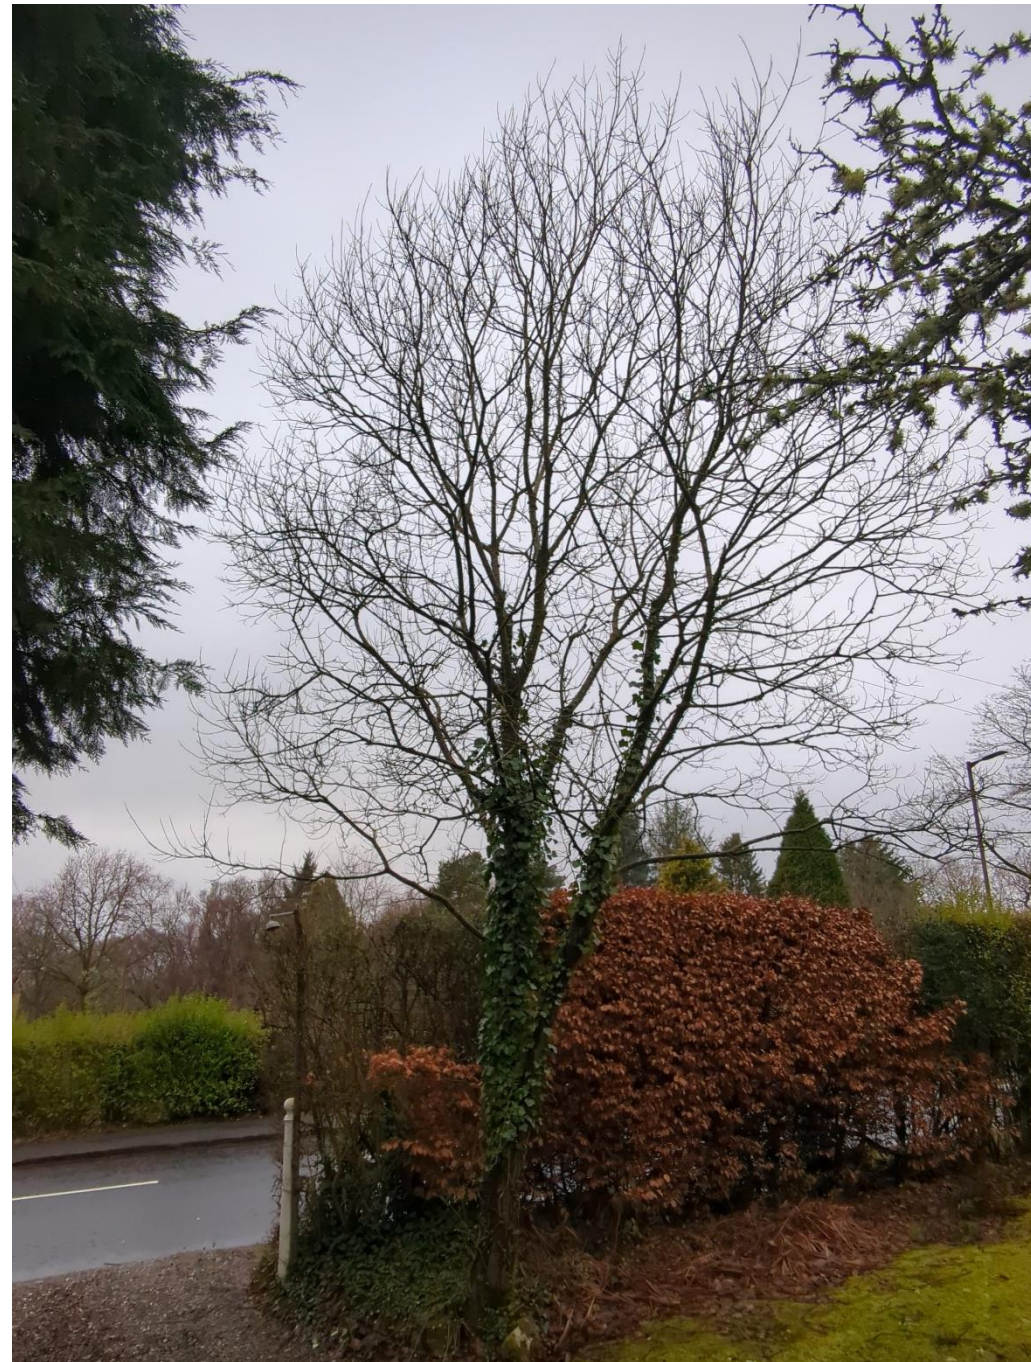
77 Main Street, Killearn, G63 9LF - Image No 01

7.1.1 Widening of the driveway entrance necessitates the removal of tree No 9951, a young goat willow recorded as Category C.

Goat willow No 9951 located adjacent to site entrance

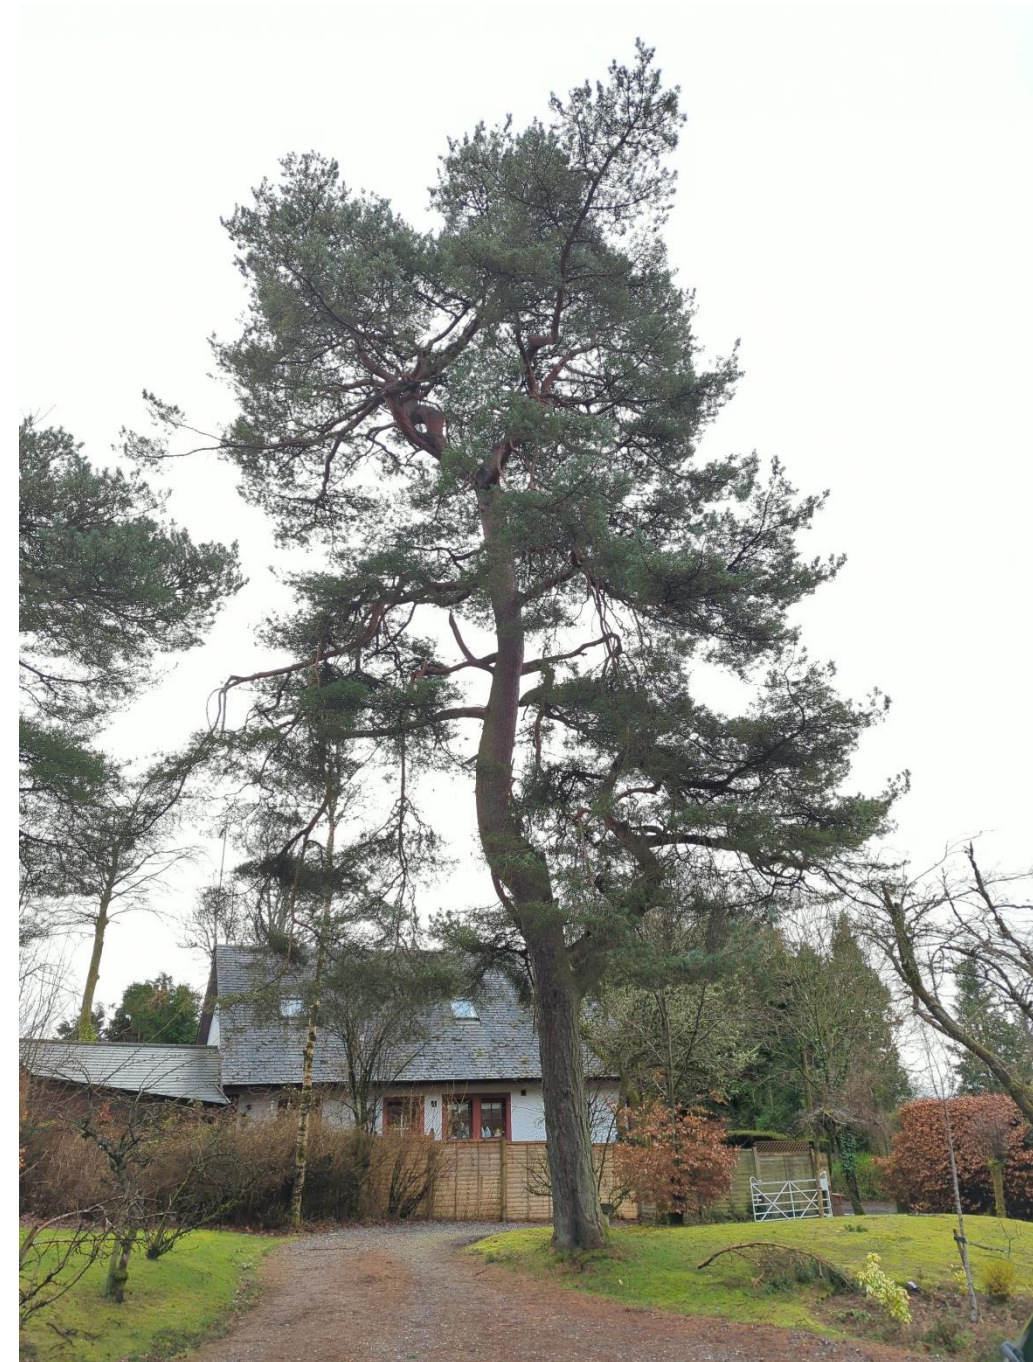
77 Main Street, Killearn, G63 9LF - Image No 02

6.2.4 Another Scots pine (No 9955) is of high-quality, locally dominant and in reasonably good physiological condition. The tree features occasional deadwoods and a fractured hanging branch oversailing an internal driveway to the southeast. This fractured branch is recommended for removal - see

Locally dominant Scots pine No 9955

preliminary management recommendations set out in the Tree Survey Schedule (Appendix. 3)

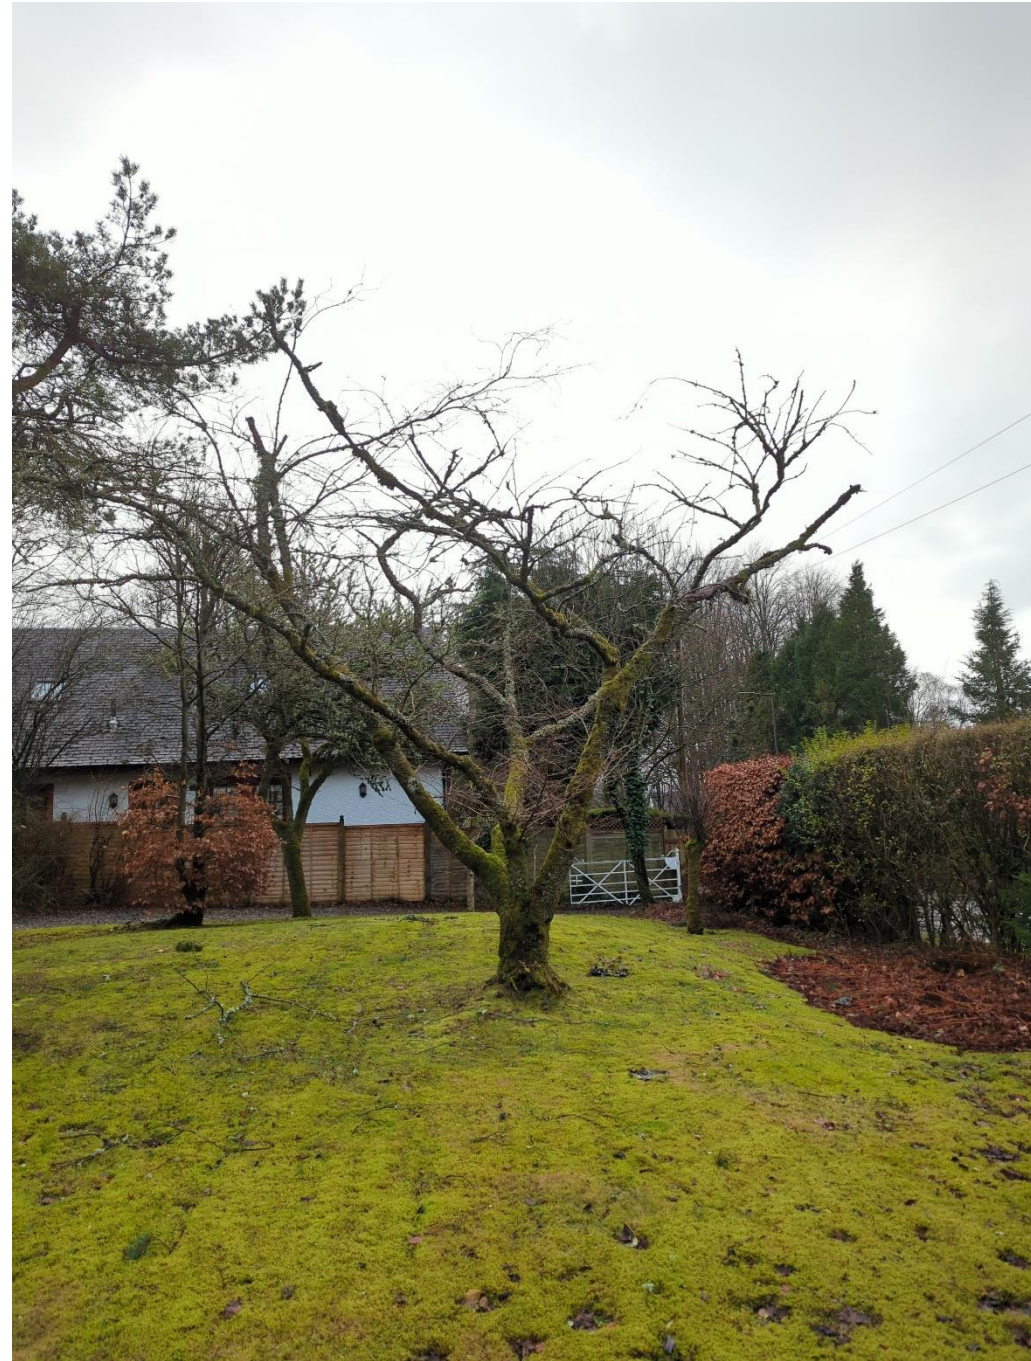
77 Main Street, Killearn, G63 9LF - Image No 01

6.2.2 Most specimens are in good or reasonably good physiological condition with the exception of tree No 9956 - a cherry nearing late maturity and presenting significant stress symptoms.

Poorly performing ornamental cherry No 9956

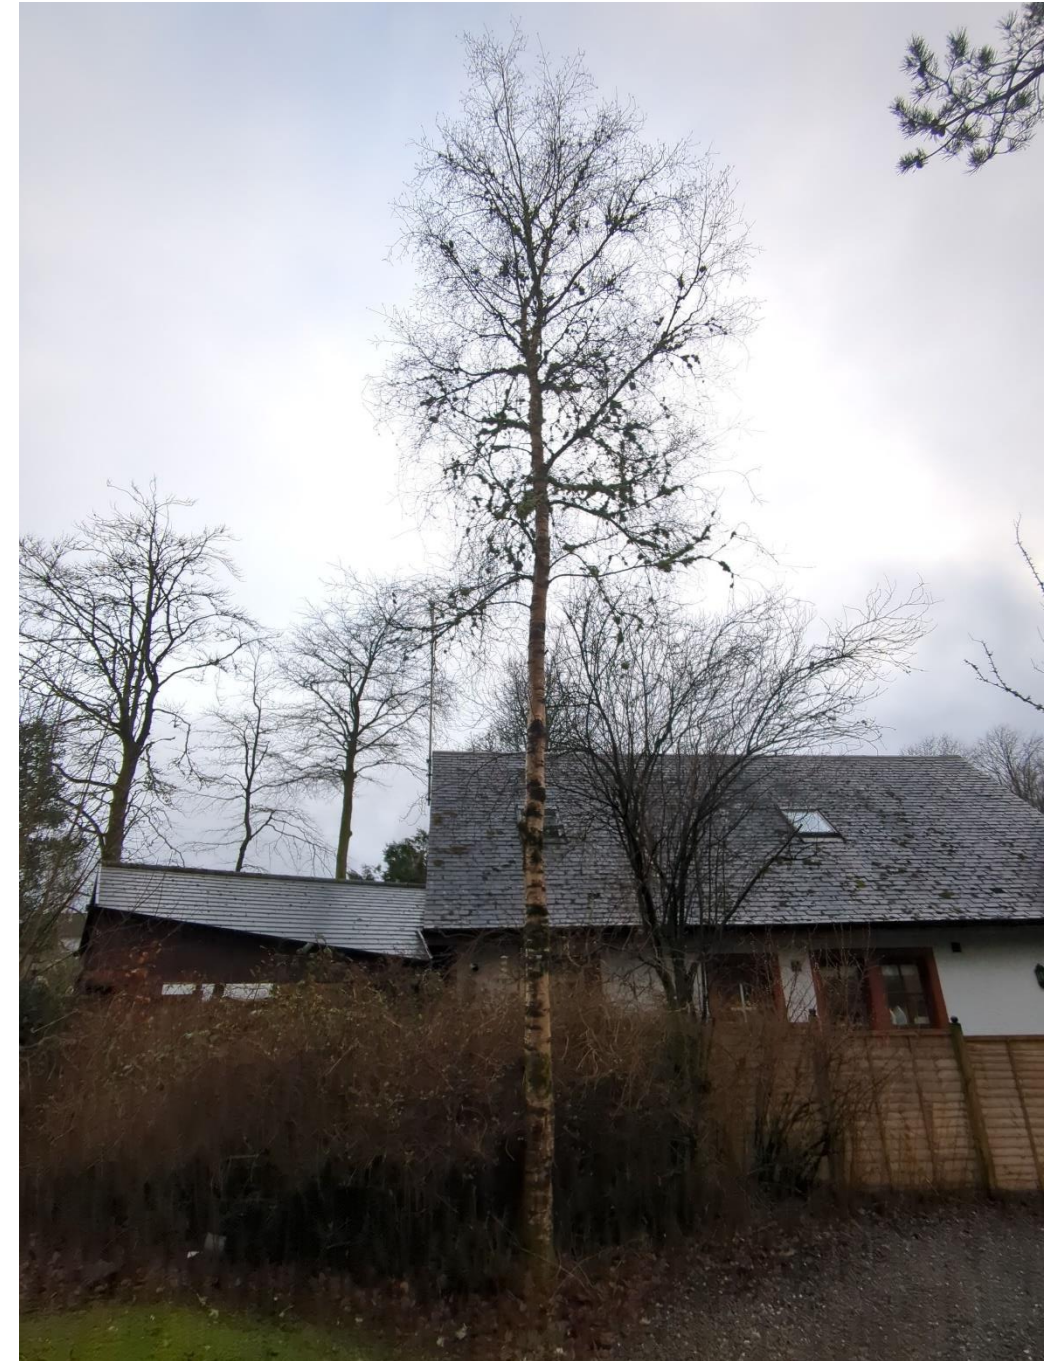
77 Main Street, Killearn, G63 9LF - Image No 02

7.1.3 Proposed laying of a new driveway would require the removal of tree Nos 9959 & 9960. These two early-mature broadleaves are in close proximity and are of low overall quality.

Stretched birch specimen No 9960

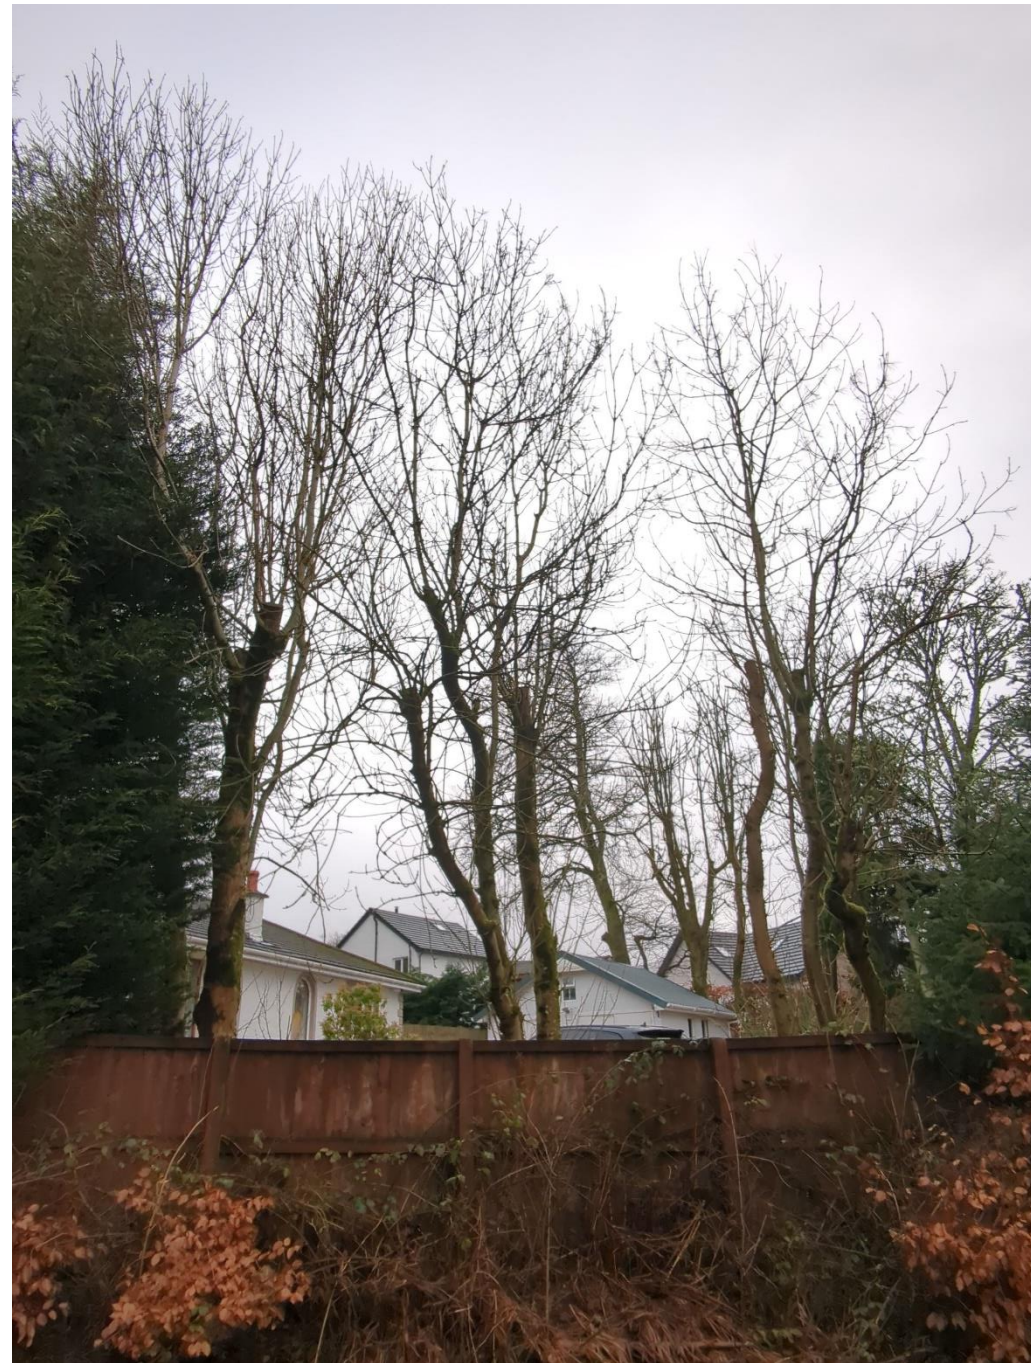
77 Main Street, Killearn, G63 9LF - Image No 01

6.5.1 E1-E3 are three young ash trees with a recent history of coarse management. Extant branch extensions present symptoms consistent with ash dieback (*Hymenoscyphus fraxineus*) – a fungal borne pathogen expected to kill between 70% and 80% of ash trees in the UK.

External ash specimens No E1-E3

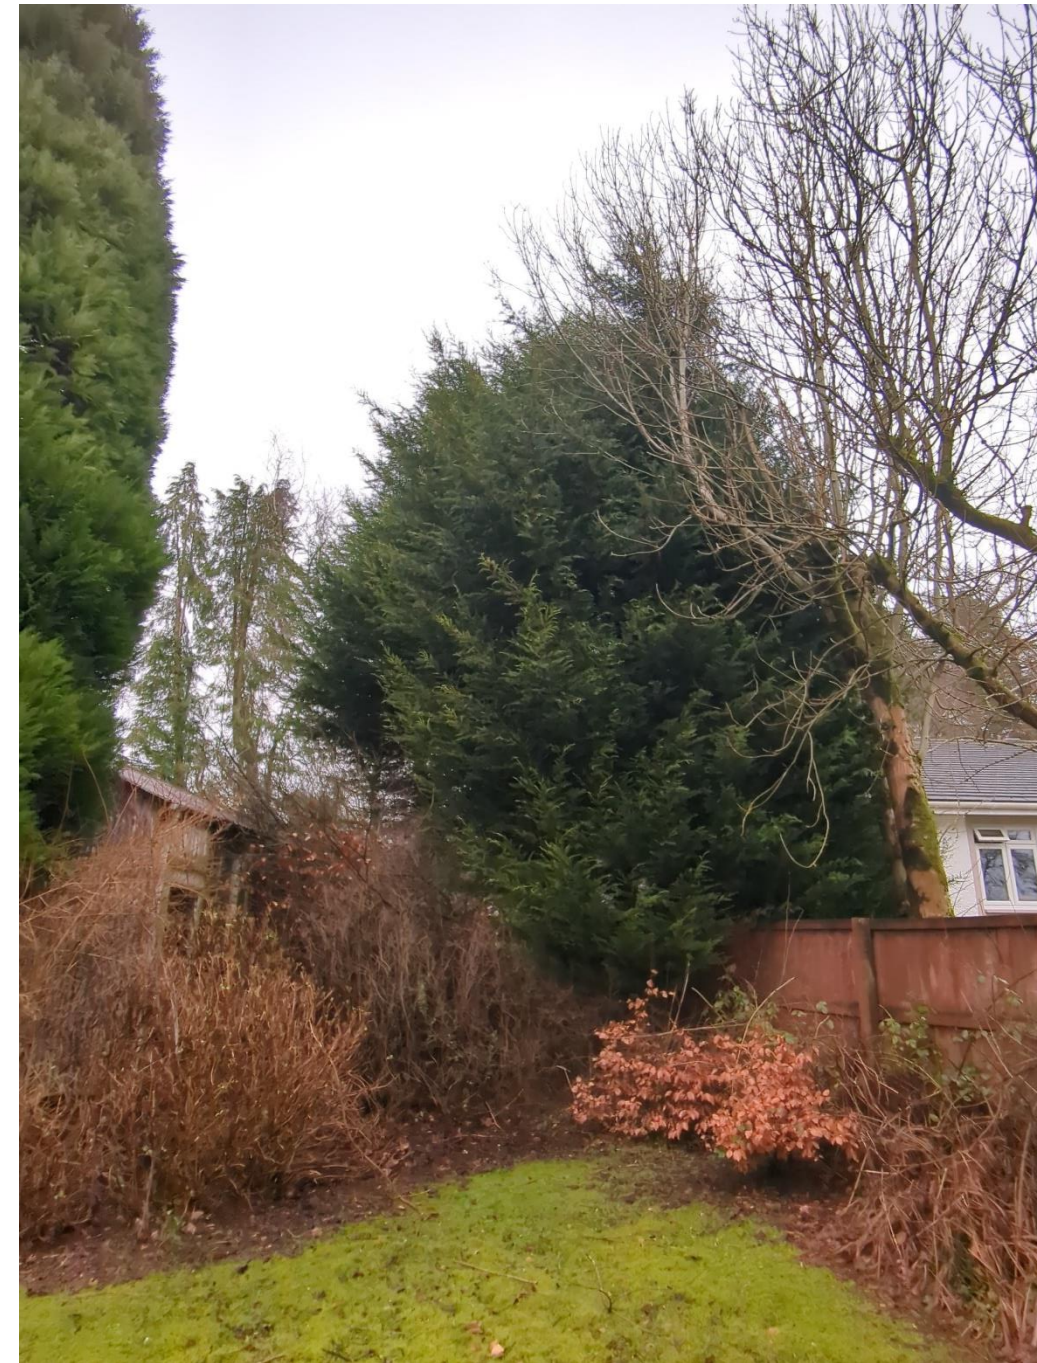
77 Main Street, Killearn, G63 9LF - Image No 02

6.5.2 A tightly planted screening line of Lawson cypress comprises tree Nos E4-E12. Sited on a raised level beyond a brick perimeter retaining wall, rooting zones are restricted to the adjoining property.

Linear group of external trees No E4-E12

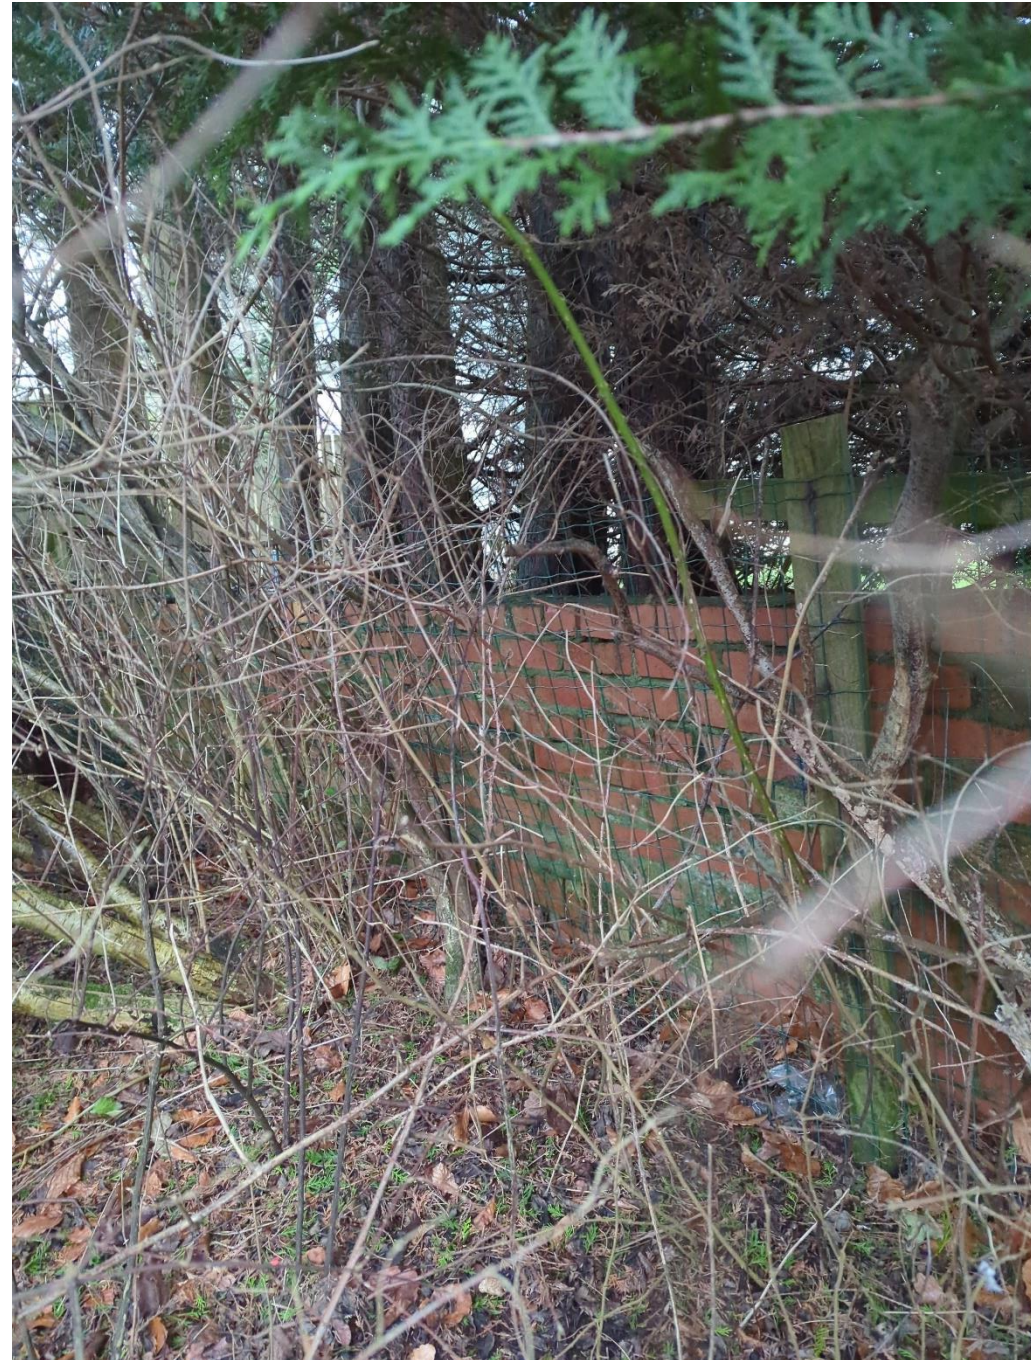
77 Main Street, Killearn, G63 9LF - Image No 01

Brick perimeter retaining wall and stems of tree Nos E4-E12

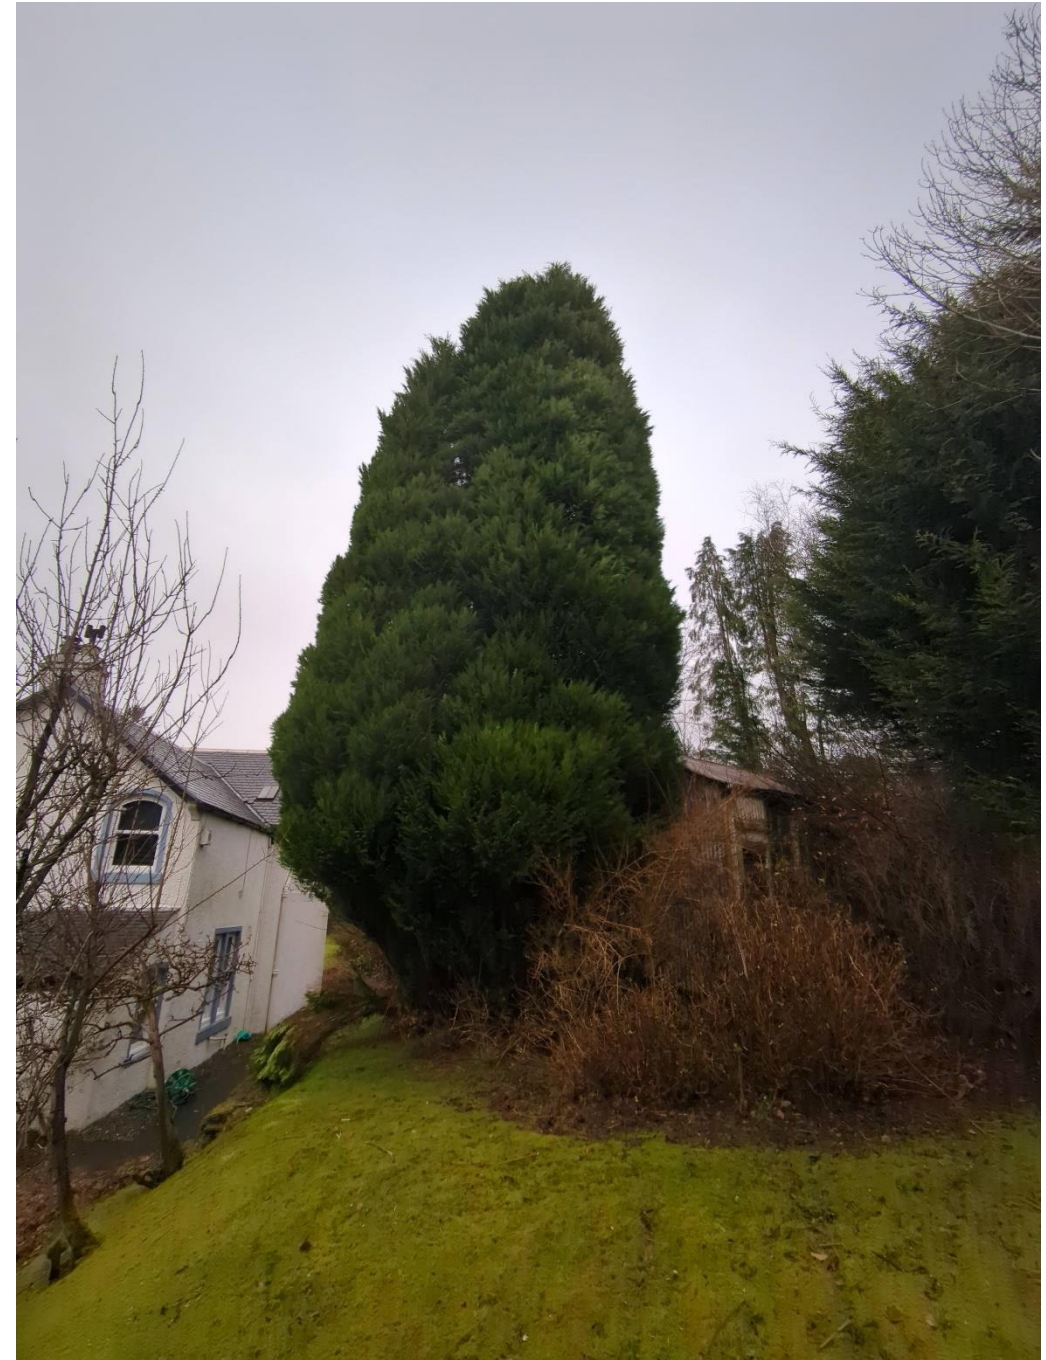
77 Main Street, Killearn, G63 9LF - Image No 02

6.2.5 Tree No 9966 is a mature ornamental cypress of moderate quality with the eastern sector of its crown beginning to envelop a derelict outbuilding.

7.2.1 The safe demolition of an existing derelict outbuilding and subsequent erection of a proposed new garage necessitates the removal of tree No 9966 - an exotic conifer of moderate quality.

Lower crown of tree No 9966 enveloping a derelict outbuilding
