Contaminated Land Phase One Desk  
Study for proposed Bed and  
Breakfast Accommodation on land  
at  
Taylors Farm,  
Long Lane,  
Scorton,  
Preston,  
PR3 1DB.

Prepared for

Graham Anthony Associates,  
2 Croston Villa,  
High Street,  
Garstang,  
PR3 1EA.

February 2024

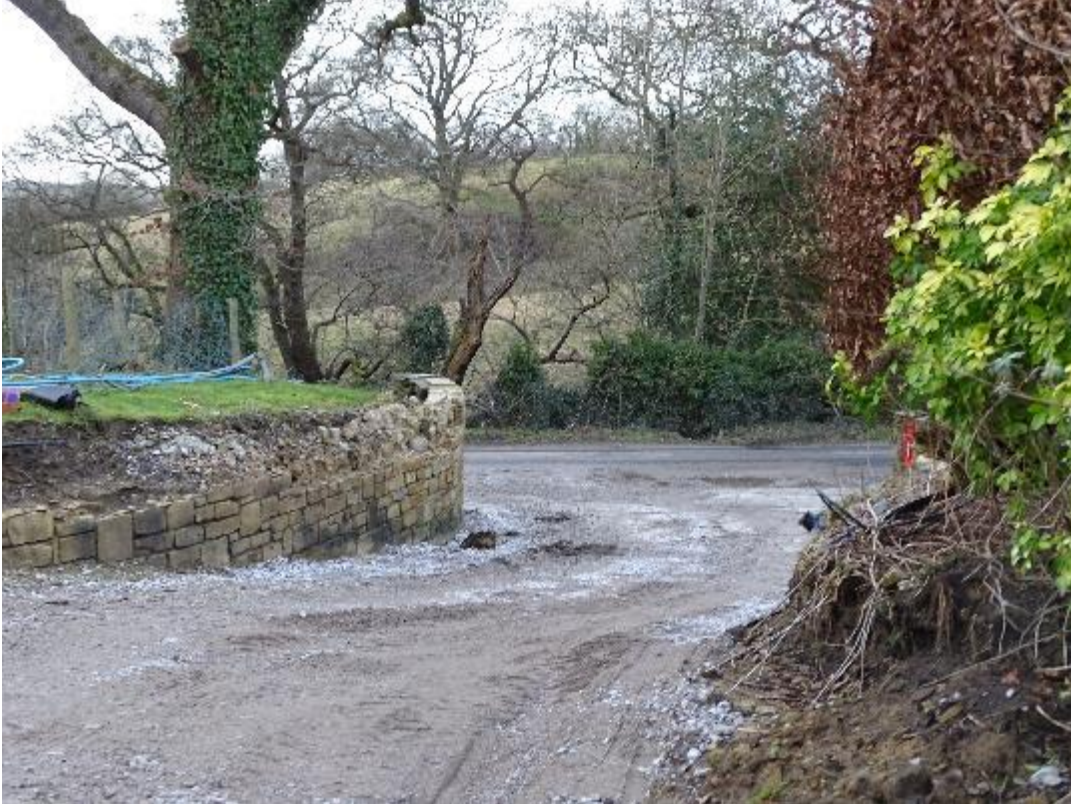
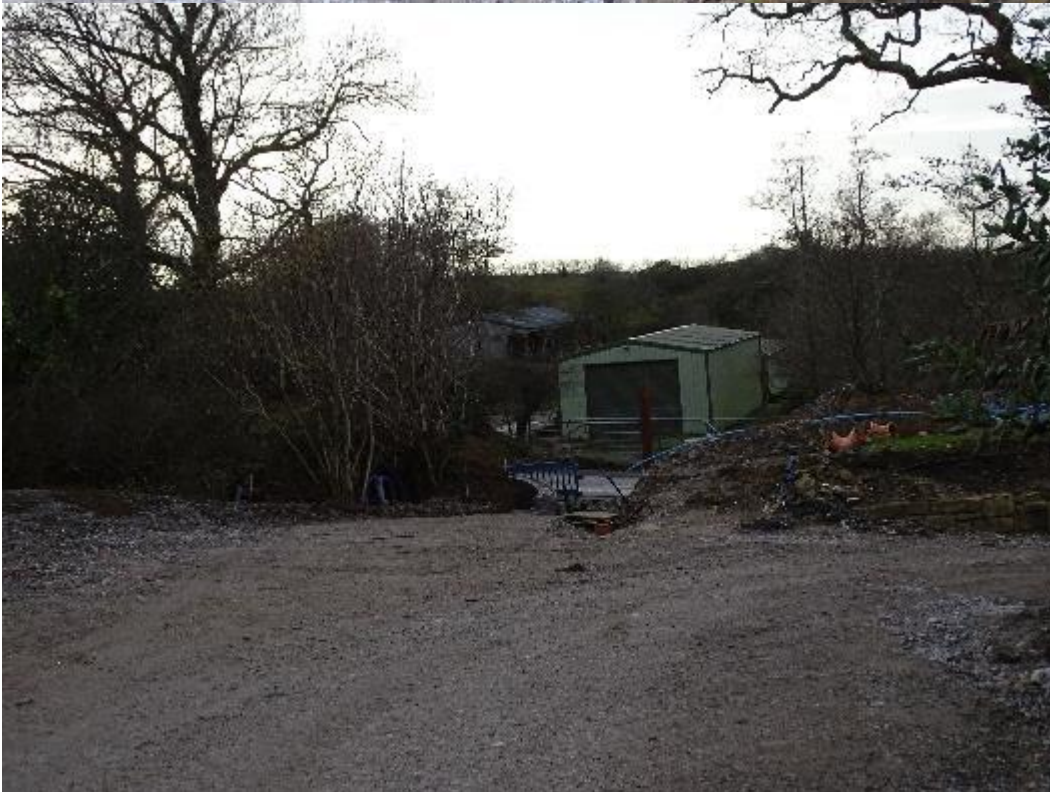
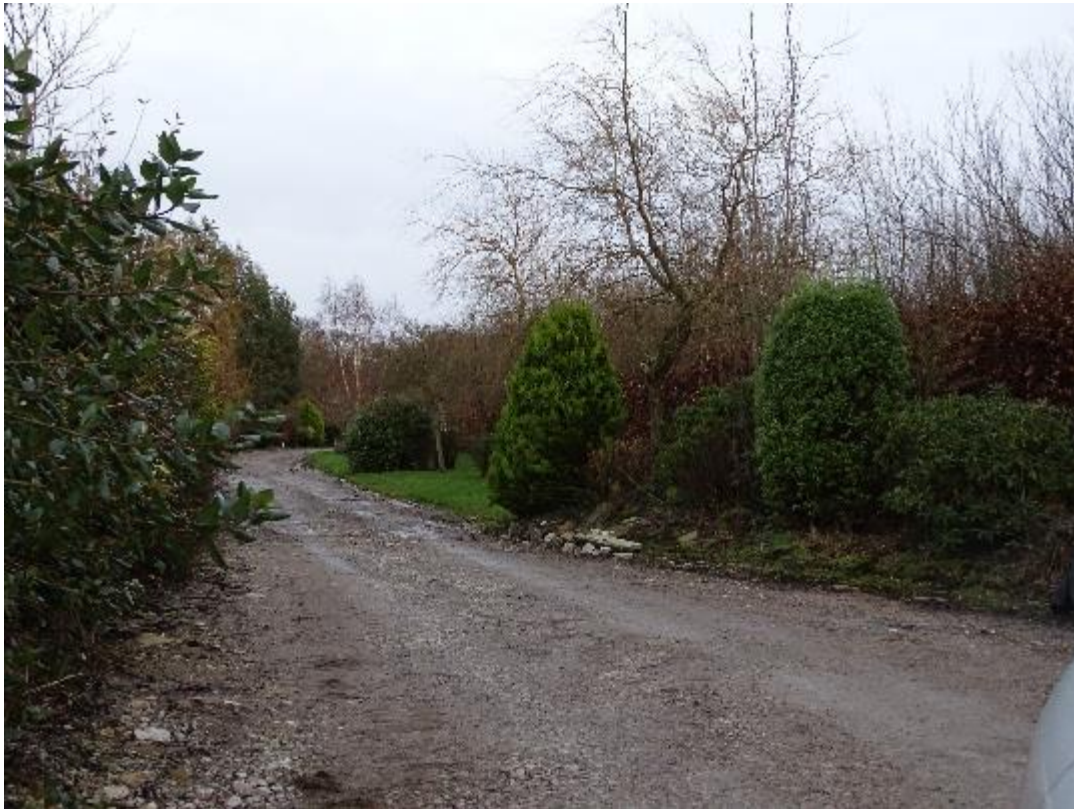
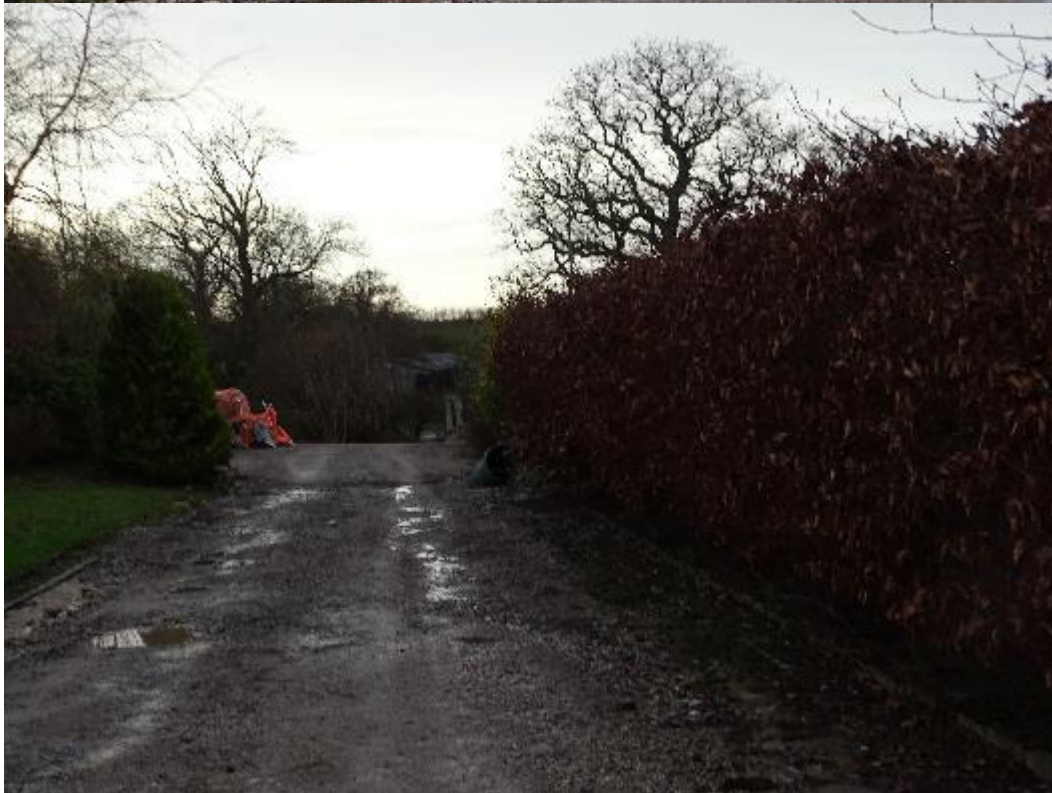
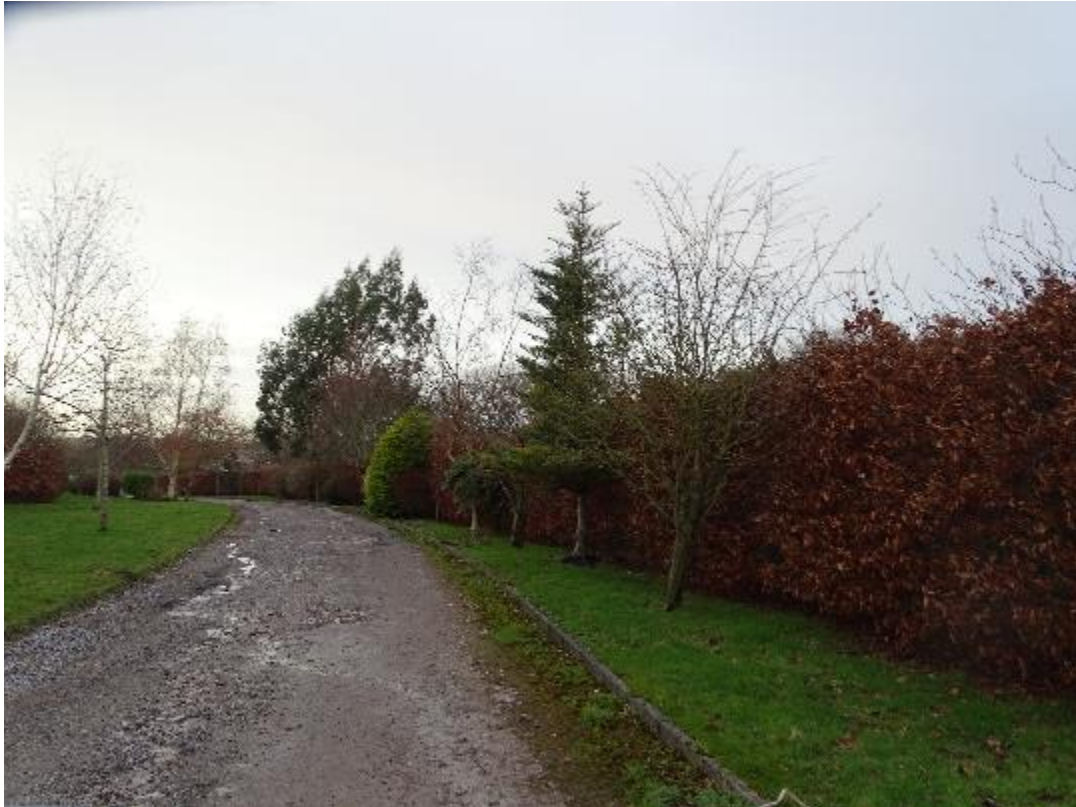
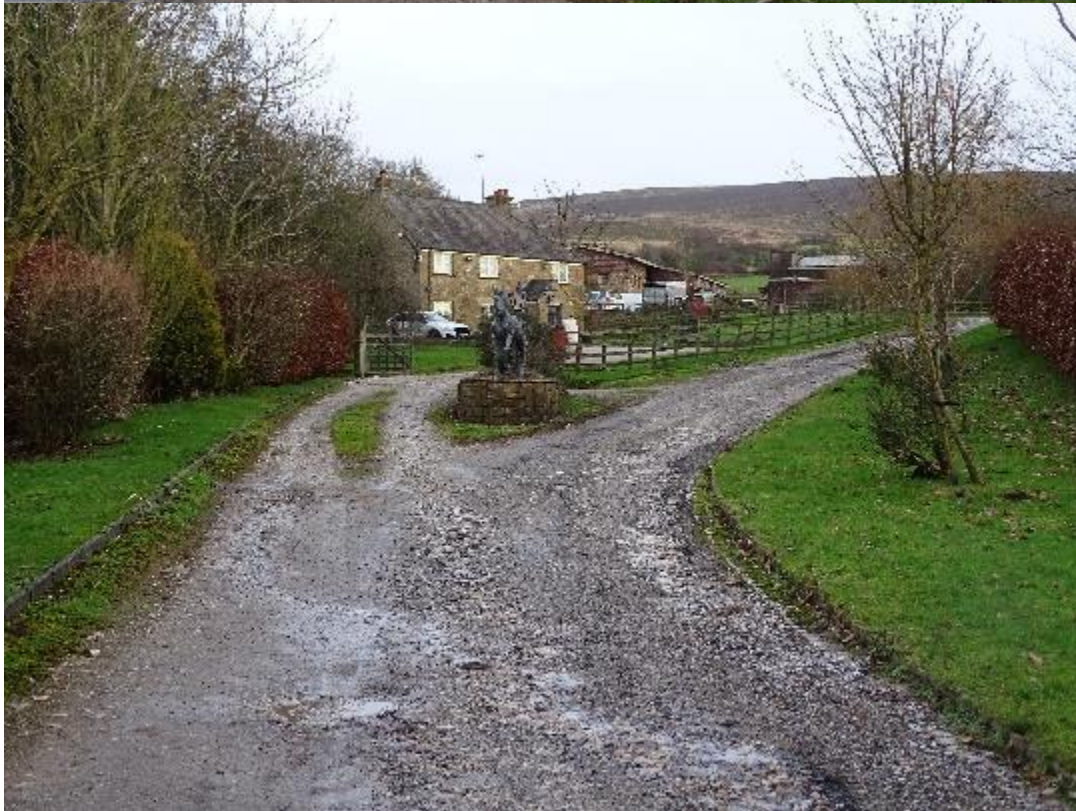
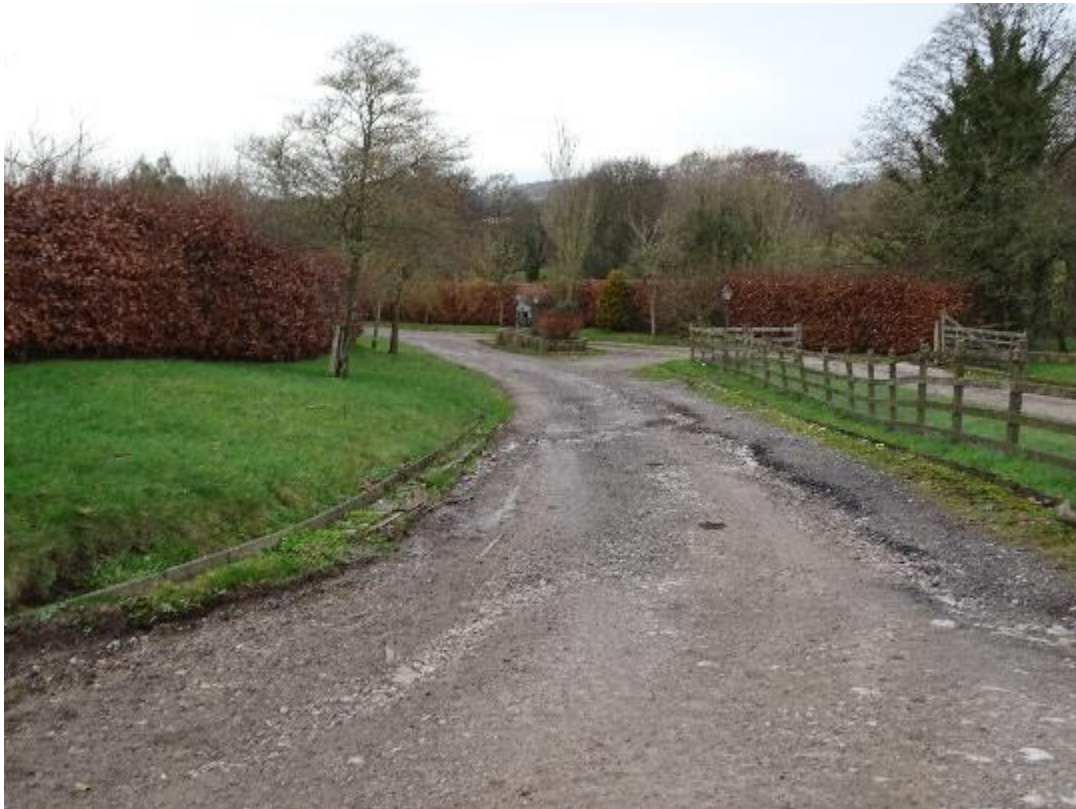
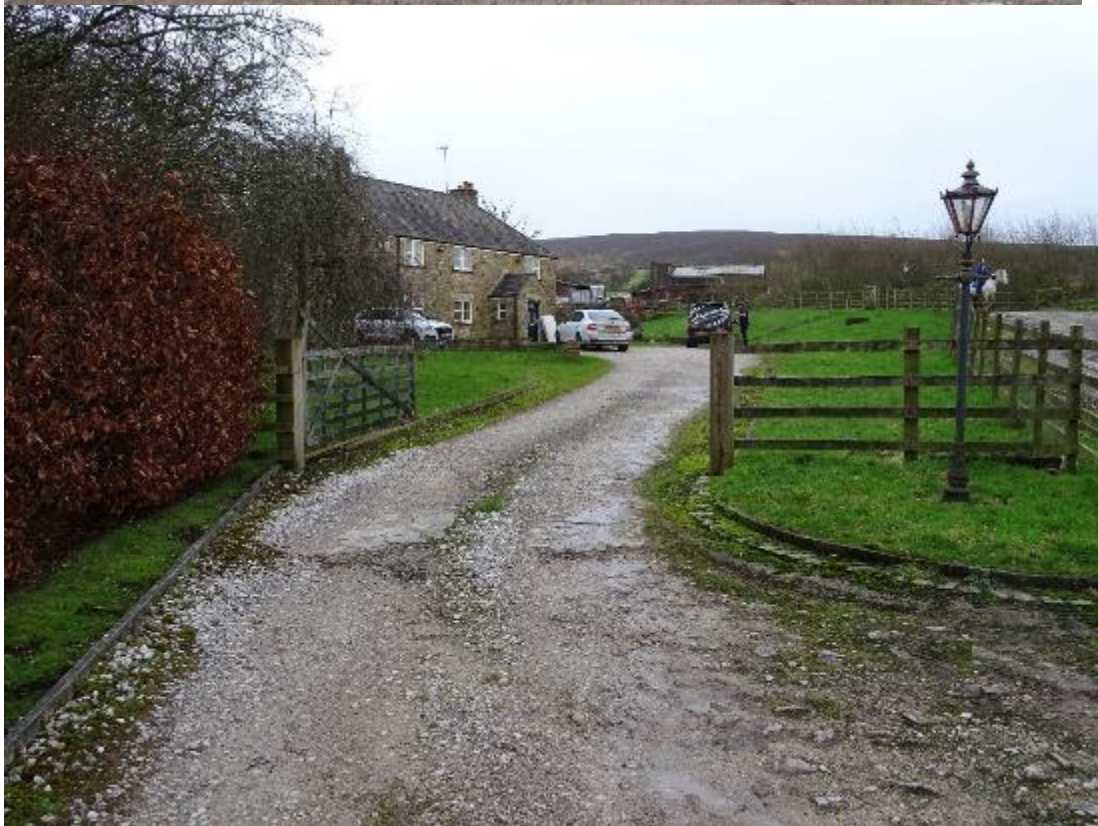
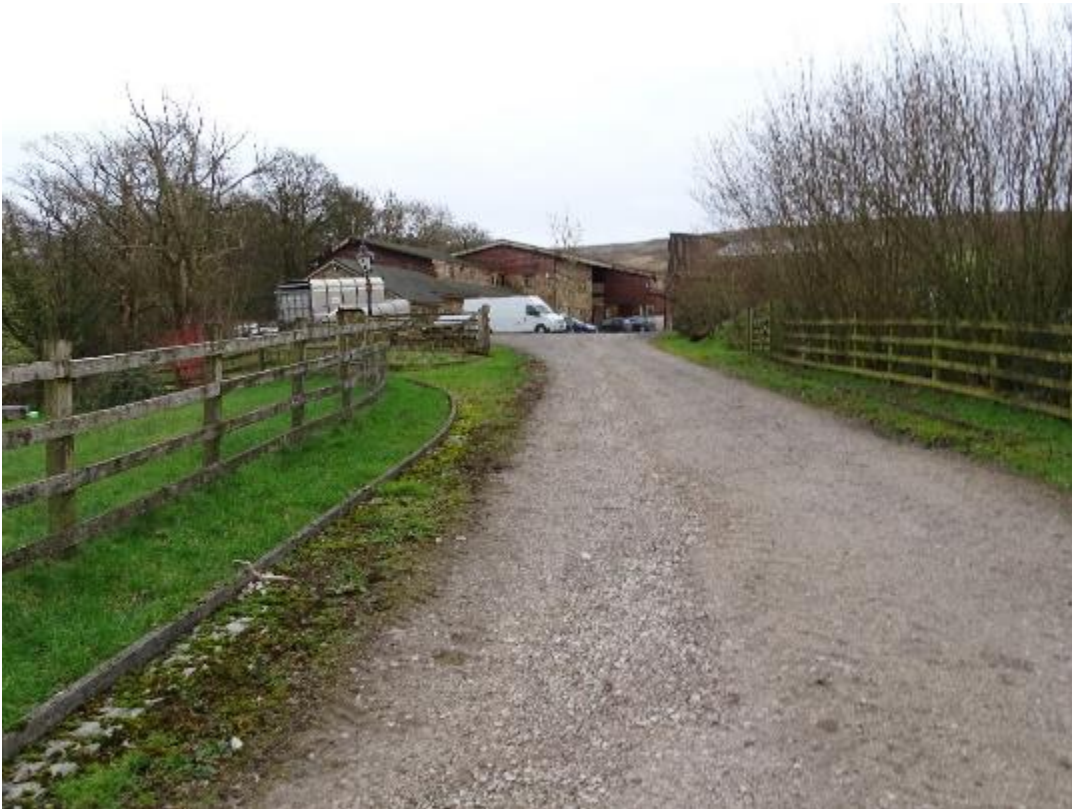
Access Road from the entrance way

The site is accessed from Long Lane to the west of the site via a long driveway. The driveway is constructed from compacted hardcore. A new entrance is in the process of being constructed. The rises from the road and the first structure is the farm house. The driveway splits to the farm house and runs past it to the stable block.

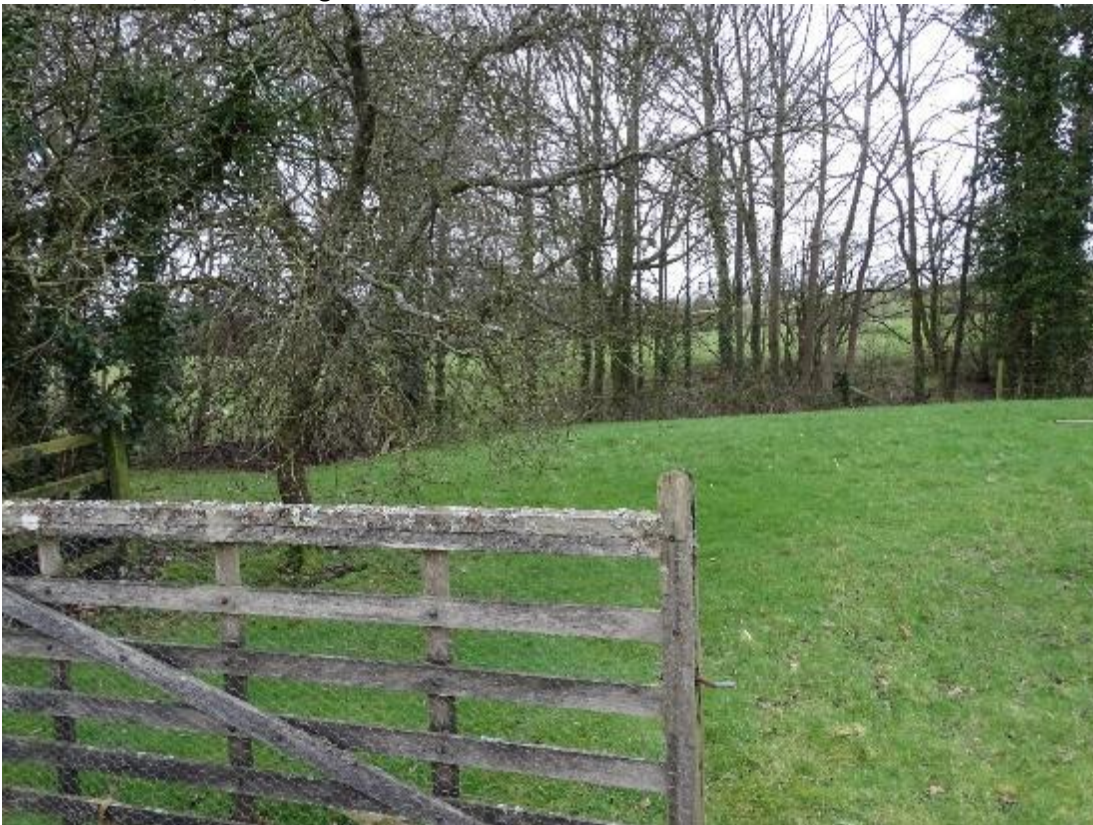
The Farm house, from the garden in the west around the rear of the house to the access road.

The farm house is a two storey stone built building with a slate roof. A septic tank is located to the west of the farm house within the garden area. A double skinned plastic and elevated oil storage tank is located to the rear of the farm house to provide heating fuel for the house.

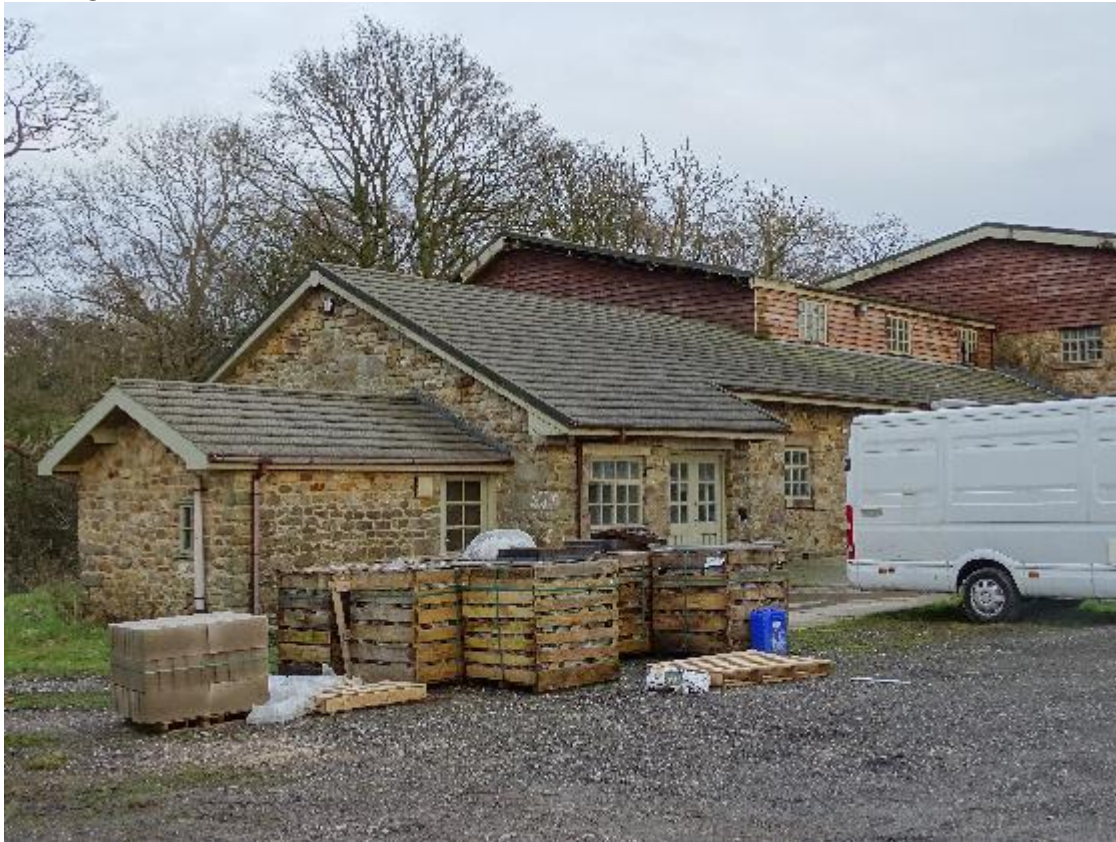
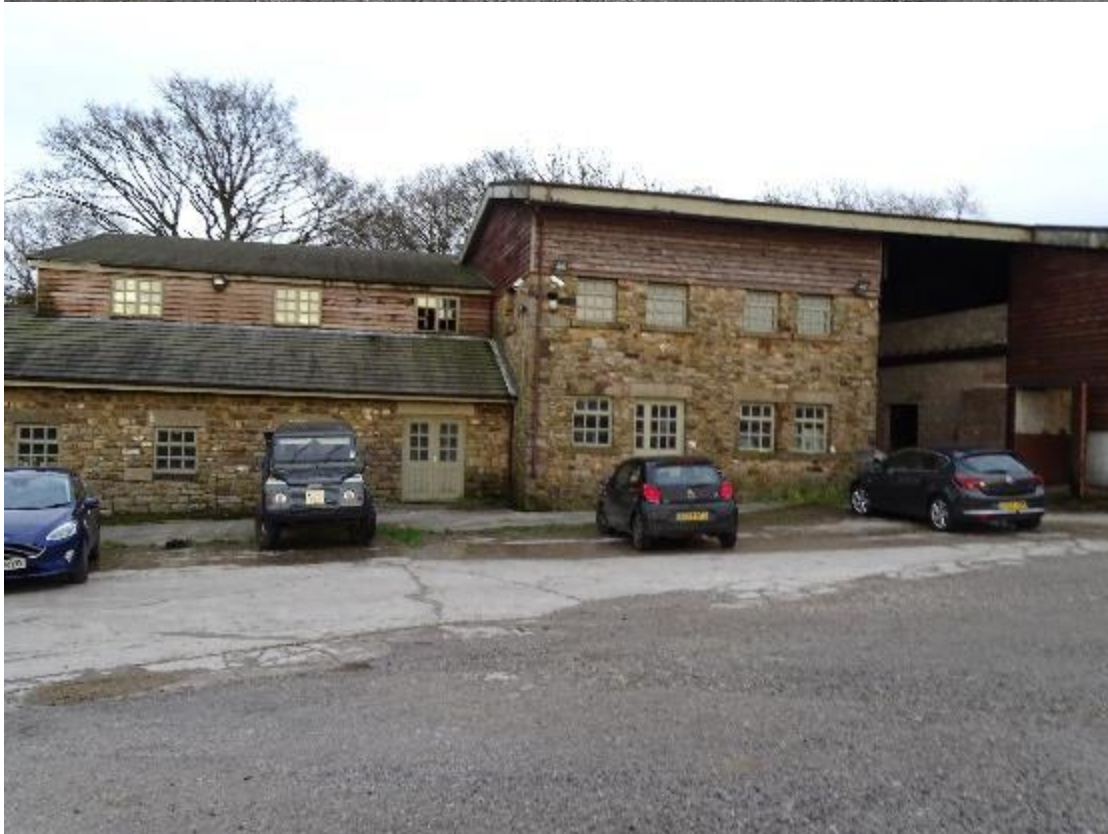
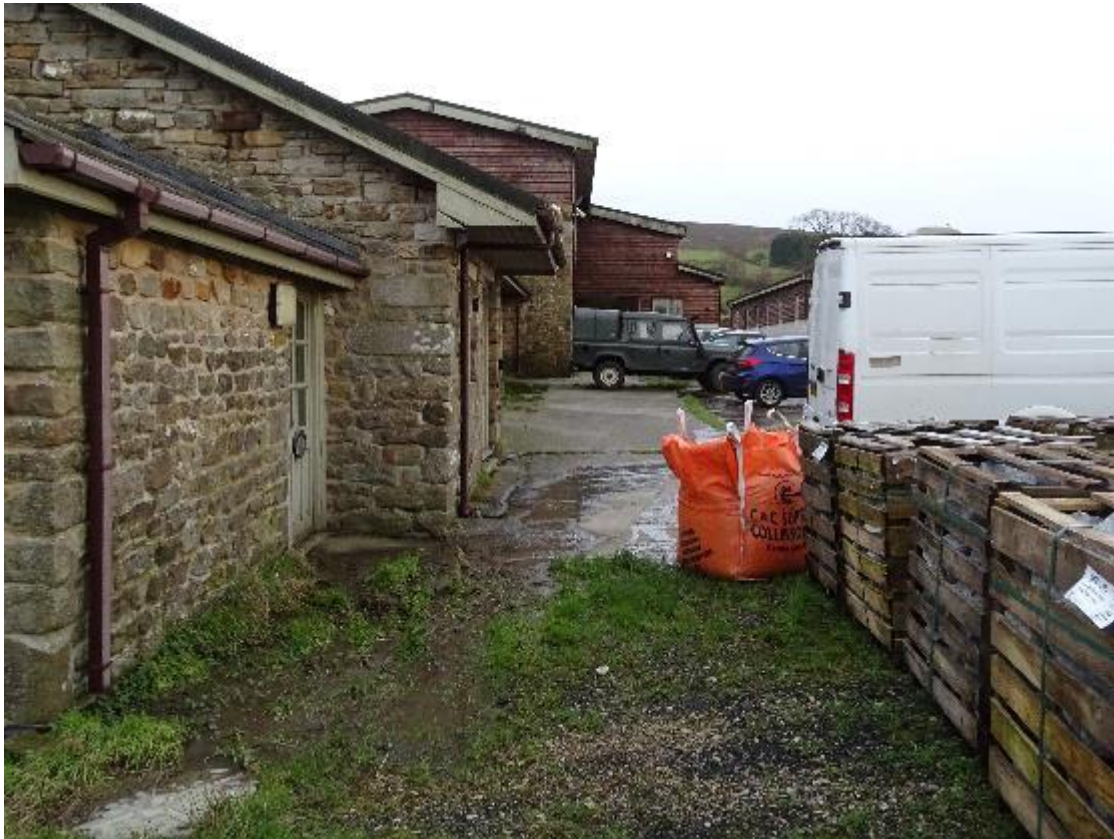
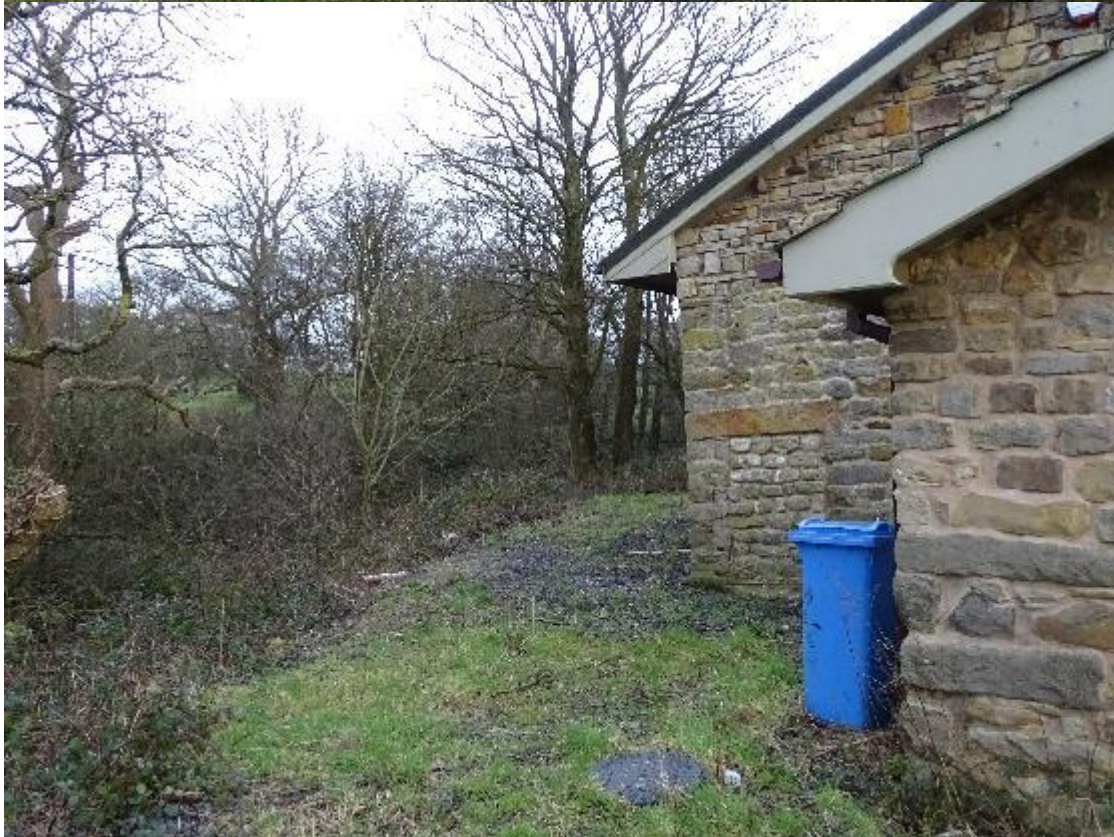
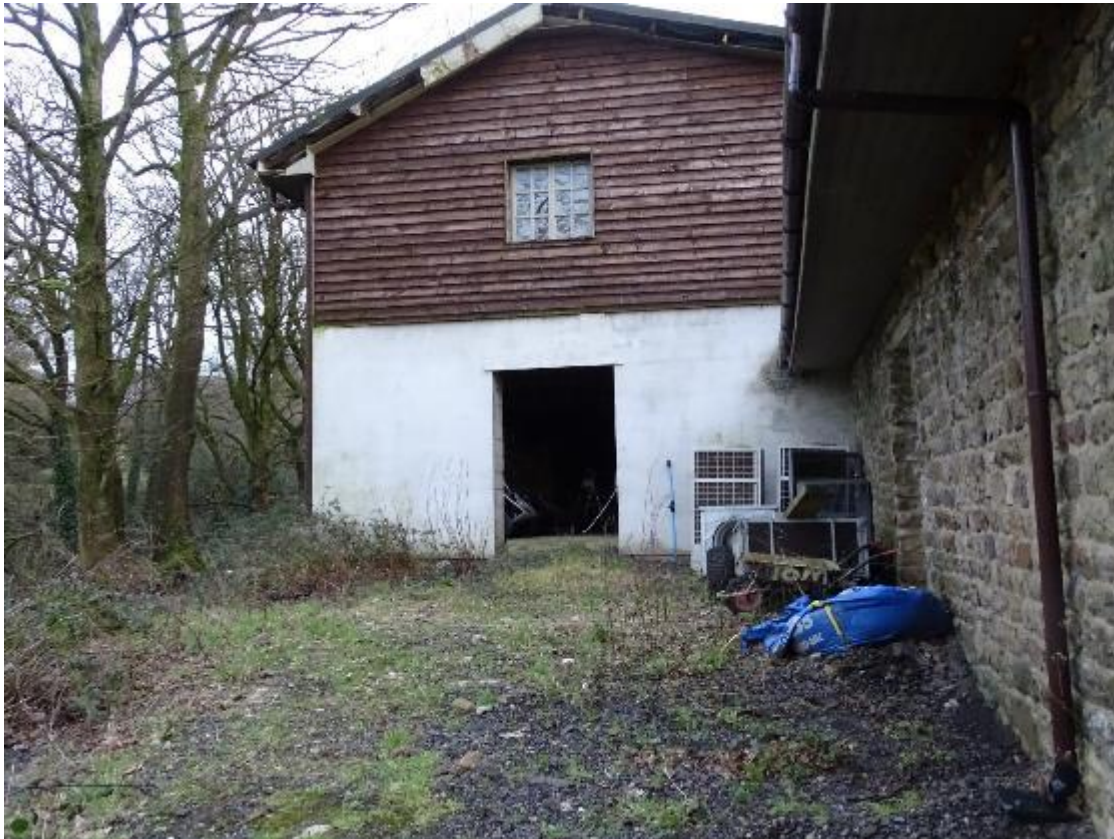
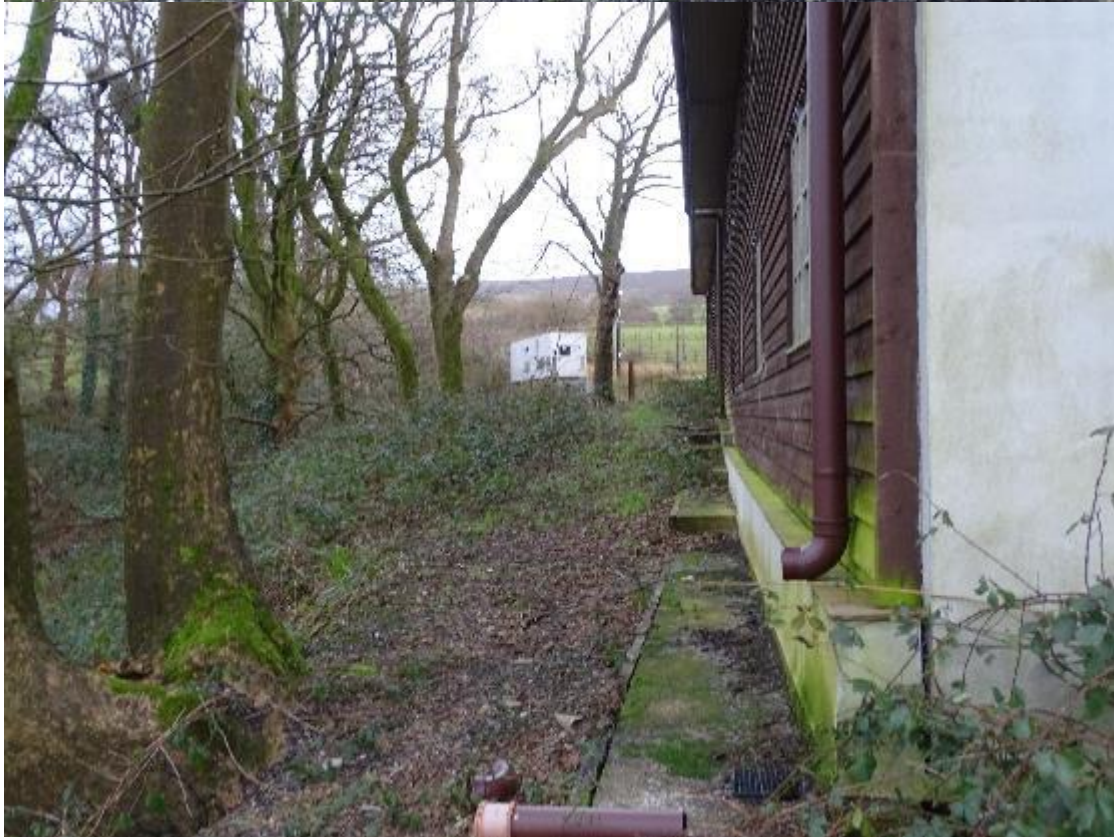
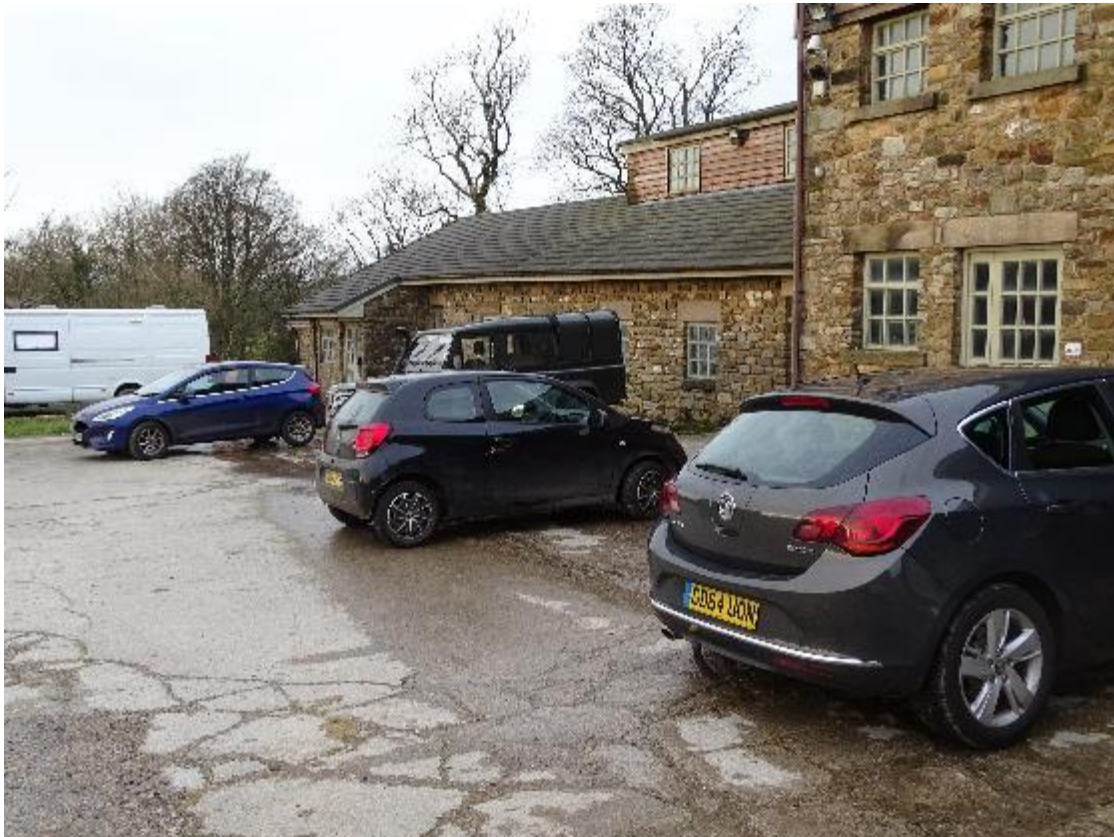
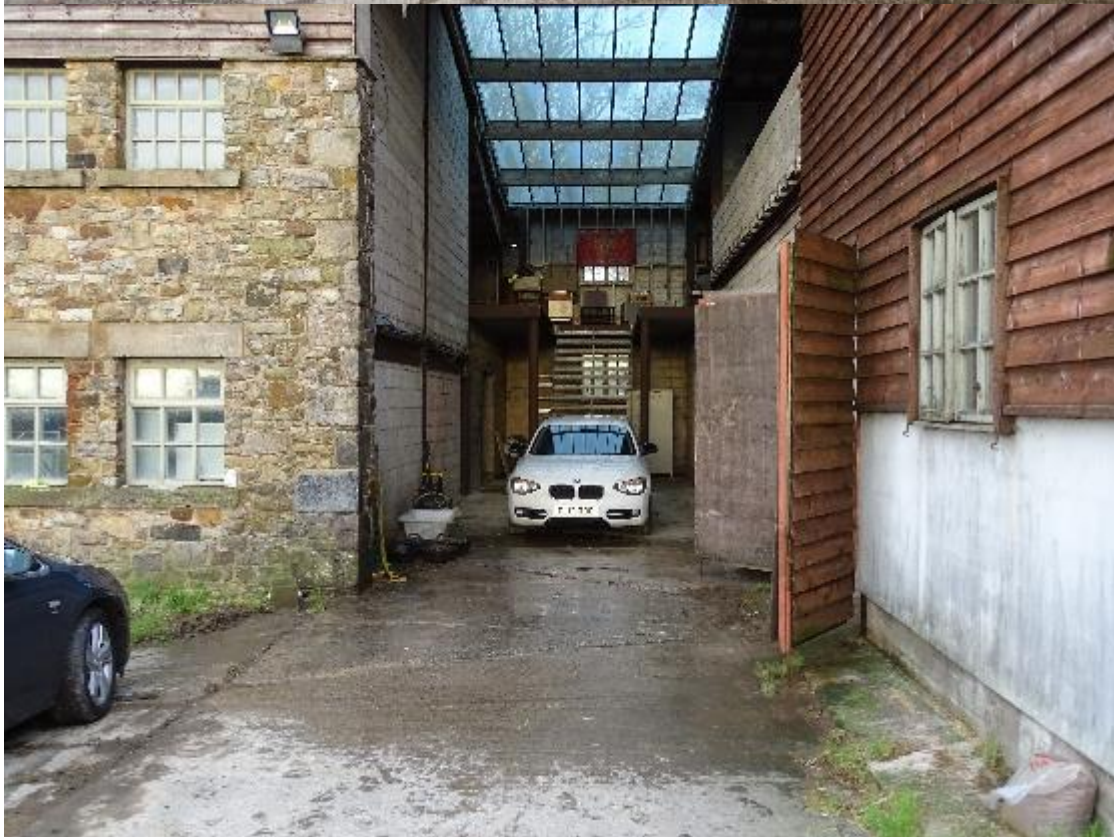
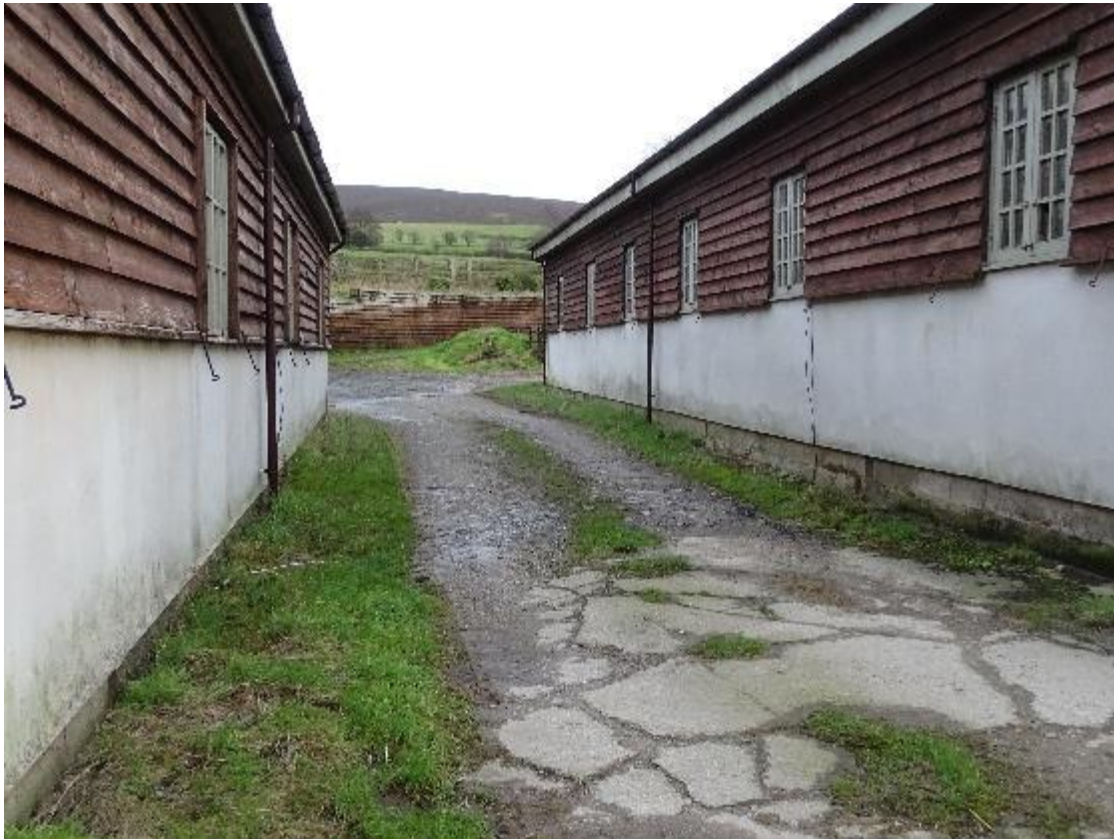
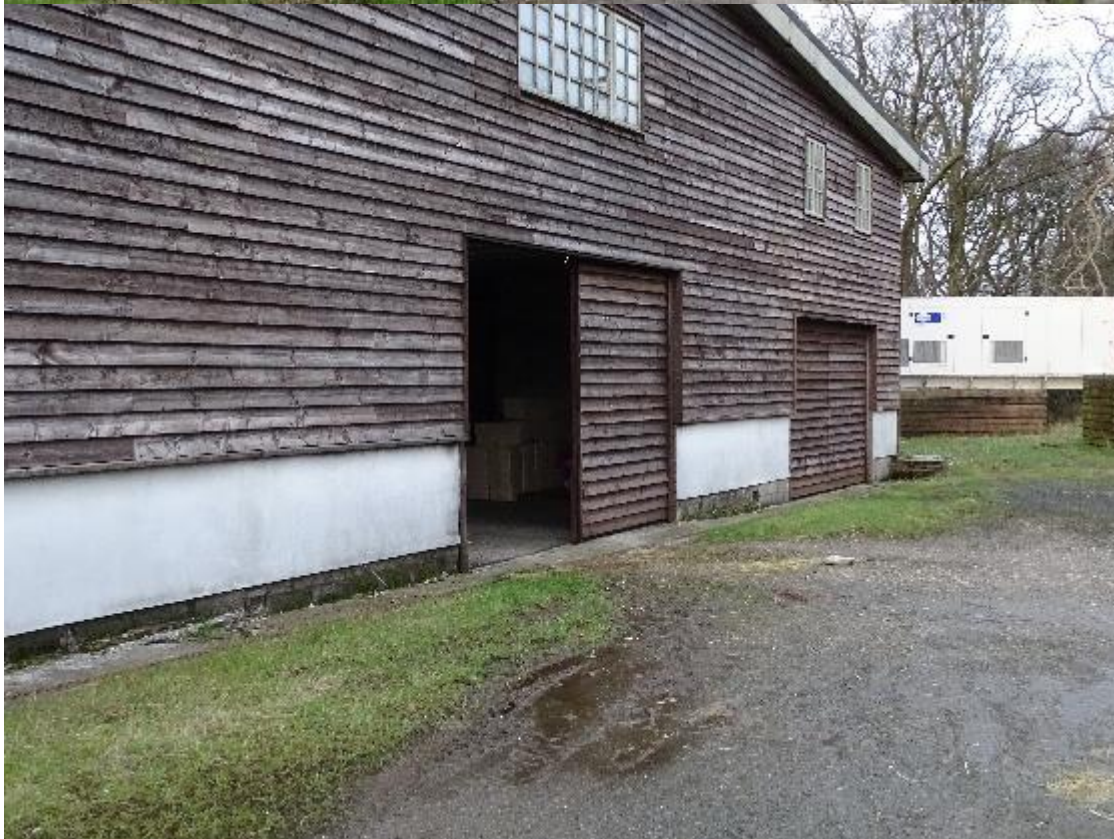
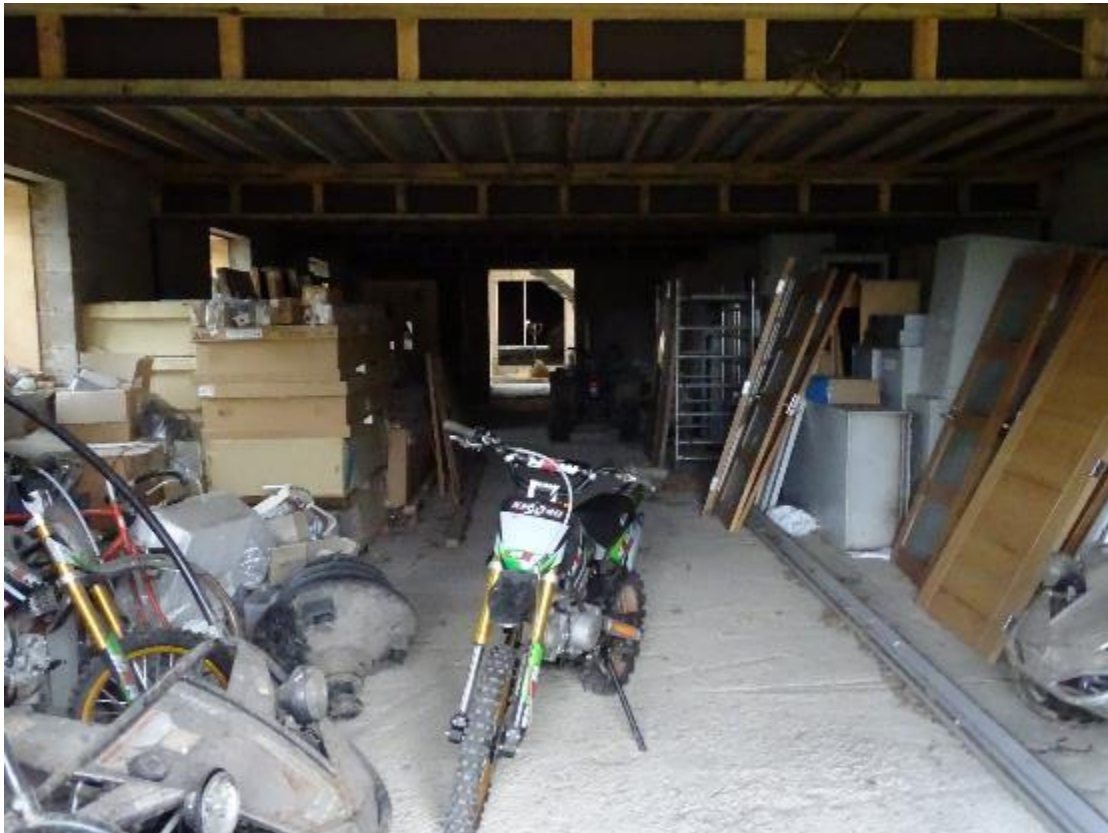
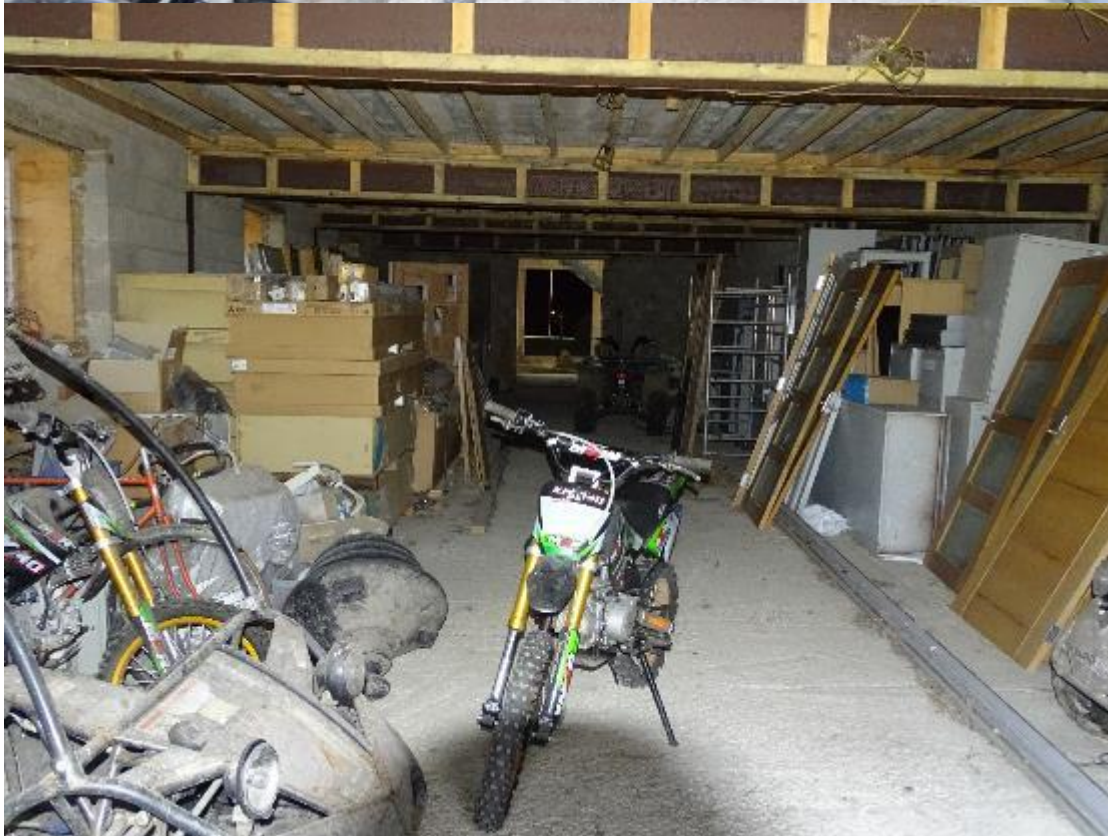
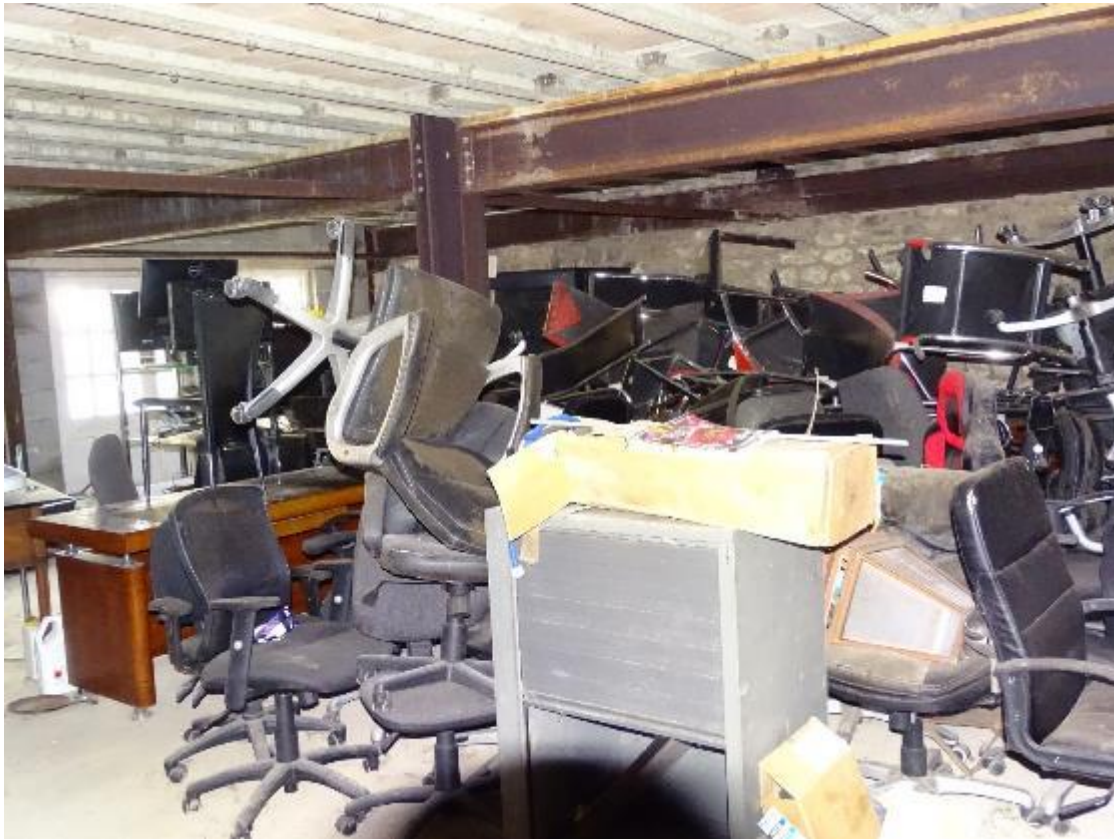
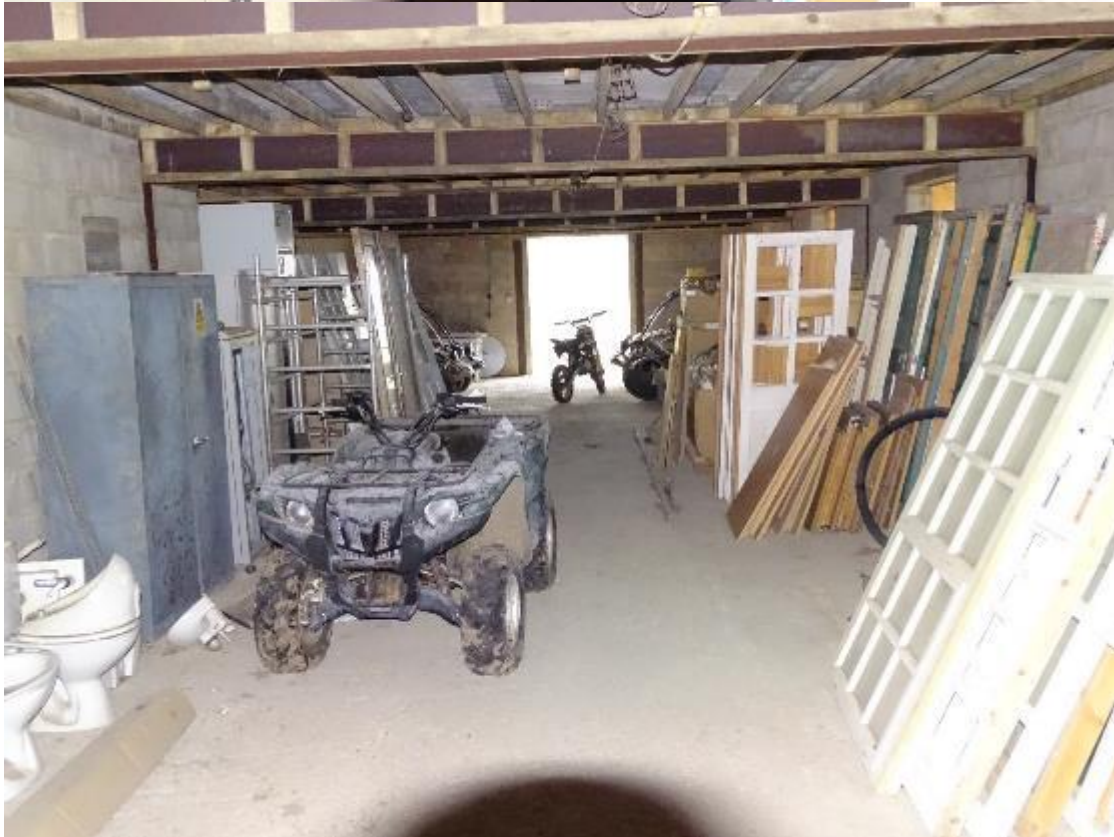
Building One

The stable buildings are located at a higher elevation to the farm house. The first building running along the northern boundary consists of a stone and wooden fronted building with slate roof. The internal leaf of the cavity wall is blockwork. A concrete base is provided to the building which extends around the site for a couple of meters. The building is used primarily for storage with the eastern section consisting of stables.
