Contaminated Land Phase One Desk  
Study for proposed Bed and  
Breakfast Accommodation on land  
at  
Taylors Farm,  
Long Lane,  
Scorton,  
Preston,  
PR3 1DB.

Prepared for

Graham Anthony Associates,  
2 Croston Villa,  
High Street,  
Garstang,  
PR3 1EA.

February 2024

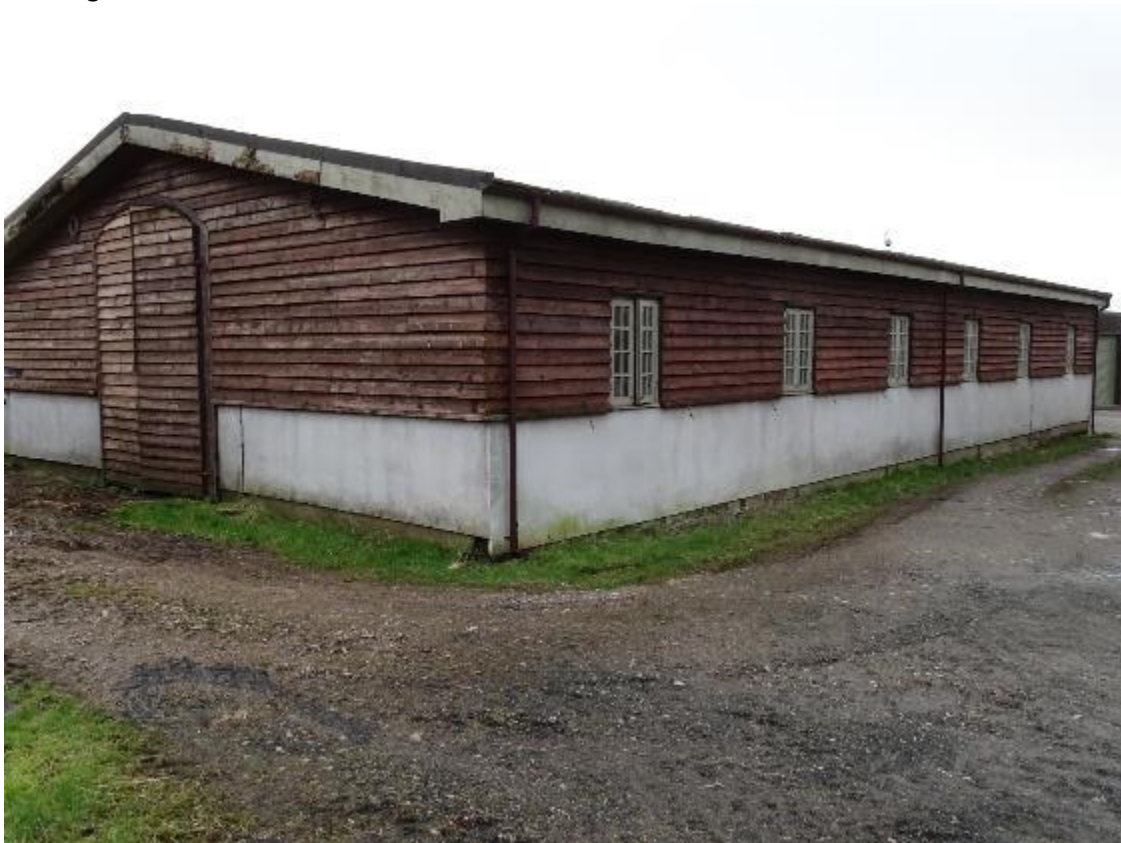
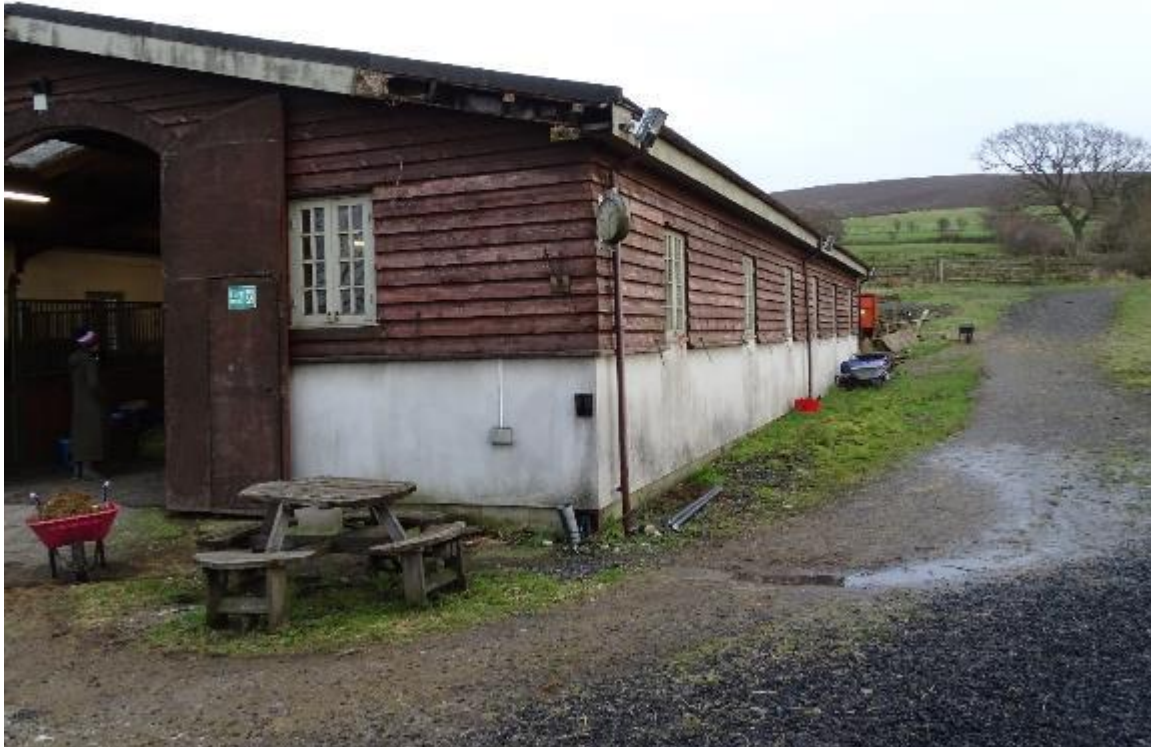
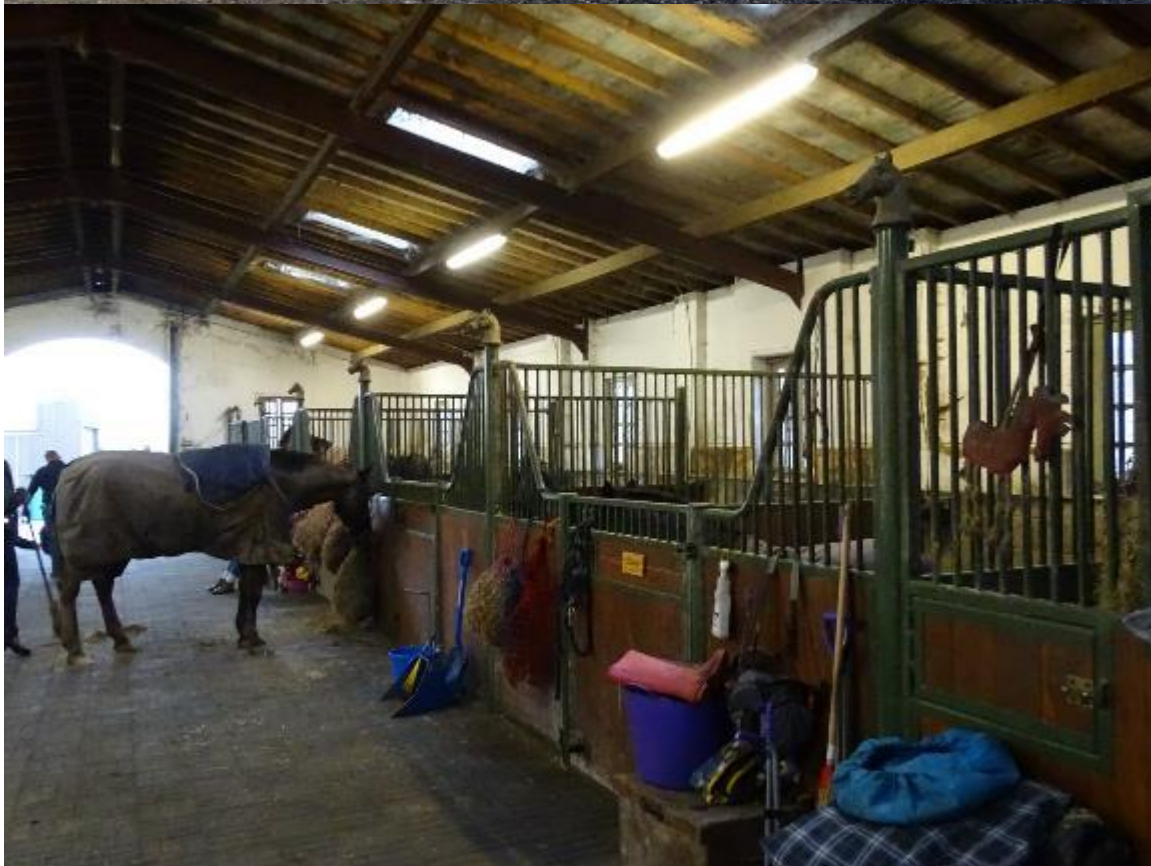
Building Two

Behind the second building is muck heap. The second building consists of a stable block constructed from concrete block and wooden cladding to the outer walls. The roof is tiled. The floor is concrete and in a good condition. To the south of this a paddock with rubber crumb as a base, this has overspilled onto a carparking area.

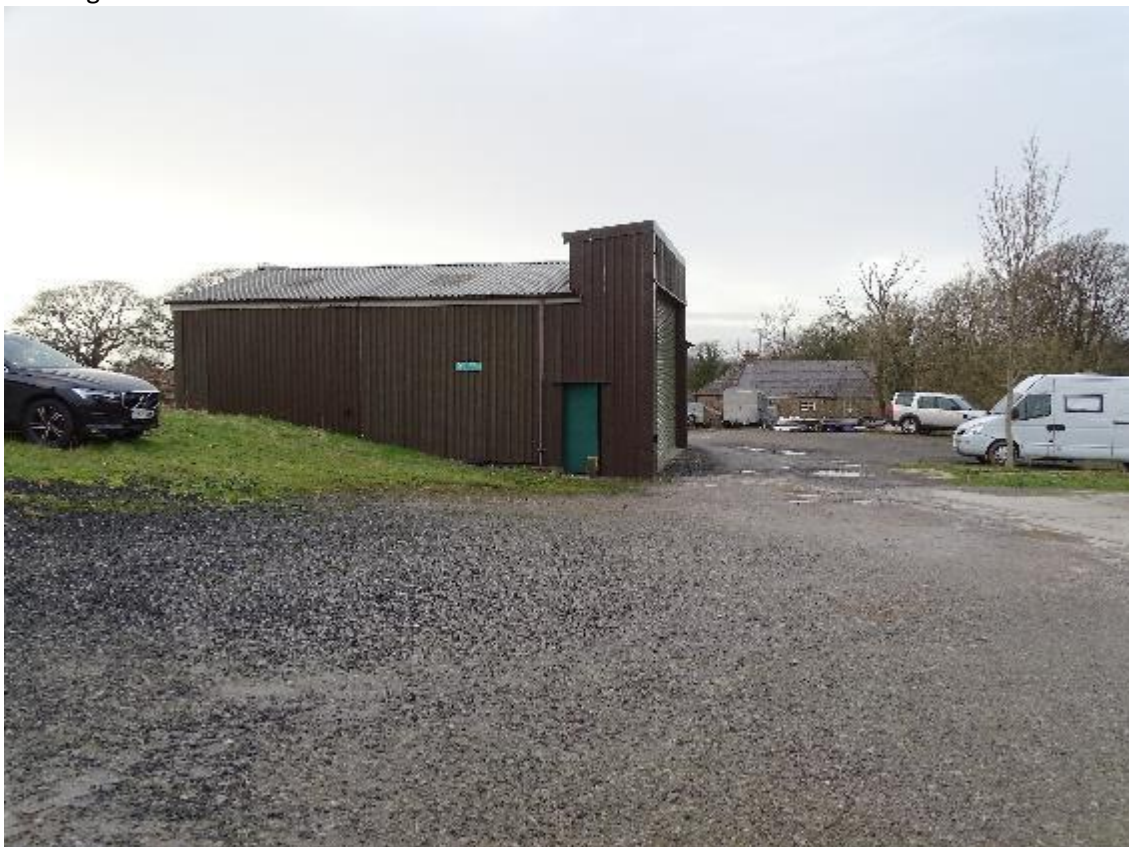
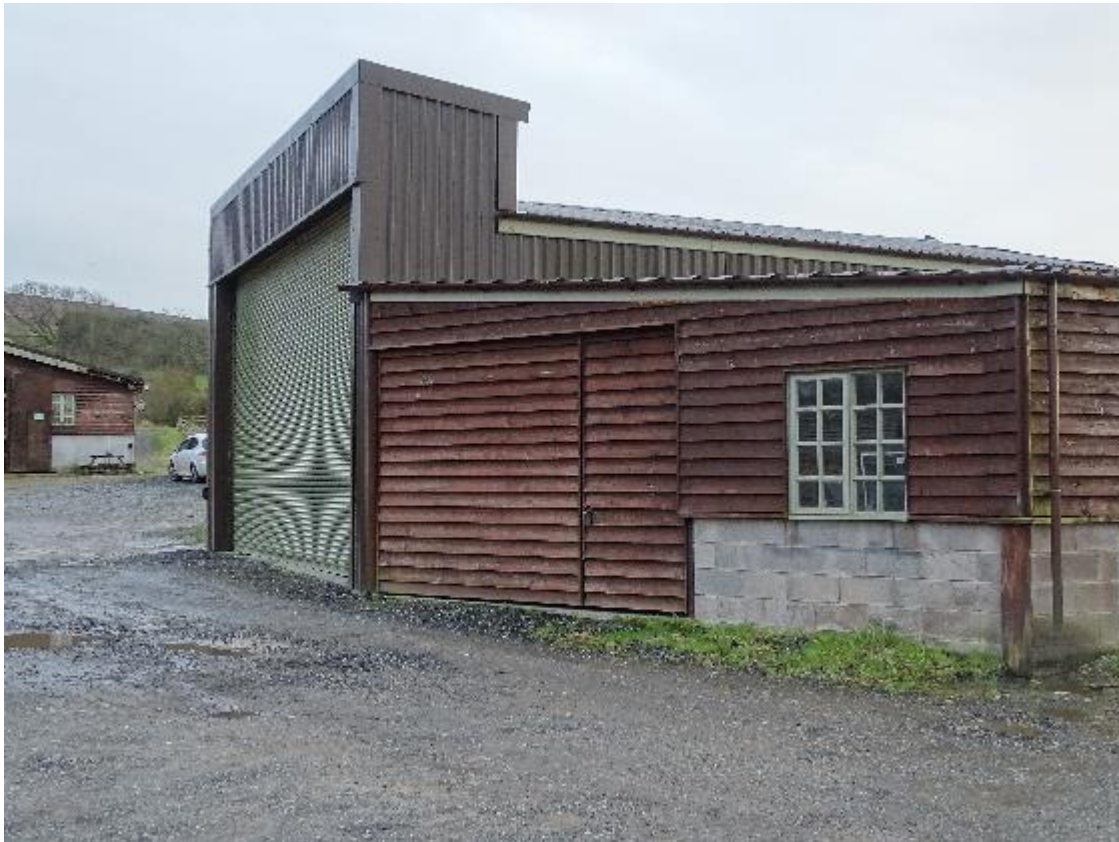
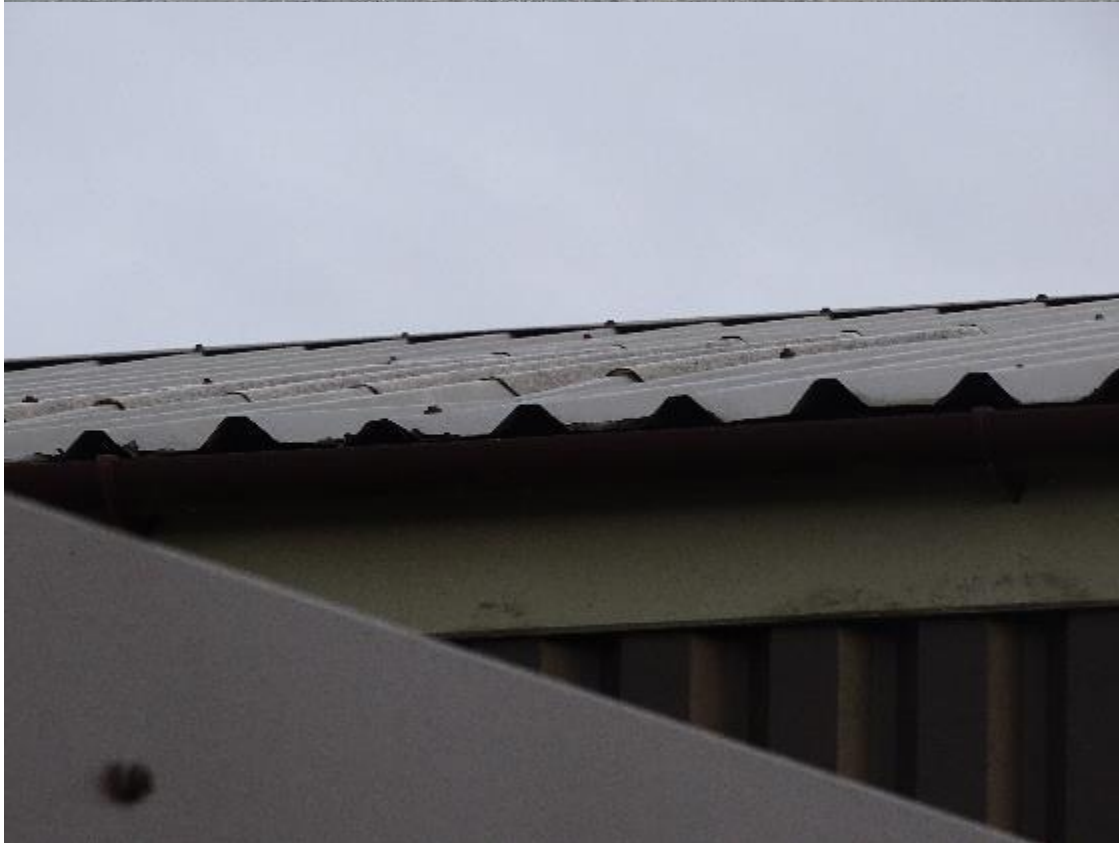
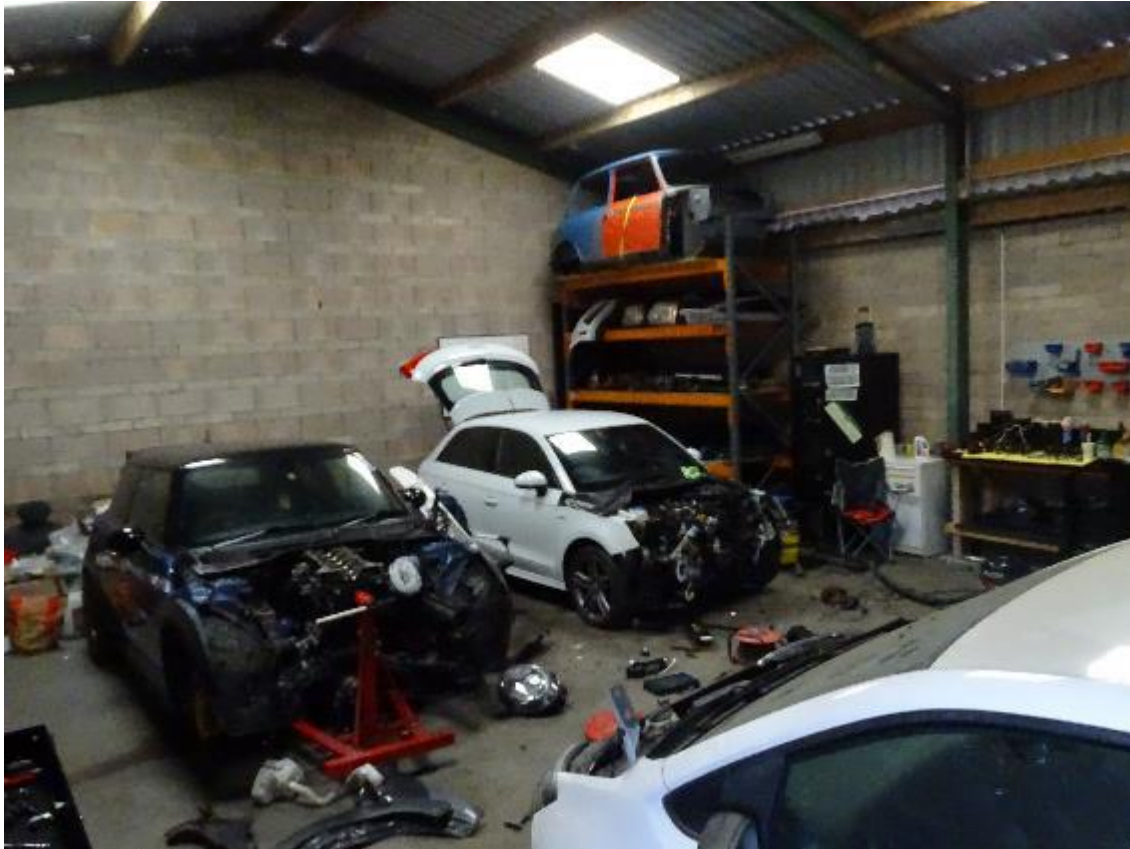
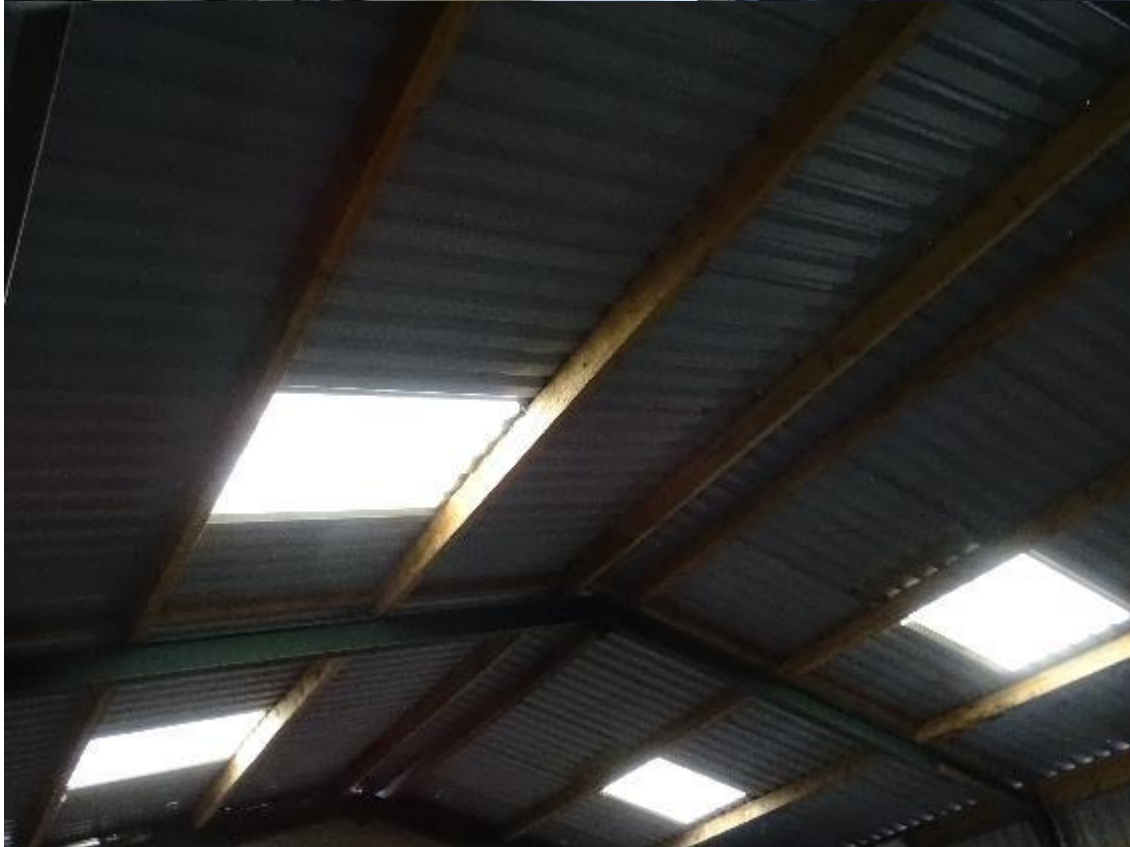
Building Three

The final building located in the centre of the site is a steel framed, concrete block building with concrete floor. Car repairs are being undertaken within the building.

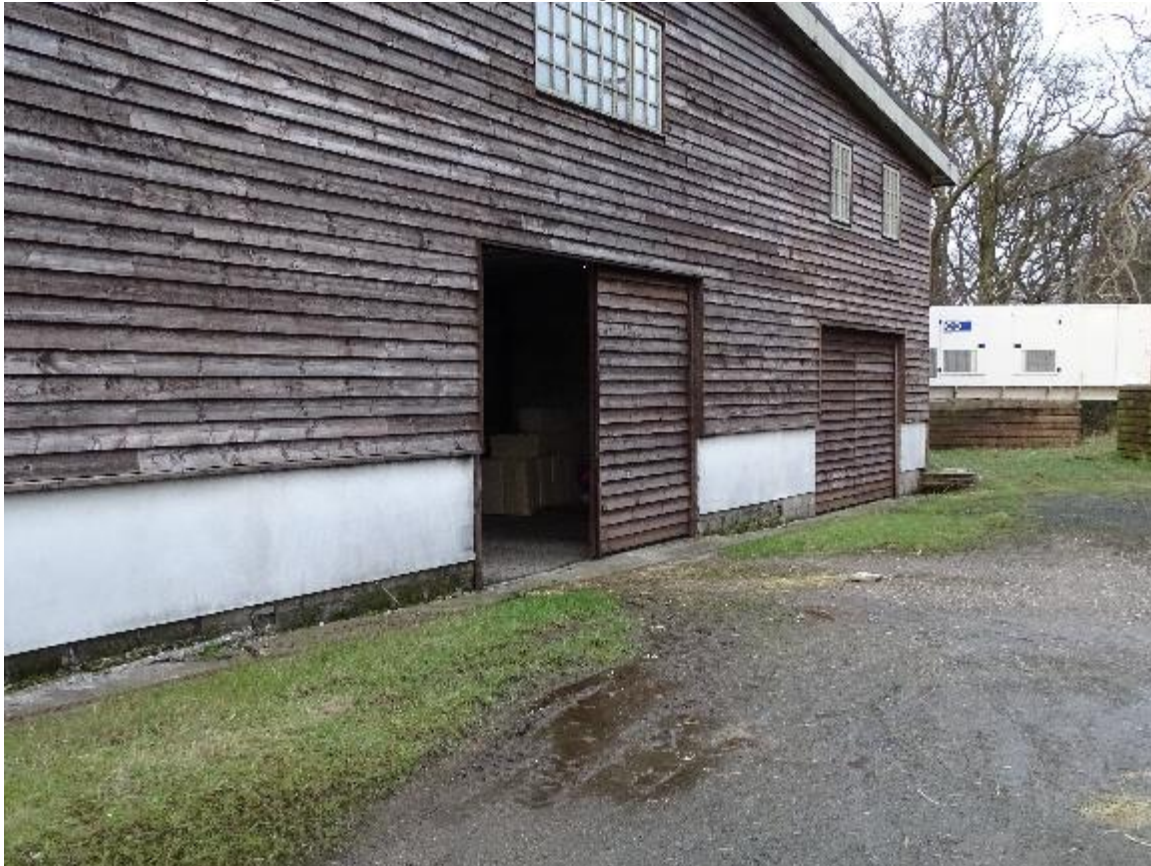
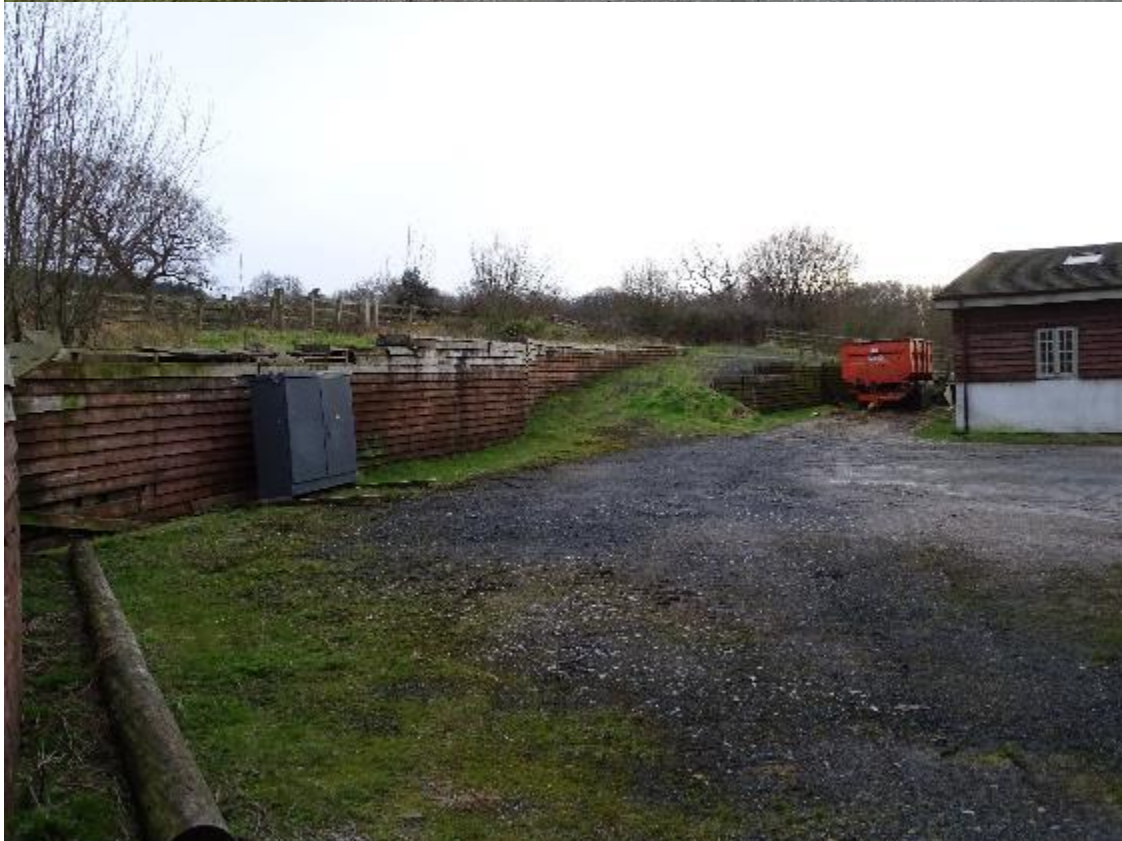
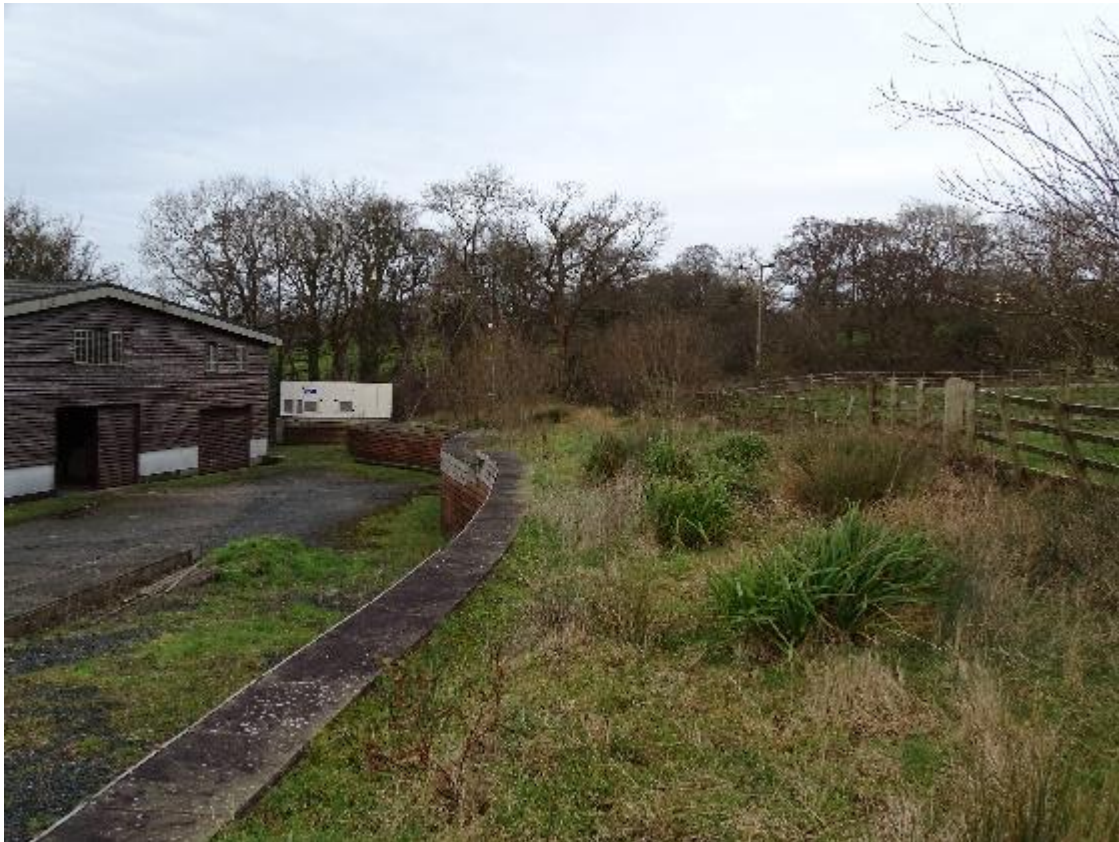
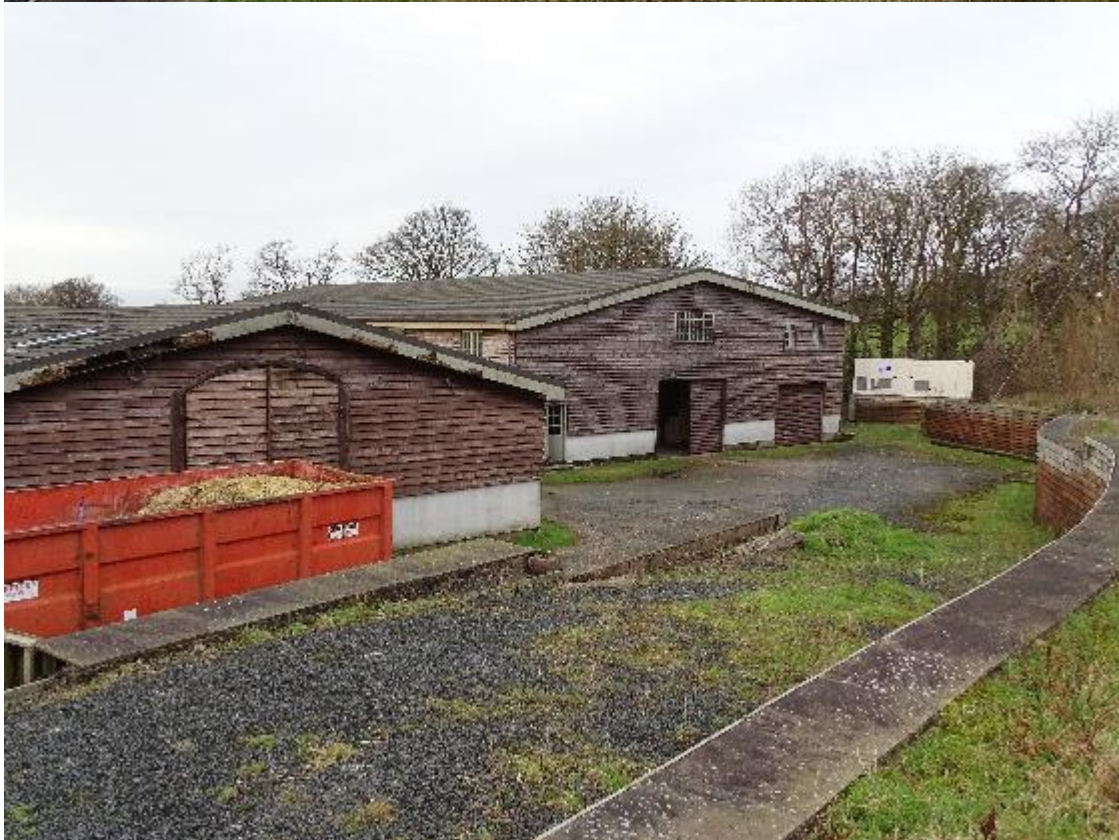
Eastern boundary, inc generator to rear of building One

To the rear of the building a generated has recently been moved to the site for storage. Along the eastern boundary the land rises again with a retain wall along the boundary.
