Structural Inspection

Inspection of Steel Portal Framed Building for Permitted Development at

Prospect Farm,
Launcherley,
Wells,
BA5 1QJ

Reference R230817/SI/Rev 1

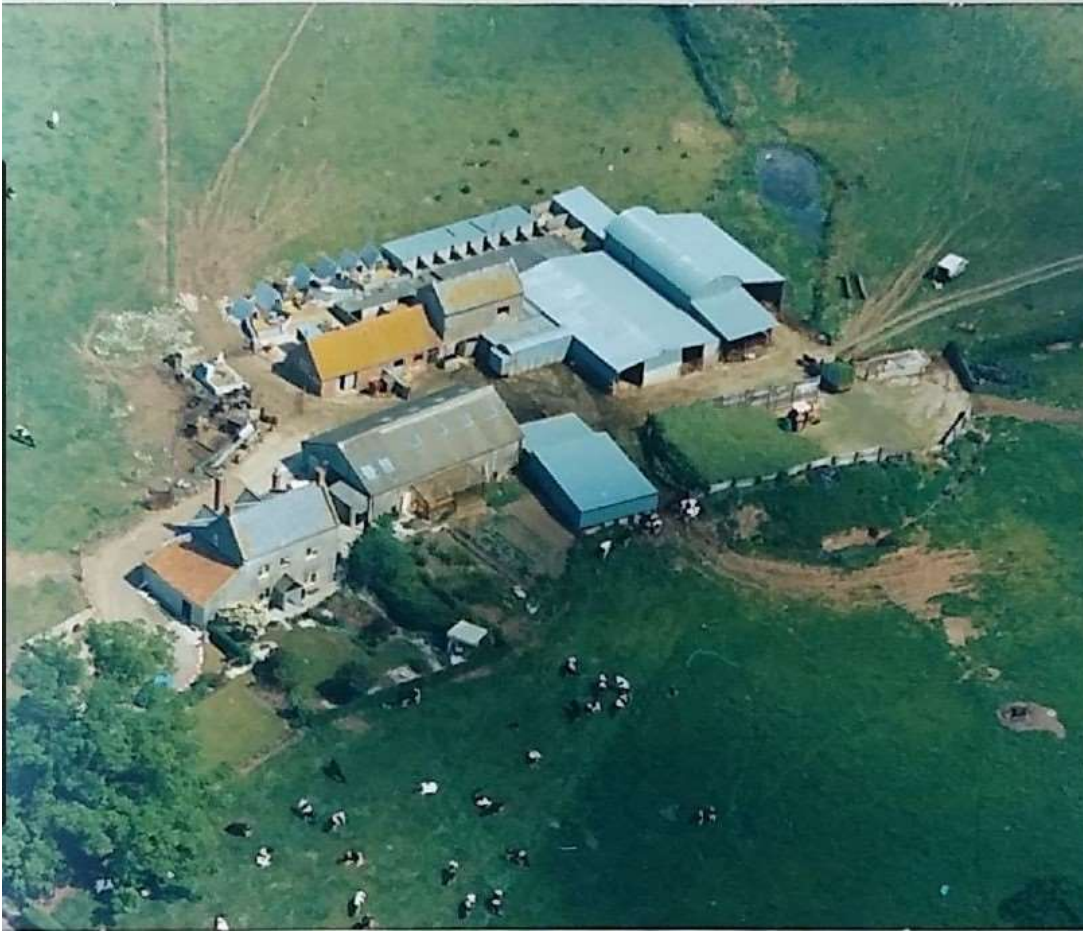
2.1.3 Historical aerial photographs (earliest 1964) indicate that the original building was a curved roof 'Dutch' barn between the left side two columns with an attached lean-to roof to the right side. The current structural arrangement predated 2009 as the duo-pitched roof building can be seen on google street view at this date.

Aerial photo (courtesy of client) taken after 1964 showing building to right hand end of yard

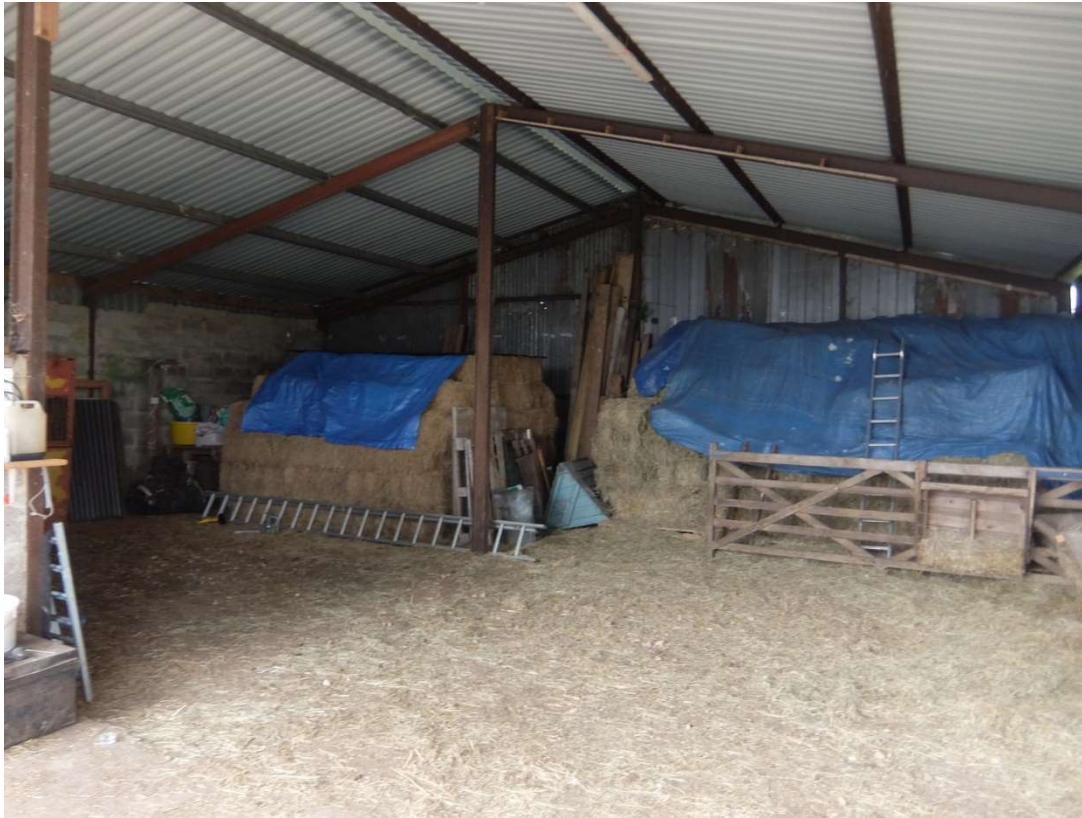
2.1.6 There are central steel wind posts within the front and rear walls each side of the central columns.

Internal view looking towards rear gable wall

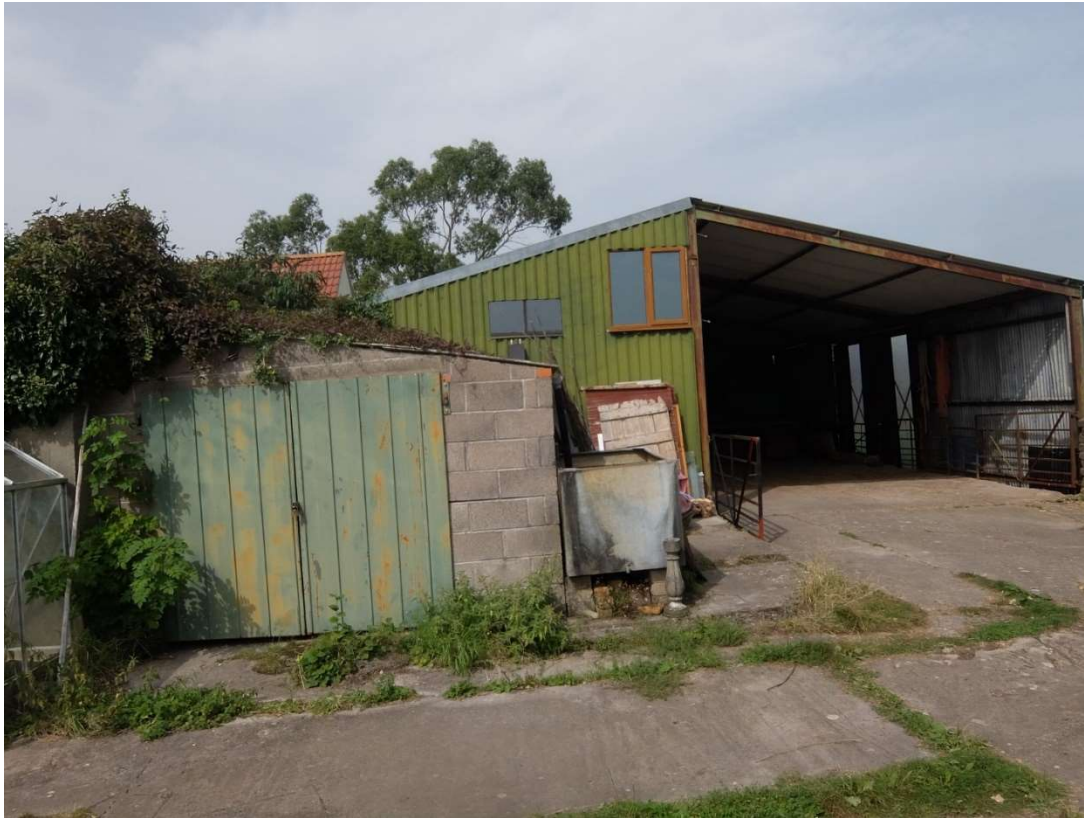
Front elevation

2.1.7 There is a full width vehicular access opening to the right side of the central column within the front wall. To the left side of the wind post, the wall consists of blockwork masonry up to the verge of the attached masonry extension. Between the central column and wind post there is a masonry wall to three courses. Above the masonry the wall consists of painted box profile steel sheeting. There are two glazed openings within this sheeting.

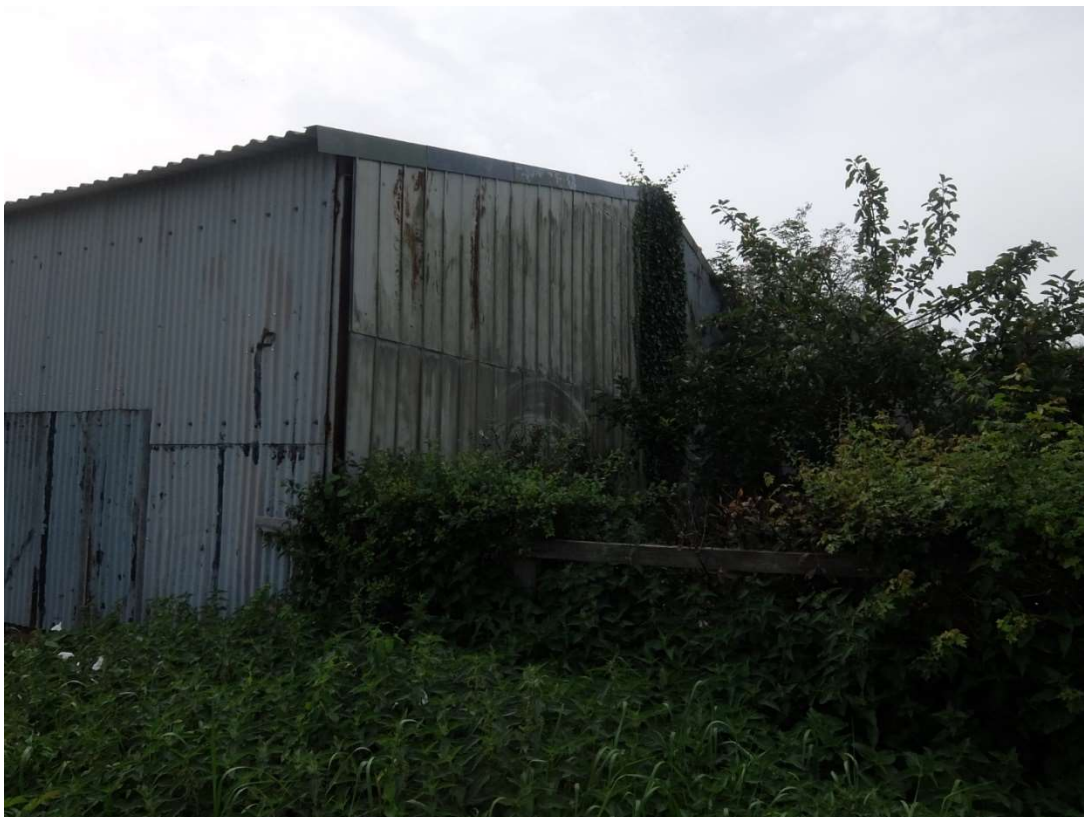
Rear and part right side elevations

2.1.9 The rear wall consists of shallow box profile steel sheeting to the right of the central column and corrugated steel sheeting to the left side. All the sheeting

is painted. The sheeting is supported by steel angle rails spanning between the columns and wind posts.

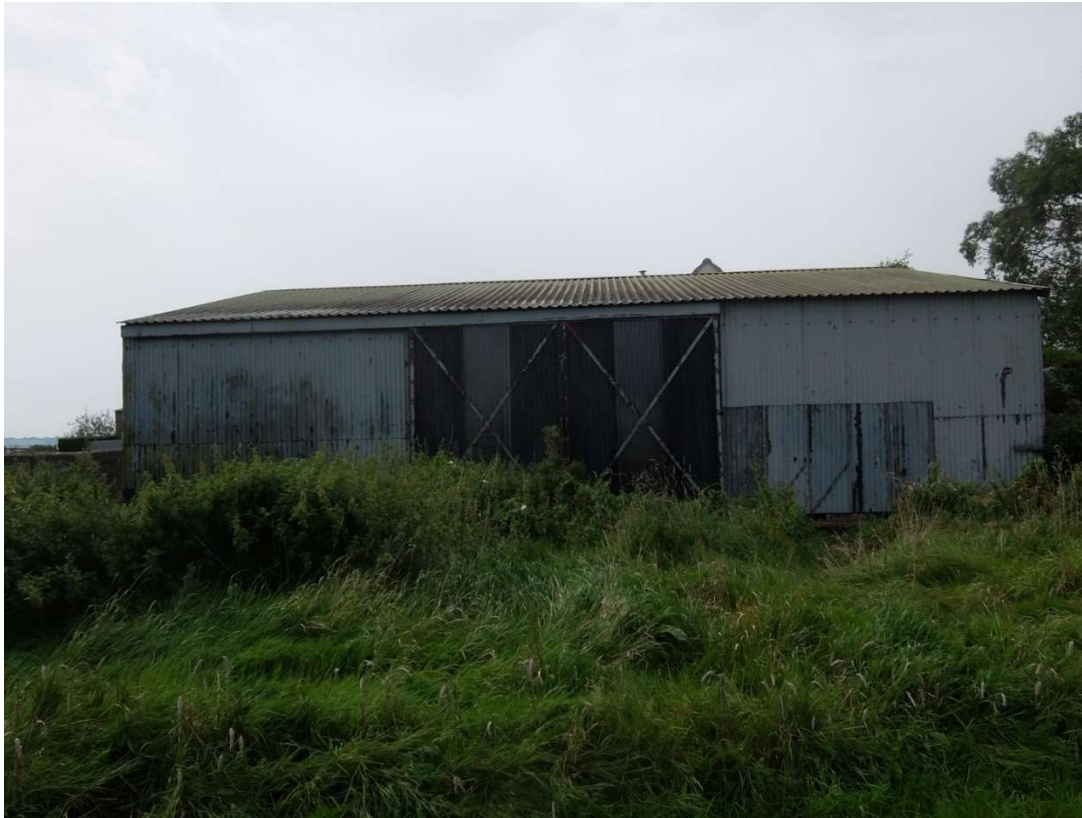
Right side elevation

2.1.8 The right side wall consists of externally painted corrugated steel sheeting. The sheeting is supported by steel angle rails spanning between the columns. There are double access sliding doors (steel framed and clad with externally painted corrugated steel sheeting and compatible opaque sheeting) within the central bay that are fixed in position. There is a substantial beam supporting the sliding doors that will be retained within the conversion.
