JANUARY 12, 2024

WISTERIA COTTAGE, DUNSTAN LANE, BURTON,  
WIRRAL. CH64 8TL (2024)  
TREE SURVEY UPDATE AND RECOMMENDED WORKS

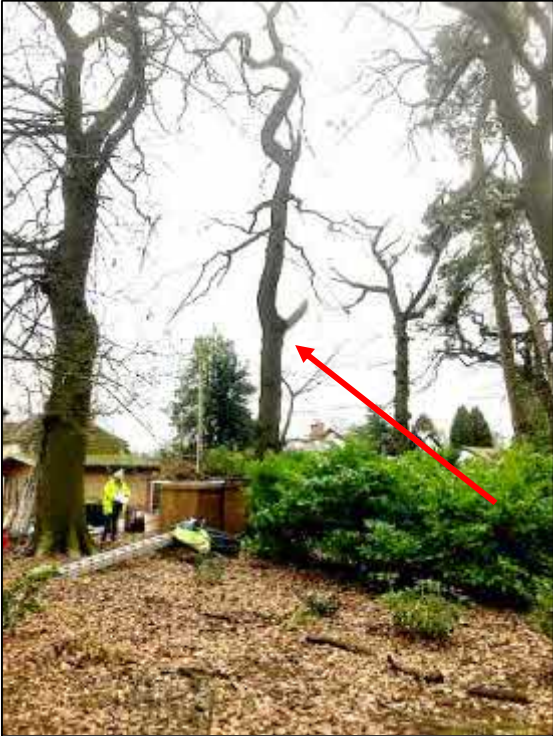
Surveyor: Guy Smallthwaite Wisteria Cottage 11/01/2024 Tree Survey									
Ref	Species	Height	Approx Stem Diameter	Cardinal Points		Vitality	Age	Comments.	Management
T1	Oak <i>Quercus robur</i>	20m	732mm	N	2	G	M	The tree is in good condition. There are two woodpecker holes, one at two metres and another at ten. There is evidence of limb failures and an asymmetric crown.	No work required at present.

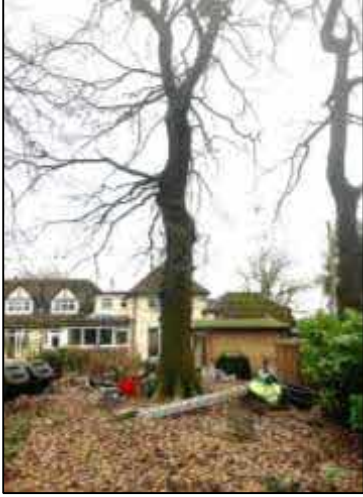
Ref	Species	Height	Approx Stem Diameter	Cardinal Points		Vitality	Age	Comments	Management
T2	Oak Quercus robur

20m	955mm	N	7	G	M	Tree in good condition with a healthy crown. Epicormic growth on first 4 metres. Foliage bias to south east.	Crown thin on east side by 20% by removing selected branches to improve balance.
T3	Oak Quercus robur

Table 1. Recommended works in order of priority – see Tree Survey Schedule for details of recommendations (Page 9).	
Individual Trees	Recommendations
T2 Oak	Crown thin on east side by 20% by removing selected branches to improve balance.
T7 Oak	A crown reduction by 25% (pruning branches by 3 metres to appropriate pruning points) concentrating on the lower lateral branches on the east side to lessen the weight bias to the east (neighbouring property) The stability of the tree should be monitored annually.
T8 Oak	Remove ivy from base to 2 metres.
T10 Oak	Remove dead branch at 9 metres.
T11 Oak	Remove dead limb at 13 metres.
T12 Oak	Remove dead branches at 4, 7 and 12 metres.
T15 Scots Pine	Remove dead limb at 14 metres.
T18 and T19 Oak	Monitor health annually
T20 Oak	Crown reduction by pruning 2 upper limbs by approx. 3m to appropriate pruning points to lessen risk of failure.
T21 Oak	Crown reduction by 25% (pruning branches by approx. 3 metres to encourage regeneration.

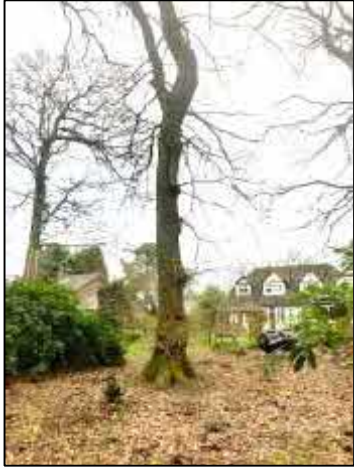
20m	796mm	N	7	G	M	Tree is healthy with no apparent defects. Epicormic growth on first 4 metres and well balanced, high canopy.	No work required at present.

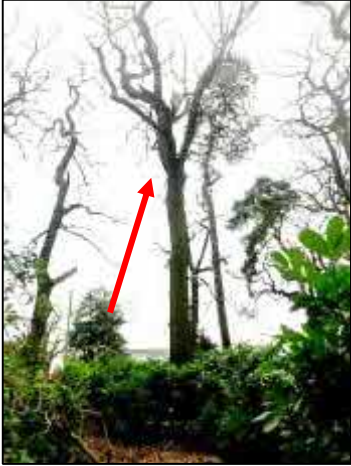
Ref	Species	Height	Approx stem Diameter	Cardinal Points		Vitality	Age	Comments	Management
T4	Oak <i>Quercus robur</i>

20m	764mm	N	7	G	M	The tree is in good condition and well balanced. There is evidence of limb failures and foliage is biased south east.	No work required at present.
T5	Scots Pine <i>Pinus sylvestris</i>	12m	414mm	N	2	D	M	A 3 metre high dead trunk.	No work required

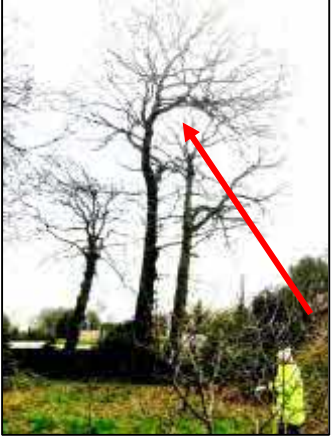
Ref	Species	Height	Approx Stem Diameter	Cardinal5 Points5		Vitality	Age	Comments	Management
T6	Oak Quercus robur

18m	820mm	N	7	G	M	1. Tree in good condition with no apparent defects. 2. A high canopy on north west side.	No work required at present.
T7	Oak Quercus robur

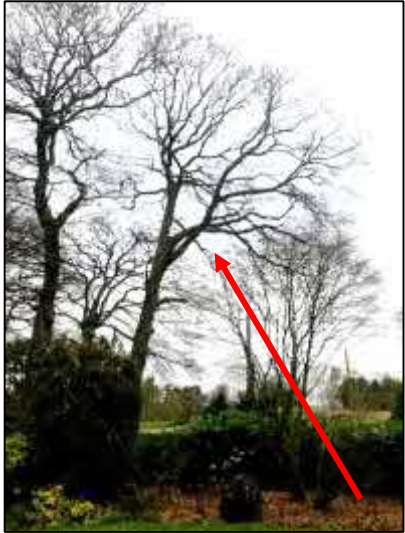
5.2 The oak tree (T7) has an imbalanced crown with limbs extending east, which are also above an electricity cable. The tree is in target range of the neighbouring property. It is recommended that a crown reduction of at least 25% should be carried out. There are recommendations for remedial pruning work to be carried out on various trees and for dead branches to be removed from some trees. It has also been advised that one large poplar tree within G3 located on third party land which is in serious decline with advanced decay evident, requires felling. While assessing its condition squirrels emerged from the hollow.

18m	812mm	N	7	G	M	1. Tree leaning east with crown extending towards neighbouring property, over a power line. 2. A high canopy on north west side.	A crown reduction by 25% concentrating on the east side. Prune back lower lateral limbs to lessen the weight bias to the east and reduce the risk of failure. The stability of the tree should be monitored annually.

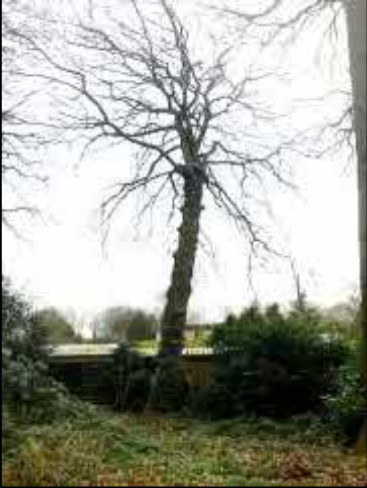
Ref	Species	Height	Approx Stem Diameter	Cardinal Points		Vitality	Age	Comments	Management
T8	Oak Quercus robur

17m	722m	N	8	G	M	1. Tree is located adjacent to boundary fence and is in good condition with no apparent defects. 2. Crown weight is biased north and the canopy is high on the south side. There is also a cavity in the crown union.	Remove ivy from base to 2 metres.
T9	Oak Quercus robur

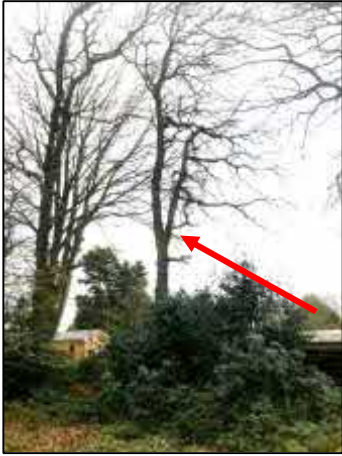
17m	509mm	N	3	G	M	1. Tree in good health with no apparent defects. It is located adjacent to boundary and bifurcates at 6 metres. Crown weight is biased north east.	No work required at present.

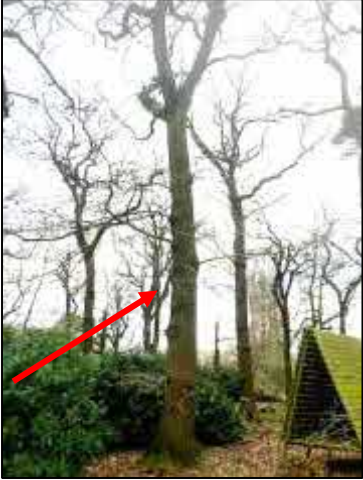
Ref	Species	Height	Approx Stem Diameter	Cardinal Points		Vitality	Age	Comments	Management
T10	Oak <i>Quercus robur</i>

19m	764mm	N	5	G	M	<ol style="list-style-type: none"> <li>1. Tree in good health with no apparent defects.</li> <li>2. It trifurcates at 9 metres.</li> </ol>	Remove dead branch at 9 metres.
T11	Oak <i>Quercus robur</i>

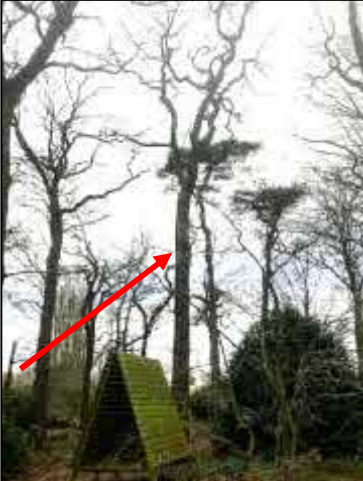
19m	605mm	N	5	G	Y	<ol style="list-style-type: none"> <li>1. Tree in good health, trifurcating at 10 metres. There are dead limbs on west side. There is a woodpecker hole at 8 metres.</li> </ol>	Remove dead limb at 13 metres.

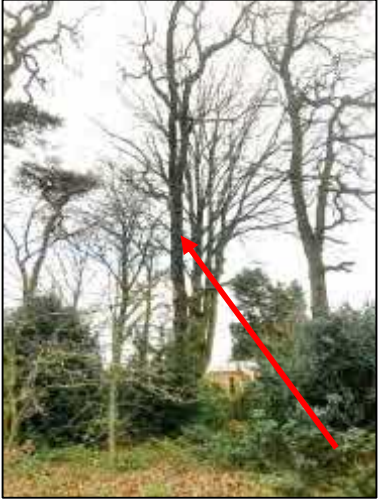
Ref	Species	Height	Approx Stem Diameter	Cardinal Points		Vitality	Age	Comments	Management
T12	Oak Quercus robur

19m	600mm	N	4	M	M	1. In good condition with no apparent defects. 2. It is multi-stemmed at 10 metres and there are dead branches evident at 4, 7 and 12 metres.	Remove dead branches at 4, 7 and 12 metres.
T13	Oak Quercus robur

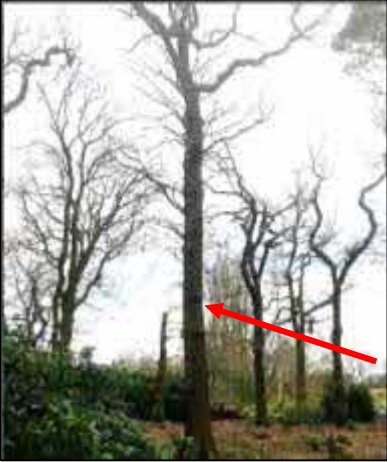
19m	600mm	N	6	G	M	1. Tree appears health with no apparent defects.	No work required at present.

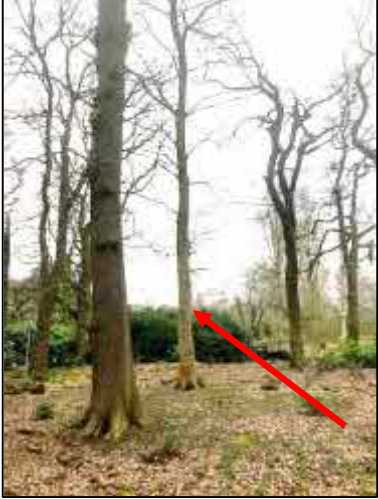
Ref	Species	Height	Approx Stem Diameter	Cardinal Points		Vitality	Age	Comments	Management
T14	Sycamore <i>Acer pseudoplatanus</i>	18m	500mm	N	3	G	M	1. Tree is in good health with no apparent defects. Epicormic growth has been removed.	No work required at present.

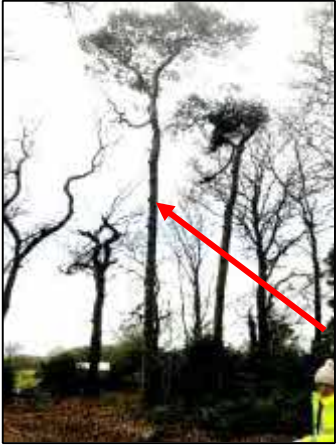
S	4				
				E	3				
				W	3				
T15	Scots Pine <i>Pinus sylvestris</i>	18m	540mm	N	3	G	M	1. Tree in good health with lower branches removed and evidence of storm damage. There is a dead limb evident extending north at 14 metres.	Remove dead limb at 14 metres.

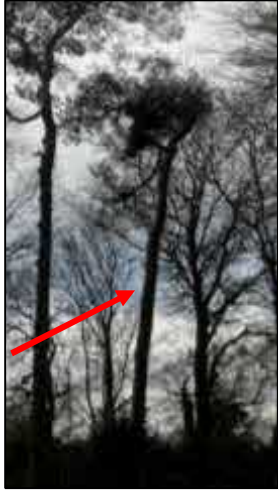
Ref	Species	Height	Approx Stem Diameter	Cardinal Points		Vitality	Age	Comments	Management
T16	Scots Pine <i>Pinus sylvestris</i>

16.5m	400mm	N	4	G	M	1. Tree in good health with lower branch removed and evidence of storm damage. Contorted with some dead branches asymmetric crown.	No work required at present.
T17	Sycamore <i>Acer pseudoplatanus</i>

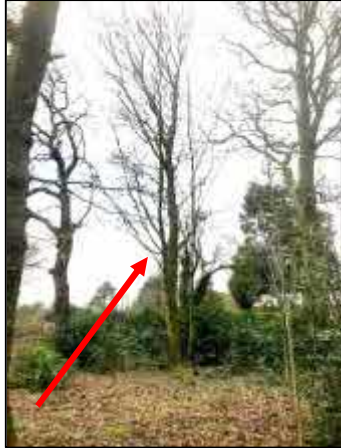
13m	1.60mm	N	4	G	M	1. Tree in good health with no apparent defects. There are two large stems growing from the base.	No work required at present.

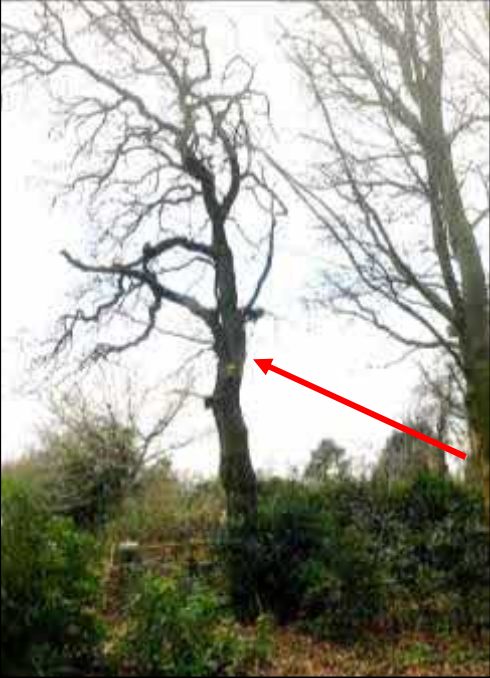
Ref	Species	Height	Approx Stem Diameter	Cardinal Points		Vitality	Age	Comments	Management
T18	Oak <i>Quercus robur</i>

12m	500mm	N	4	G	M	1. in good health with some dead wood in crown and a large cavity at 3 metres on the west side.	No work required at present. Monitor health annually.
				S	2				
				E	2				
				W	6

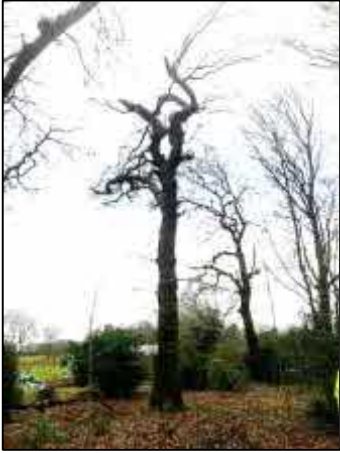
Ref	Species	Height	Approx stem diameter	Cardianl Points	Validity	Age	Comments	Management
T19	Oak Quercus robur

14m	716mm	N 5 S 4 E 4 W 5	M	M	1. There has been a reduction of the crown since the previous survey due to fairly recent limb tear outs.	No work required at present. Monitor health annually.
T20	Oak Quercus robur

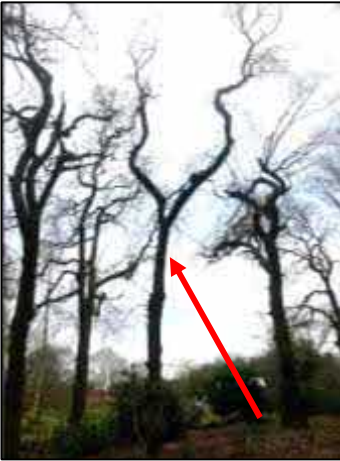
16m	496mm	N 4 S 3 E 3 W 3	G	M	1. Tree in good condition with no apparent defects bifurcates at 8 metres. The crown reduction will lessen the risk future limb failures.	Crown reduction by pruning 2 upper limbs by approx. 3m to appropriate pruning points to lessen risk of failure.

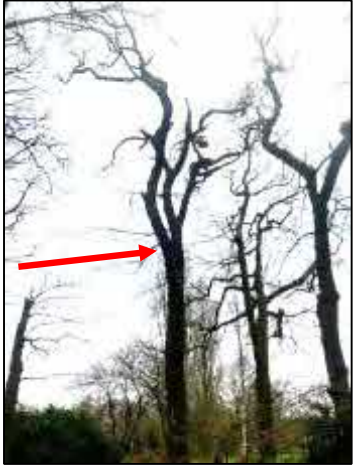
Ref	Species	Height	Approx Stem Diameter	Cardinal Points		Vitality	Age	Comments	Management
T21	Oak <i>Quercus robur</i>

16m	636mm	N	4	M	M	1. Tree in moderate health with no apparent defects. It bifurcates at 6 metres and evidence of pruning cuts and storm damage.	Crown reduction by 25% to encourage regeneration.
T22	Oak <i>Quercus robur</i>

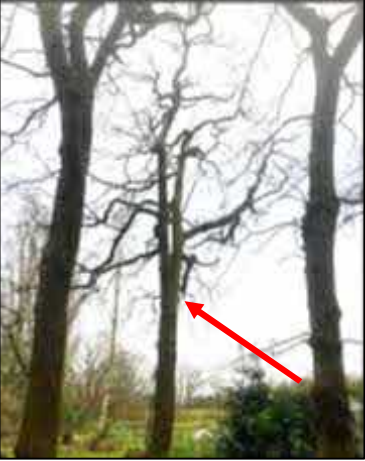
15m	541mm	N	6	G	M	1. Tree in good condition with no apparent defects. It bifurcates at 5 metres with the majority of the foliage on the northwest side.	No work required at present.

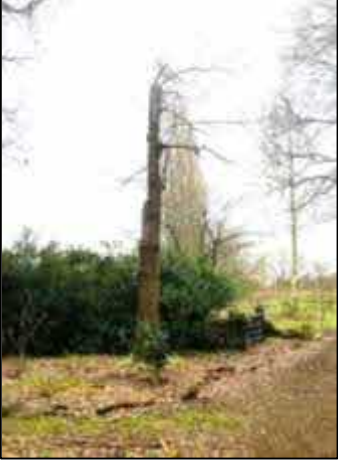
Ref	Species	Height	Approx Stem Diameter	Cardinal Points		Vitality	Age	Comments	Management
T23	Oak <i>Quercus robur</i>

8m	509mm	N	3	P	M	1. Tree in decline and hollow with various holes. It is good for wild life habitat, but could become unstable in the future.	No work required at present.  Consider removal on the grounds of health and safety.
T24	Oak <i>Quercus robur</i>

T23 Oak	Consider removal on the grounds of health and safety.
T25 Oak	Reduce height to 2 metres.
G2 Oak	Remove lower branches which are now in contact with the ground.
G3 Poplar, Sycamore, Cherry	Tree located on neighbouring property. Remove the poplar indicated by the red arrow, located closest to the building. Advanced decay at base.

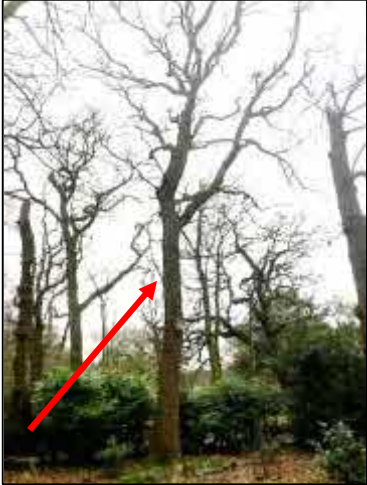
16m	675mm	N	6	M	E/M	Tree in good health with no apparent defects, located by fence and spreading in to three main stems at 9.5 metres.	No work required at present.

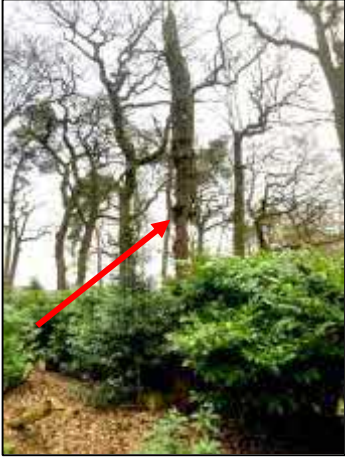
9m	493mm	N	0	P	M	Tree in decline and hollow with various holes. It is good for wild life habitat. The tree has no structural integrity.	Reduce to 2 metres.
T26	Oak <i>Quercus robur</i>

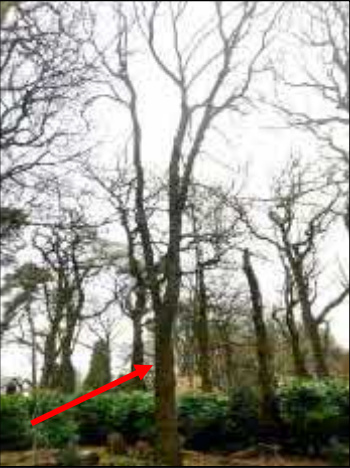
18m	572mm	N	4	G	M	Tree in good condition with no apparent defects and bifurcates at 4 metres	No work required at present.

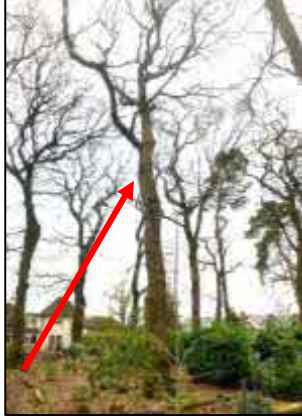
Ref	Species	Height	Approx Stem Diameter	Cardinal Points		Vitality	Age	Comments	Management
T27	Oak <i>Quercus robur</i>

18m	700mm	N	6	G	M	1. Tree in good condition with no apparent defects. A high crown with some dead branches. There is a tear out evident in the upper crown.	No work required at present.
T28 and T29	Oak <i>Quercus robur</i>

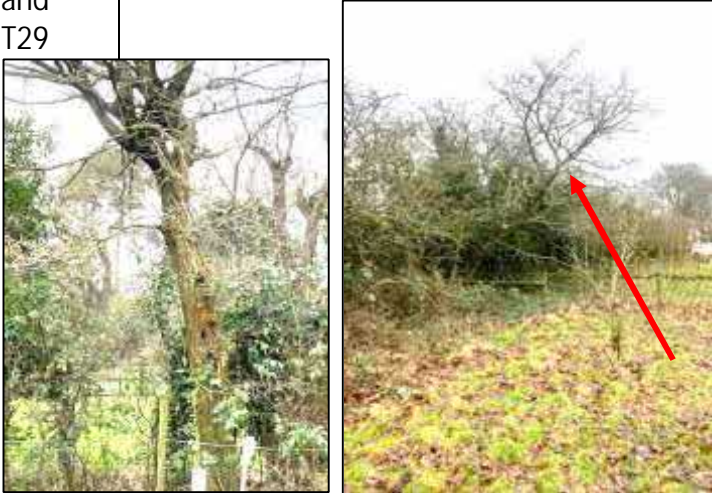
5m	150mm	N	0	G	Y	Both trees are located within a boundary hedgerow. T29 has a tear out at 2 metres and T30 leans acutely over the field.	No work required at present.

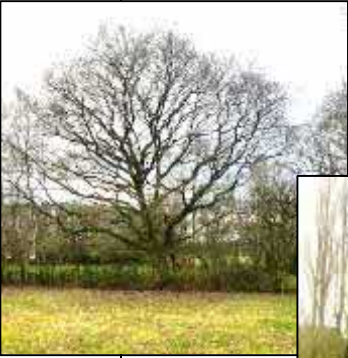
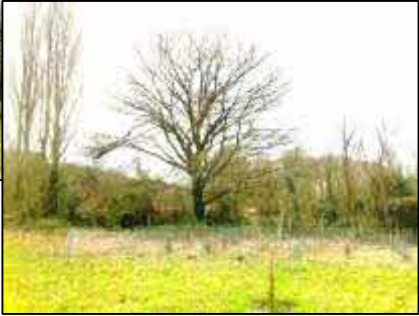
Ref	Species	Height	Approx Stem Diameter	Cardinal Points		Vitality	Age	Comments	Management
T30 and T31	Oak <i>Quercus robur</i>	14m	Approx 400mm	N	5	G	E/M	1. Multi-limbed trees on neighbouring land, in good condition with no apparent defects, overhanging field.	No tree work required at present.

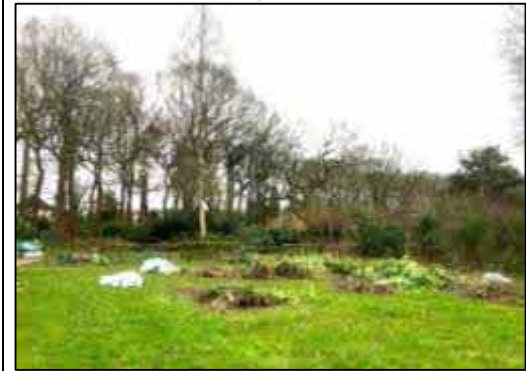
Ref	Species	Height	Approx Stem Diameter	Cardinal Points		Vitality	Age	Comments	Management
G1	Goat Willow <i>Salix caprea</i> (2) Prunus Sp. (1) Silver Birch <i>Betula pendula</i> (1)	Av 9m	Av 200mm	N	3	G	S/M	1.All in good condition. The willows have been reduced to hedge height.	No work required at present.

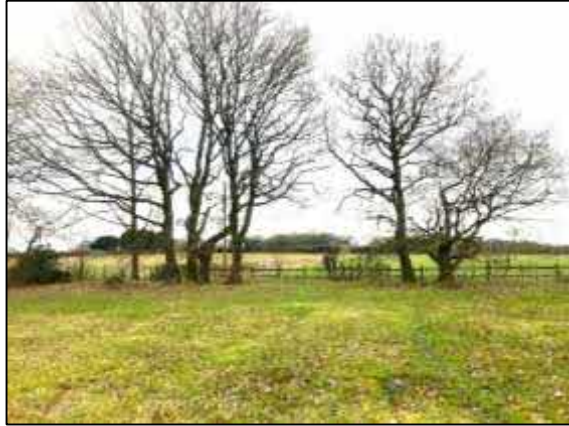
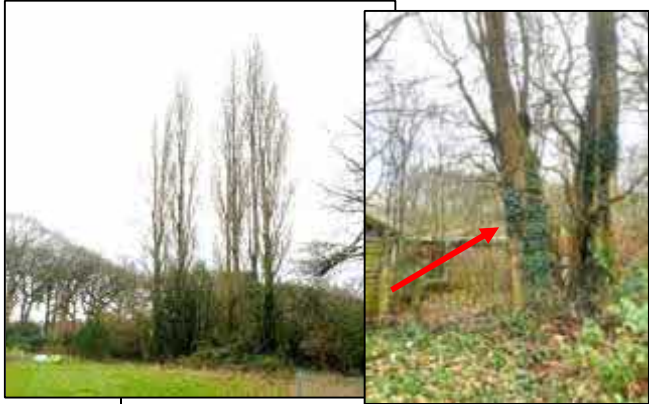
Ref	Species	Height	Approx Stem Diameter	Cardinal Points		Vitality	Age	Comments	Management
G2	Oak <i>Quercus robur</i> (7)	Av 11m	330mm	N S E W	3 3 3 3	G	S/M	1.All in good condition with no apparent defects.	Remove lower branches which are now in contact with the ground.
G3	Poplar <i>Poplar Lombardi</i> (6) Cherry <i>Prunus avium</i> (2) Sycamore <i>Acer pseudoplatanus</i> (1)	24m	450mm	N S E W	3 3 3 3	G	M	1.In good condition with no apparent defects at present except for one poplar. The poplars are fragile by nature. 2.The large poplar located closest to the shed and also leaning towards it has advanced decay in the lower trunk and is now hollow.	Remove the poplar indicated by the red arrow.

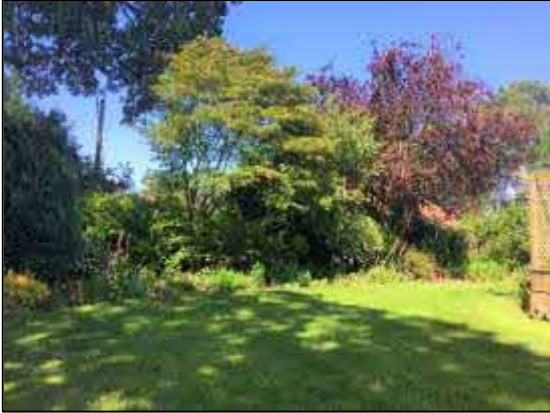
Ref	Species	Height	Approx Stem Diameter	Cardinal Points		Vitality	Age	Comments	Management	
G4	Japanes Maple <i>Acer palmatum</i> Plum/ Cherry <i>Prunus nigra</i> Portugal Laurel <i>Prunus lusitanica</i>	Av 6m	Av 180mm	N S E W	2 2 3 3	G	S/M	1.All appear healthy with no apparent defects.	No work requires at present.
