# ROSE DOBSON

## FORESTRY LTD

This document is prepared at the request of Mr Gareth Hart and dated Monday 19<sup>th</sup> February 2024.

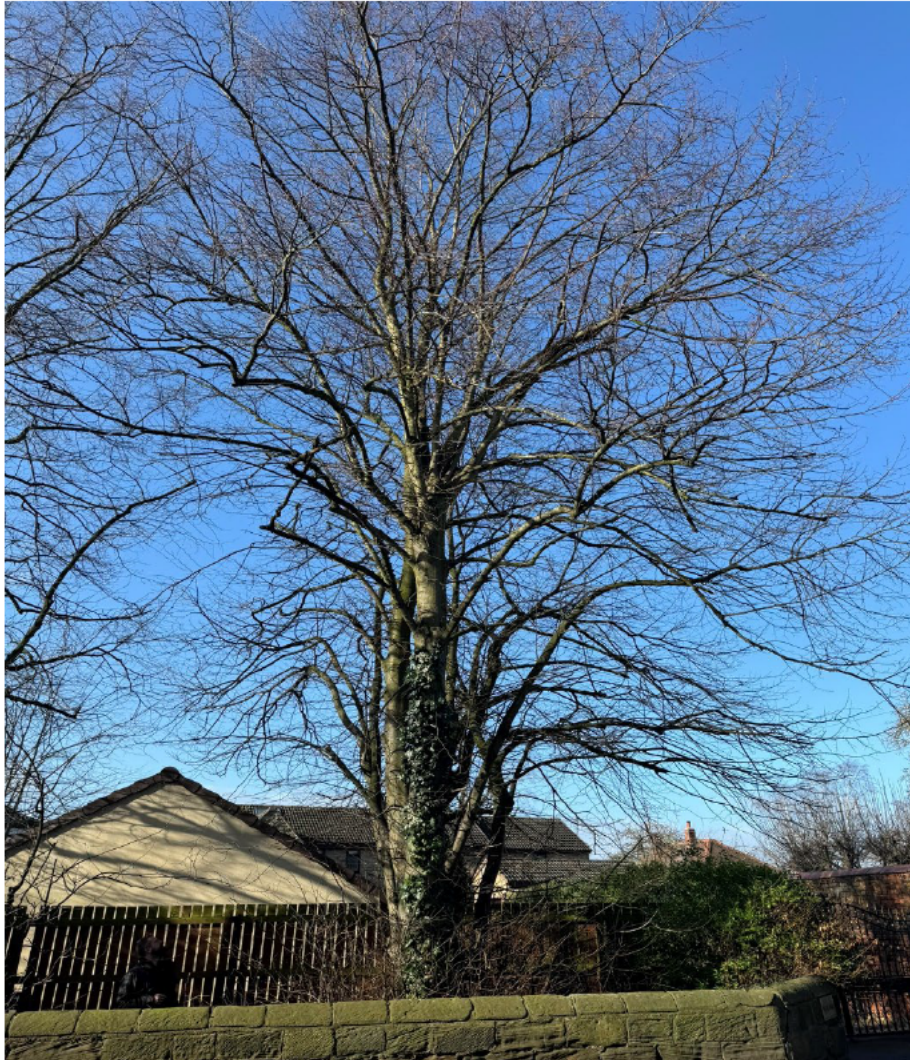
## T1

Broad leaf lime (*Tilia Platyphyllos*). The tree is roughly 20 meters in height with a crown girth of roughly 12-15 meters and a stem combined girth of 800mm measured at 1.5 meters from ground level. It is multi stemmed at the base with typical epicormic stem-base growth associated with Lime trees and young mature in its age. It has signs of previous cutting and reductions throughout its life, most of the cuts are evident of professional cutting though some are evident of typical homeowner pruning, more so on the left side of the tree. None of which have had any detrimental effect to the tree. The tree is well balanced all round and in good health. The crown is heavy with buds with a healthy and dense canopy of healthy branches reaching out over the roadside and garage. There are very little dead branches and those which are present are through natural tree aging. In all, this is a fine specimen of Lime with a healthy crown and stem. There is no disease obvious within the tree and no evidence of decline.

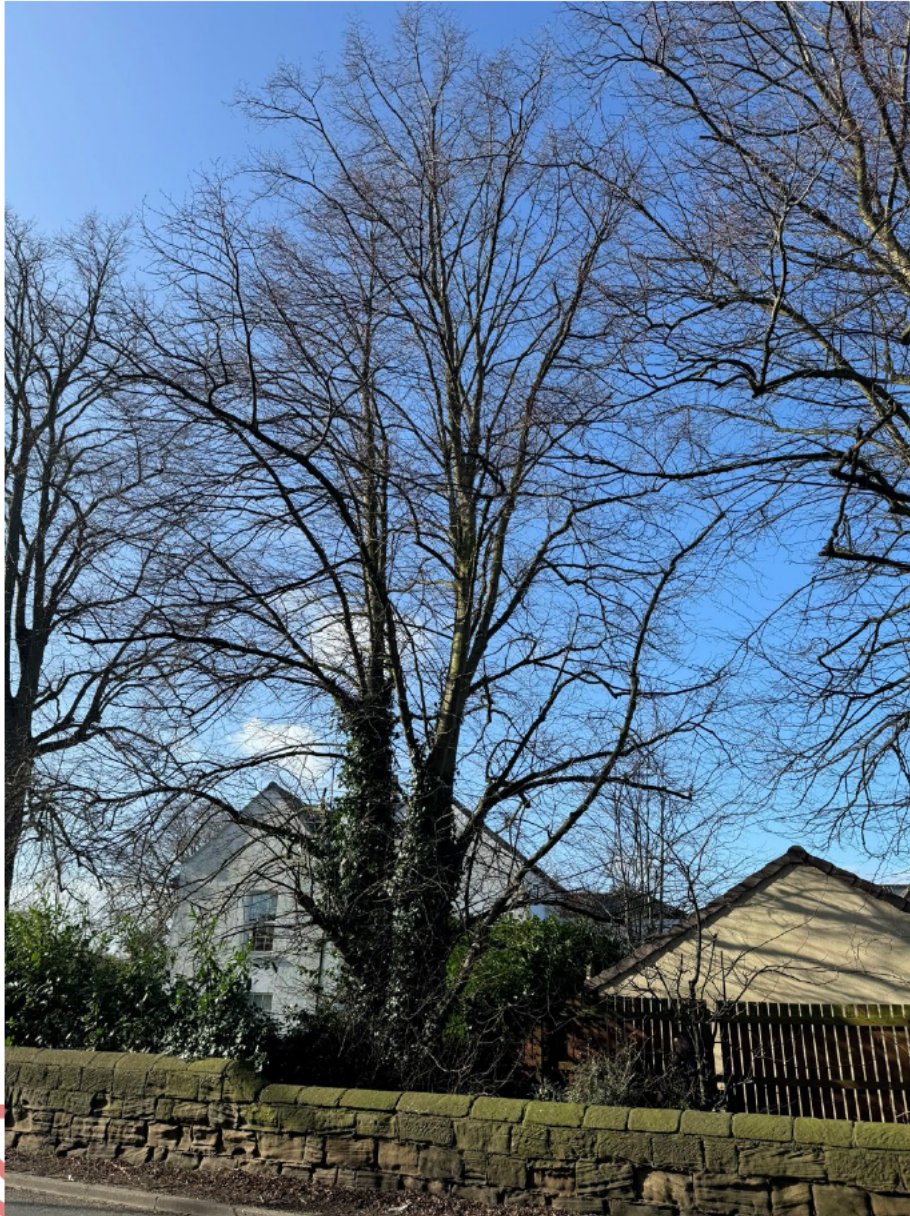
T2

Broad leaf lime (*Tilia Platyphyllos*). The tree is roughly 17 meters in height with a crown girth of roughly 12-15 meters and a stem combined girth of 600mm measured at 1.5meters from ground level. It is a dual stem tree with typical epicormic stem-base growth associated with Lime trees and young mature in its age. It has signs of previous cutting and reductions throughout its life, most of the cuts are evident of professional cutting though some are evident of typical homeowner pruning. None of which have had any detrimental effect to the tree. The tree is well balanced all round and in good health, though it is infested with Ivy. The crown is heavy with buds with a healthy and dense

canopy of healthy branches reaching out over the roadside and garage. There are a small amount of dead branches and those which are present are through natural tree aging. In all, this is a fine specimen of Lime with a healthy crown and stem. There is no disease obvious within the tree and no evidence of decline.

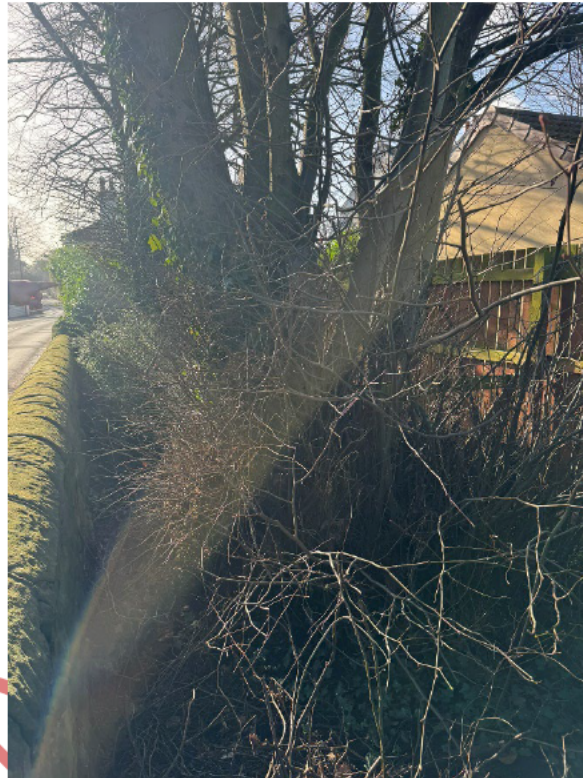
The trees are in a section of rough ground, situated between a wooden fence and a solid stone wall outlining the public/private boundary.

The section of rough ground is roughly 7 meters in diameter and runs from the property entrance gates and along the entire frontal boundary of the property. The soil is well drained and of good quality, there is no heavy compaction and a good grounding for rotting leaf vegetation, allowing for a sound composting area and aided by lack of human foot fall. Both trees are well established in this area, with new saplings in and around the soil base. This is maintained and kept clear. There is no compaction in this area.

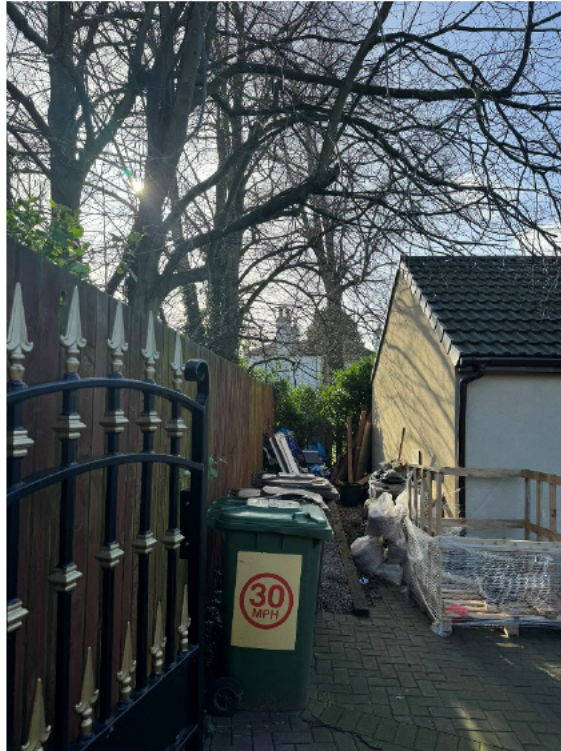
Behind the trees is the private land and a stone-built garage. At least 5 meters of gravelled floor and then the rear of the stone-built garage.

Looking at the base of the garage, there are no visual signs to show either tree is causing any issues to the foundation of the garage. When describing visual signs, this refers to cracks, sinking and green discoloration caused by trees being too close to a property.

There is no lifting of the ground between the trees and the garage, and the ground is gravelled, allowing good drainage and air transition.

It is in my opinion as an Arborist, no damage to either tree has occurred during the construction of the garage and in turn, no damage to the garage is being caused by either tree. At present I am quite satisfied neither pose a risk to one another.
