# South Street, Elgin, Moray: Historic Building Recording Report

*AOC Project: 70787  
16th February 2024*

On Behalf of:	Robertson Property Ltd 10 Perimeter Road Pinefield Elgin IV30 6AE
Planning Reference Nos:	Pre-planning
OASIS Ref:	aocarcha1-522526
National Grid Reference (NGR):	NJ 21559 62774
AOC Project No:	70787
Prepared by:	Fiona Jackson
Illustration by:	Fiona Jackson
Date of Fieldwork:	14th – 19th December 2023
Date of Report:	14th February 2024

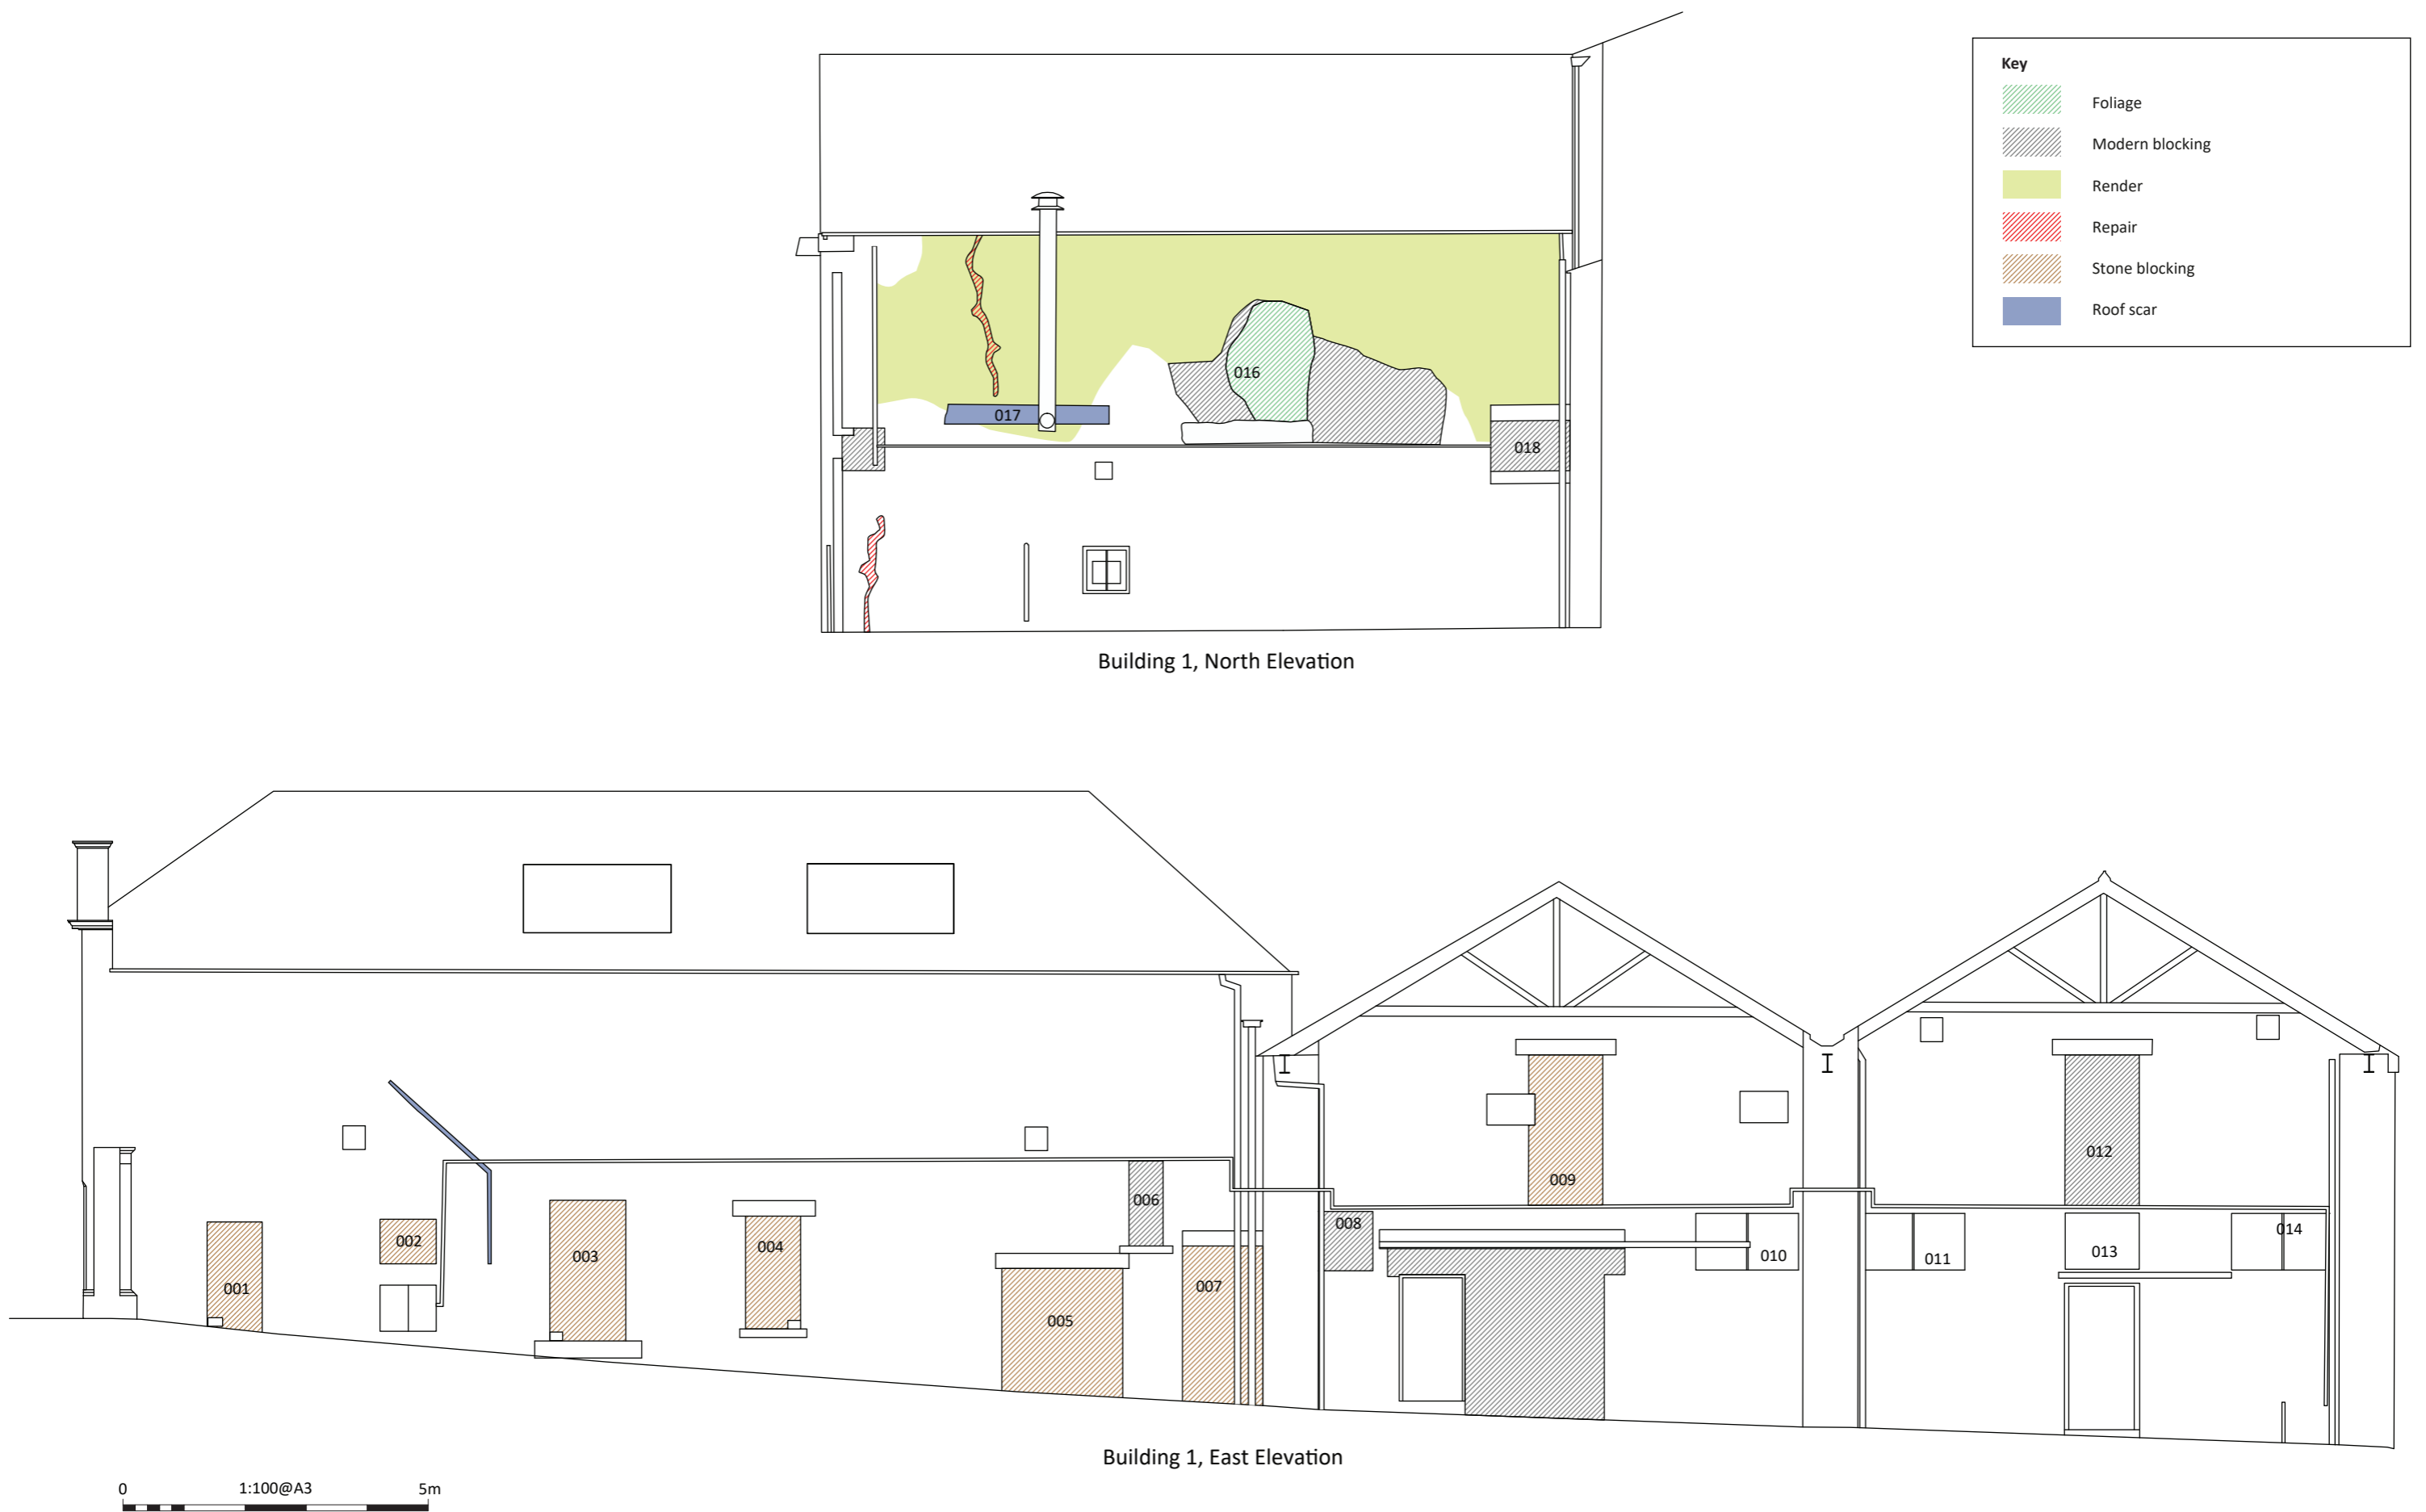
Figure 9: Elevations 1 and 2

The north elevation is the rear elevation of building and is primarily constructed of roughly-coursed rubble with dressed quoins on the east corner with a chamfered corner and converging stop (Figure 9; Plates 4 – 9). The stonework is in poor repair with large cracks visible towards the top and east of the elevation along with large areas of repair in the form of concrete blocks covered in render. There is visible damage from vegetation towards the centre of the elevation.

There are two vertical projecting stone courses located towards the east corner on the quoins; this may represent the remnants from a previous extension to the building (Plate 4). Immediately adjacent to the projecting course is a small rectangular brick-blocked opening located roughly halfway up the wall. There is a thin circular vertical modern steel pipe projecting from the lower west corner of the opening, entering the building towards the top. The opening may represent repair to the building during the installation of the pipe.

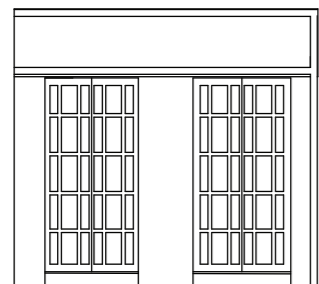
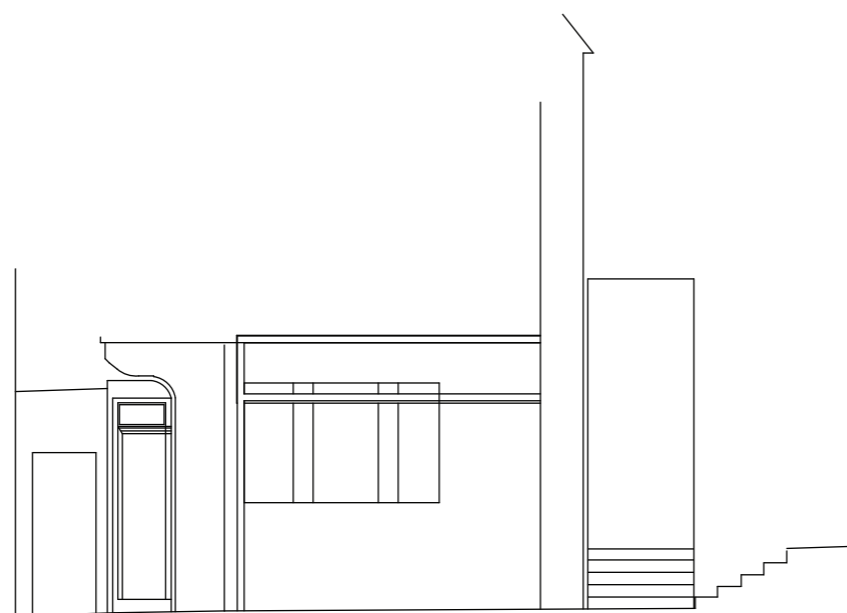
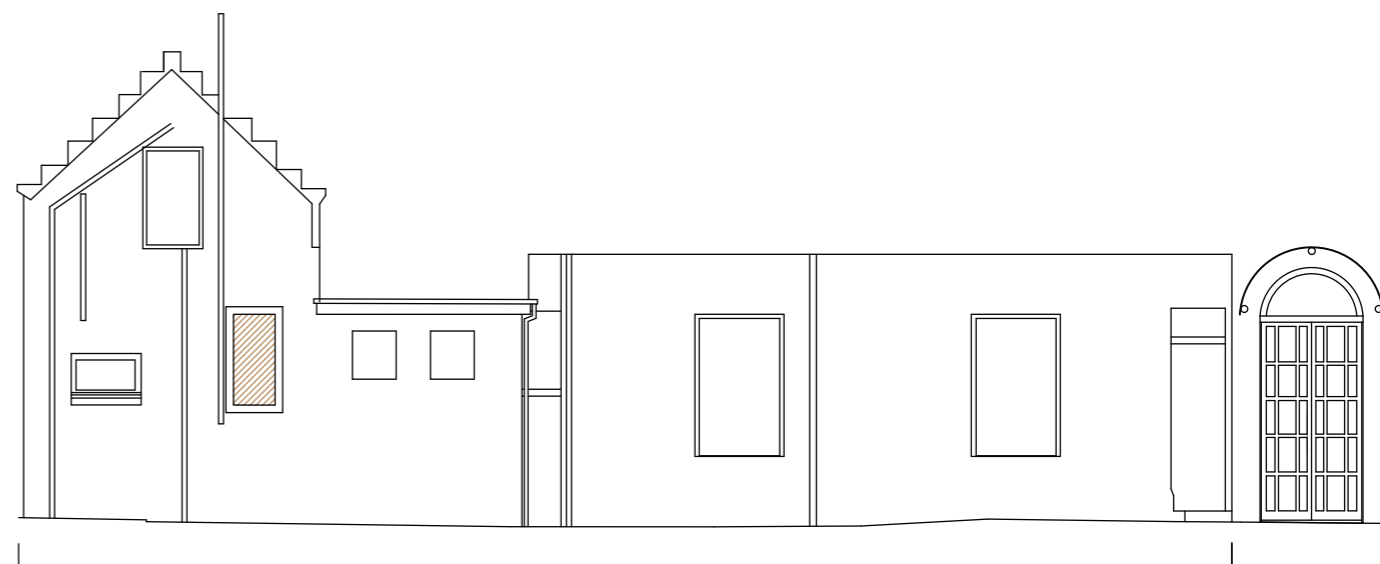
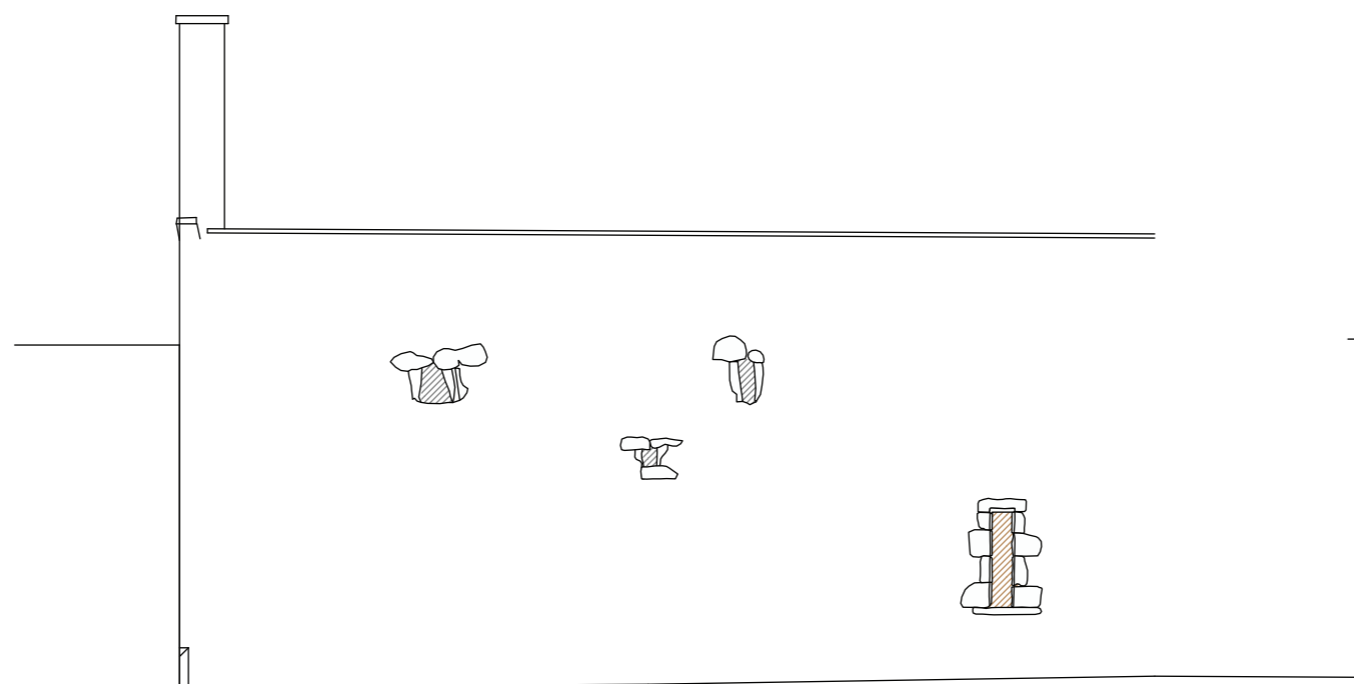
Figure 11: Elevations 4, 5, 6 and 7

Building 4 is a two-storey NNW-SSE aligned rectangular structure with basement, which originally formed the north end of the 1851 market building (Figures 11 & 13; Plates 148 – 201). The structure has been weakened due to fire damage in the late 1990s. The roof structure is almost entirely missing resulting in damp conditions, stone erosion, and vegetation growth across most of the ground floor area. Remnants of the first floor structure are intact towards the south, but were inaccessible at the time of the survey, with only I-beams remaining to the majority of the structure. The recording of Rooms 1/2, 1/5, 1/6, 1/7 and 1/8 was restricted to details visible from exterior openings due to the presence of ceiling collapse within these rooms. Stairwells located in Rooms 1/10 and 1/17 were only partially accessed due to health and safety concerns regarding damage visible on the upper stairs. Following on from its use as a market the building has most recently been used as a nightclub and, whilst the majority of the original warehouse features can be seen, a large number of I-beams have been placed across the building to provide additional flooring including a mezzanine floor still visible on the west side of the building. Due to restricted access, the floor plan provided was incomplete hence where possible additional measurements have been taken to add further detail to the plan. The approximate locations of windows on the east wall have been noted on the floor plan via information gathered from the photographic record. Access to the rooms located to the north-west of the main entrance was not available at the time of the survey.

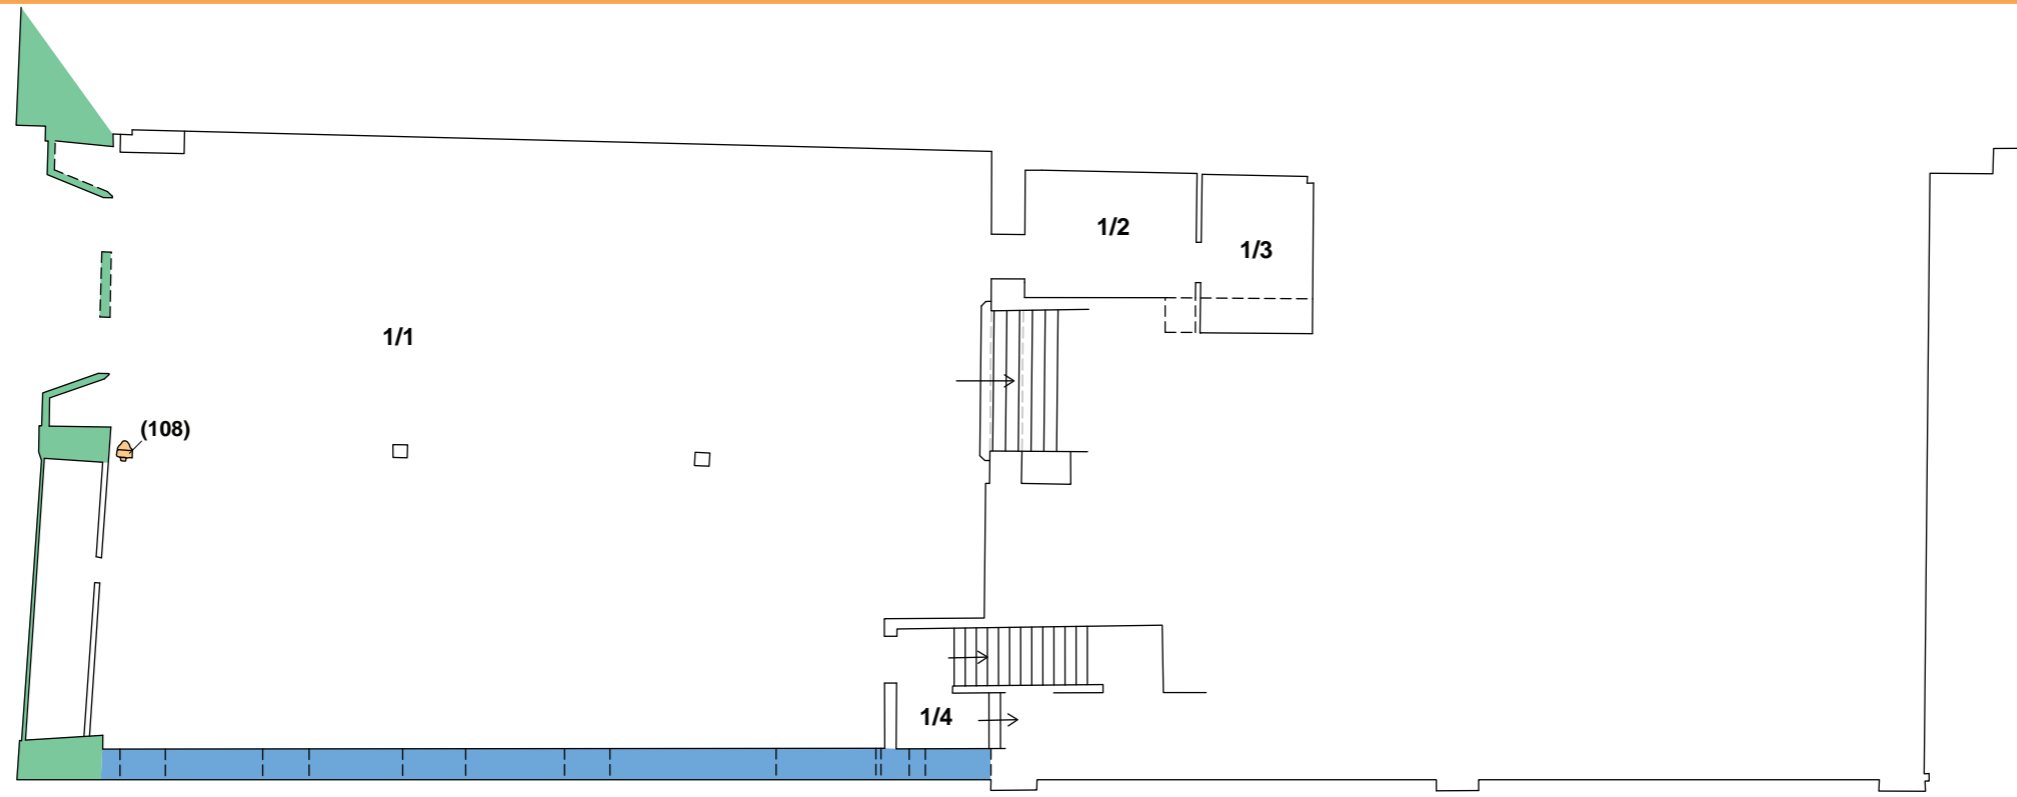
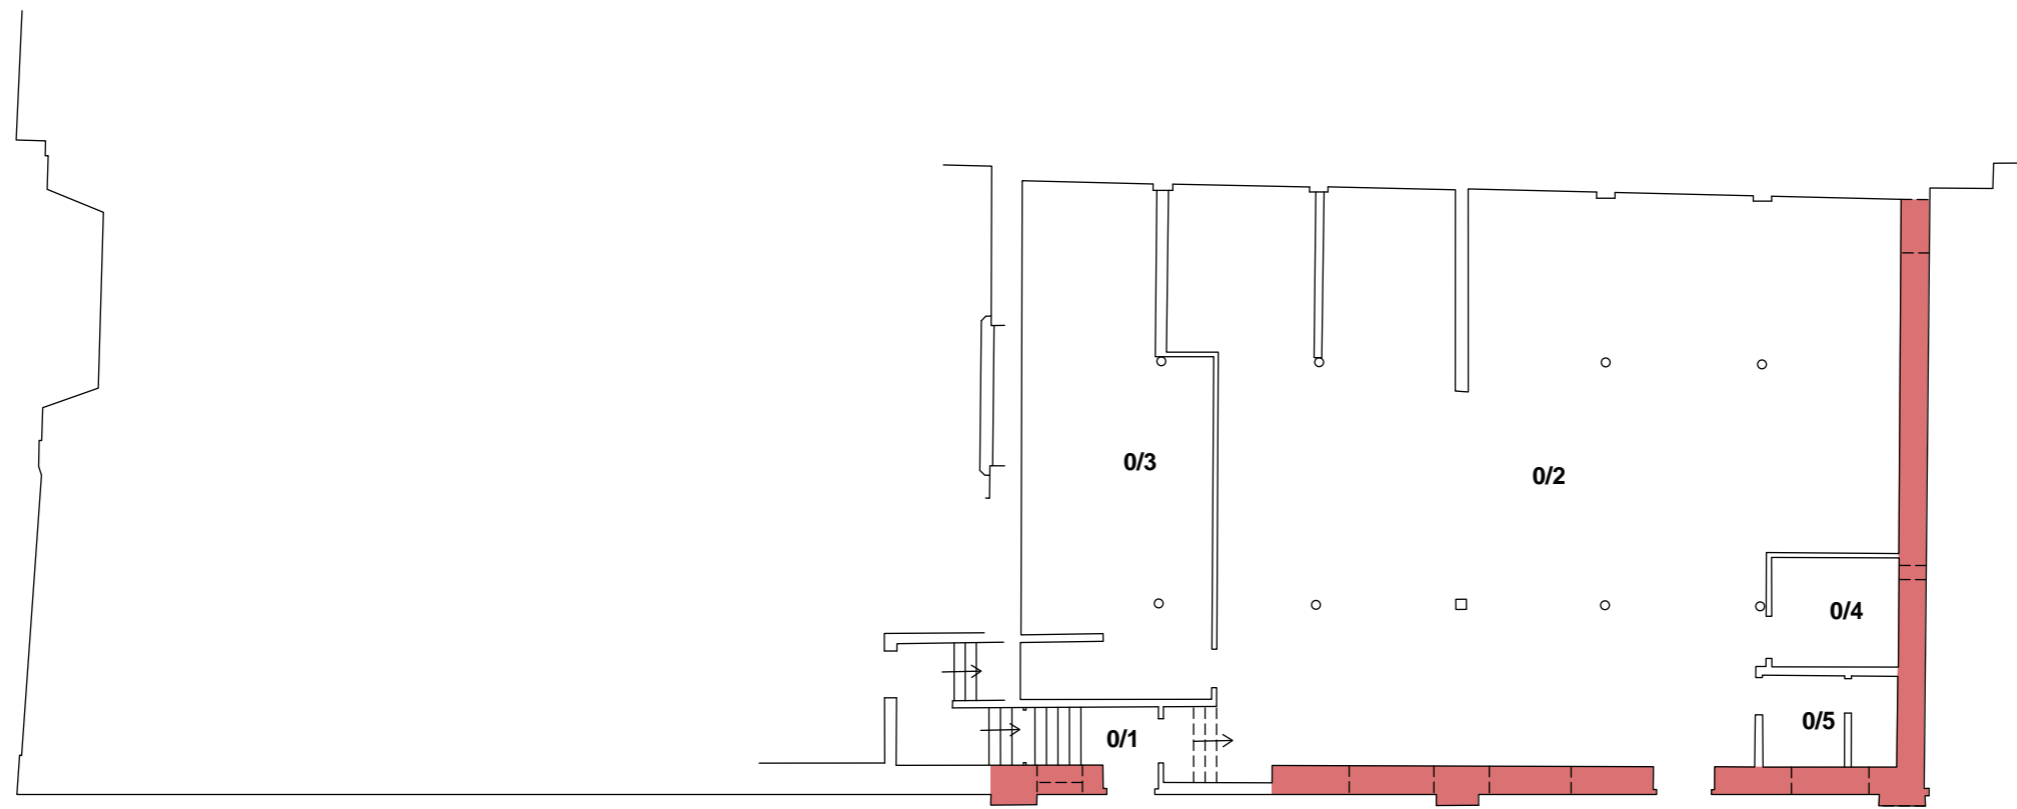
Figure 15: Building 1 basement and ground phased floor plans

Examination of the building on site, together with the historical mapping evidence, suggests that at least four phases of construction are evident on the site from its origins prior to 1868 to the present day. Previous use for the structure is visible towards the north end with evidence for the housing livestock with tethering points fixed to the internal columns in the basement and remnants of barn door style tracks on the east facing elevation. Figure 15 presents a phased ground floor plan of the exterior of Building 1, and a precis of the phases can be broken down below.

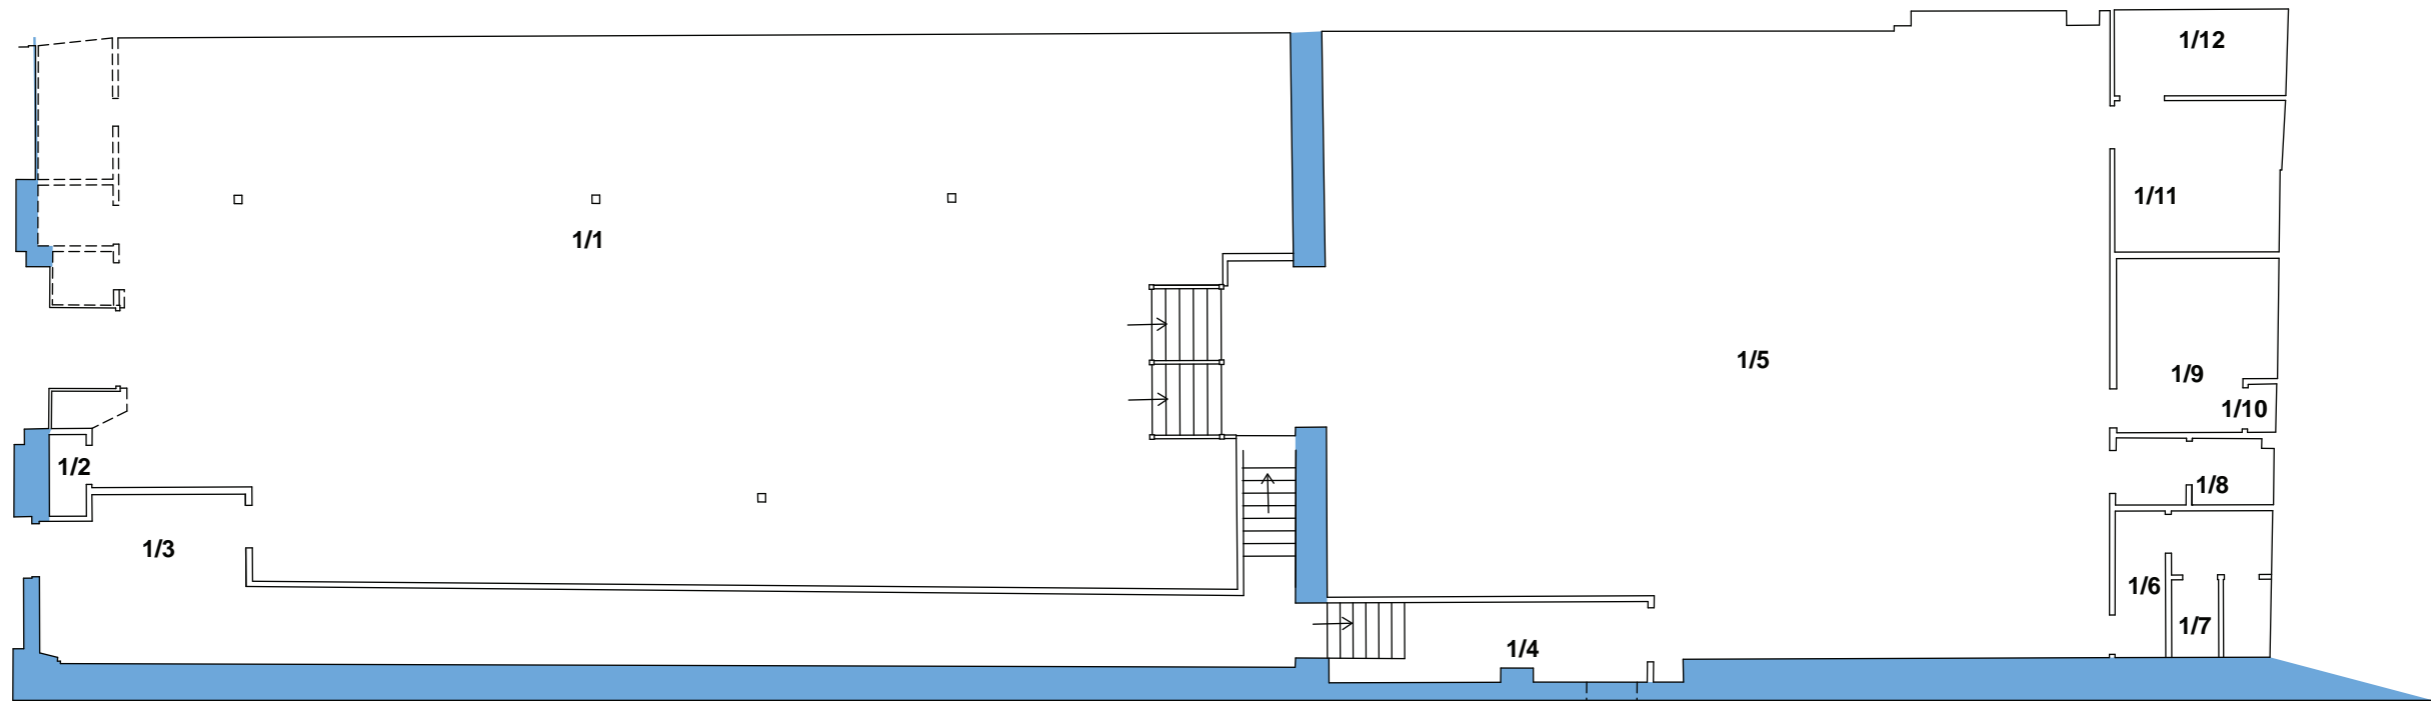
Figure 16: Building 3 ground floor phased plan

The main external structure of Buildings 3 and 4 has remained the same since the construction of the market in 1851. There is significant evidence of internal alterations in both buildings following the separation of the two areas and subsequent change of use. Figures 16 and 17 present a phased ground floor plan Buildings 3 and 4 respectively, and a precis of the phases can be broken down below.

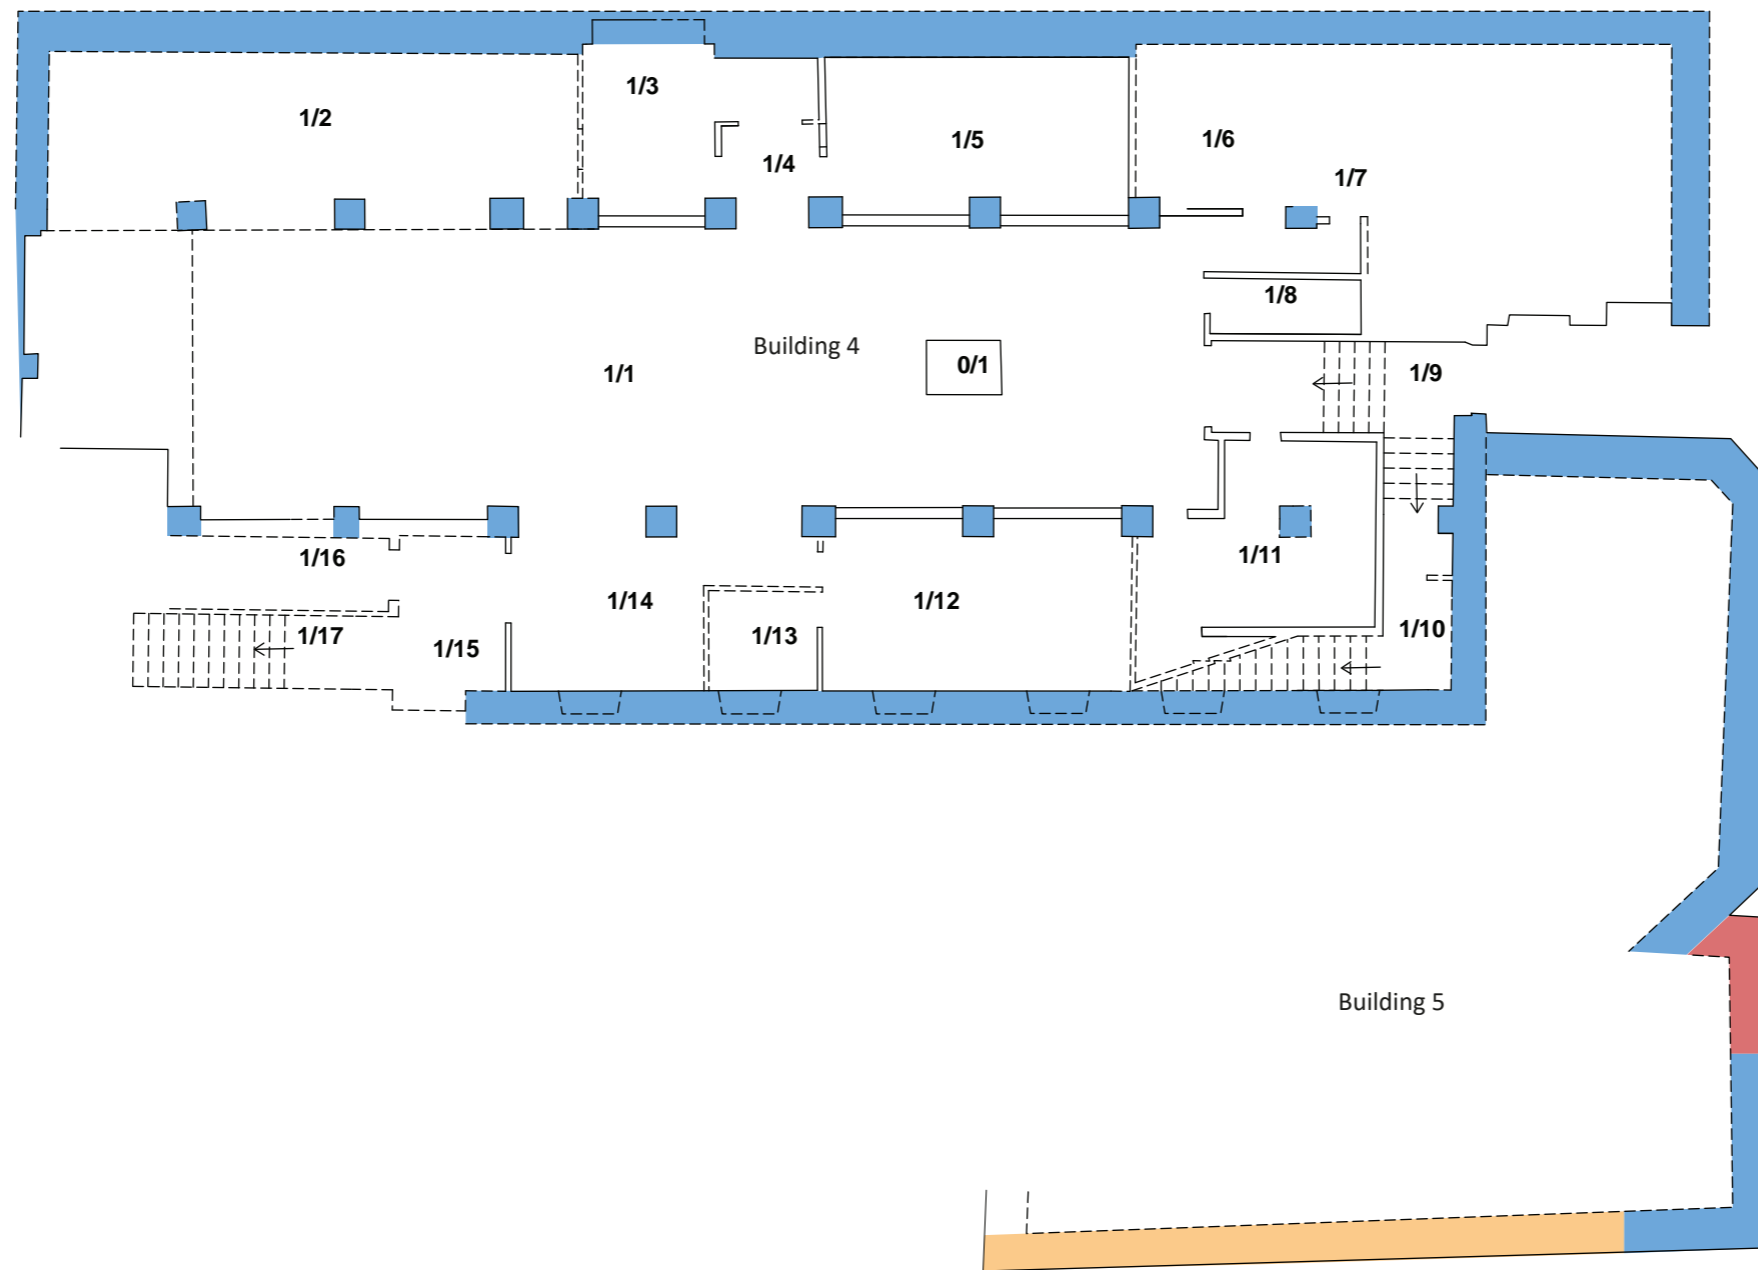
Figure 17: Buildings 4 and 5, phased plan

Examination of Building 5 suggests that there may be three possible phases of construction evident on the site, based on the exterior elevations. Figure 17 presents a phased ground floor plan of the exterior of Building 5, and a precis of the phases can be broken down below.
