Project: GROVE FARMHOUSE
LITTLE WYHAM

Section: BRIEF / LOADINGS

Section: INSPECTION

INSPECTION 14/02/2024

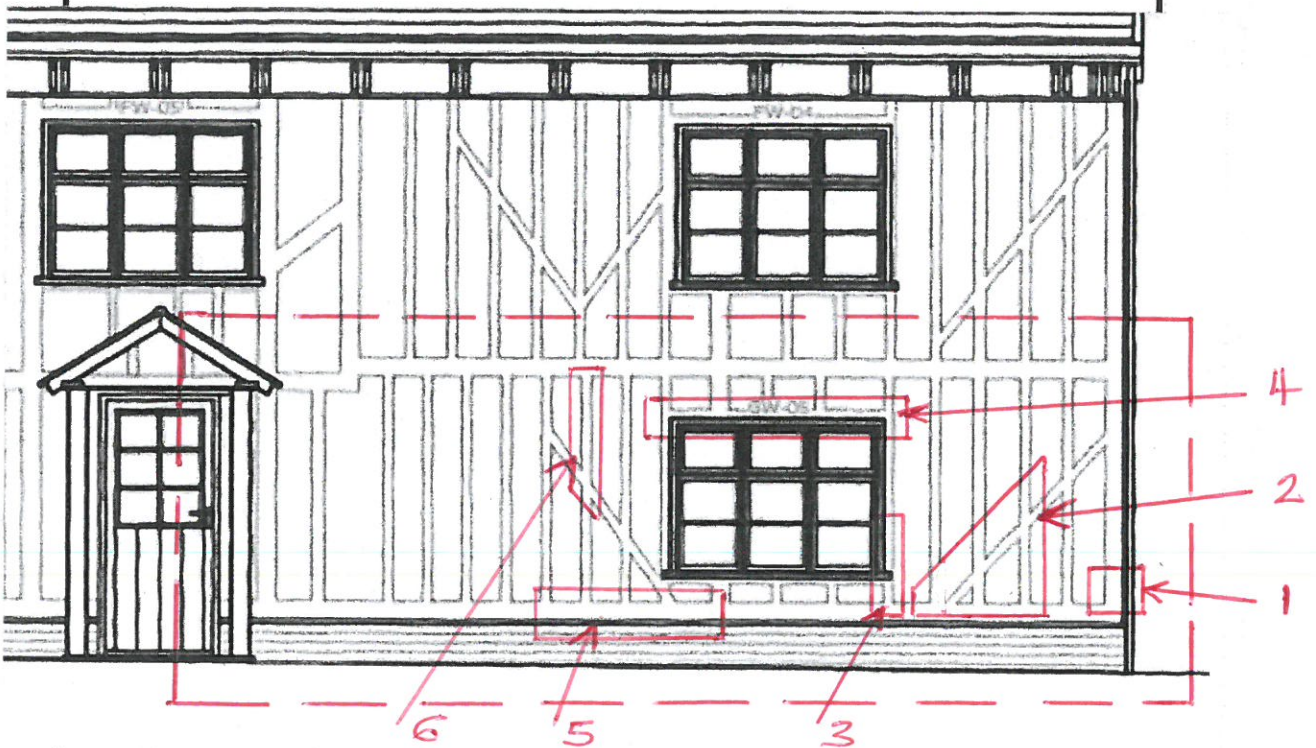
FRAME ELEVATION OPENED UP

THE SECTION OF FRAME OPENED UP WAS IN BETTER STRUCTURAL CONDITION THAN EXPECTED SO ONLY LIMITED WORK WILL BE REQUIRED, HOWEVER THE LINTEL OVER THE EXISTING WINDOW WAS FOUND TO BE INADEQUATE AND WILL NEED REPLACING.

--- = AREA EXPOSED FOR
INSPECTION 14/2/2024

THERE ARE SIX AREAS OF WORK,
5 x TIMBER REPLACEMENT
1 x NEW LINTEL (W24)

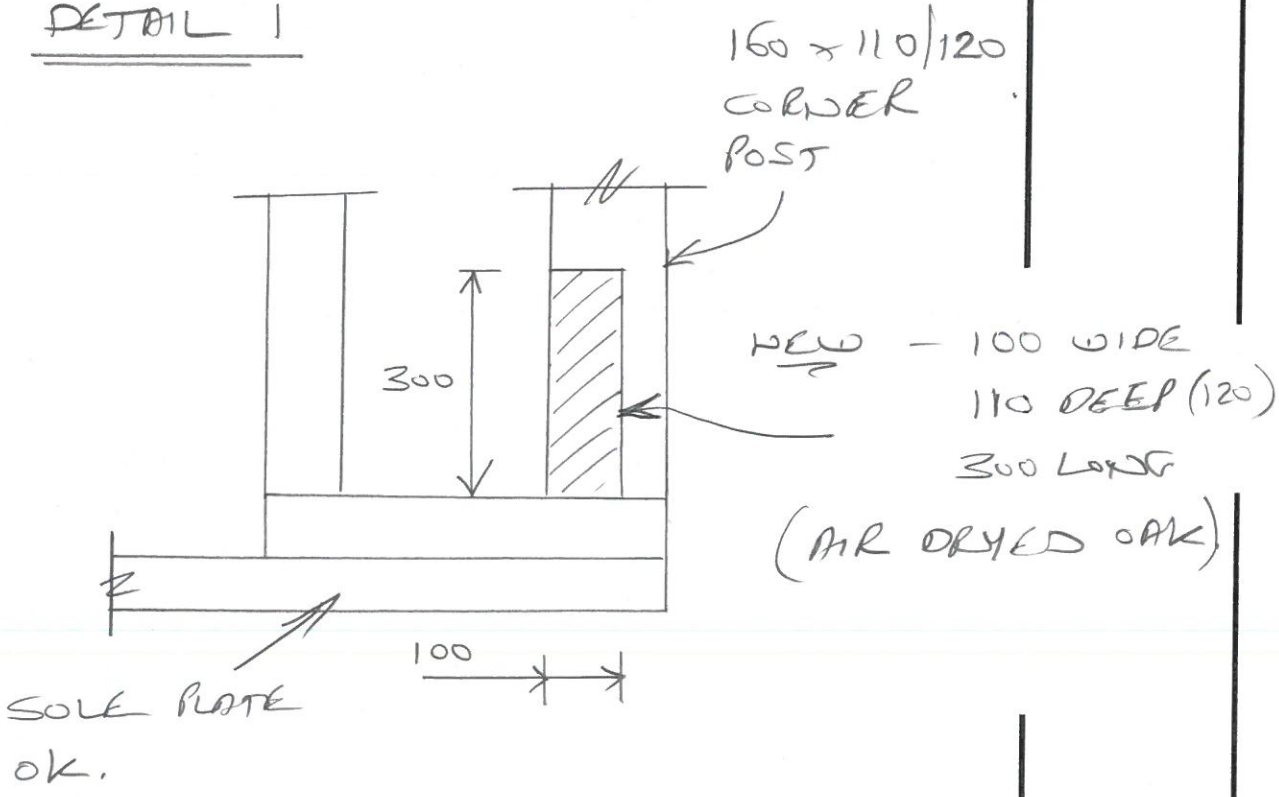
DETAIL 1

BOTTOM OF CORNER POST IS
SOFT / ROTTON ON ONE SIDE.

THIS SECTION IS TO BE CUT OUT
BACK TO SOLID TIMBER AND
A NEW PIECE OF OAK INSERTED,
GLUED AND FIXED INTO PLACE

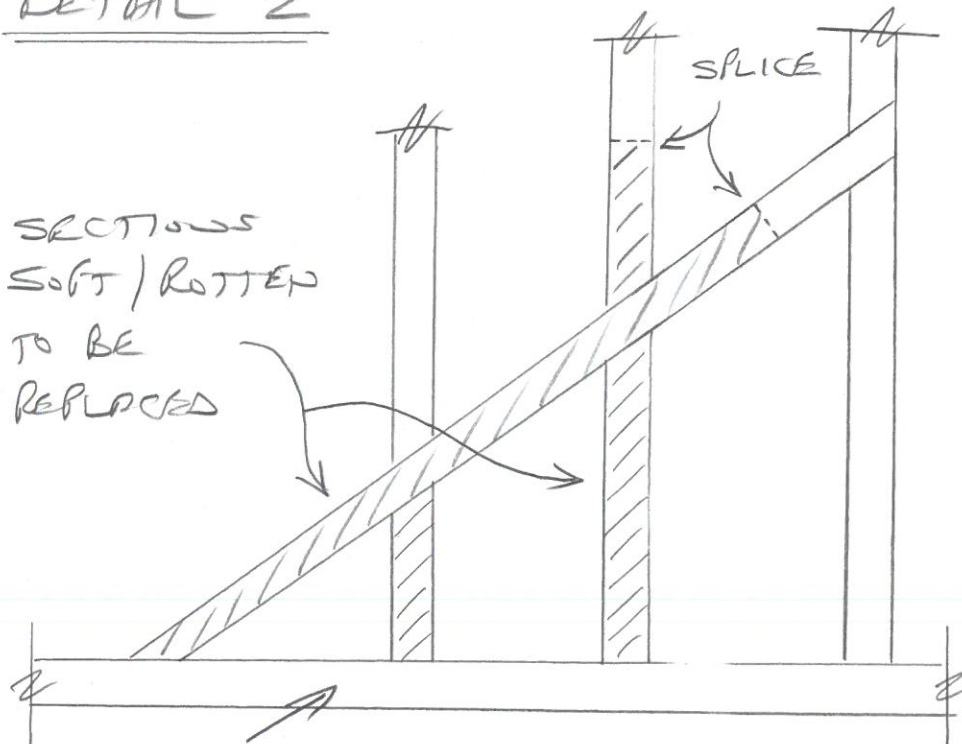
DETAIL 2

SECTIONS
SOFT / ROTTEN
TO BE
REPLACED

SOLE PLATE
OK

TIMBERS SHOWN HATCHED TO
BE REPLACED WITH SOME SIZE
OAK TIMBERS
HALF LAP SPLICES ARE TO BE
PROVIDED AS SHOWN, GLUED AND
FIXED INTO PLACE.

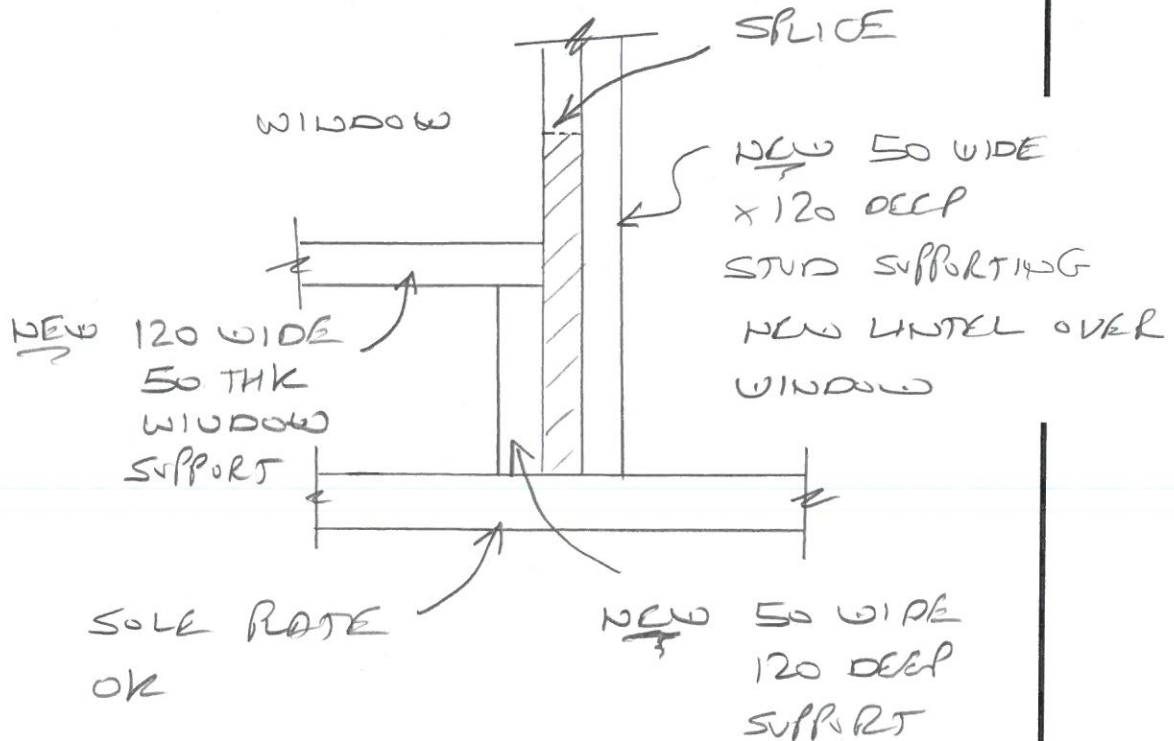
DETAIL 3

TIMBER SHOWN HATCHED IS
SOFT/ROTTEN AND IS TO BE
REPLACED WITH A SAME SIZE OAK
WITH HALF LAP SPLICE, GLUED
AND SECURELY FIXED.
NEW OAK TIMBERS EACH SIDE.

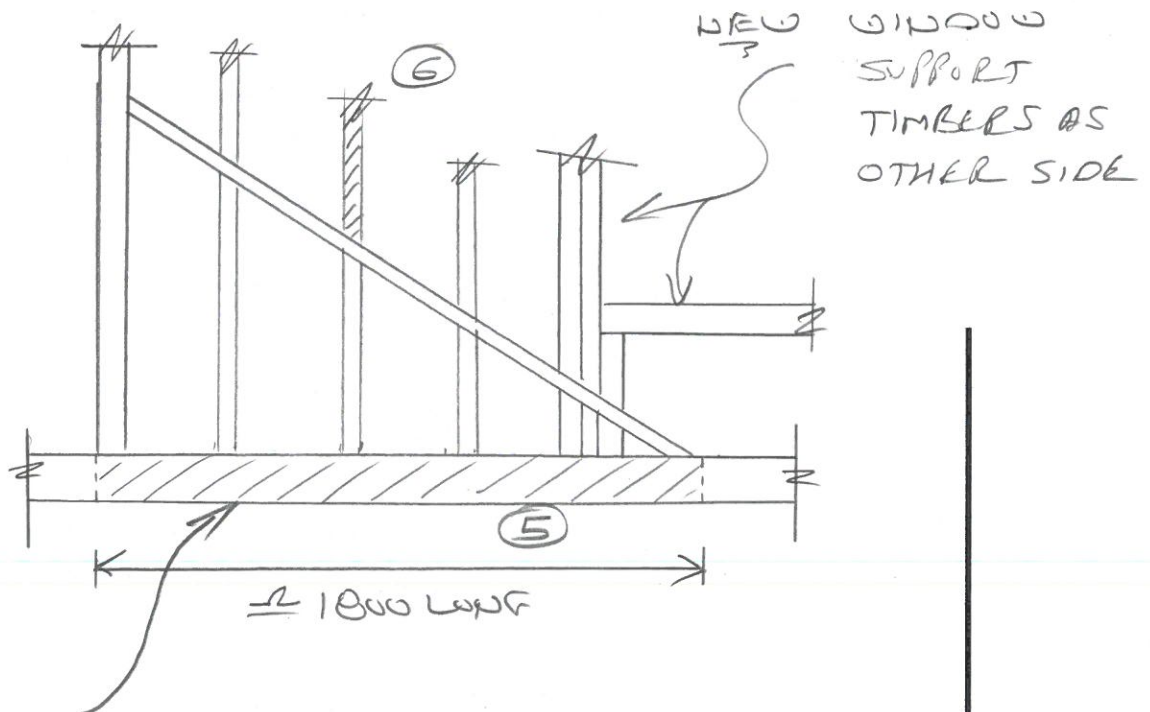
DETAIL 5 & 6

CENTRE OF SOLE PLATE IN THIS LOCATION HAS ROTTED FOR ± 1800 mm
REPLACE WITH NEW 150 x 150 OAK
OR NEW DPC

PLACE NEW TIMBERS AS PREVIOUSLY SPECIFIED FOR THE OTHER SIDE OF WINDOW ON THIS SIDE (SHT 06 & 08)

REPLACE TIMBER MARKED /// WITH A NEW OAK OF THE SAME SIZE.

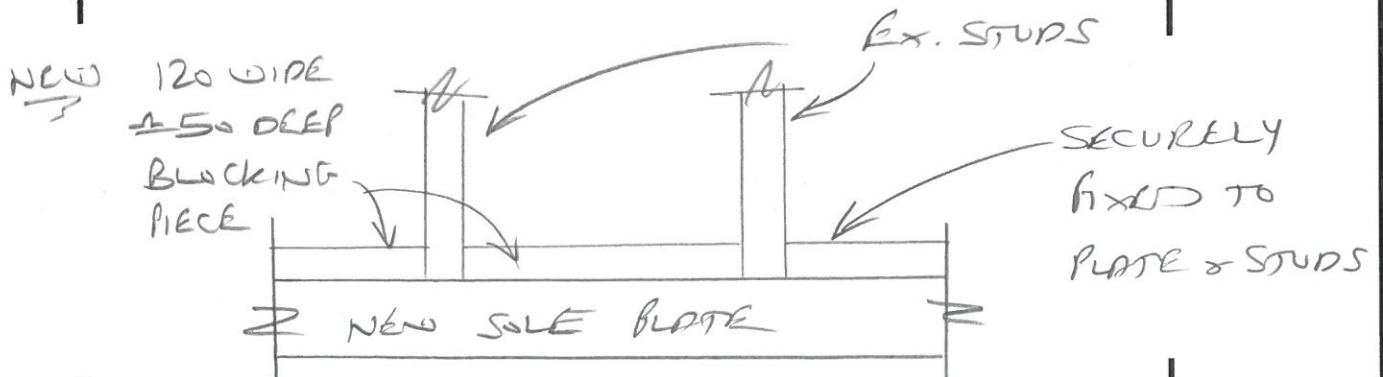
DETAIL 5 CONT

THE TENONS ON THE BOTTOM OF THE VERTICAL STUDS HAVE ALSO ROTTED AS THESE WERE HOUSED IN THE MORTISE OF THE SOLE PLATE.

AS THESE TENONS COULD NOT BE REPLACED AND IT IS NOT CONSIDERED NECESSARY TO REPLACE THE STUDS A "BLOCKING" PIECE IS TO BE INSERTED ON TOP OF THE SOLE PLATE TO "TRAP" THE STUDS.
