► PROJECT Proposed Window Replacement
Grove Farmhouse, Grove Lane
Little Wenham, Suffolk, CO7 6QB
CLIENT Mr. N. Brown
► STATUS **PLANNING**

► TITLE Timber Condition Evidence
► SCALE 1:100 SHEET SIZE A3
ISSUE DATE 16/02/2024
AUTHOR FDS CHECK CW

| JOB No. | DRAWING No. | REVISION |
|---|---|---|
| 5836 | PA_16 | |

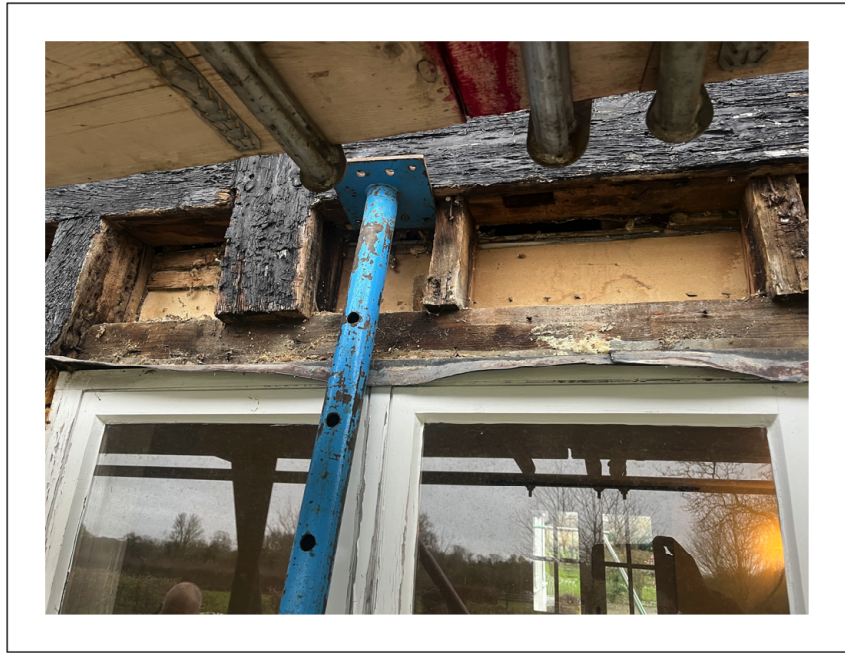
Structural timber in poor condition.

Visible damage to existing internal laths.

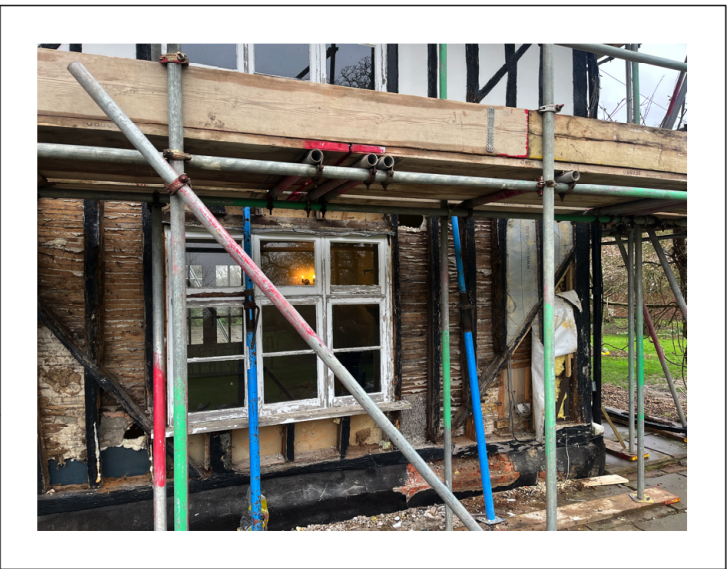
Inconsistent existing build up showing, timber laths, plaster board and galvanized metal laths within the historic timber frame.

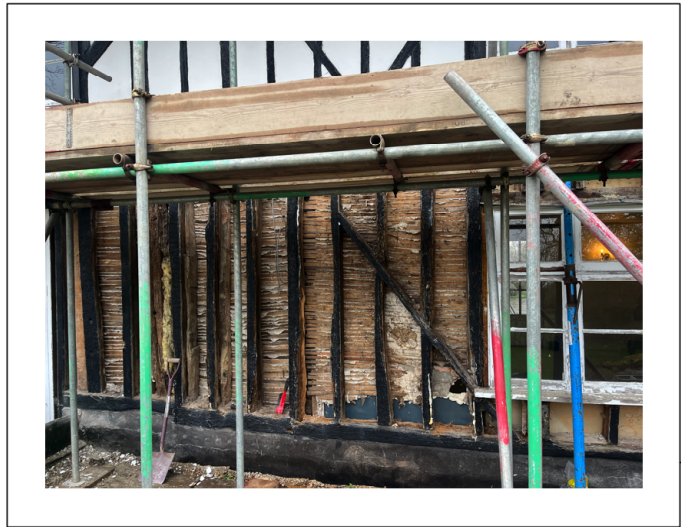
Visible damage to existing internal laths.

Visible damage to laths and plaster boarding.

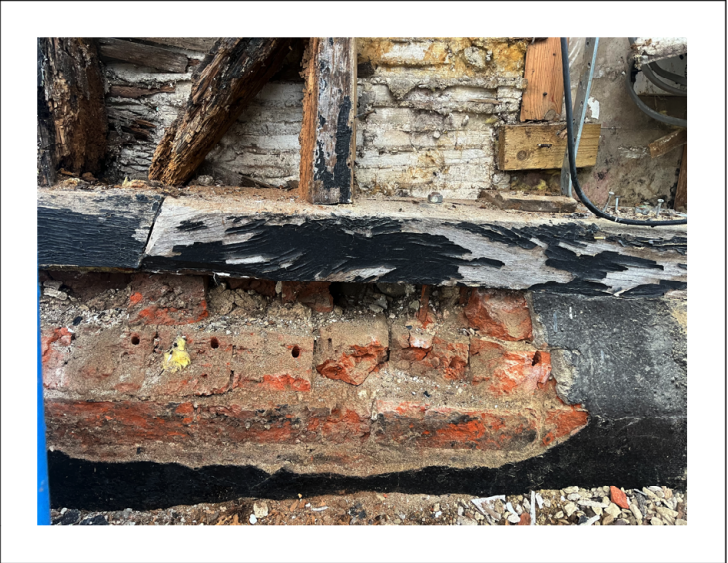
Brick plinth is currently in an extremely poor condition.

Refer to structural engineer details prepared by Revel Architecture & Engineering.
