Job N°: SLP/23/003

1st March 2023

**STRUCTURAL REPORT
FOLLOWING
A
VISUAL INSPECTION
OF
2 N° STEEL FRAMED BARNs
AT
OAK FARM
GREEN BARNs LANE
LITTLE HAY
LICHFIELD
WS14 0QN**

**Prepared by:
S L Pountney, BEng, CEng, MICE, MStructE, FFB.
For SLP Consultants**

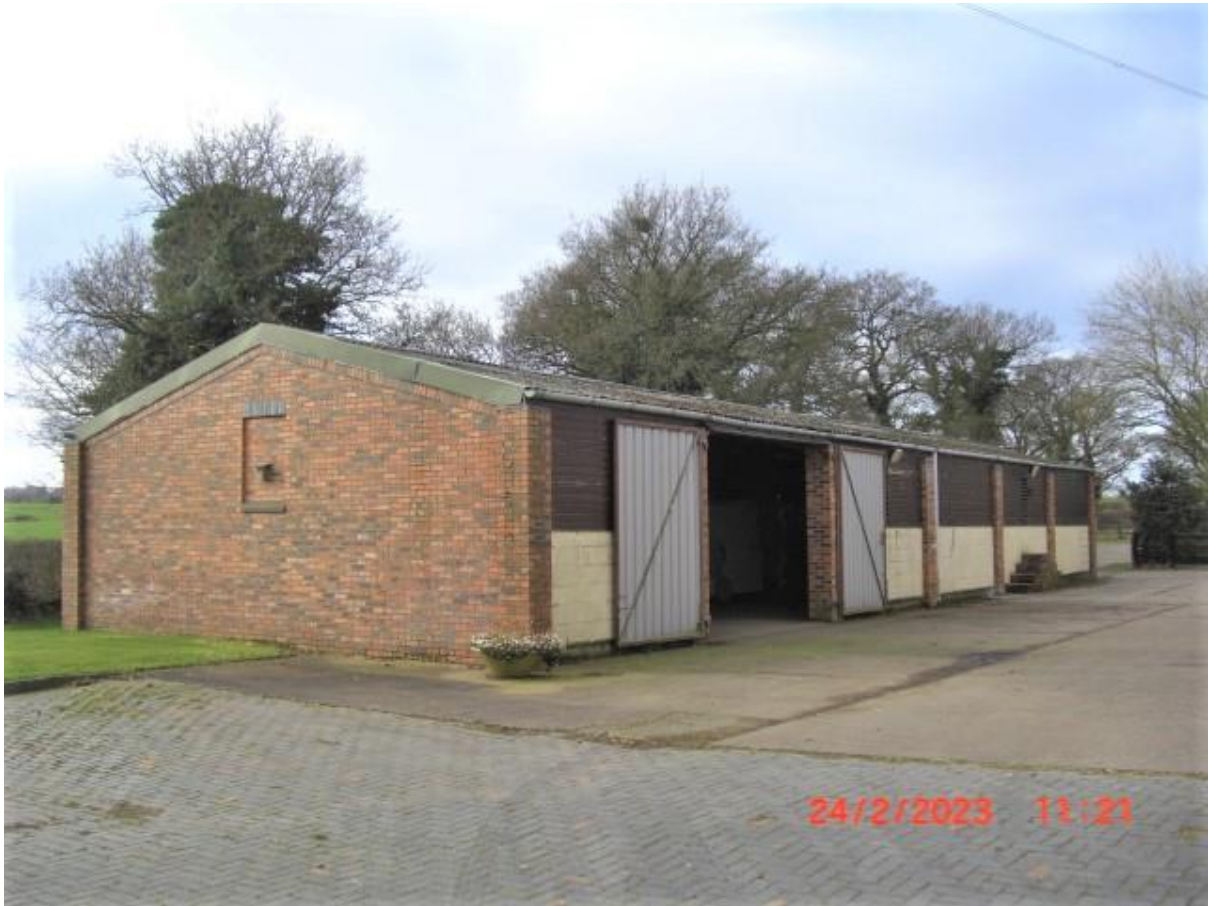
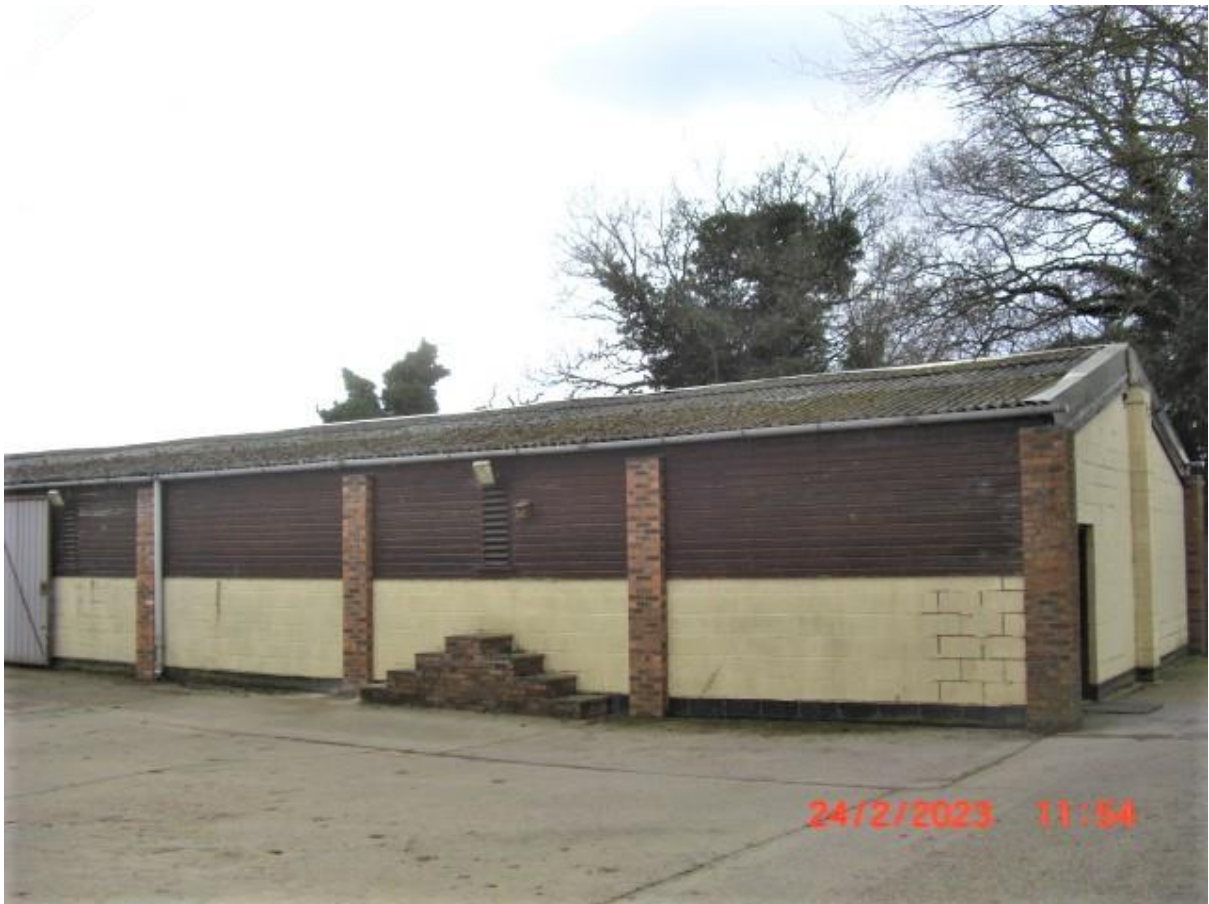
Barn A is a single storey, steel portal framed structure with masonry infill panels and an eaves height of approximately 3.0 metres. (*Photographs 1 & 2*) It is approximately 27 metres long x 9 metres wide on plan and is located close to the south boundary of the site adjacent to Green Barns Lane. It is currently used as stables and tack storage for approximately 4 to 6 horses. The roof of the building is duo pitched across the narrower width at an angle of approximately 15° to the

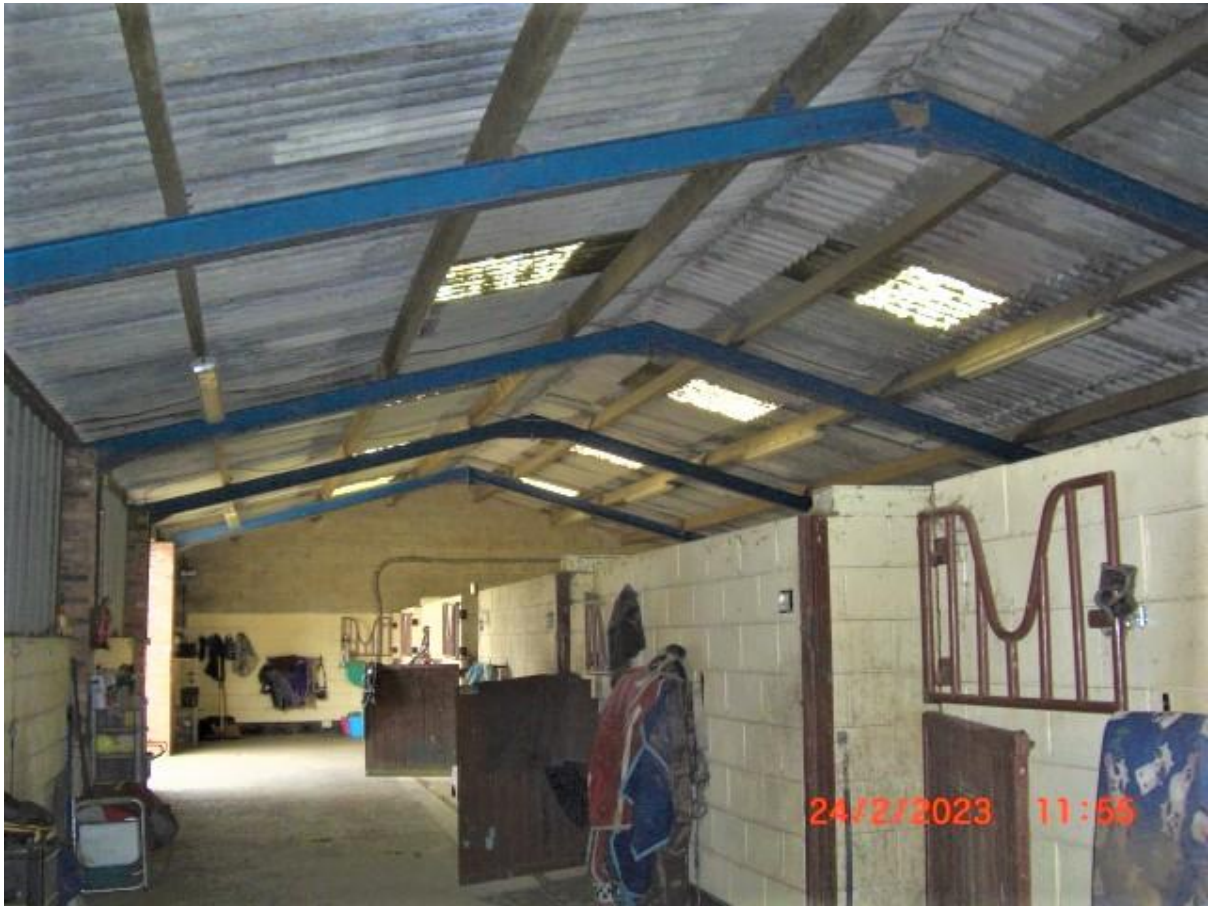
Photograph 3

horizontal and is covered with deep profile corrugated fibre cement roof sheets. The steel portal frames are located at approximately 4.5 metre centres using 178 x 102 x 19 UB rafters supporting 220 x 75 timber rafters at approximately 1200mm centres. *(Photographs 3 & 4)* It was not possible to see the steel column sections to the portal frames due to the fact that they are fully encased within 460mm square face brickwork piers. *(Photograph 5)* However, I anticipate that these members are most probably either 203 x 102 UB or 203 x 133UB sections. The west gable wall of Barn A is constructed as an infill masonry panel beneath the last steel portal frame. This wall appeared to be constructed using solid 190mm wide blocks incorporating a 460mm square vertical blockwork pier at the mid-point. *(Photographs 6 & 7)* At the opposite east end of the building there appeared to be no steel portal frame. Instead, this wall appeared to be constructed as a load bearing cavity wall with an outer leaf of face brickwork and an inner leaf of 190mm wide blockwork. The internal division walls between and at the front and back of the stable units were all found to be constructed using 190mm solid blocks to a height of approximately 1600mm above the finished ground floor level.

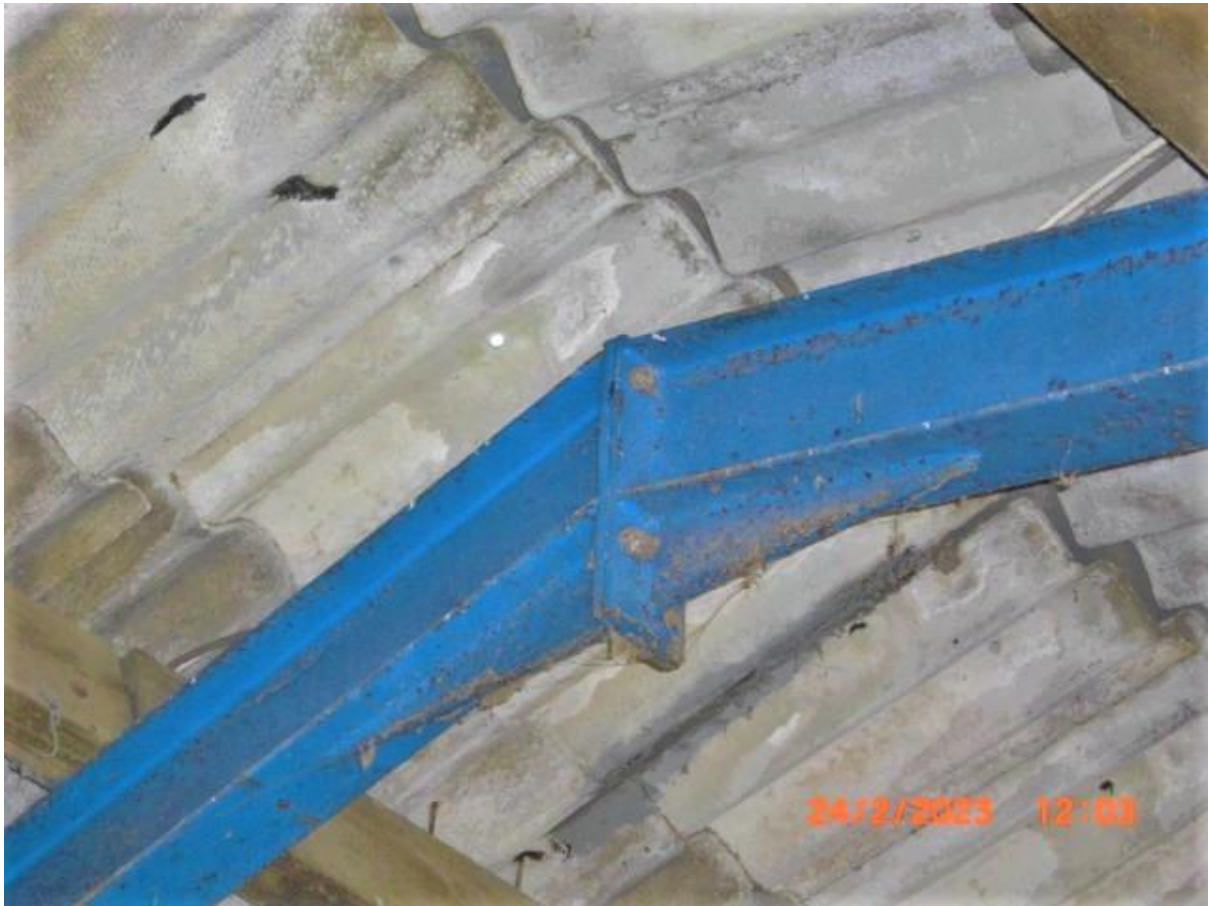
Photograph 13

- 3.1b All of the portal frame rafters were found to be in very good condition with very little surface rusting present and no signs of buckling of the members either locally or within their length. The ridge connections to the rafters were noted to be made using end plates approximately 350mm x 120mm x 10mm thick, incorporating triangular stiffened plates, all fillet welded to the ends of the rafters and bolted together using 4N° approximately 20mm diameter bolts. (*Photograph 13*) As mentioned previously, I was unable to inspect the tops of the steel columns of the portal frames. However, from the presence of similar triangular stiffener plates projecting out of the face brickwork column surrounds, I anticipate that similar bolted connections are present at the rafter to column interfaces. (*Photograph 14*)

- 4.1b As can be seen from *Photograph 13*, the welded and bolted ridge connections to the portal frame rafters, have been fabricated and erected to a very good standard with no localised or overall distortions to the members present. I also believe that similar quality connections are present at the rafter to column positions.

Therefore, I am of the opinion that all of the portal frame connections are working satisfactorily to support the applied loads and will continue to do so.

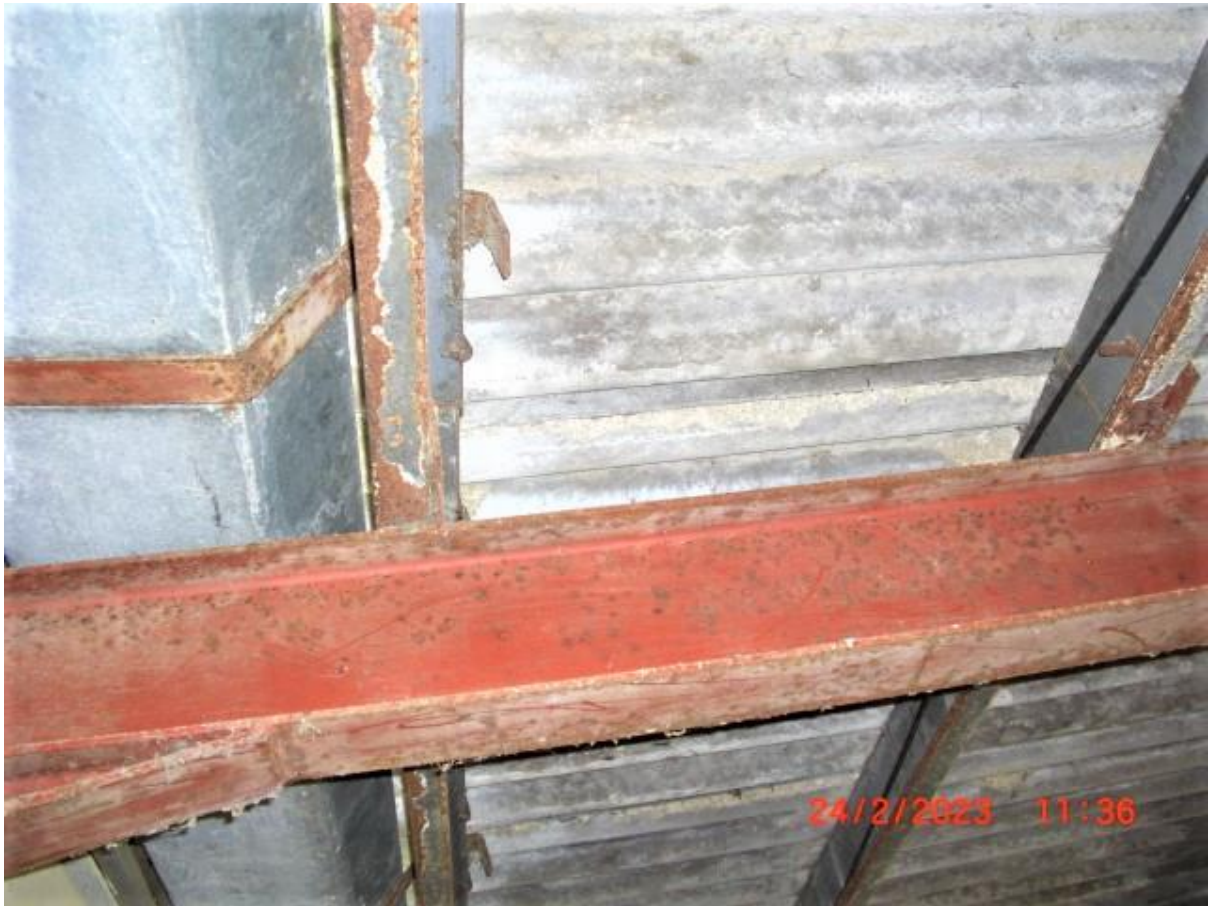
Photograph 15

- 3.2a As with Barn A, I noted that the roof cladding to Barn B was in good condition with no obvious signs of rainwater ingress, localised damage, sagging of the roof sheets or timber purlins. As mentioned previously some cold rolled, galvanised steel purlins were noted, particularly in areas close to the valley gutters. Some light surface rusting of these members and the valley gutter support straps was noted. (*Photograph 15*) No obvious signs of insect infestation or dry/wet rot of the

- 4.2a My conclusions for Barn B regarding its roof structure are identical to those given for Barn A in item 4.1a with the exception that I believe the reason a small number of galvanised steel zed purlins have been installed is most probably due to localised replacement of rotten timber purlins, particularly if the valley gutters have leaked in the past.

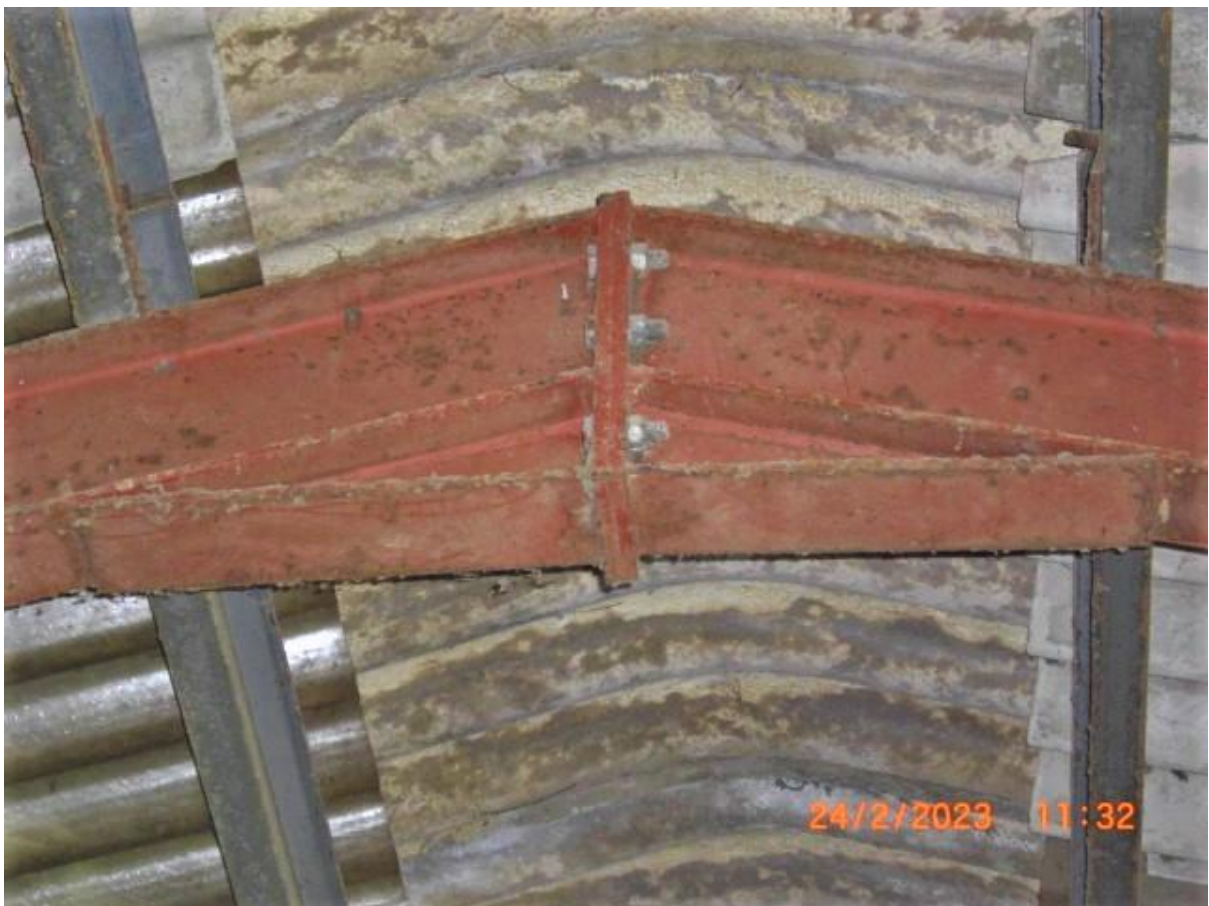
Photograph 16

- 3.2b As with Barn A all of the portal frame rafters were found to be in very good condition. In addition, the steel columns of the portal frames also showed very little signs of surface rusting and no signs of localised or overall buckling. The portal frame rafter connections were found to be very similar to those used in Barn A. However, in this instance 6N° bolts have been used rather than 4N°. (*Photograph 16*) Similar, 6N° bolt connections were also noted at the rafter to column interfaces. (*Photograph 17*)

- 4.2b In my opinion the use of 6N° bolts at both the rafter to rafter and rafter to column connections on Barn B compared with 4N° bolts in Barn A is most probably as a result of the slightly larger span of the portal frames of Barn B. (i.e., 11 metres compared to 9 metres). Otherwise, the steel portal rafter sizes and spacings appear to be the same or very similar on both Barn A and Barn B. Also, from past design experience, I am aware that the rafter and column section sizes used on Barn B are satisfactory for the span and spacing of the frames. Therefore, I am of the opinion that all of the portal frame members and connections for Barn B are again working satisfactorily and will continue to do so.

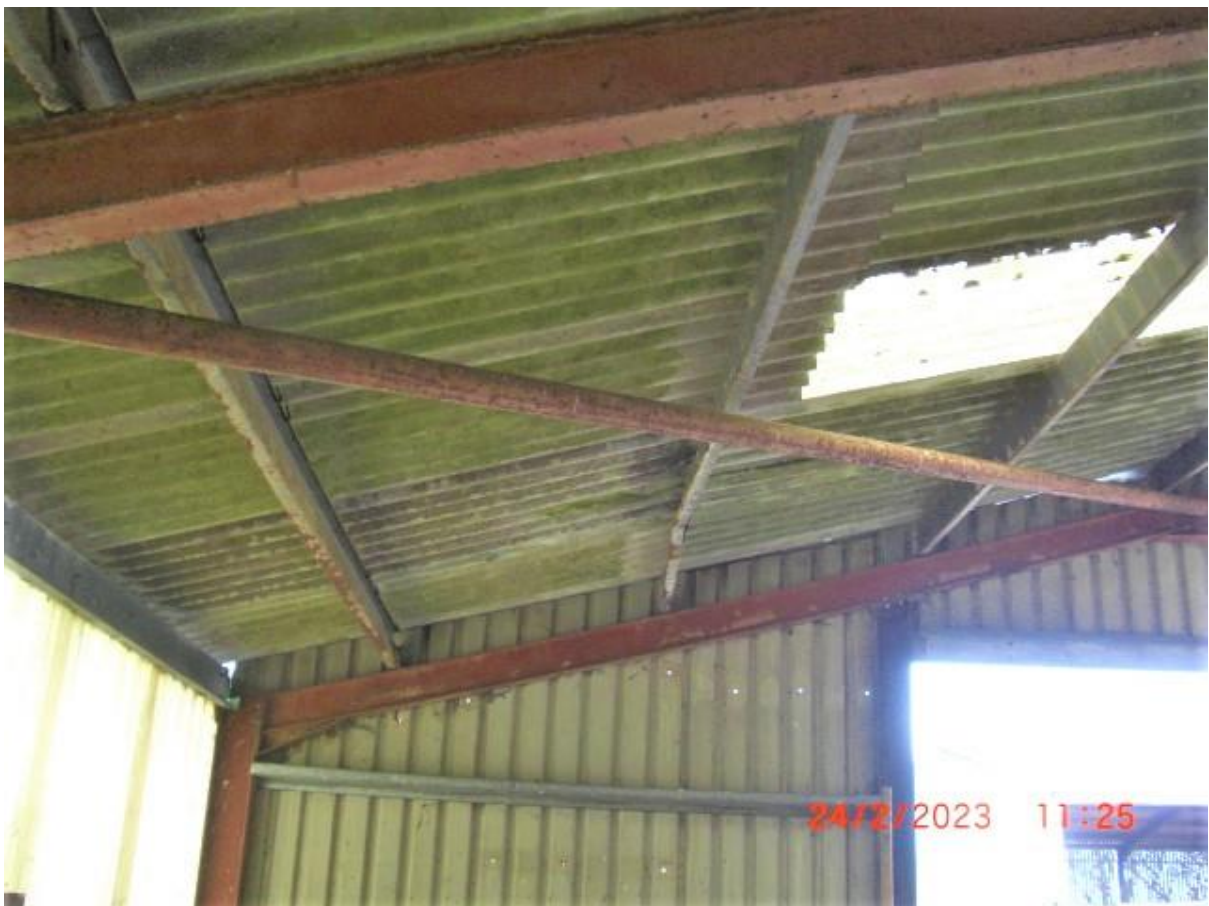
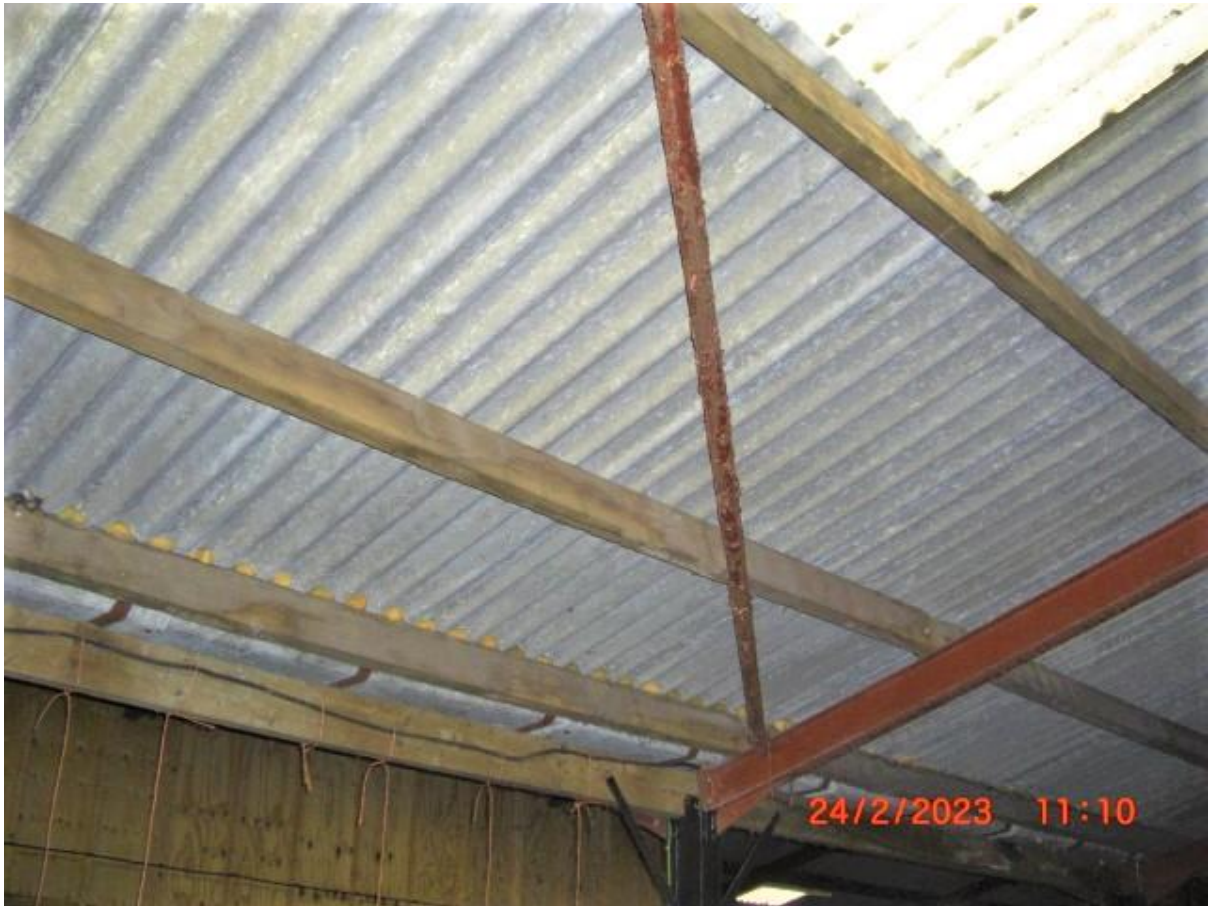
- 3.2c Tubular circular hollow section diagonal wind bracing members were found to be present within the plane roof at both ends of the building. (*Photographs 18 & 19*) In addition, steel knee bracing members were noted to both internal and external columns. (*Photographs 20 & 21*)

- 4.2c In my opinion the larger plan size and more open nature of Barn B dictates that suitable wind bracing be installed. As mentioned in item 3.2c, in plane diagonal circular hollow section roof bracing and column to purlin knee bracings have been installed. Therefore, providing that these members are retained when the conversion to domestic properties takes place, I believe that there will be no requirement to install additional longitudinal bracing.
