Monitoring visit 3 of 5

### Monitoring Plus Report

Owners name	Mr R Davison	Suspected cause	to be advised	Monitoring type	levels & cracks
Address	1 Ivydene Gardens Dorrita Avenue Waterlooville  PO8 8NP	Principal area of damage	to be advised	Installed	24/05/2023
Comment		Damage category	to be advised	Frequency (weeks)	8.7
Max movement	20.9 mm	Surface geology	to be advised	Completion date	Jan 24
Focal area	Pts 5r, 6r, 7r, 8r, 9r,	Feedback from last visit		Status	open
		Feedback from this visit	no feedback for this visit		
0		Sketch showing location of monitoring points

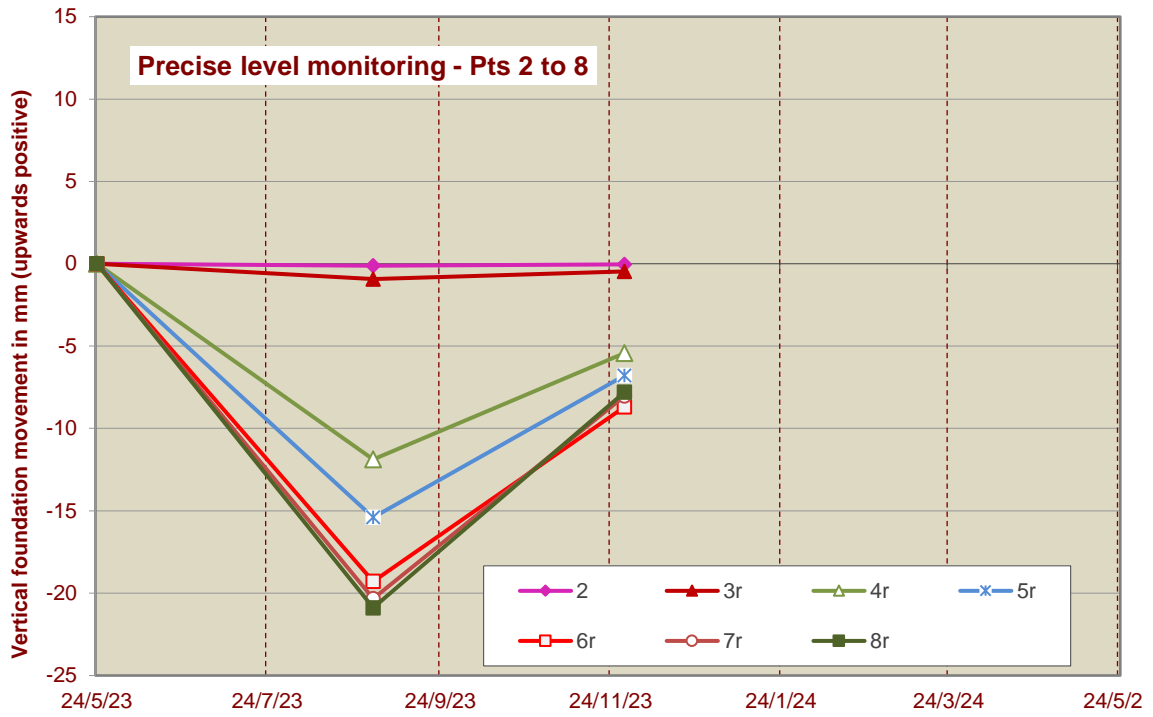
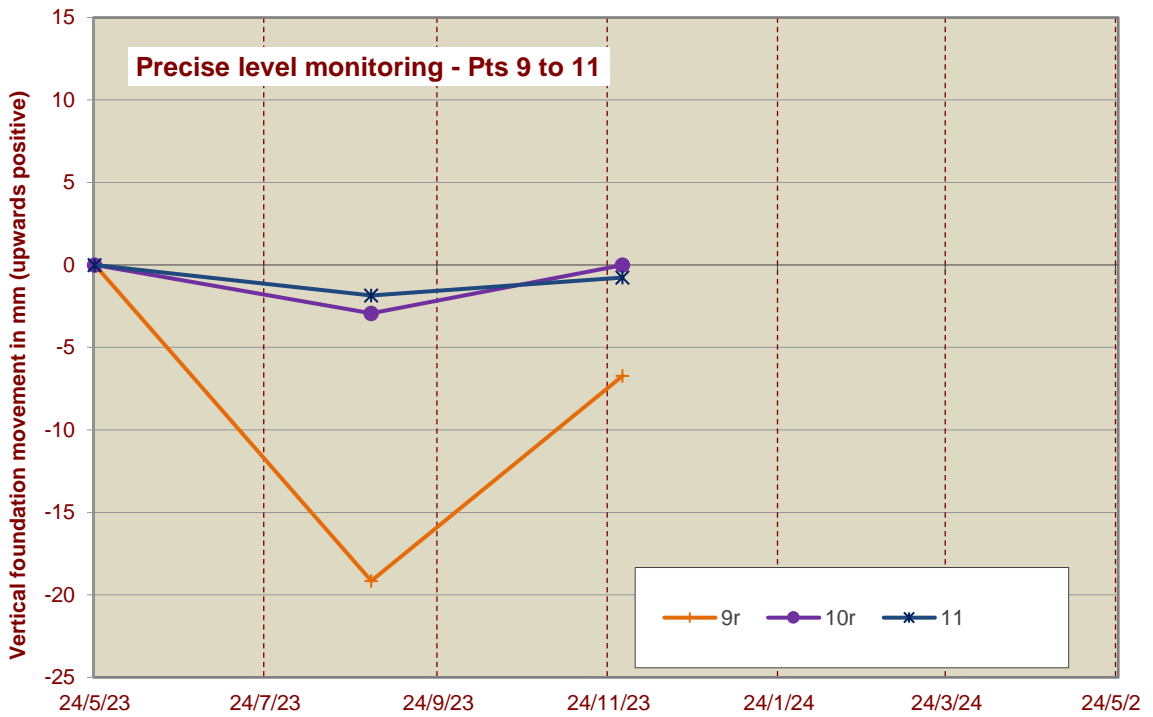
## Precise level monitoring related to Point 1

Survey:	1		2		3		4		5	
By:	VV		VV		VV		#N/A		#N/A	
Date:	24/05/2023		31/08/2023		29/11/2023		#N/A		#N/A	
Point ID	levels mm	<i>chngs</i> <i>mm</i>	levels mm	<i>chngs</i> <i>mm</i>	levels mm	<i>chngs</i> <i>mm</i>	levels mm	<i>chngs</i> <i>mm</i>	levels mm	<i>chngs</i> <i>mm</i>
1	<b>1000.00</b>	<b>0.0</b>	<b>1000.00</b>	<b>0.0</b>	<b>1000.00</b>	<b>0.0</b>		#N/A		#N/A
2	1074.90	<b>0.0</b>	1074.78	<b>-0.1</b>	1074.86	<b>0.0</b>		#N/A		#N/A
3r	1483.94	<b>0.0</b>	1483.01	<b>-0.9</b>	1483.47	<b>-0.5</b>		#N/A		#N/A
4r	1494.48	<b>0.0</b>	1482.60	<b>-11.9</b>	1489.06	<b>-5.4</b>		#N/A		#N/A
5r	1497.16	<b>0.0</b>	1481.76	<b>-15.4</b>	1490.38	<b>-6.8</b>		#N/A		#N/A
6r	1494.56	<b>0.0</b>	1475.27	<b>-19.3</b>	1485.87	<b>-8.7</b>		#N/A		#N/A
7r	1482.53	<b>0.0</b>	1462.20	<b>-20.3</b>	1474.51	<b>-8.0</b>		#N/A		#N/A
8r	1471.96	<b>0.0</b>	1451.07	<b>-20.9</b>	1464.17	<b>-7.8</b>		#N/A		#N/A
9r	1467.02	<b>0.0</b>	1447.87	<b>-19.1</b>	1460.30	<b>-6.7</b>		#N/A		#N/A

10r	1464.09	<b>0.0</b>	1461.16	<b>-2.9</b>	1464.08	<b>0.0</b>		#N/A		#N/A
11	1074.50	<b>0.0</b>	1072.65	<b>-1.8</b>	1073.74	<b>-0.8</b>		#N/A		#N/A

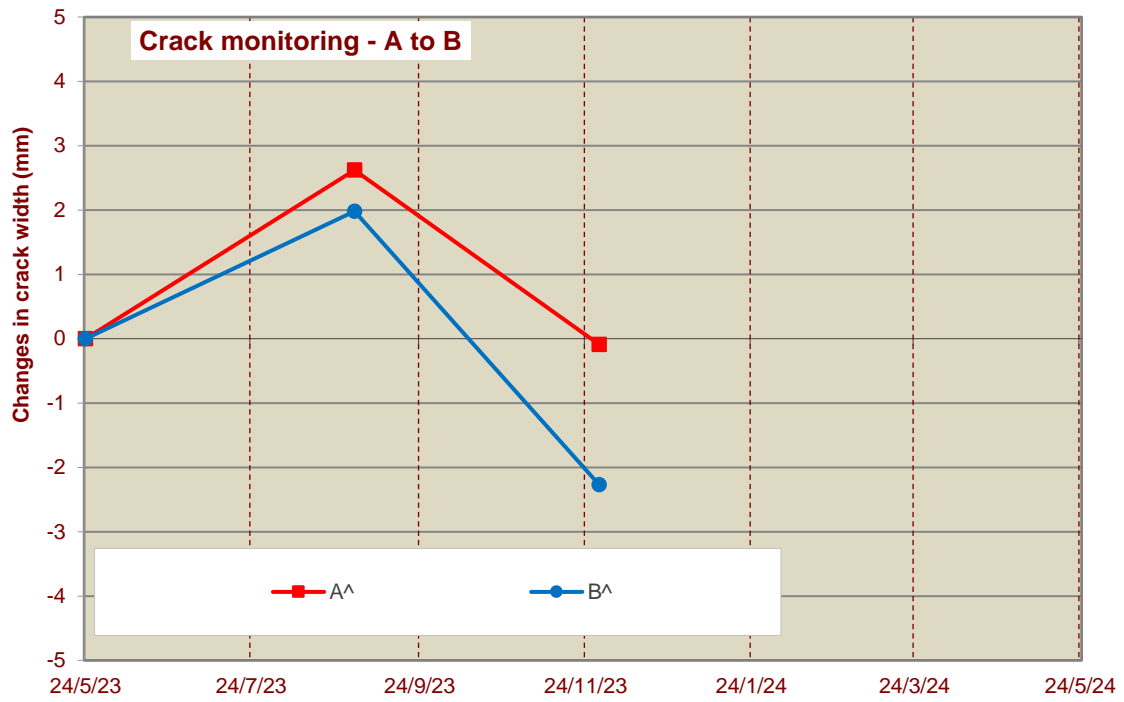
# Crack monitoring

Survey:		1		2		3		4		5	
By:		VV		VV		VV					
Date:	initial	24/05/2023		31/08/2023		29/11/2023		#N/A		#N/A	
Crack ID	width mm	sprtn mm	<i>chngs</i> <i>mm</i>	sprtn mm	<i>chngs</i> <i>mm</i>	sprtn mm	<i>chngs</i> <i>mm</i>	sprtn mm	<i>chngs</i> <i>mm</i>	levels mm	<i>chngs</i> <i>mm</i>
A^	2.70	76.50	<b>0.0</b>	79.12	<b>2.6</b>	76.41	<b>-0.1</b>		#N/A		#N/A
B^	19.10	66.01	<b>0.0</b>	67.99	<b>2.0</b>	63.74	<b>-2.3</b>		#N/A		#N/A

A^	Angle bracket, external , Rhs of conservatory
B^	Angle bracket, external, LHS of conservatory
