Engineers Report

Risk Address 1 Ivydene Gardens
Dorrita Avenue
Waterlooville
PO8 8NP

Claim Refence 084431824
Policy Holder Mr R Davison

Date Notified 30 August 2022
Date Instructed 30 August 2022
Report Date 19 October 2022

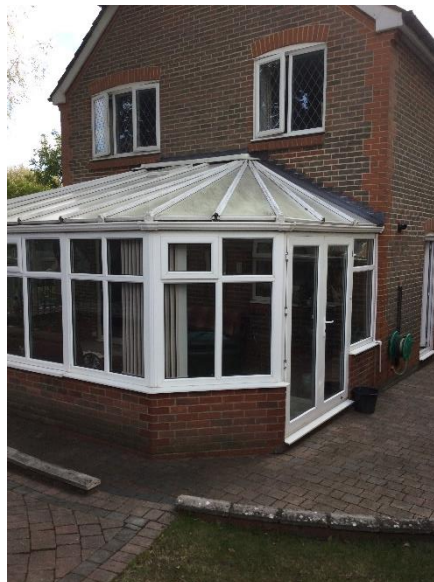
General view of rear
conservatory

All the indications from the evidence obtained suggest that the damage to the conservatory results from subsidence of the site upon which the property stands. Live roots in firm active clays have led to cyclical shrinkage and expansion below the foundations of the property, which together have led to consequent building movement and damage.

We note that there is the presence of the significant vegetation to the rear of the property, which is believed to be a Beech tree, within the grounds of 1 Dorrita Avenue. To abate any further foundation movement from occurring and provide long-term stability for the conservatory, it is recommended that this particular tree is removed in full.

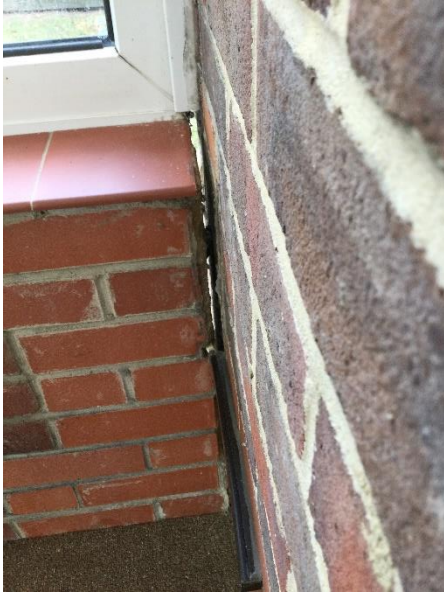
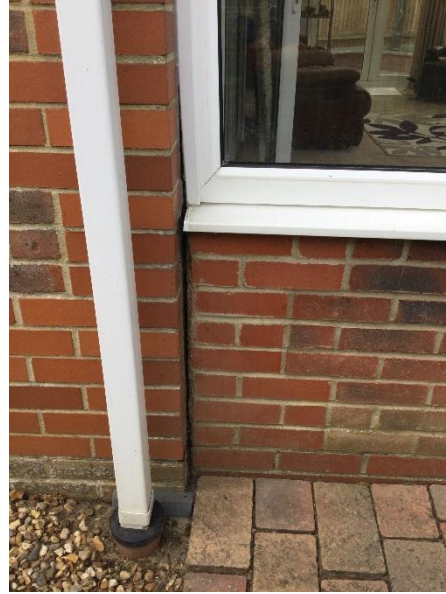
There is a vertical gap of approximately 10-12mm noted at the junction of the right-hand side dwarf brickwork with the main property. This gap extends through the tiled window board to this junction also.

There is a relatively uniform vertical gap of approximately 10-12mm noted at the junction of the right-hand side dwarf brickwork with the main property. This gap extends through the uPVC window sill to this junction also. There is a reverse tapering gap of approximately 1-6mm at the junction of the uPVC window trim and the main property.

Gap at the junction of the right-hand wall and the main property

It is common practice to categorise the damage in accordance with B.R.E. Digest 251 “Assessment of Damage in Low-Rise Buildings”. In this case, the localised damage to the property falls into Category 3 “Moderate”.

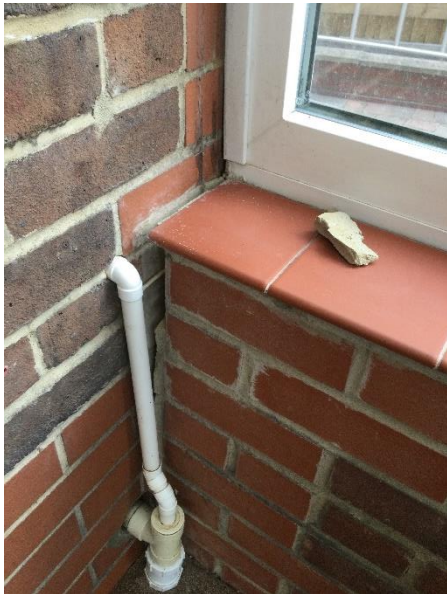
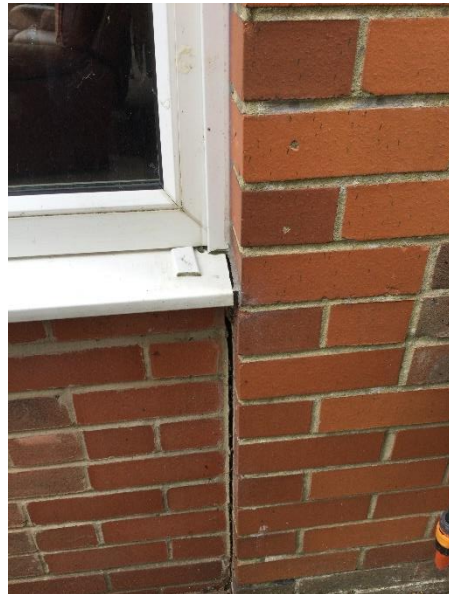
There is a tapering vertical gap of approximately 3-15mm noted at the junction of the left-hand side dwarf brickwork with the main property. The previous mortar joint to this area has partially fallen out, which has created the approximately 15mm gap at the top of the dwarf wall. This gap extends through the tiled window board to this junction also. There is a minor diagonal hairline crack to the left-hand wall close to the junction with the main property.

There is a tapering vertical gap of approximately 3-12mm noted at the junction of the left-hand side dwarf brickwork with the main property. This gap extends through the uPVC window sill to this junction also.

Gap at the junction of the left-hand wall and the main property

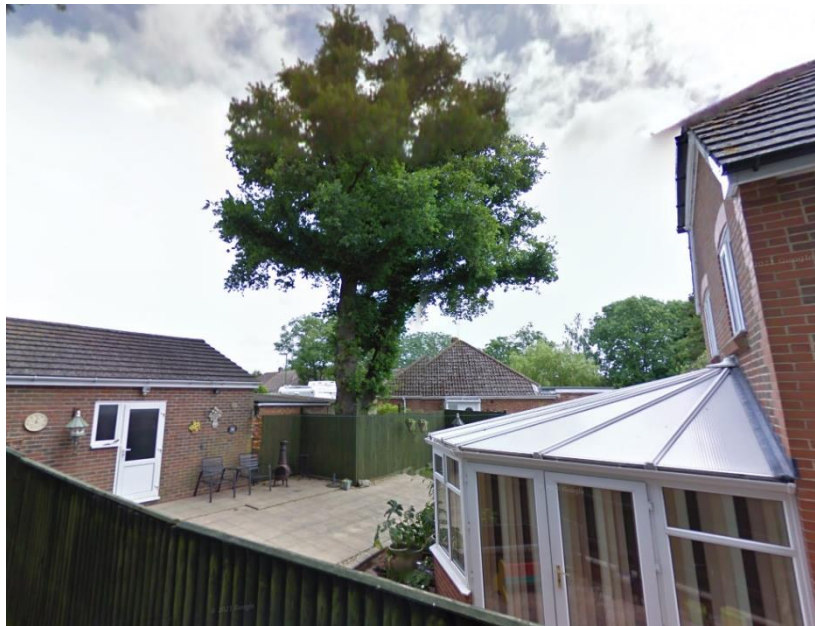
Map to show proximity of significant vegetation to the rear

Trees / vegetation	Distance to building (m)	Approx. height (m)	Mature height (m)	Water demand	Ownership	Action
Beech	5	15	10	Moderate-High	Neighbour	Remove

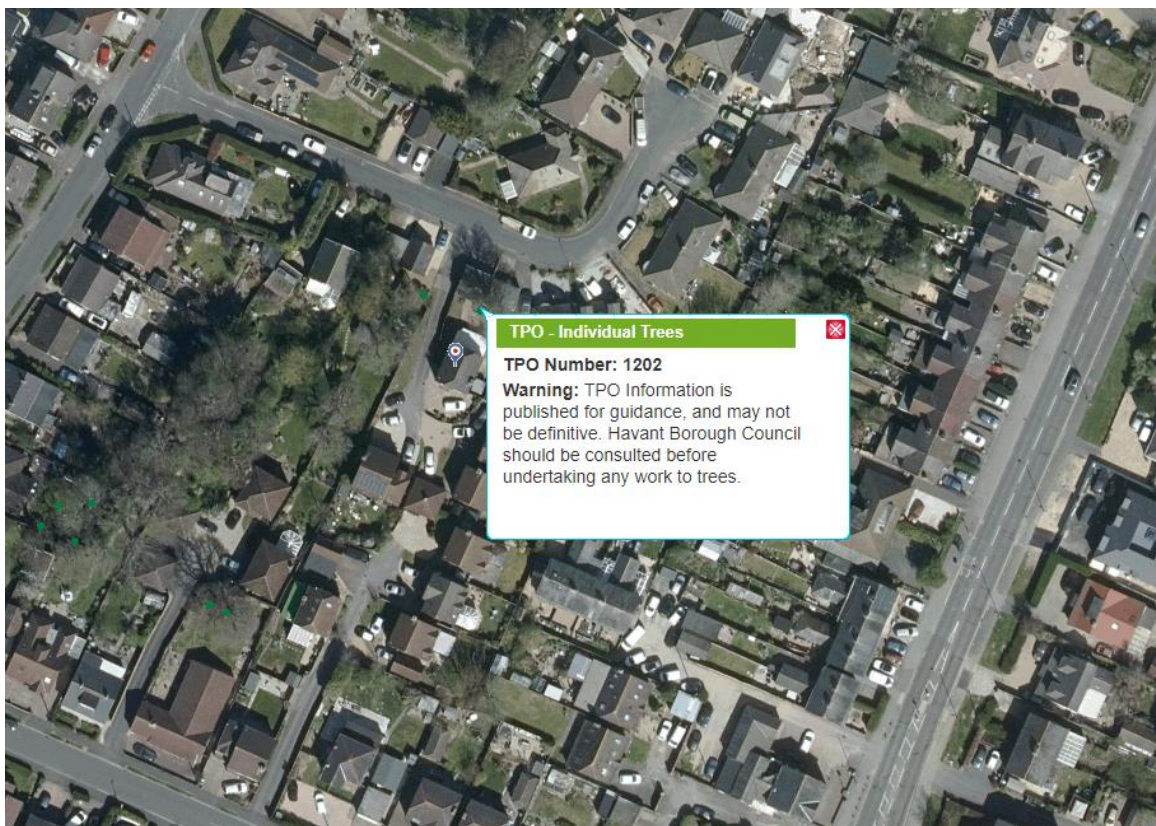
Confirmation that the tree to the rear possesses a Tree Preservation Order

If the claim is accepted, given that the causative tree is protected by a Tree Preservation Order, a certain level of evidence is required in order to prove to Local Authority that this vegetation is having an adverse influence on the ground beneath the property. This will include an intrusive site investigation externally within the vicinity of the damage, as well as a level monitoring exercise to accurately reflect ongoing movement of the building. Readings at the property are to be undertaken every 8 weeks. In addition, a report from an arboriculturist will be sought, to confirm in their expert opinion that the Beech tree is the main factor in the damage to the conservatory.
