**ARBORICULTURAL REPORT**  
at  
**1 Ivydene Gardens**  
**Dorrita Avenue**  
**Waterlooville**  
**Hampshire**  
**PO8 8NP**

**JCA Ref:**  
20880/AJB

- 1.1.1 This arboricultural report is required by our client as part of an investigation into suspected soil shrinkage subsidence damage at **1 Ivydene Gardens, Dorrita Avenue, Waterlooville, Hampshire, PO8 8NP.**

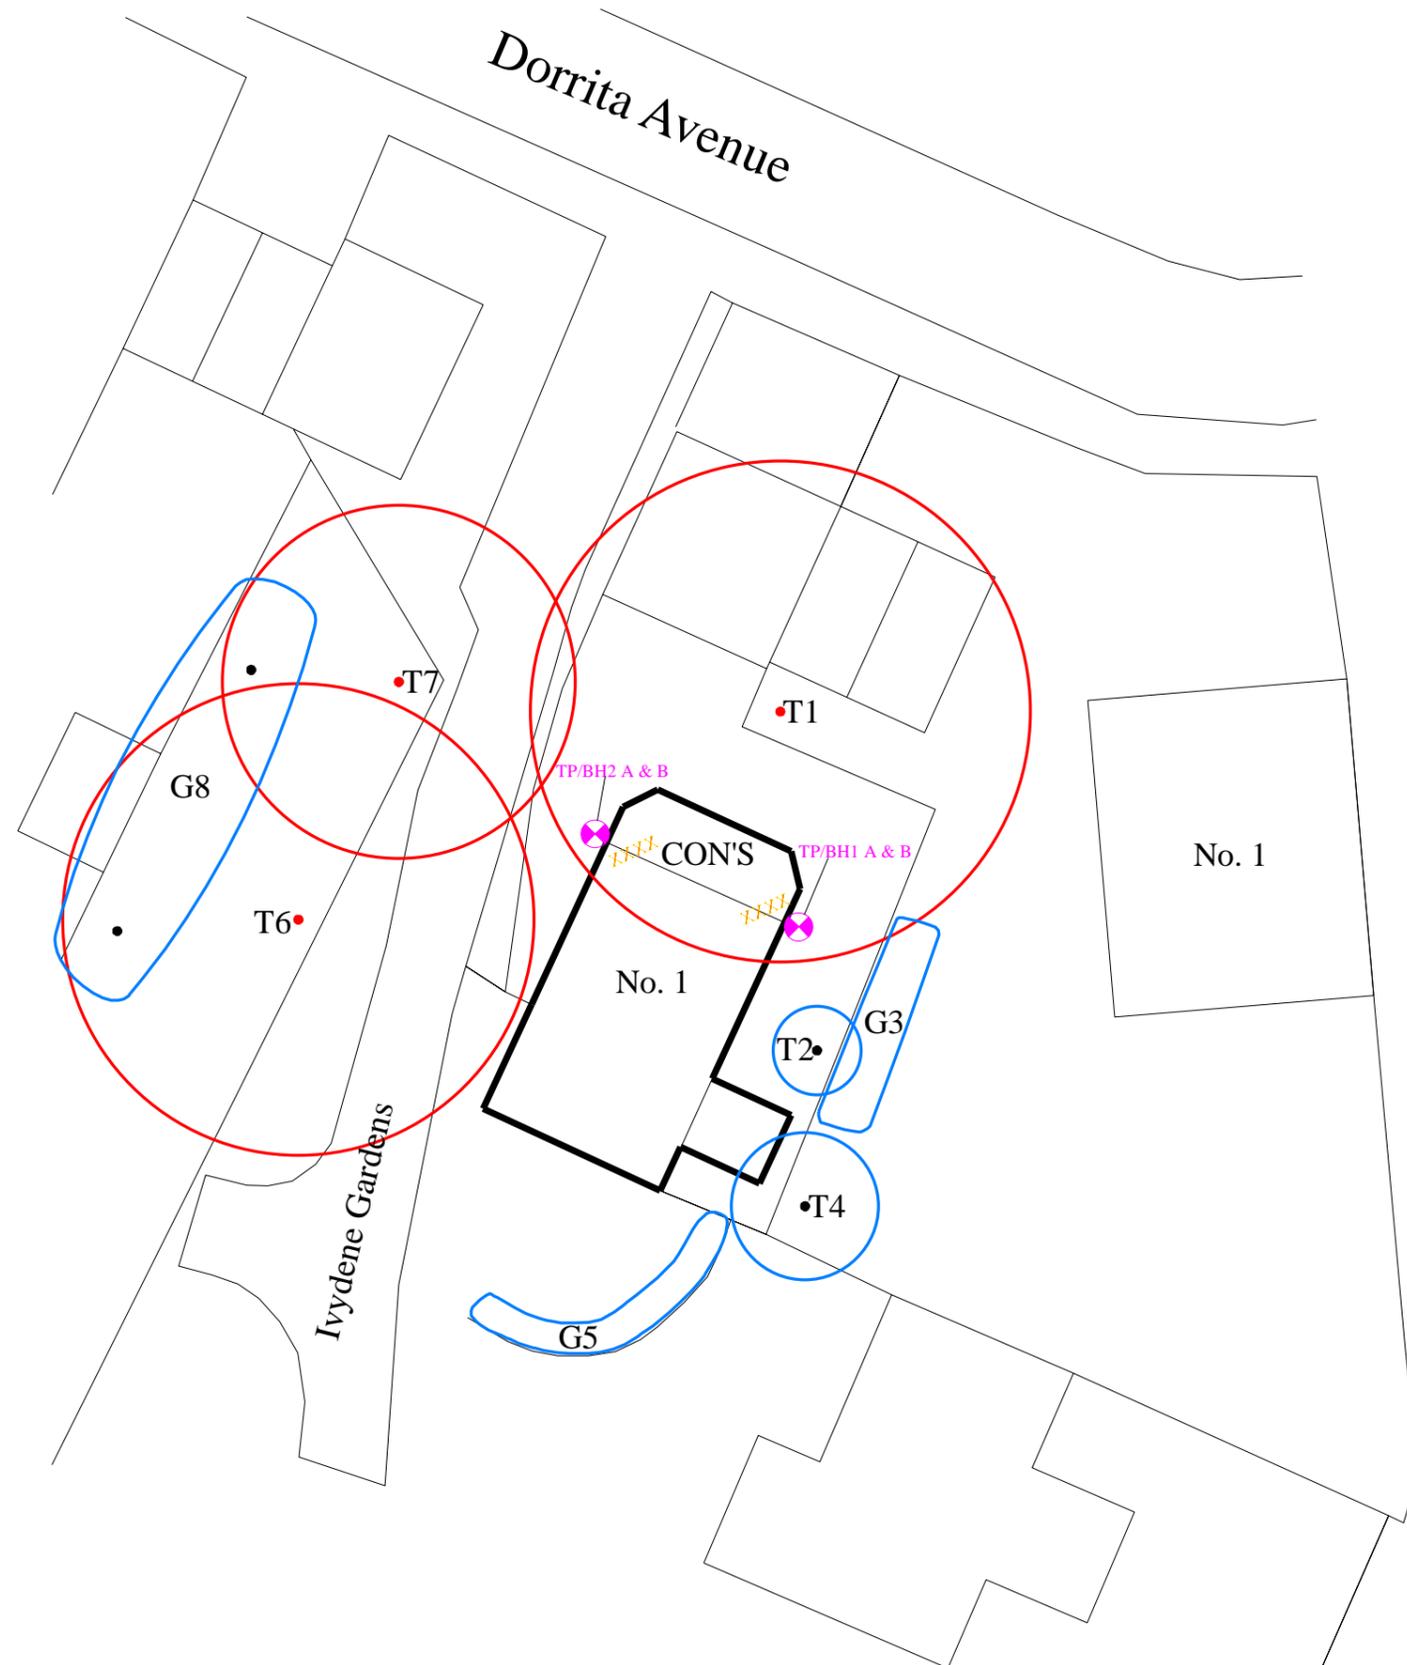
### Appendix 2: Site Plan

- 6.3 We consider the vegetation identified as **T1**, **T6** and **T7** to be contributing to the damage observed at the subject property. We have therefore recommended that **T1**, **T6** and **T7** be removed to ground level and that the stumps be treated to prevent regrowth.

- Monitoring of cracks or level monitoring indicating cyclical movement.
- 6.5 We consider the vegetation identified as **T2**, **G3**, **T4**, **G5** and **G8** to be of possible future concern to the subject property, if left unmanaged. We have therefore recommended that **T2**, **G3**, **T4**, **G5** and **G8** be maintained at their current height and spread over the forthcoming years, This work is only recommended as a precaution and is not considered a priority to resolve the damage observed at the subject property.
