1.1.1 This arboricultural report is required by our client as part of an investigation into suspected soil shrinkage subsidence damage at 1 Ivydene Gardens, Dorrita Avenue, Waterlooville, Hampshire, PO8 8NP.

ADDRESS: 1 Ivydene Gardens, Dorrita Avenue, Waterlooville, Hampshire, PO8 8NP. JCA REF: 20880/AJB

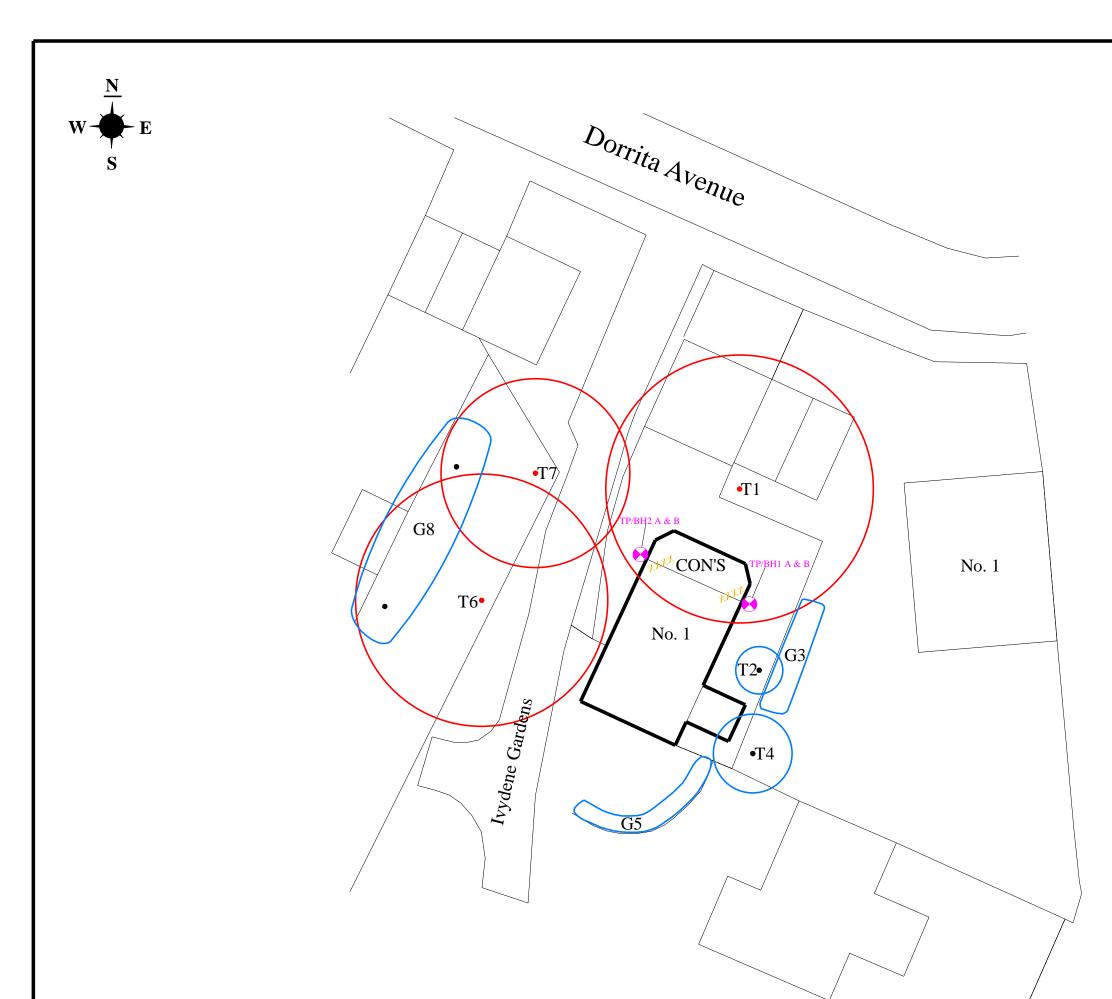
# Appendix 2: Site Plan

3.4.2 The root identification is a match to the vegetation identified as **T1**, **T6**, **T7** and **G8** in this report.

- 6.3 We consider the vegetation identified as **T1**, **T6** and **T7** to be contributing to the damage observed at the subject property. We have therefore recommended that **T1**, **T6** and **T7** be removed to ground level and that the stumps be treated to prevent regrowth.

Item	Species	Recommended Action	Location/Ownership	Planning Restriction
T1	English Oak	Remove to ground level and treat stump to prevent regrowth	Third Party - Presumed No. 1 Dorrita Avenue	ТРО
Т2	Silver Birch	Maintain at current height and spread over the forthcoming years.	Policy Holder	No TPO / Conservation Area
G3	Privet and Dogwood	Maintain at current height and spread over the forthcoming years.	Third Party - No. 1 Dorrita Avenue	No TPO / Conservation Area
Т4	Ash	Maintain at current height and spread over the forthcoming years.	Third Party - No. 1 Dorrita Avenue	No TPO / Conservation Area
G5	Laurel, Rhododendron and Lawson Cypress	Maintain at current height and spread over the forthcoming years.	Policy Holder	No TPO / Conservation Area
Т6	English Oak	Remove to ground level and treat stump to prevent regrowth	Third Party - 10b Longwood Avenue	TPO
Т7	English Oak	Remove to ground level and treat stump to prevent regrowth	Third Party - 10b Longwood Avenue	ТРО
