CCTV REPORT FOR: 1 IVYDENE GARDENS  
DORRITA AVENUE  
WATERLOOVILLE  
PO8 8NP

Insured: Mr R Davison  
Reference: 084431824

Site Visit: 09-Mar-23  
Report Date: 18-May-23

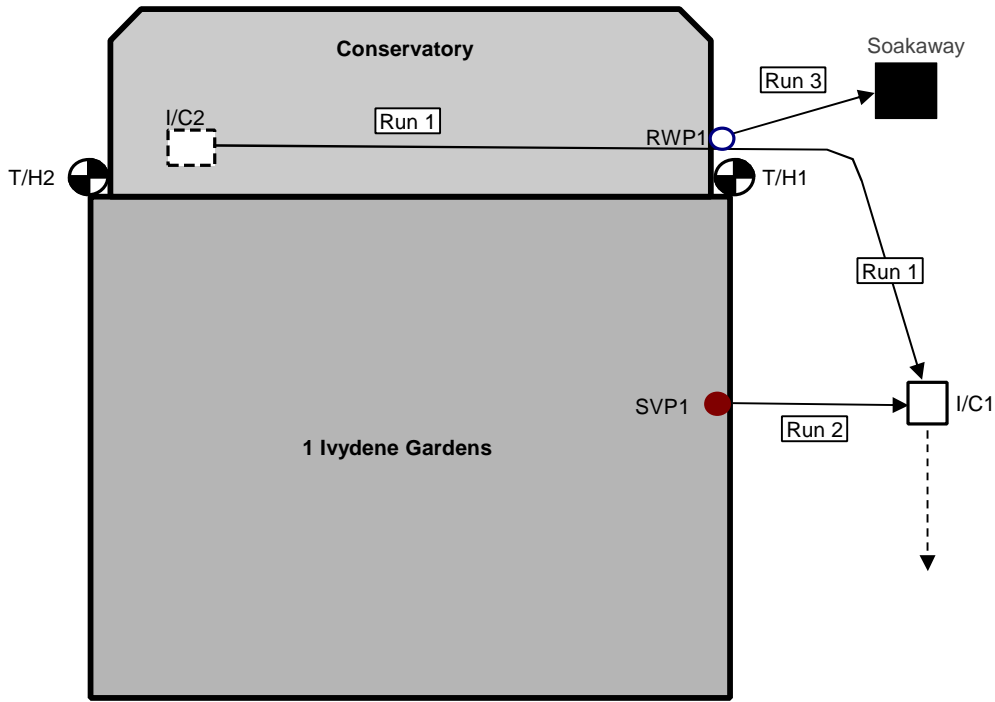
The current soakaway is located very close to the house at 2.0m downstream. Current Building Regulations require soakaways to be sited no closer than 5.0m to buildings.

The current soakaway is located very close to the house at 2.0m downstream. Current Building Regulations require soakaways to be sited no closer than 5.0m to buildings. We recommend that a new soakaway is installed that complies with Building Regulations, with new pipework installed to connect this to RWP1.

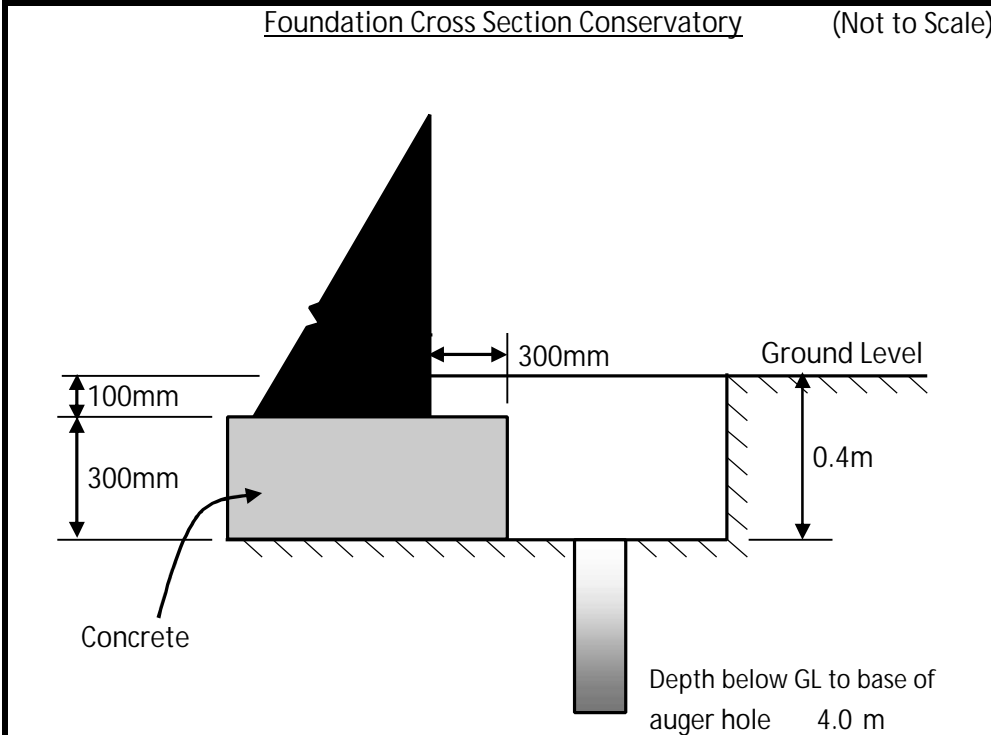
Location: Right hand side junction of house and conservatory      T/H No. 1a  
 Ground Surface: Dry      Weather: Dry      Date: 09-Mar-23

Roots Depth & Diameter:  
 From 0.4m  
 Down to 2.0m  
 up to 6mm diameter

Water Depth Hit & Rise:  
 None observed on site

Depth (m)	Soil Descriptions (NB: Field crew description only)	Test Type	Depth (m)	
			From	To
G.L.				
0.40	Soft brown sandy CLAY	V(n) 33	0.400	
1.00	Soft/firm brown slightly gravelly slightly sandy CLAY	V(n) 41	1.000	
1.50	Firm brown slightly gravelly slightly sandy CLAY	V(n) 59	1.500	
2.00	Firm grey mottled brown CLAY	V(n) 65	2.000	
4.00	End of Borehole	V(n) 65	2.500	
		V(n) 61	3.000	
		V(n) 63	3.500	
		V(n) 65	4.000	
Photograph

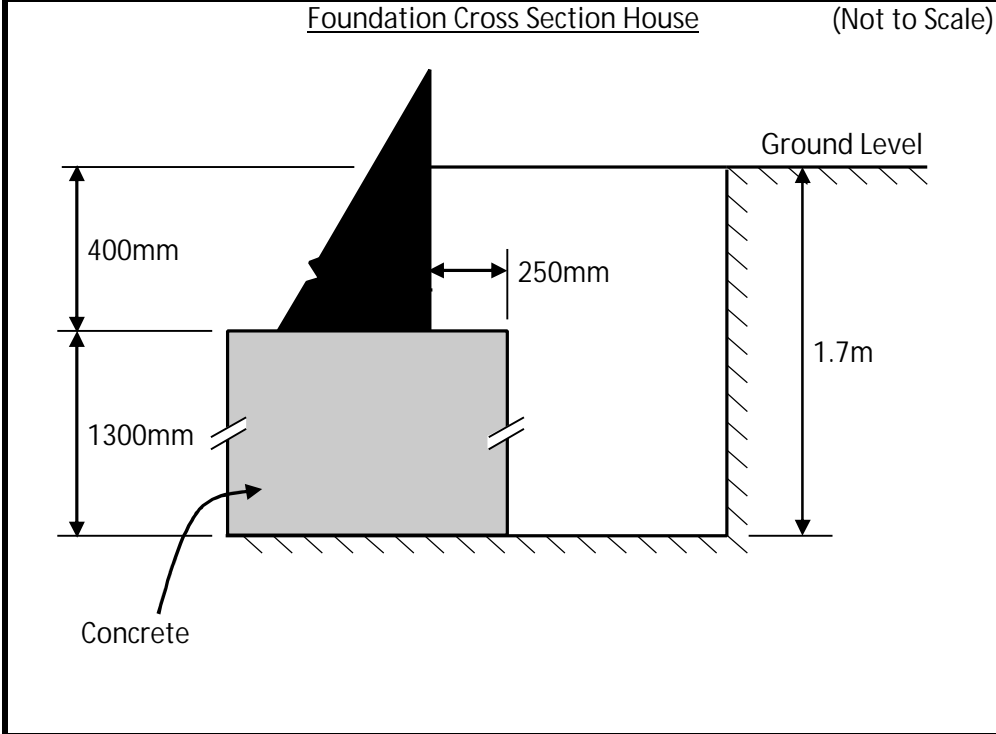
Location: Right hand side junction of house and conservatory	T/H No. 1b
Ground Surface: Dry	Weather: Dry
	Date: 09-Mar-23

Roots Depth & Diameter:
From 0.4m
Down to 2.0m
up to 6mm diameter
Water Depth Hit & Rise:
None observed on site
Reason for Termination :
Trial hole only

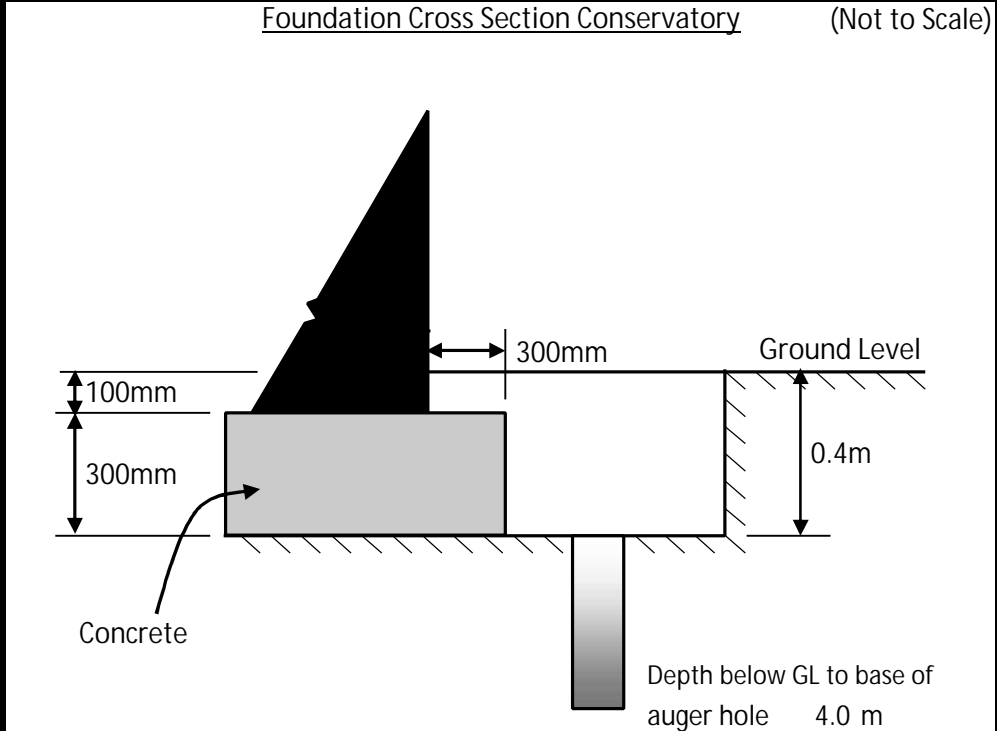
Location: Left hand side junction of main house and conservatory	T/H No. 2a
Ground Surface: Dry	Weather: Dry
	Date: 09-Mar-23

Roots Depth & Diameter:
From 0.4m
Down to 2.0m
up to 6mm diameter
Water Depth Hit & Rise:
None observed on site
Reason for Termination :
Hole at instructed depth

Depth (m)	Soil Descriptions (NB: Field crew description only)	Test Type	Depth (m)	
			From	To
G.L.				
0.40	Soft brown gravelly sandy CLAY	V(n) 32	0.400	
1.50	Firm brown gravelly sandy CLAY	V(n) 39	1.000	
2.00	Firm grey mottled brown CLAY	V(n) 57	1.500	
4.00	End of Borehole	V(n) 64	2.000	
		V(n) 65	2.500	
		V(n) 63	3.000	
		V(n) 66	3.500	
		V(n) 66	4.000	
	Photograph

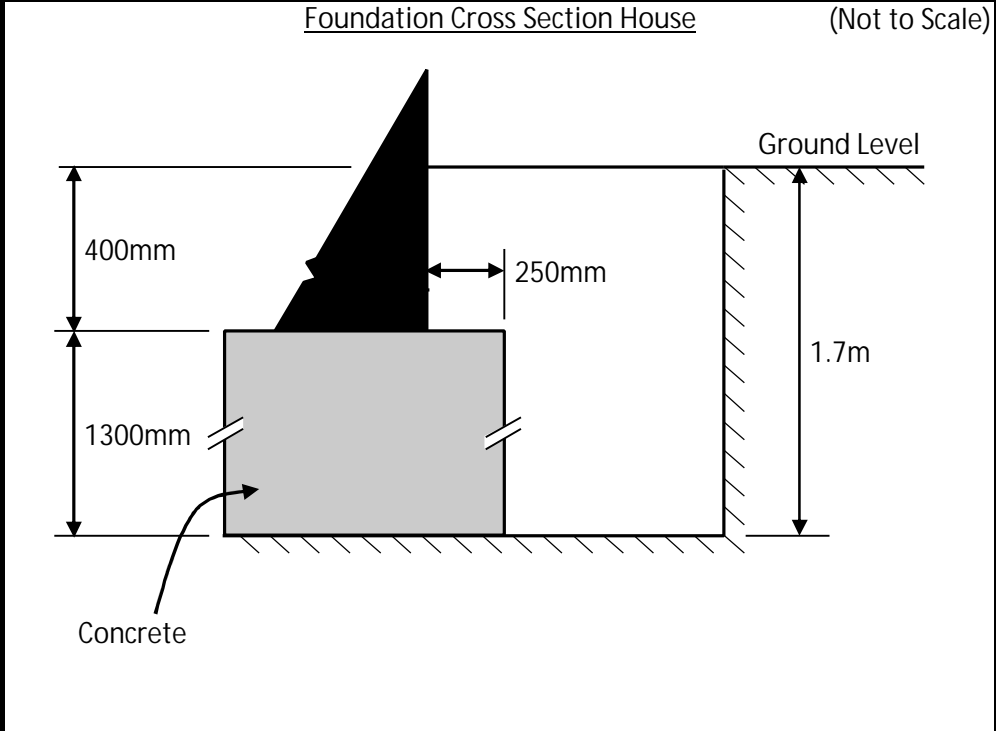
Location: Left hand side junction of main house and conservatory T/H No. 2b  
 Ground Surface: Dry Weather: Dry Date: 09-Mar-23

**Roots Depth & Diameter:**  
 From 0.4m  
 Down to 2.0m  
 up to 6mm diameter

**Water Depth Hit & Rise:**  
 None observed on site

**Reason for Termination :**  
 Trial hole only
