**Project Name**  
873325 Waddesdon

**Project Date**  
02/02/2024

**Company:** Waddesdon Church of England School

### Project Drawing, Page '873325 Waddesdon'

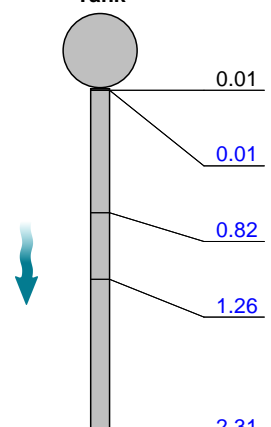
<table><tr> <td style="width: 10%; text-align: right;">0.01</td> <td style="width: 10%;"></td> <td style="width: 10%;">MH</td> <td style="width: 40%;">Start node, manhole, reference: Tank</td> <td style="width: 10%;">00:00:03</td> <td></td> <td></td> </tr><tr> <td style="text-align: right;">0.82</td> <td></td> <td>REM</td> <td>General remark: PERFORATED PIPE</td> <td>00:00:20</td> <td rowspan="2" style="vertical-align: middle;">1_0-82m_150539.jpg</td> <td></td> </tr><tr> <td style="text-align: right;">2.31</td> <td></td> <td>SA</td> <td>Survey abandoned: UNABLE TO PUSH</td> <td>00:00:56</td> <td></td> <td></td> </tr></table>

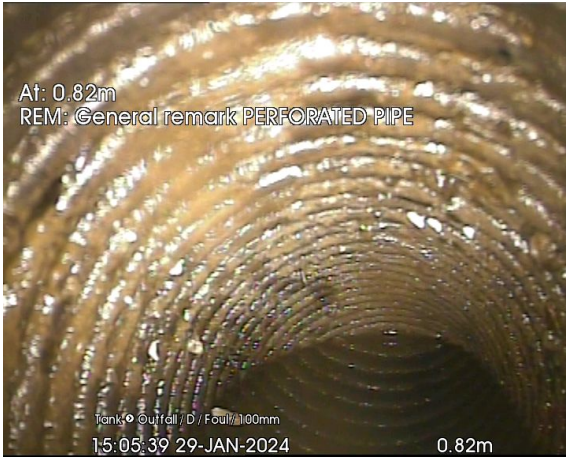
1\_0-82m\_150539.jpg, 00:00:20, 0.82 m  
General remark, PERFORATED PIPE

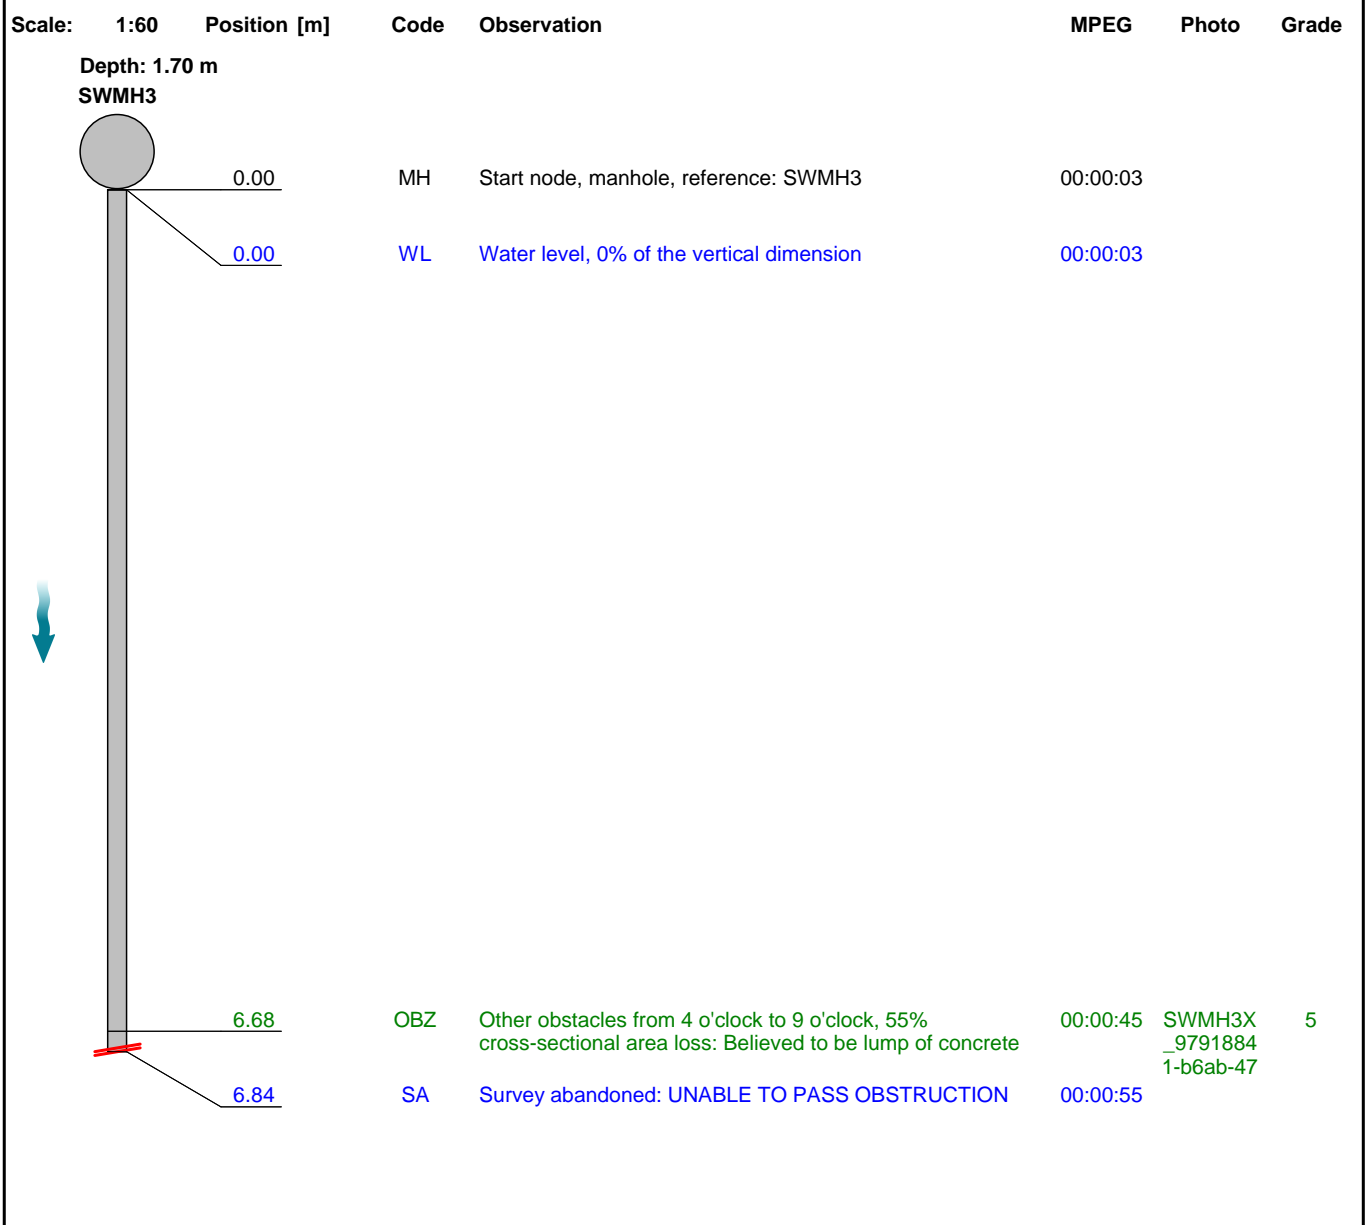
## Section Inspection - 14/02/2024 - SWMH3X

Construction Features					Miscellaneous Features				
Structural Defects					Service & Operational Observations				
STR No. Def	STR Peak	STR Mean	STR Total	STR Grade	SER No. Def	SER Peak	SER Mean	SER Total	SER Grade
0	0.0	0.0	0.0	1.0	1	10.0	1.5	10.0	5.0

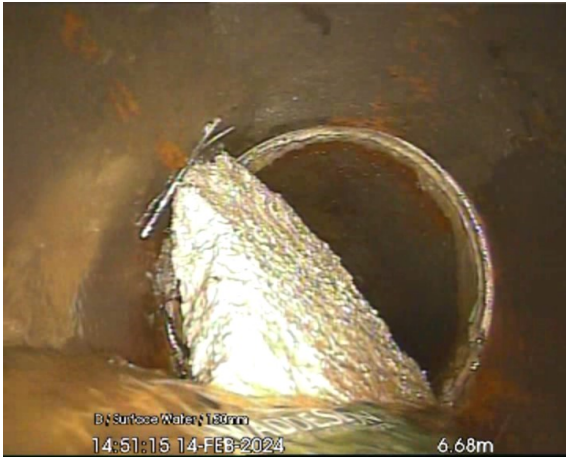
Section	PLR	Grade	Description
2	SWMH3X	5	Other obstacles from 4 o'clock to 9 o'clock, 55% cross-sectional area loss

B:\Surface Water\133mm  
14:51:15 14-FEB-2024 6.68m  
SWMH3X\_97918841-b6ab-4752-98de-a92e181b85d6\_20240  
220\_135933\_332.jpg, 00:00:45, 6.68 m  
Other obstacles from 4 o'clock to 9 o'clock, 55%  
cross-sectional area loss, Believed to be lump of concrete
