DESIGN AND ACCESS & HERITAGE STATEMENT

7 King Street

Sandwich

Recovering of roof, removal of render and structural repairs to brickwork

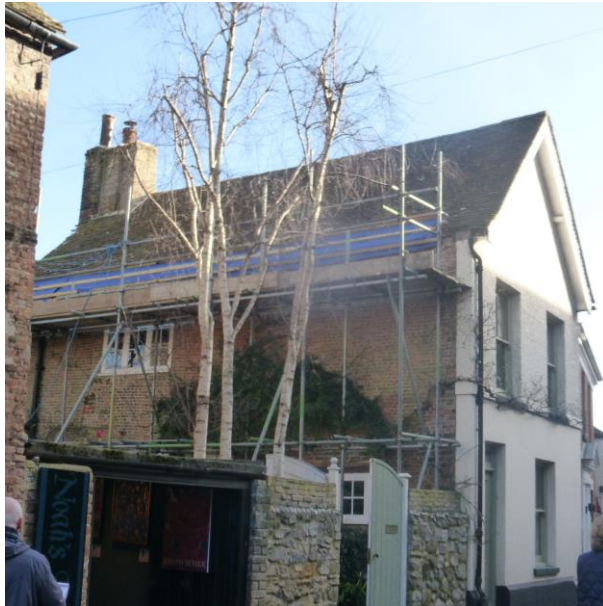
The roof covering is unfortunately now at the end of its useful life. The battens are completely rotten as seen within the roof structure and there is no underfelt. Continuous patch repairs have been carried out but due to the extent of rot to the battens complete recovering of the roof is necessary as during high winds, tiles are frequently dislodged and blown into the street below.

The proposal is to strip all the existing Kent Peg tiles and to salvage as many as possible. The roof will then be recovered with a modern underfelt, tanalised battens and then recovered with Kent Peg tiles.

Several repairs are required to the rafters and sole plate at the same time as the recovering where these are rotten.

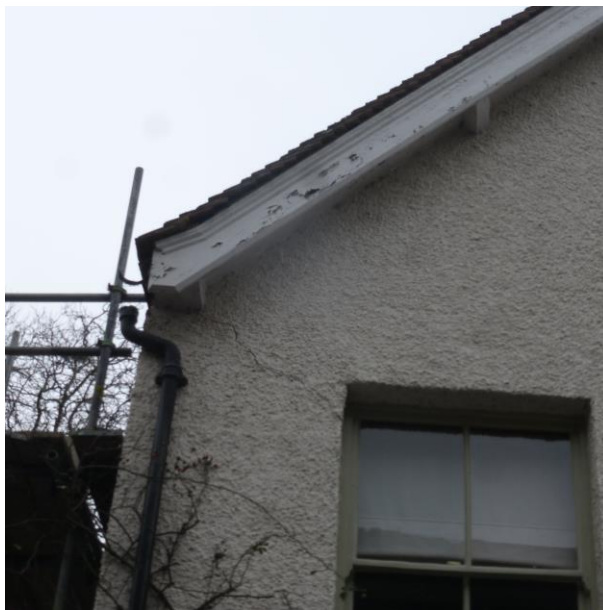
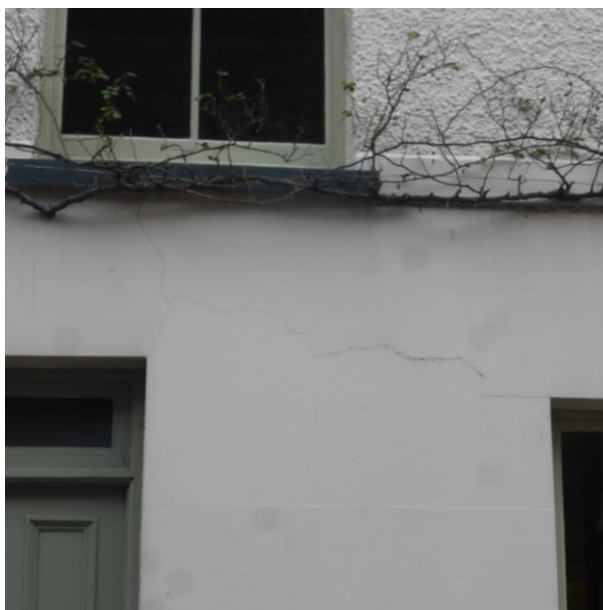
There are diagonal cracks in the render to the front elevation notably to the top left hand side over the bedroom window and to the mid-level as shown on the below photographs and accompanying drawings.

It is anticipated that the repairs to the cracking will be carried out using helical (twisted) stainless steel rods which can be concealed in the mortar joints and then be unseen. The extent of the cracking can be assessed once the render has been removed, in small areas to be agreed with the Conservation Officer of Dover District Council.

It is also proposed to completely remove the smooth render at ground floor and pebble dash render at first floor to expose the existing red stock brick work. The brickwork will then be cleaned using DOFF system and the brickwork repointed in a lime based mortar mix.
