# Arboricultural Consultancy for Lloyds Bank

## 1. Case Details

Insured	Nicholas Richardson	Address	3 High Meadows, Kirk Ella, Hull, HU10 7NJ		
Client	Subsidence Management Services	Contact	John Morrison	Claim No.	IFS-LBG-SUB-22-0101724
ES Ref	SA-250503	Consultant	Giles Mercer	Contact No.	0330 380 1036
Report Date	11/10/2022

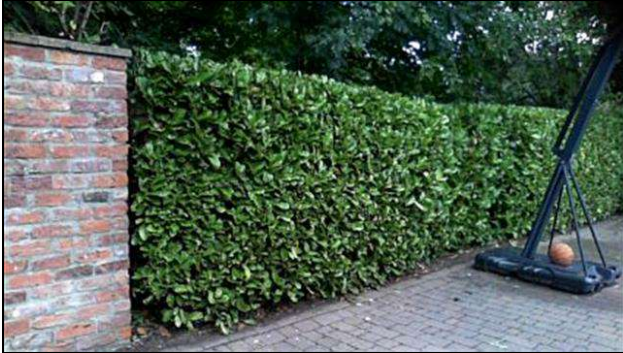
H1 - Laurel (Cherry)

Tree No.	Species	Age Cat	Approx. Height (m)	Distance to Building (m) *	Ownership	Action	Requirement
C1	Wisteria	1	2	0.1	C - Insured	Action to avoid future risk	Maintain at broadly current dimensions by way of regular pruning.
H1	Laurel (Cherry)	1	2	4.1	C - Insured	Action to avoid future risk	Maintain at broadly current dimensions by way of regular pruning.
T3	Willow (Goat)	1	9.1	2.5	A - Third Party	Action to avoid future risk	Do not allow to exceed current dimensions by way of regular pruning. Distance quoted relates to garage.

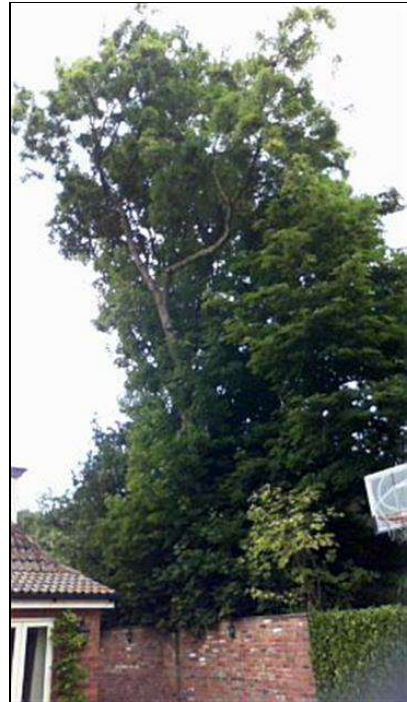
T1 - Sycamore

With due regards to species profile, size and proximity, the Sycamore (T1) and the Ash (T2) are considered the dominant features proximate to the focal area(s) of movement and accordingly, where vegetation is confirmed as being causal, we have identified them as the primary cause of the current subsidence damage.

Tree No.	Species	Age Cat	Approx. Height (m)	Distance to Building (m) *	Ownership	Action	Requirement
T1	Sycamore	3	21	5.6	A - Third Party	Remove	Remove close to ground level and treat stump to inhibit regrowth.
T2	Ash	3	21	4.75	A - Third Party	Remove	Remove close to ground level and treat stump to inhibit regrowth.

Consequently, we have advocated the complete removal of the Sycamore (T1) and the Ash (T2) as it will offer the most certain arboricultural solution likely to restore long-term stability.
