Validation Letter

Our Ref: M41977-JNP-XX-XX-RP-G-0026-P01

Re: Former Sunninghill Gas Works – Validation of Capping Layer for Plots 54- 63 inclusive (Block H - Apartments)

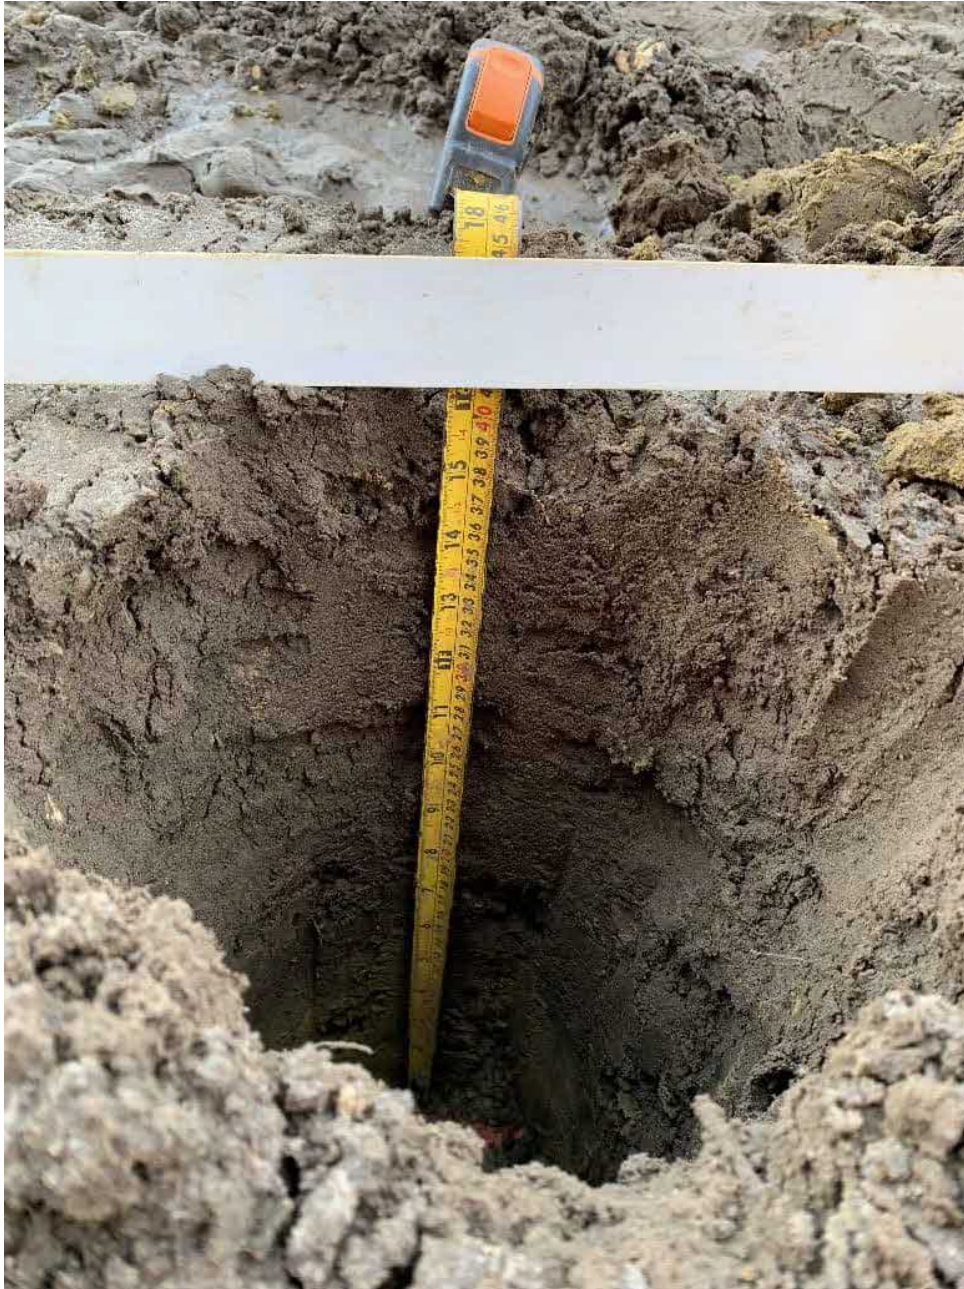
Block H Landscaping area capping layer with geotextile visible

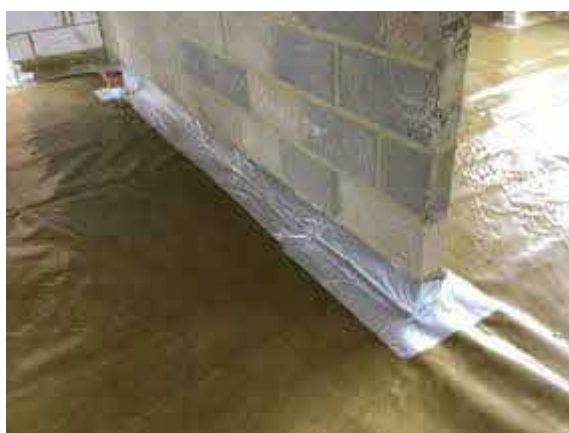
Retro fit detail using SAGM to the internal block work wall.

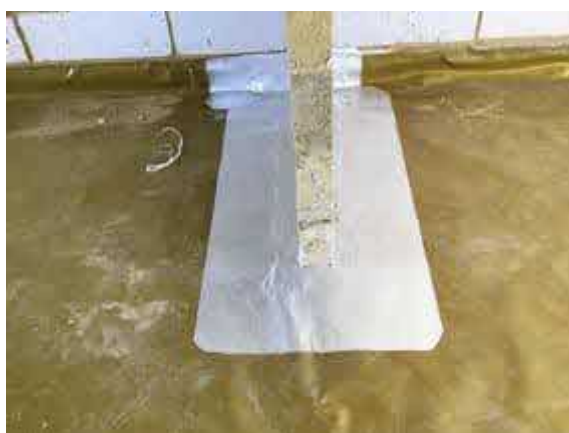
Plot 3 retro fit detail over the damaged membrane that is under the internal block work wall.

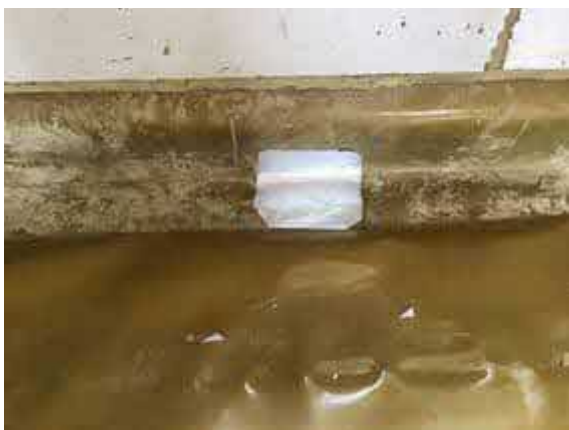
Plot 7 patch repair using SAGM.

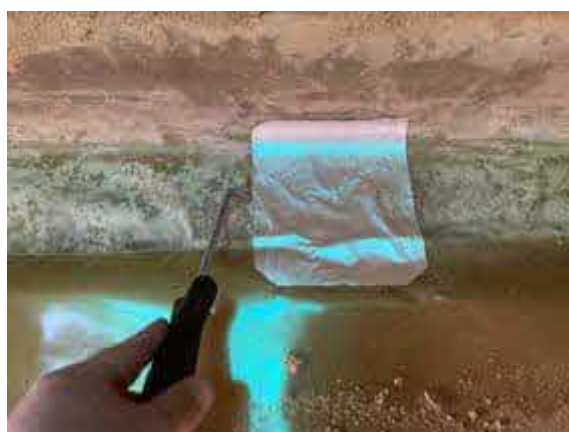
Plot 29 - Pick test upon a successful patch repair using SAGM.

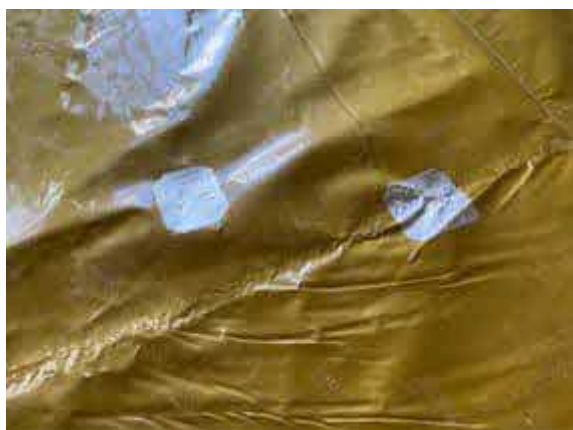
Plot 30 - Patch repairs using SAGM.

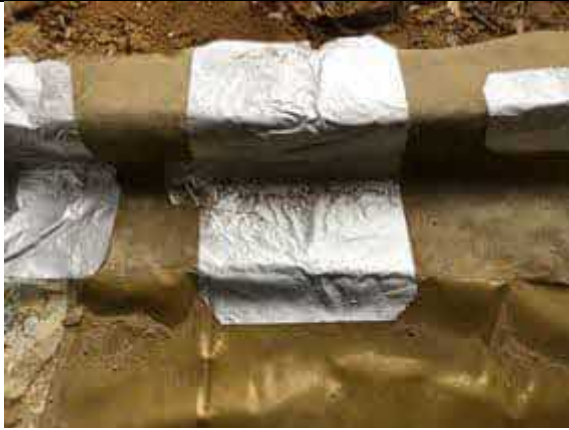
Plot 27 patch repair using SAGM to damage caused by follow on trades.

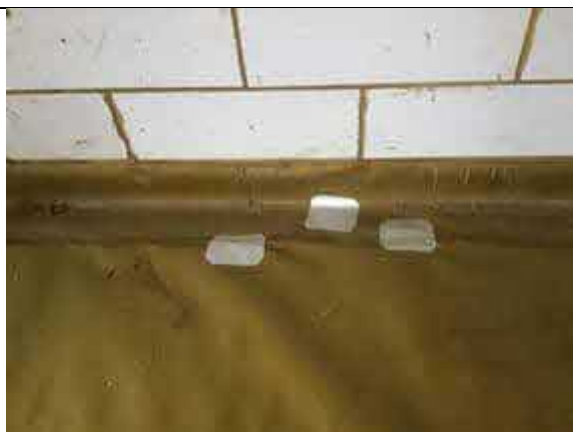
Patch repairs using SAGM to plot 36.

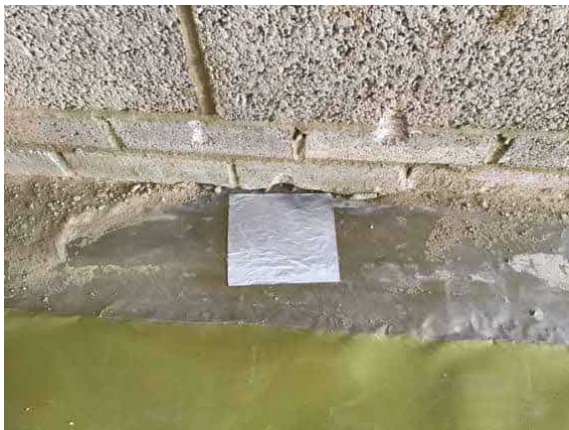
Patch repair using SAGM to damaged perimeter membrane in plot 41 garage.
