Validation Letter

Date: 18 October 2023

Our Ref: M41977-JNP-XX-XX-RP-G-0021-P01

Re: Former Sunninghill Gas Works – Validation of Capping Layer for Plot 42 (Block C)

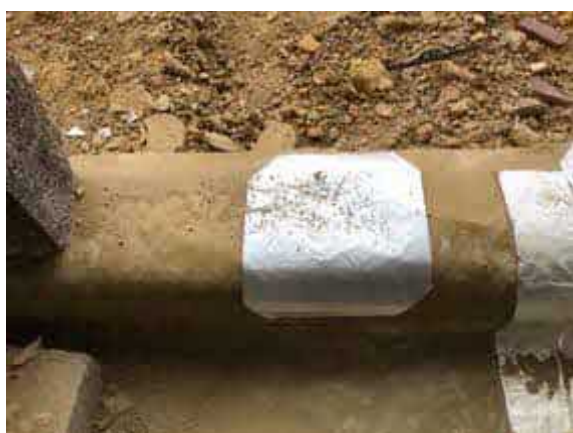
Patch repair using SAGM to damaged perimeter membrane.

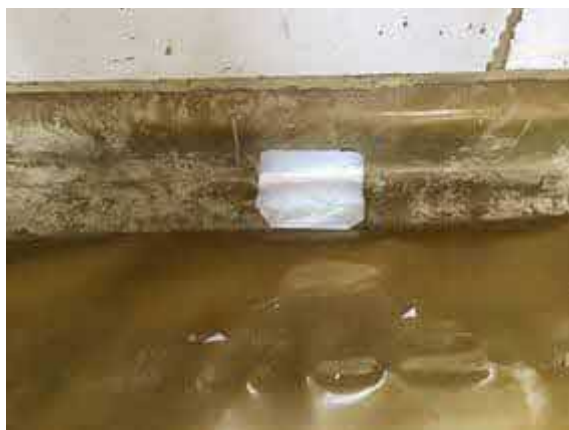
Plot 7 patch repair using SAGM.

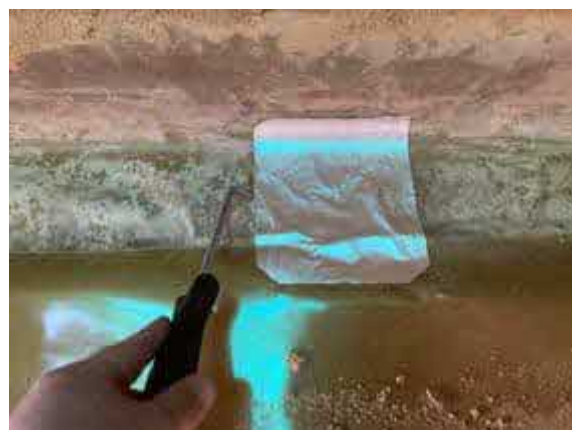
Plot 29 - Pick test upon a successful patch repair using SAGM.

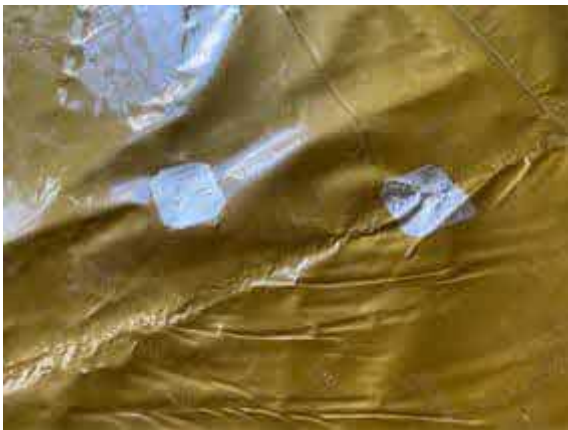
Plot 30 - Patch repairs using SAGM.

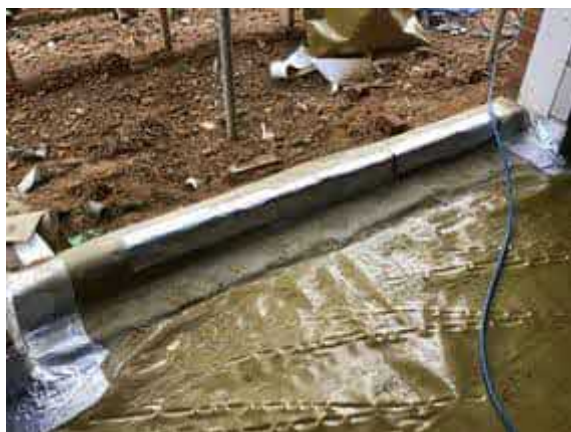
Repaired damaged to the door threshold due to follow on trades using SAGM.

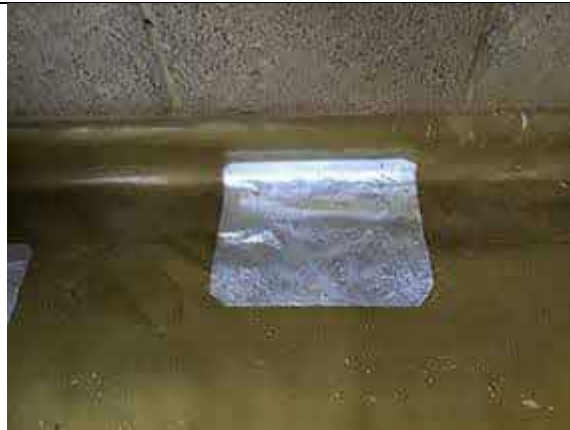
Repaired damaged perimeter membrane using SAGM to plot 39.

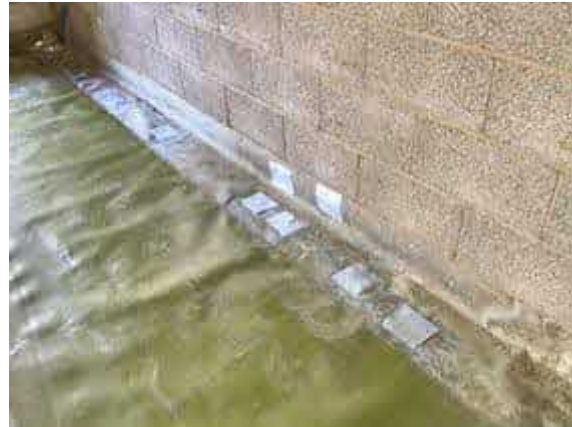
Patch repairs to damaged perimeter membrane using SAGM to plot 67.

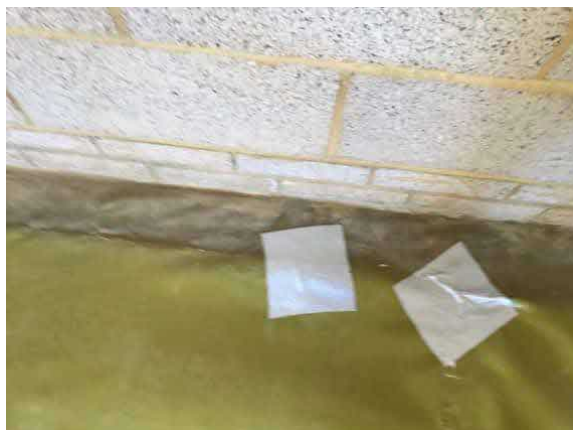
Patch repairs using SAGM to damaged membrane.
