Validation Letter

Our Ref: M41977-JNP-XX-XX-RP-G-0027-P01

Re: Former Sunninghill Gas Works – Validation of Capping Layer for Plots 64-67 inclusive (Block I)

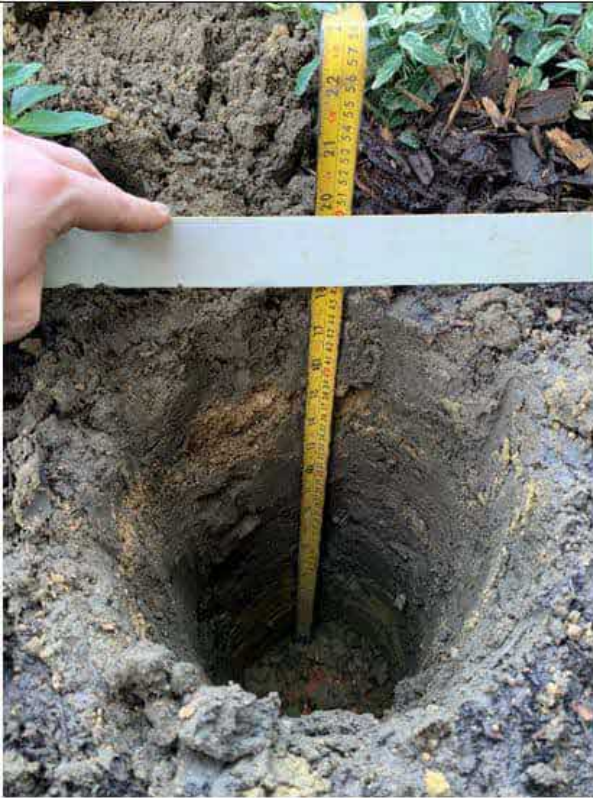
Photo : Plot 64 front garden showing depth to geotextile.

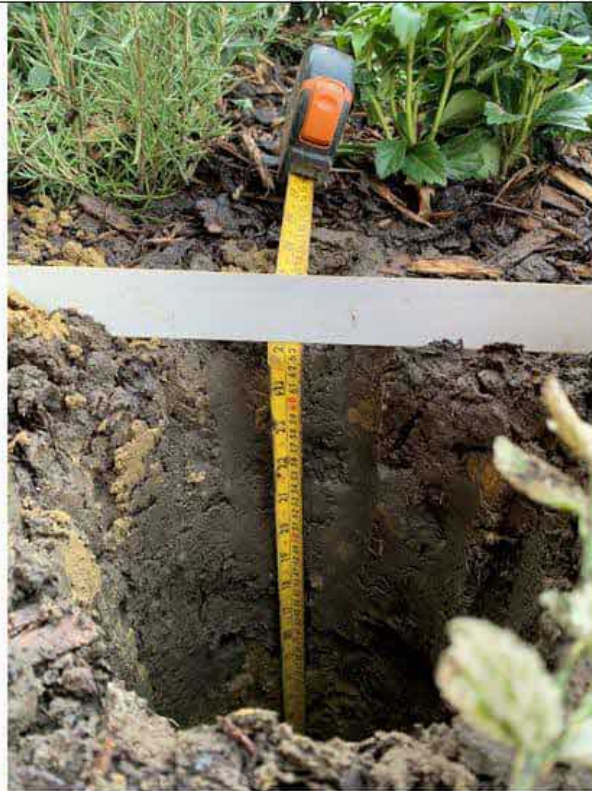
Photo : Plot 67 front garden showing depth to geotextile.

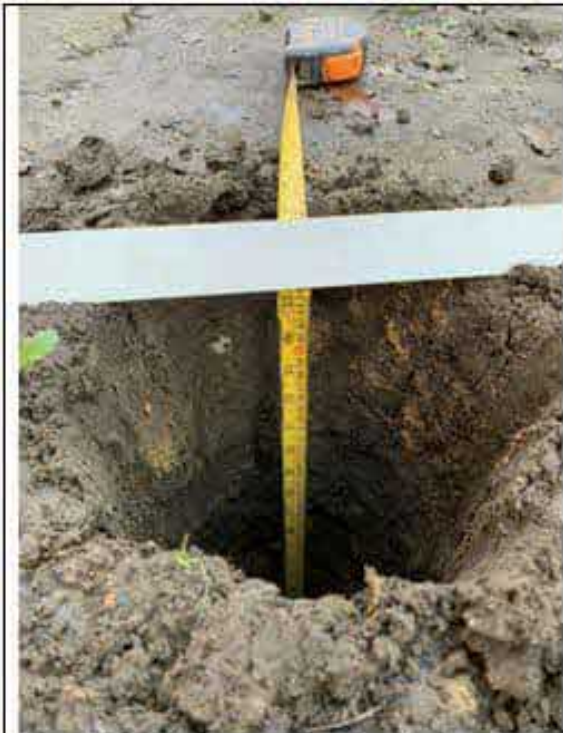
Photo : Plot 64 rear garden showing depth to geotextile.

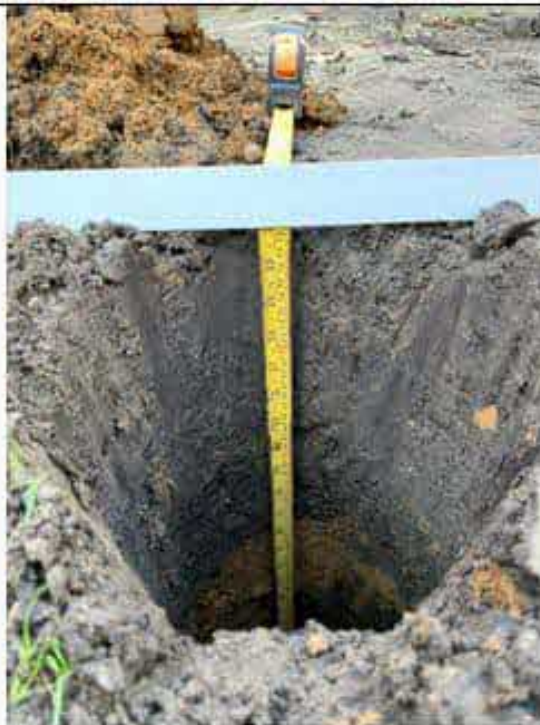
Photo : Plot 66 rear garden showing depth to geotextile.

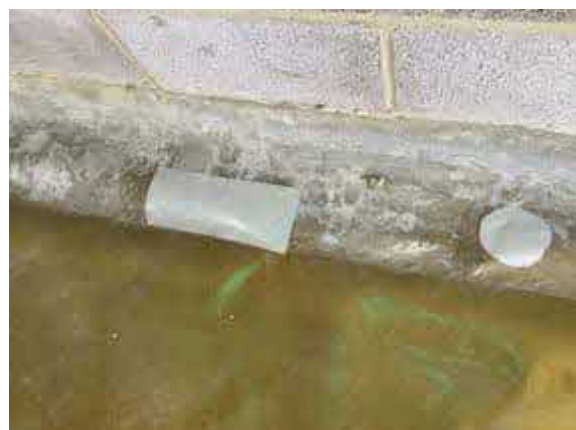
Plot 4 patch repair using SAGM.

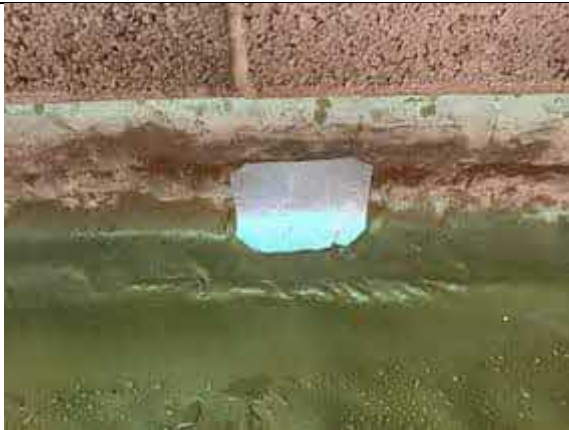
Plot 34 patch repair using SAGM to damaged perimeter membrane.

Prior to our inspection patch repairs were made by the installers to the damaged perimeter membrane caused by follow on trades and repaired using SAGM to plots:

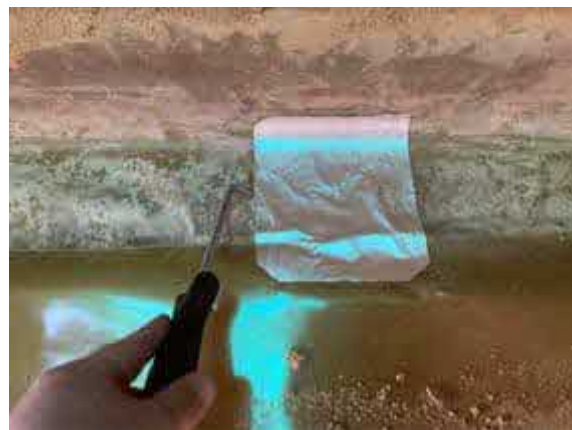
Plot 29 - Pick test upon a successful patch repair using SAGM.

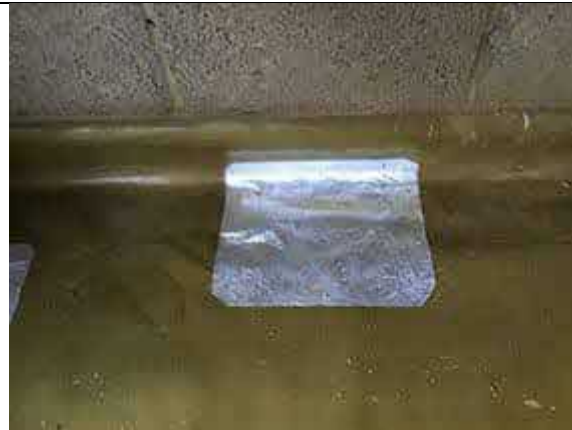
Repaired damaged perimeter membrane using SAGM to plot 39.
