RECORD OF SITE VISIT

<p>JNP GROUP CONSULTING ENGINEERS</p> <p>www.jnpgroup.co.uk</p>	<p>Site: Former Sunninghill Gas Works, Ascot</p> <p>Client: Berkeley Homes</p> <p>Job No: M41977</p>
<p>Date of Inspection: 19th May 2021 Time: 11:10 – 12:30 PM</p> <p>Weather: Warm and sunny. 15°C. Inspection made by Hilary Ilsley</p>

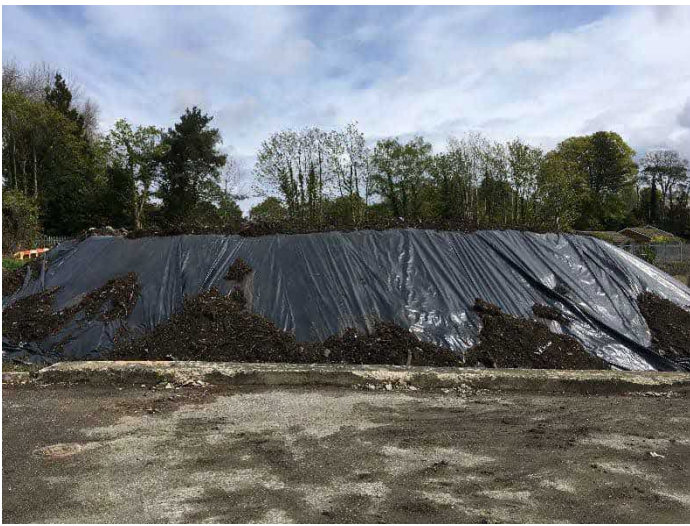
Stockpile of contaminated soil awaiting off-site disposal.

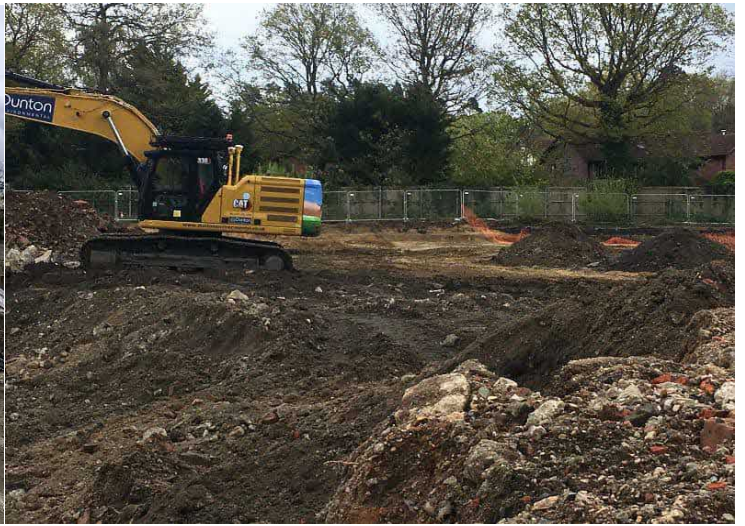
Excavation in central site.

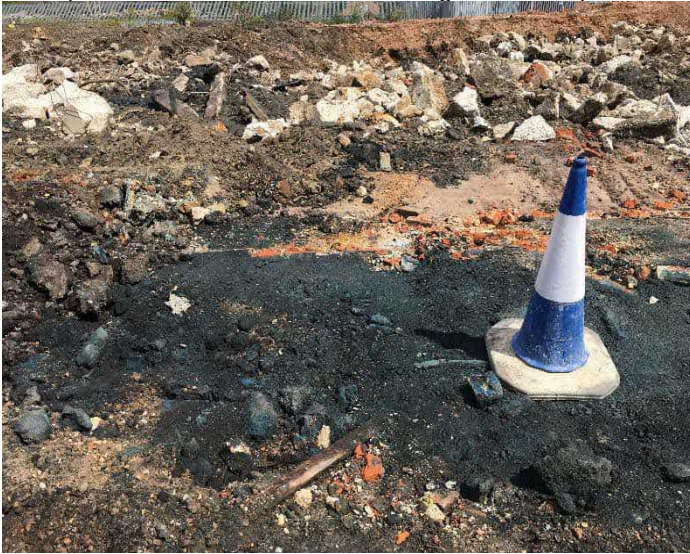
Spent oxide within soils along HV electricity cable route.

The line of the HV EC remains prominent in the central eastern area, marked by blue cones and spent oxide contaminated Made Ground. When the diversion work occurs, to avoid stockpiling the intention is to load this material directly onto the haulage lorries.

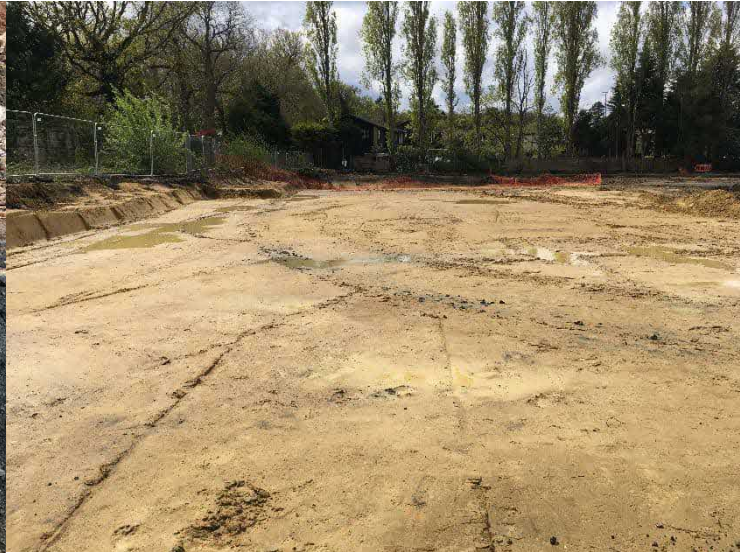
Excavation area in south-east corner, onto natural ground.

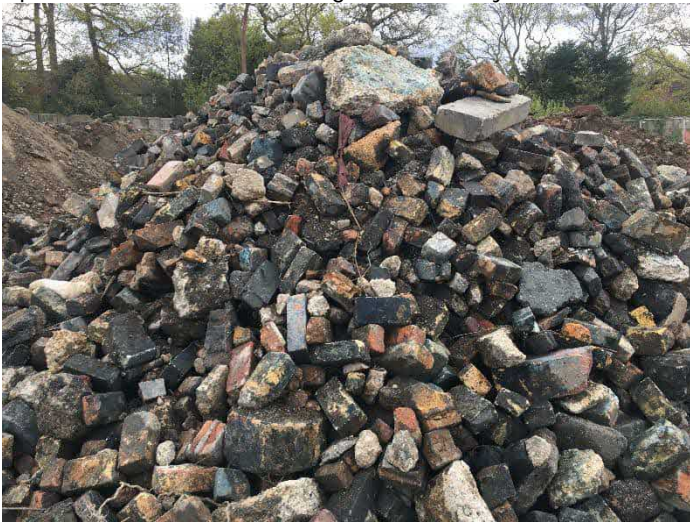
Rubble / concrete stockpile.

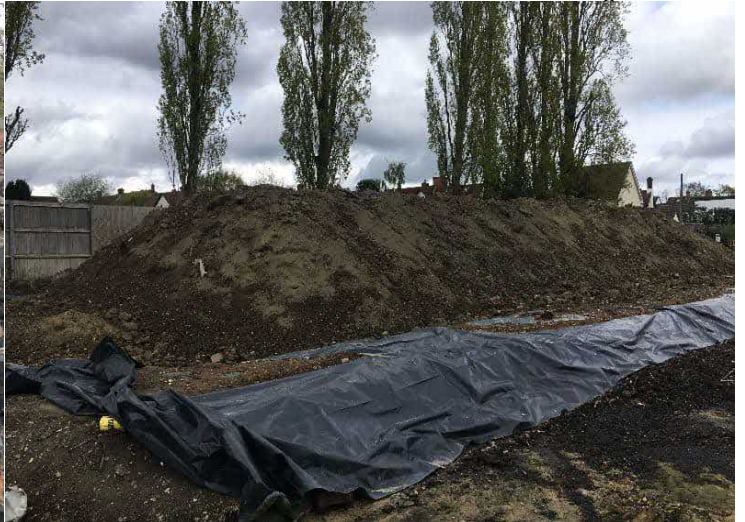
Windrow Turning.

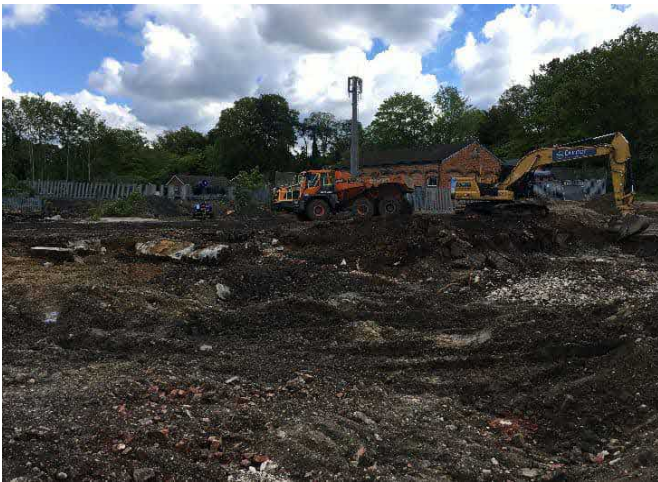
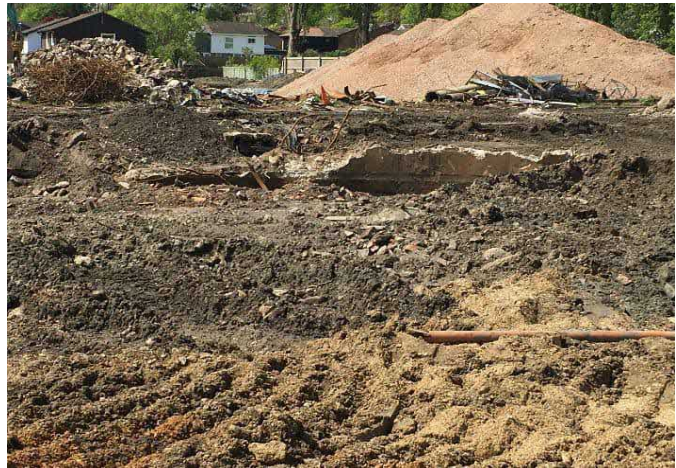
Remediation work has moved into central section – with two former gasholder remaining brick walls being uncovered by hot spot 4 and then moving east. The larger of the two was backfilled with a variety of material including wood, tyres, brick work to partially demolished walls, Made Ground and natural ground. This material has to be removed due to the piling requirements. Some of it has been screened and some of it has gone to treatment area.

Excavations in central site – former gasholder basins.

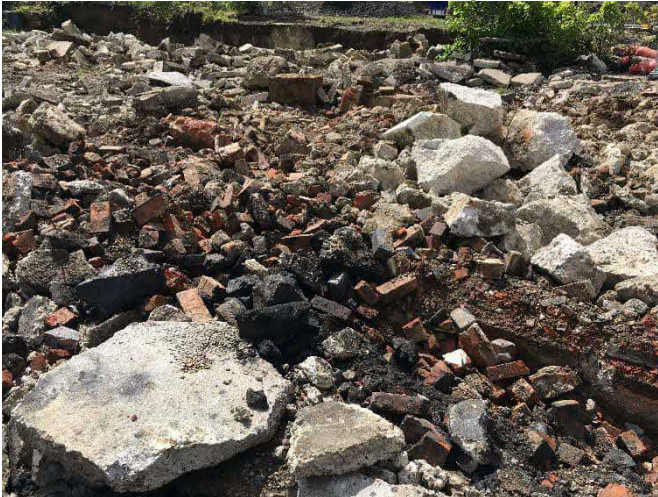
The concrete around area 1 in north-east corner has been broken out. A metal pipe containing tar had been uncovered. However, some of the PRB BH were not visible; the borehole closest to the rail line (adjacent to the cone) is PRB 109. The one directly south is PRB 110. Duntons are looking for PRB108, which is to the west of PRB110. BH 202 remains. The slab up to the SE compound has been broken out so we can place our monitoring borehole. A notable tarry odour is present in this area but localised.

Broken out concrete in NE corner.

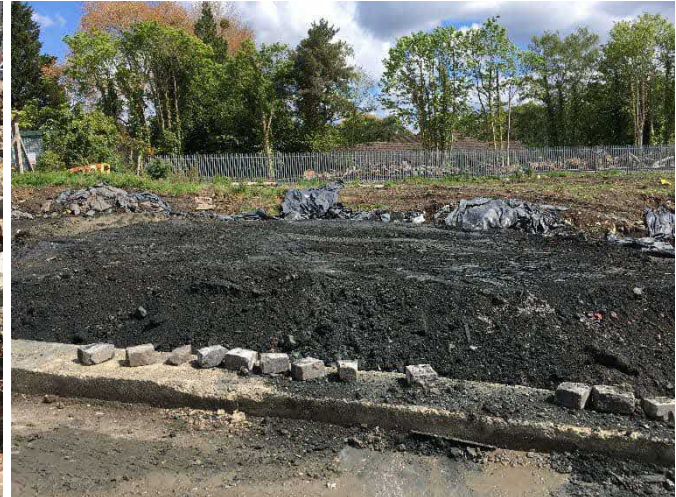
Odour suppression is in operation. They are looking to use a foam system to assist. They have received numerous complaints over odours. The EHO (Michael McNorty) is scheduled to visit site next day. The main reason for the strong odour is that the spent oxide stockpile located by the main gate (north-west corner) is being removed off-site. The majority of it has gone leaving a small volume – that at present is uncovered.

Remains of Spent Oxide Stockpile.

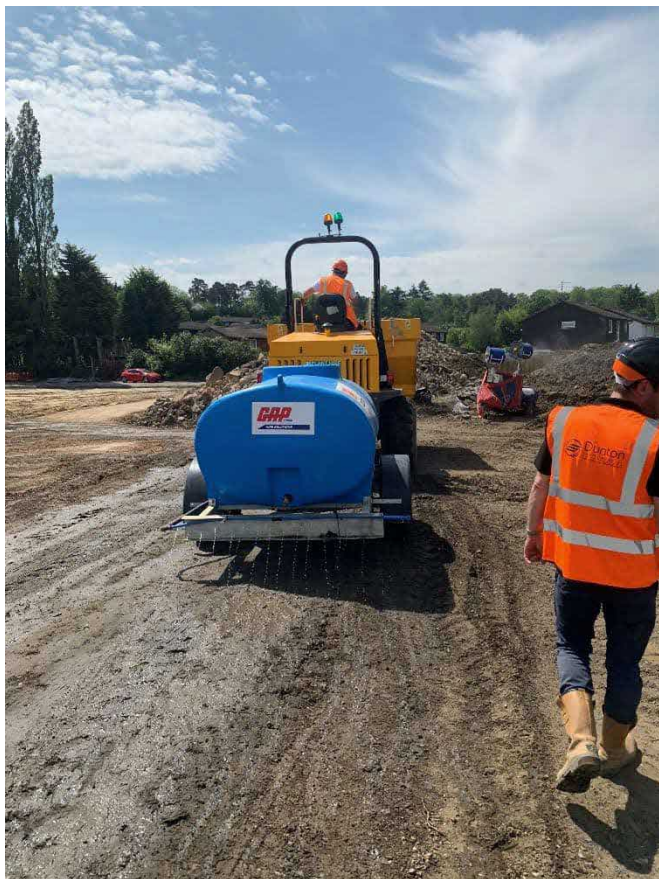
Dust suppression measures were in place, with a mobile unit spraying on all access tracks and a static unit over the contaminated material.

Mobile dust suppression

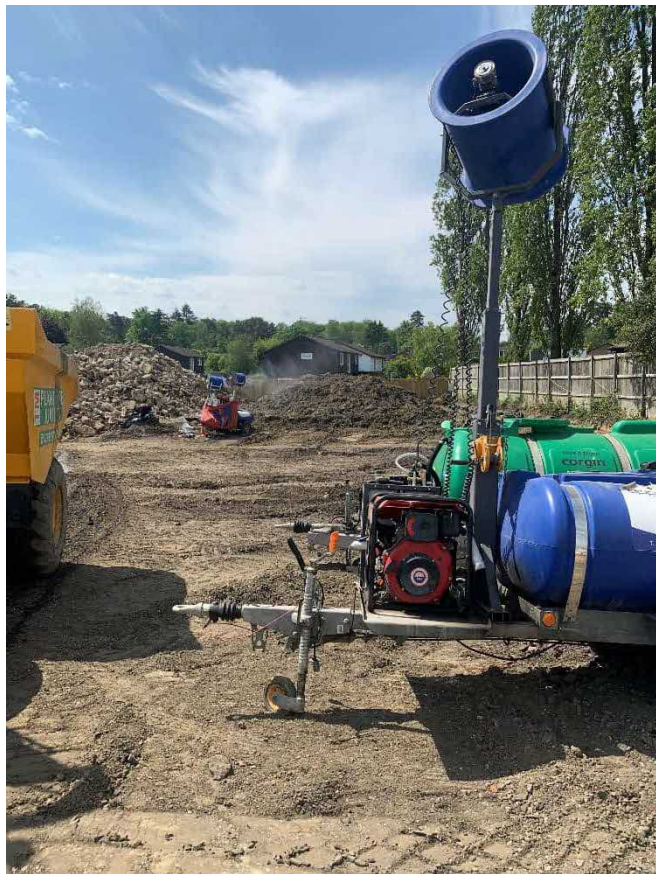
Static dust suppression

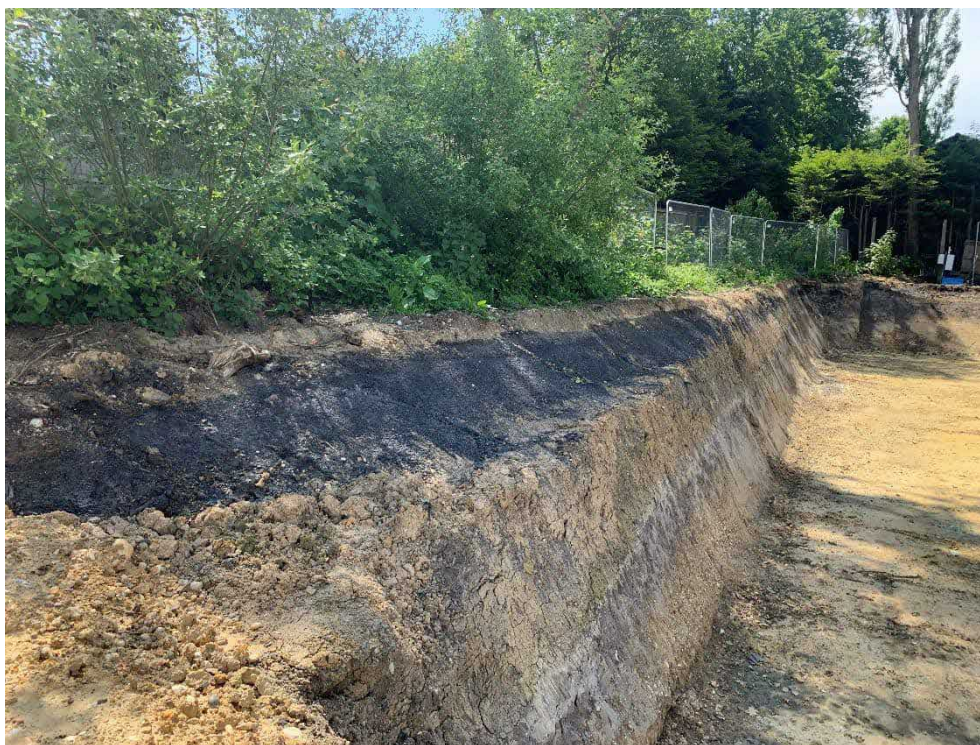
South-eastern area with fenced off TPO area.

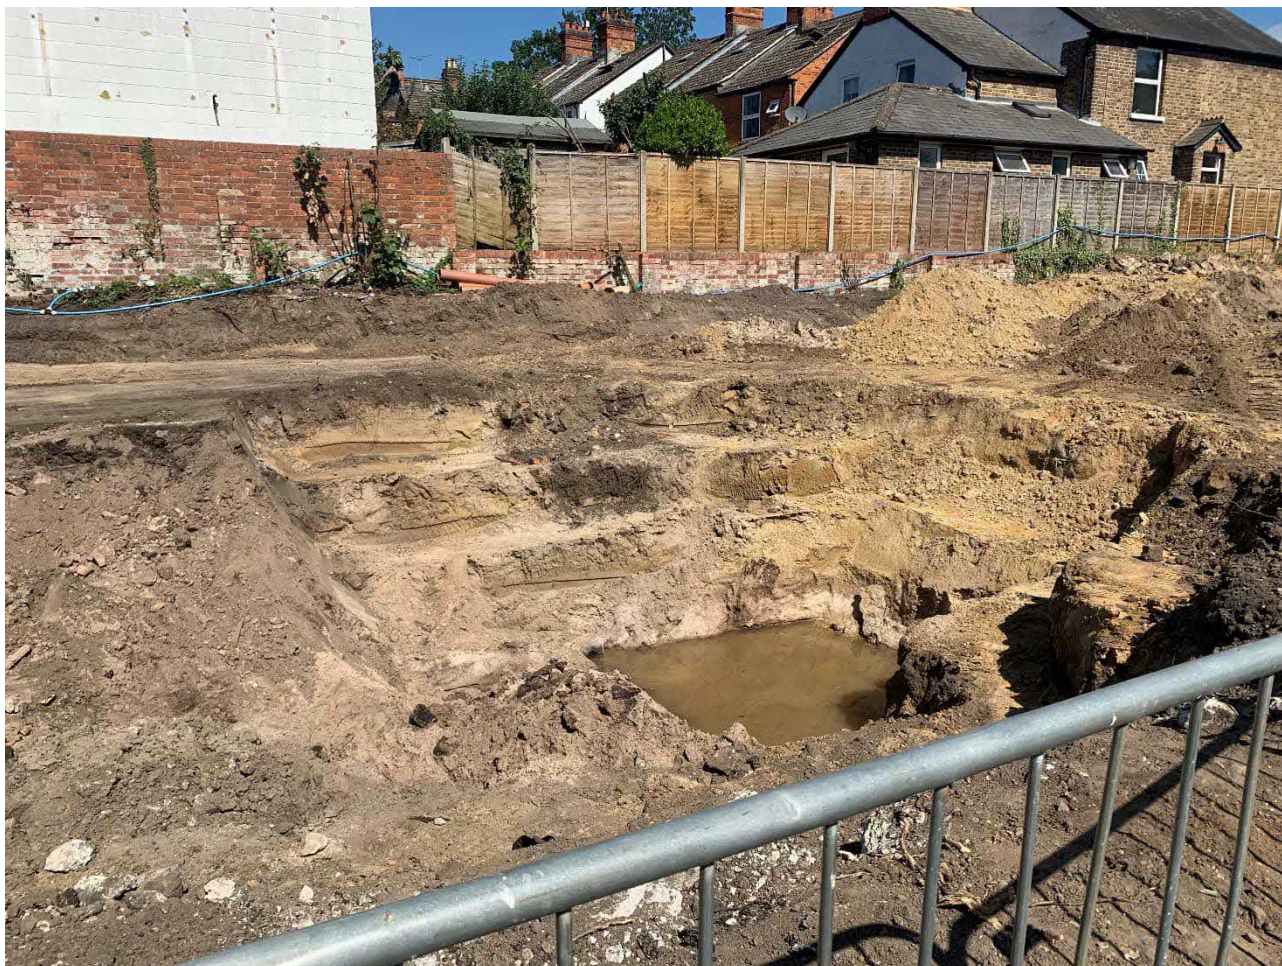
Site inspection indicates demolition and remedial works ongoing. A deep, partly flooded excavation was present in north-west of the site. A windrow of black oily soils present in treatment area.

Excavation in north-west of the site

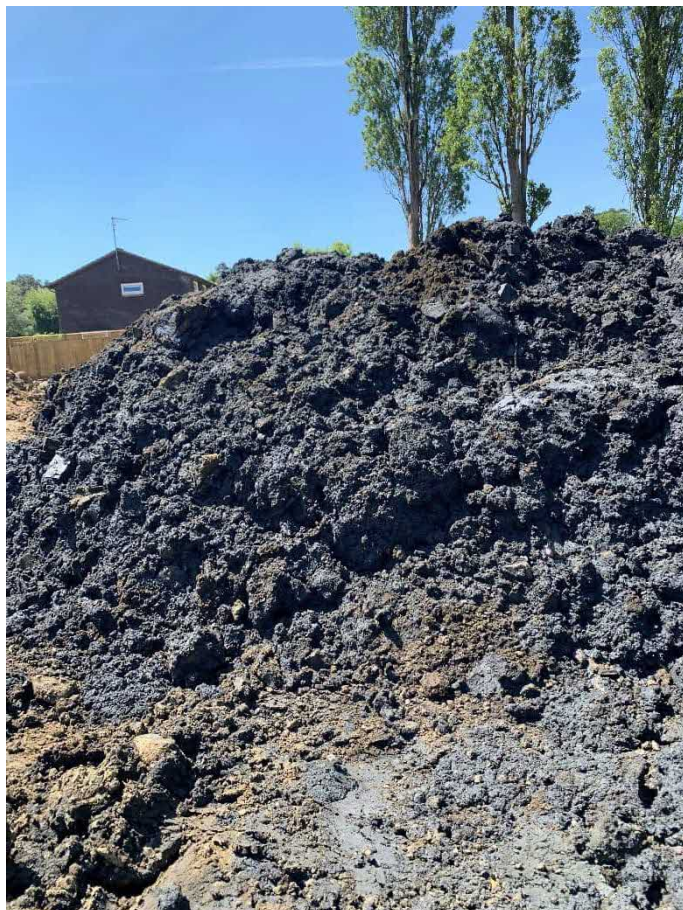
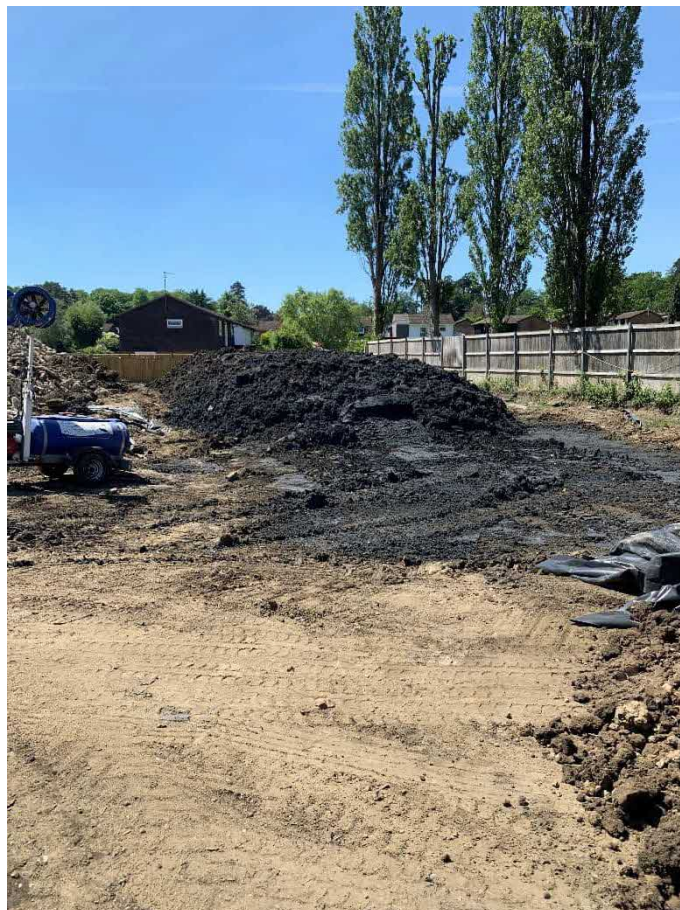
Windrow of contaminated material in south-west of the site

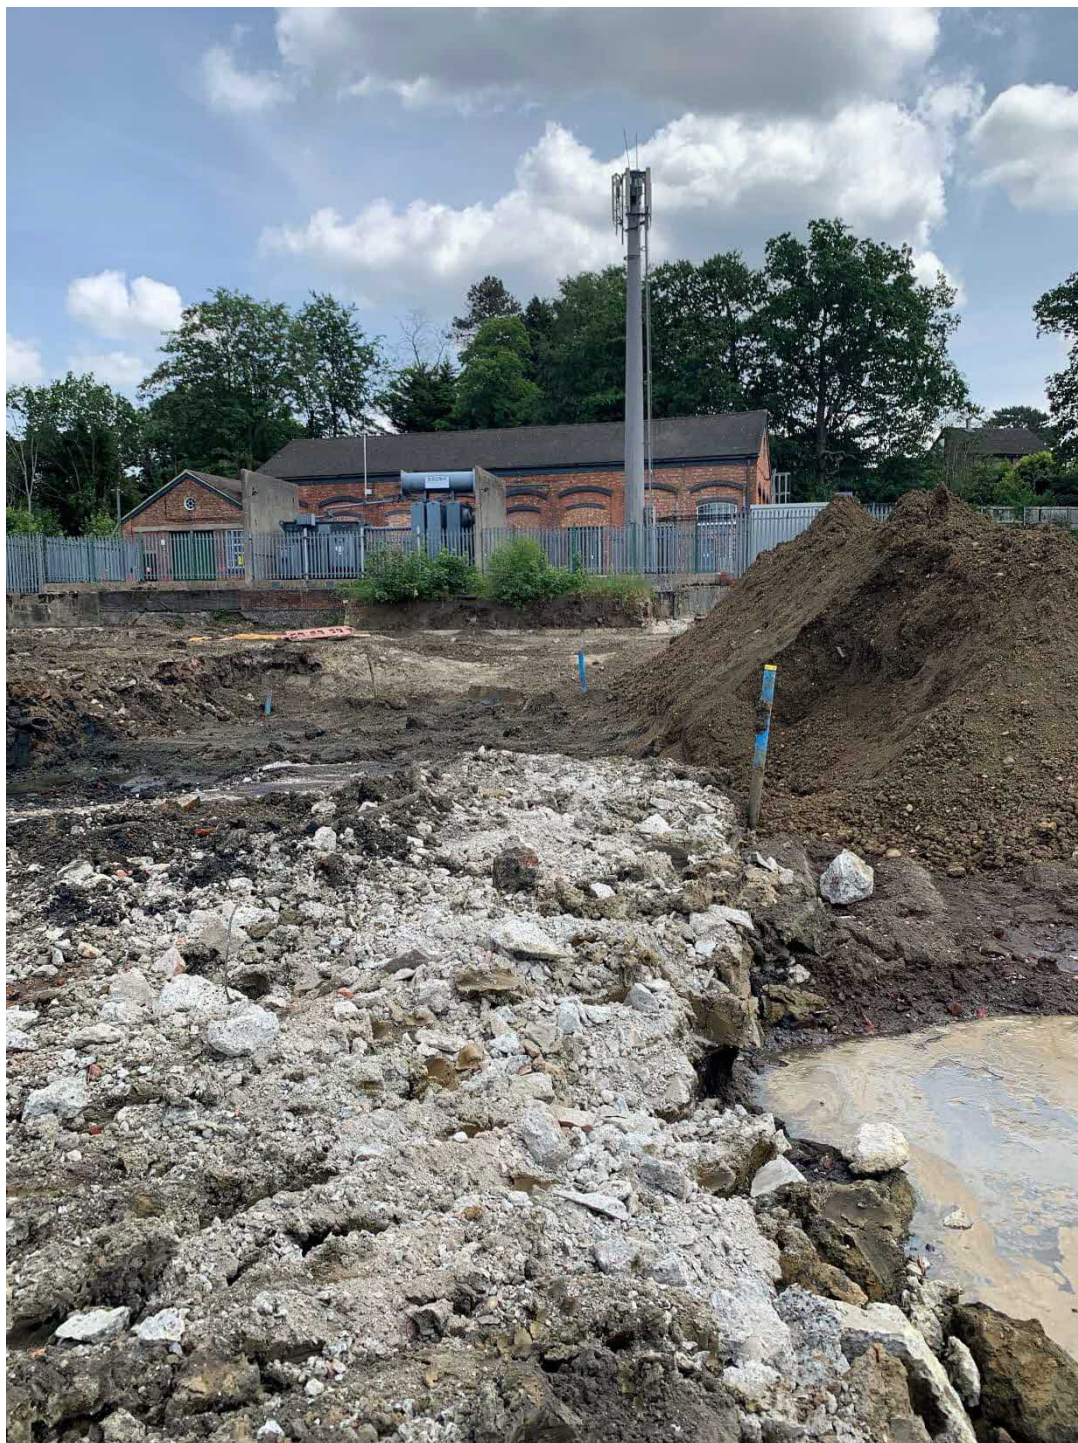
Blue borehole tops of PRB104, PRB108, PRB110, BH202B and PRB117 visible. Dunton asked to preserve all pipes as long as possible.

Remaining borehole pipes in north of the site.

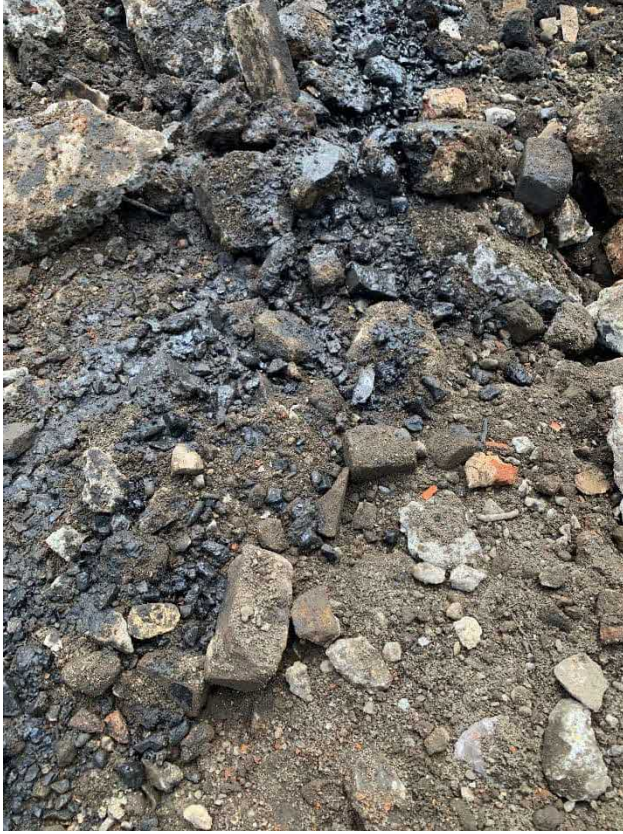
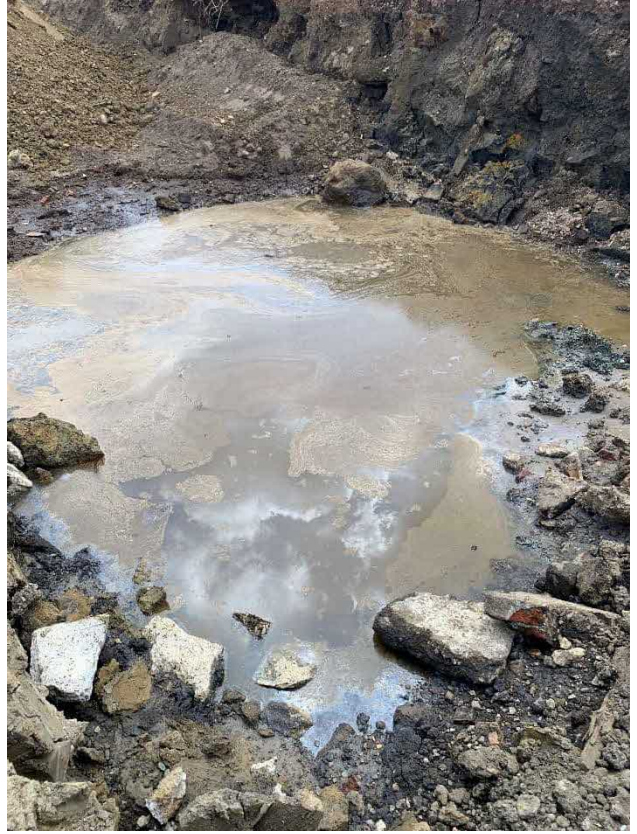
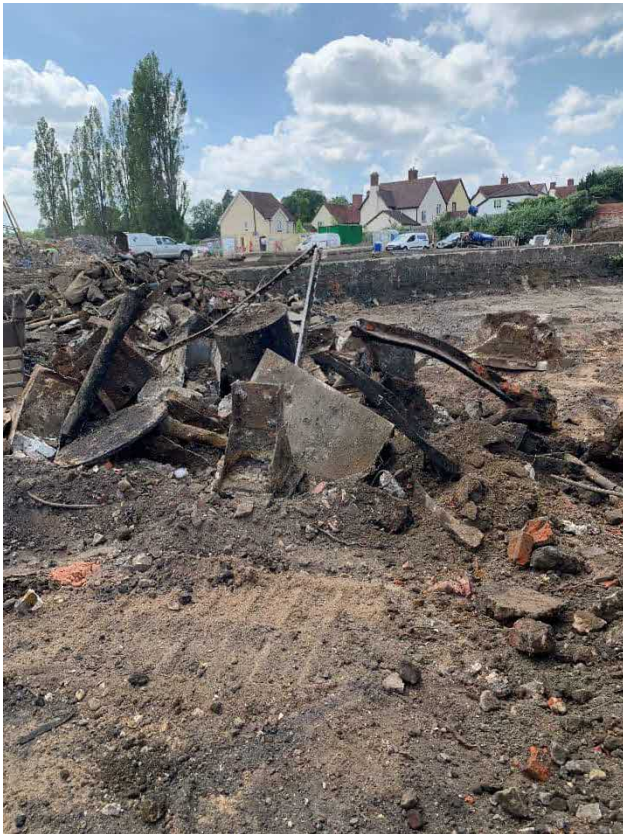
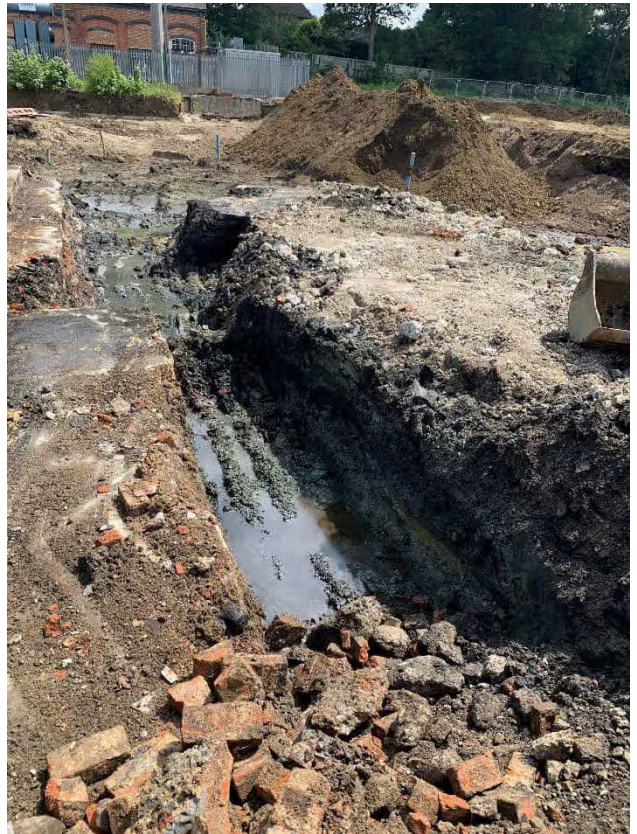
Excavation of contaminated soils and demolition of substructures continues within the north of the site. Excavations into black oily soils recorded in the north-centre of the site in proximity to PRB104, PRB108 and PRB110. Deeper excavations are flooded, with oily water present with a 'scum' on top.

Demolition progress and remedial excavations.

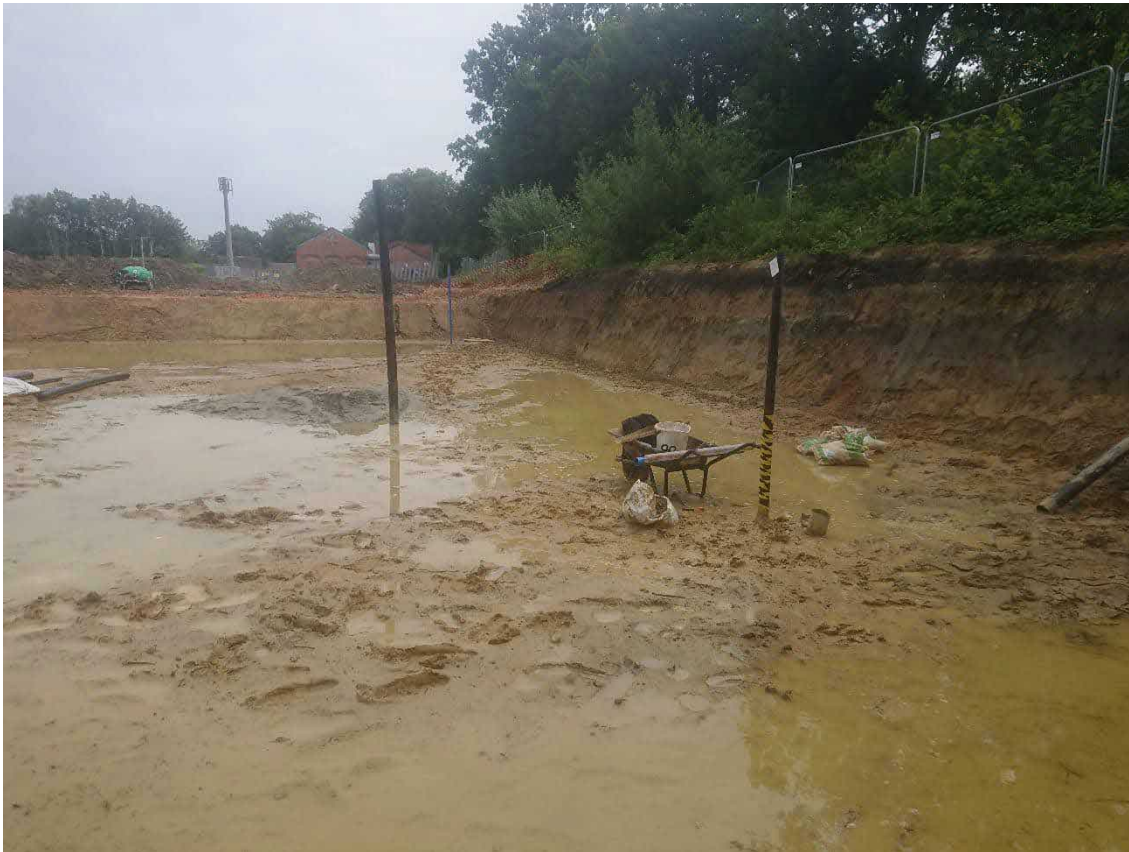
DS105, BH304 and BH305 and remedial excavation

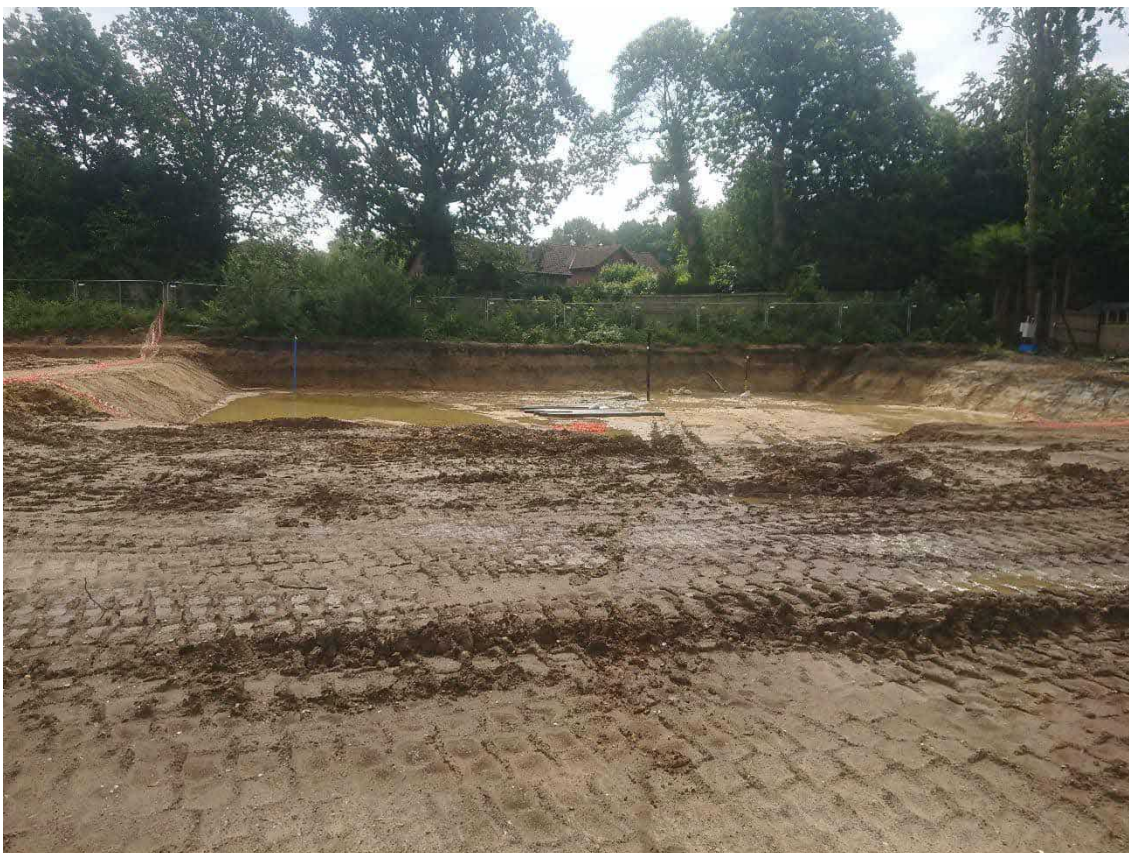
South-east part of the site, remedial excavation

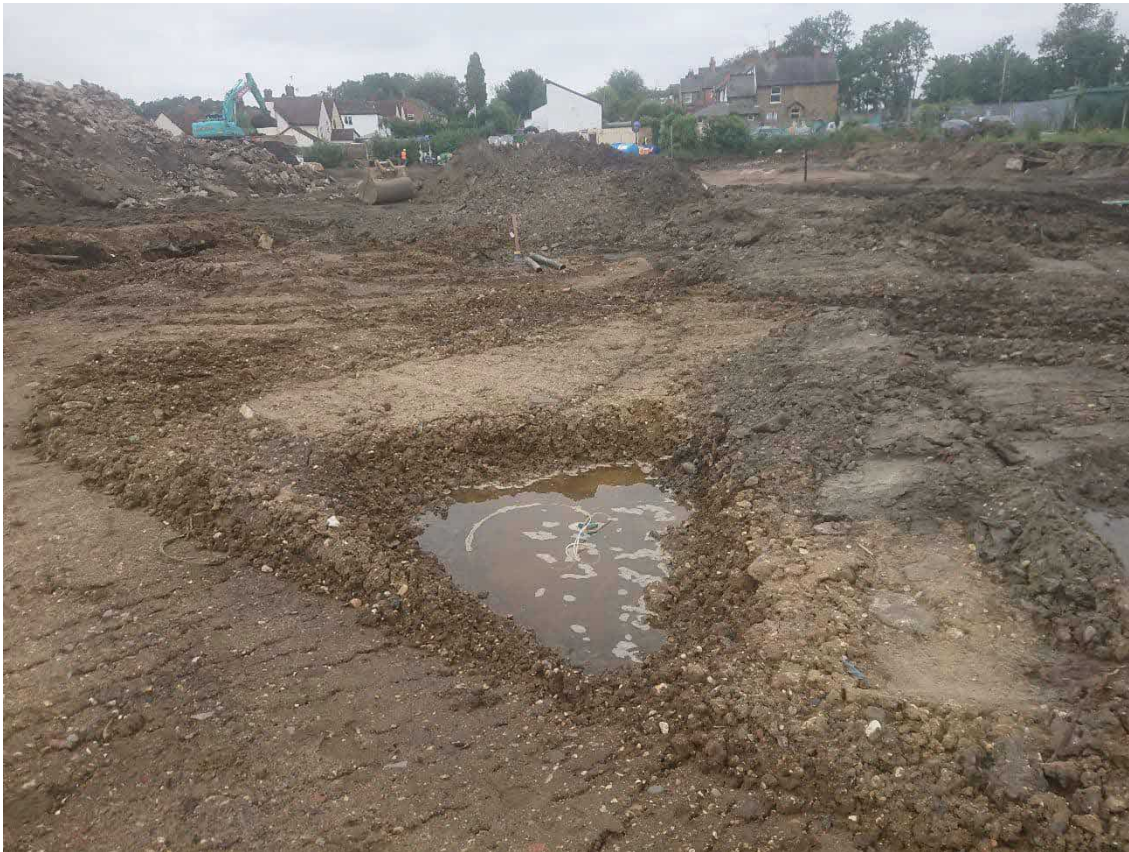
PRB110 was found to be under water, in a flooded part of the site.

North of site, PRB108 and PRB110

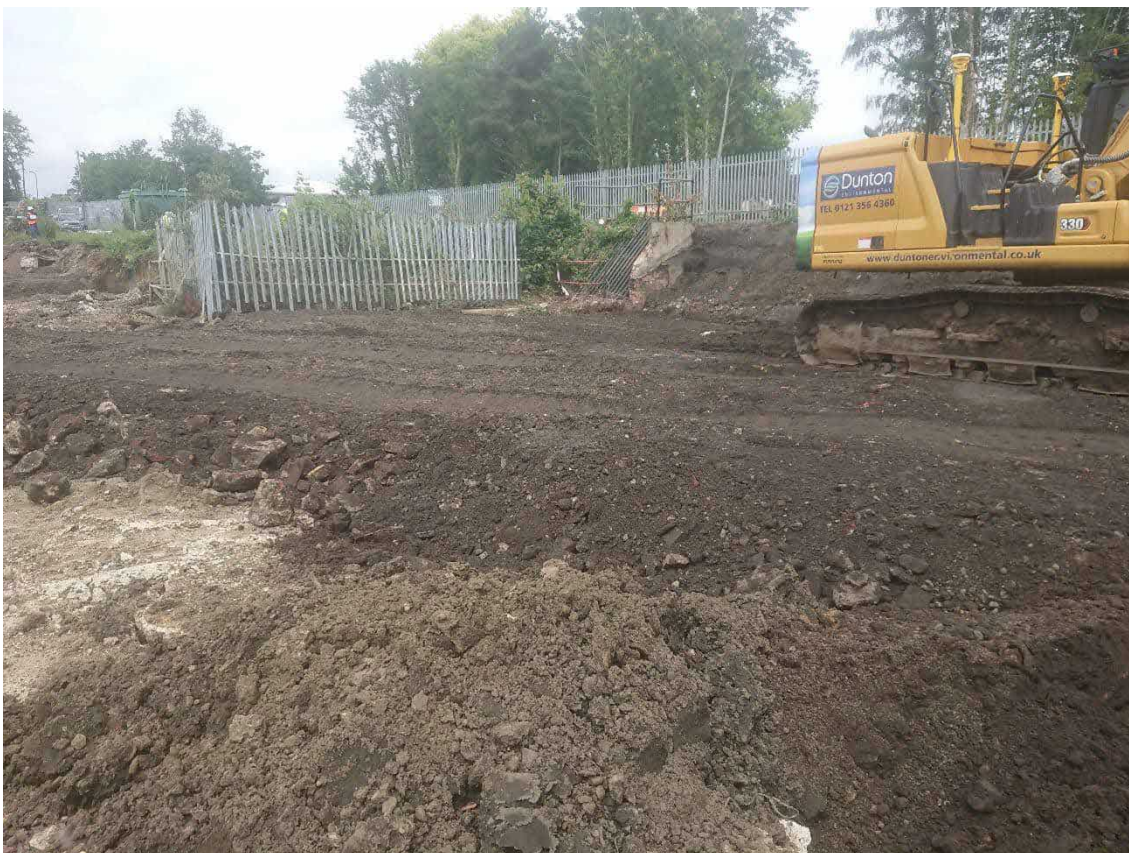
Filling in north-east of the site

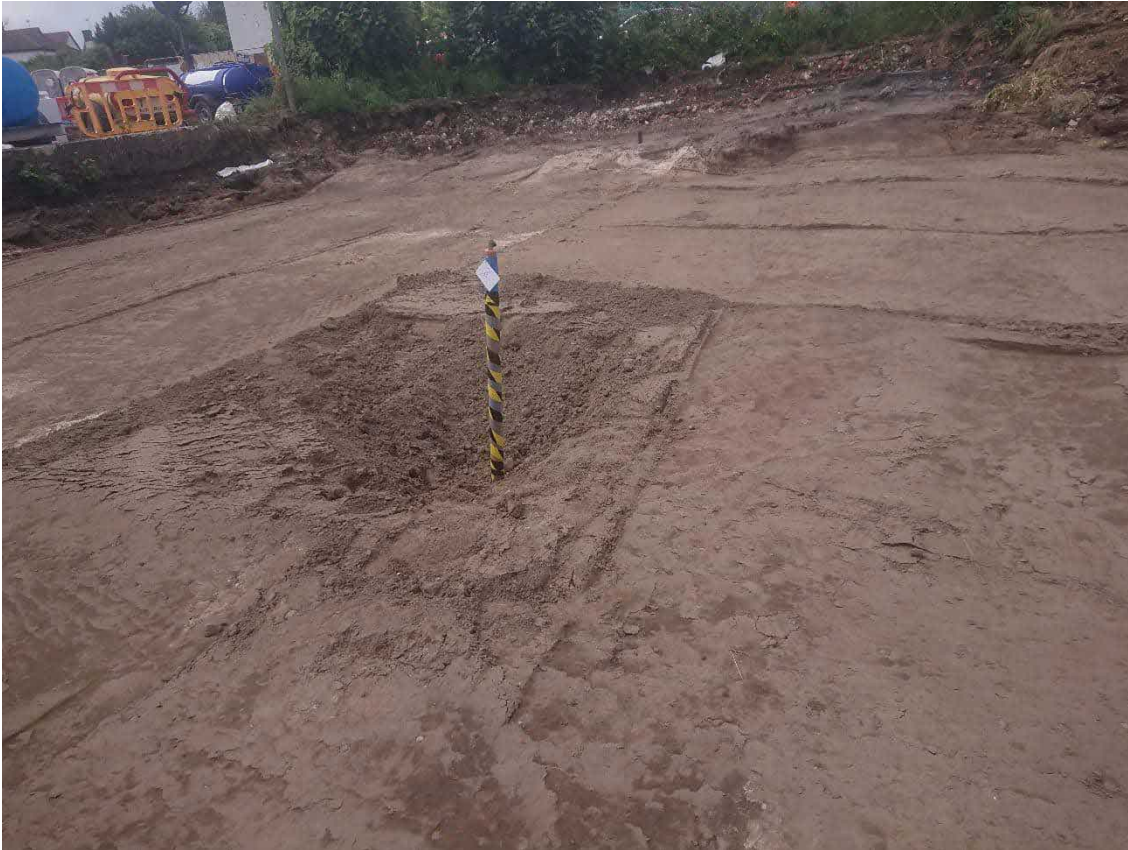
At request of Dunton's, a number of the previously installed boreholes were extended upwards with additional pipework, in order to allow for raising of site levels. Due to damage sustained during site demolition, the tops of BH202B, BH203 and MWA1 were found to be partly crushed. Repairs were undertaken however the boreholes remained partly crimped and bent.

Filling in north-west of the site, DS01 and MWA1

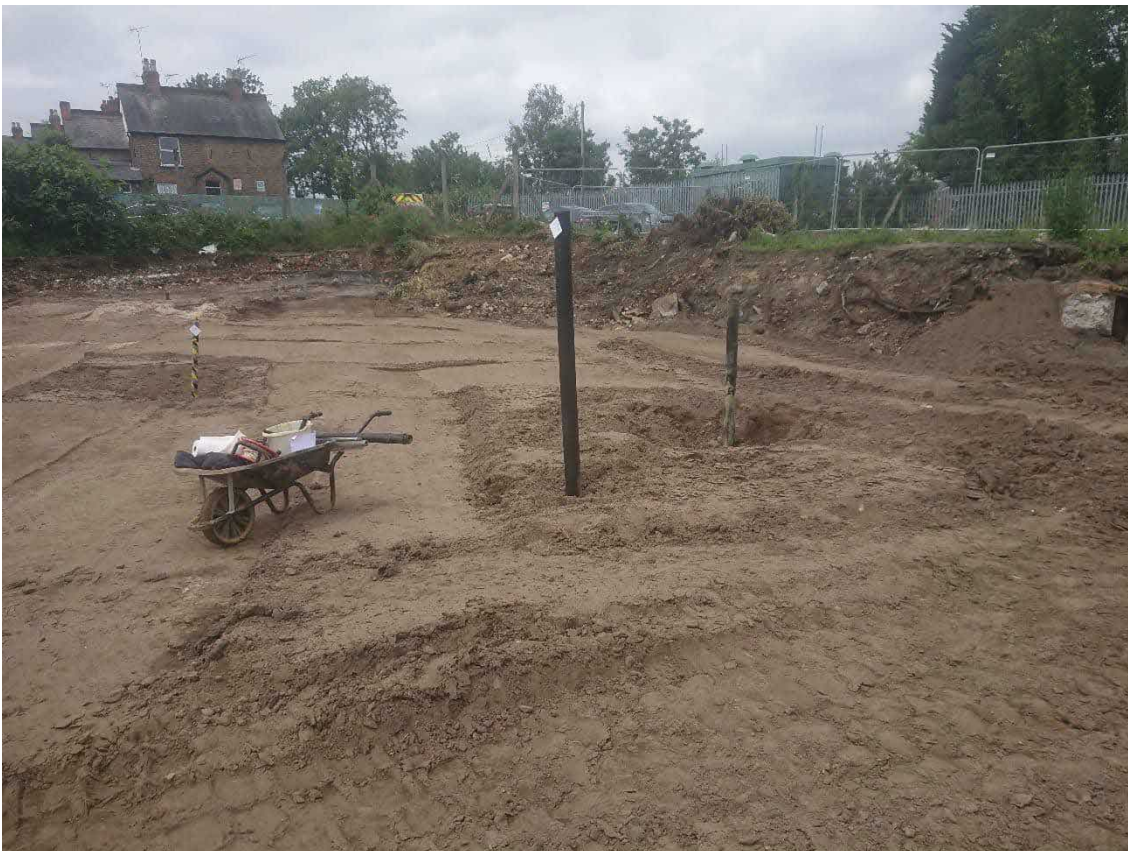
BH306 and BH307 area

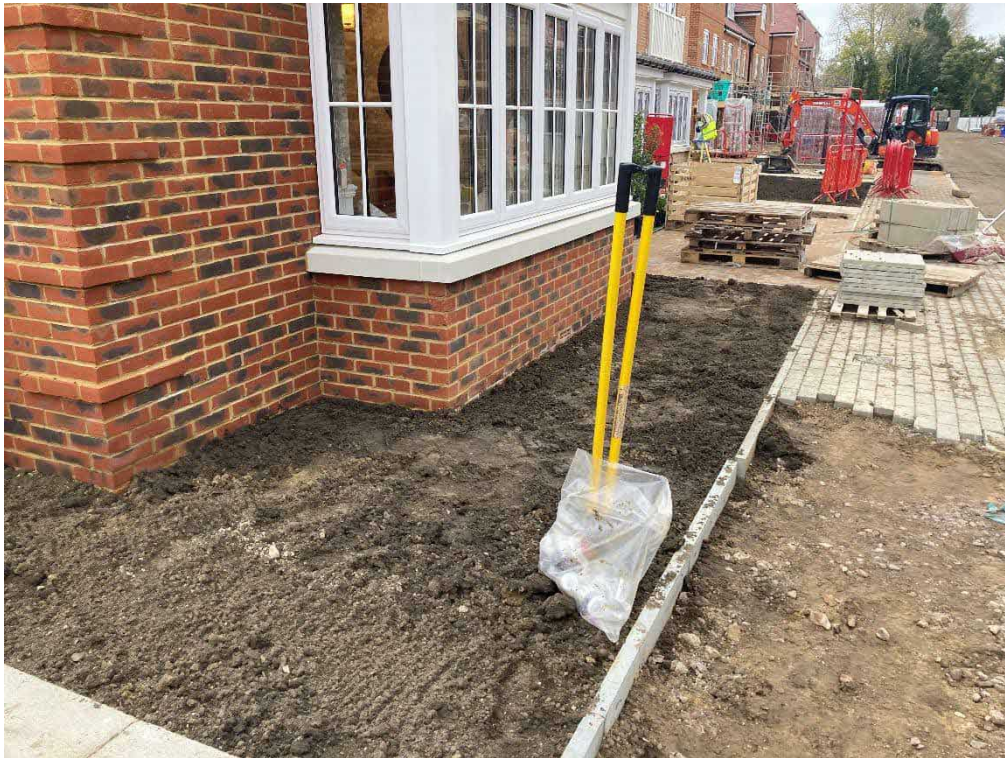
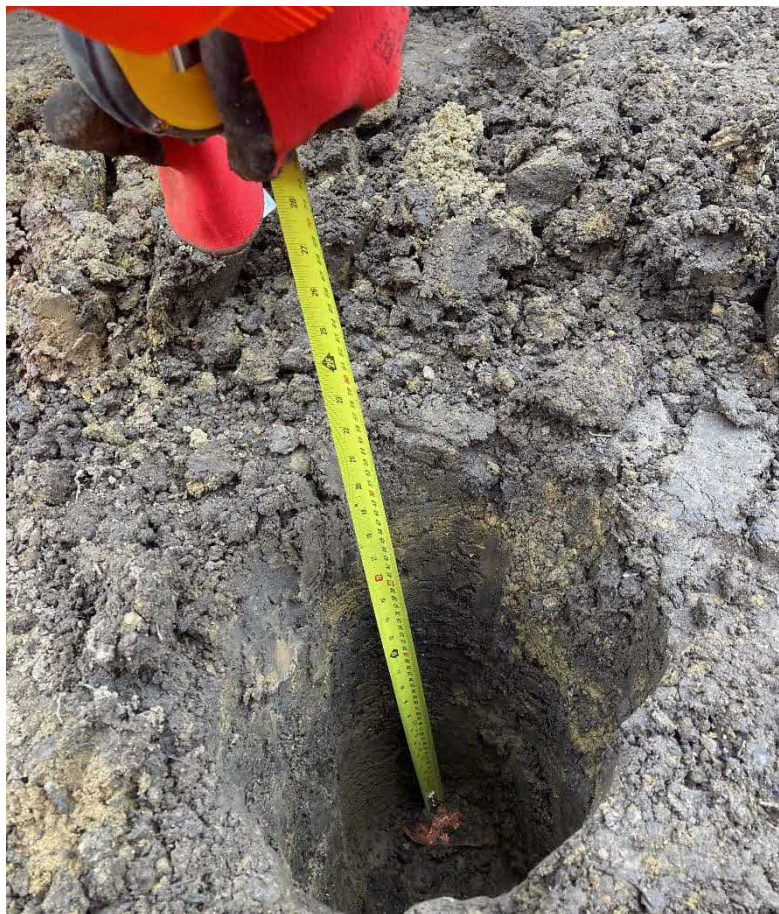
Photo 1: Plot 1 (front garden)

Plot 1 front garden had 300 mm bgl of topsoil, over subsoil which consisted of soft grey very sandy CLAY with occasional fine to medium sub-angular to sub-rounded flint gravel to 500 mm bgl, overlying a geotextile. A hand pit was undertaken to 0.50 m and samples were taken from the subsoil (at 0.40 m bgl) and were scheduled for heavy metals, speciated PAH, TPH CWG, asbestos, SOM and pH.

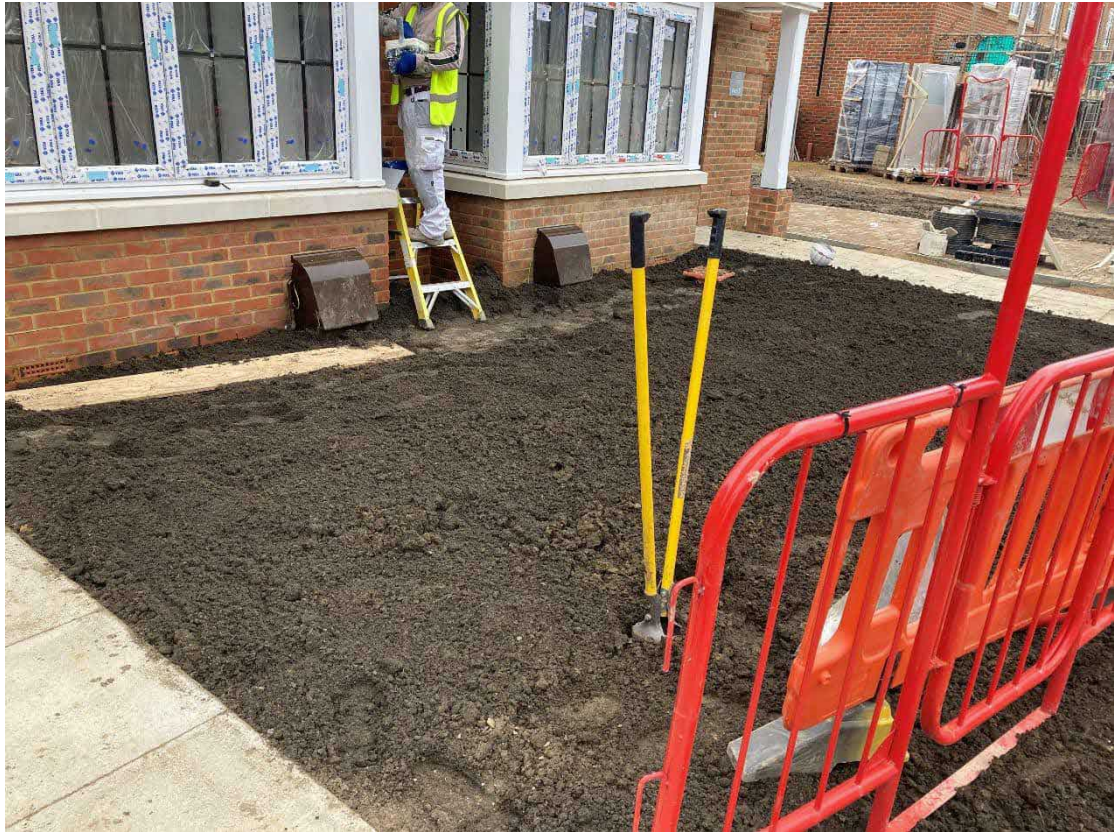
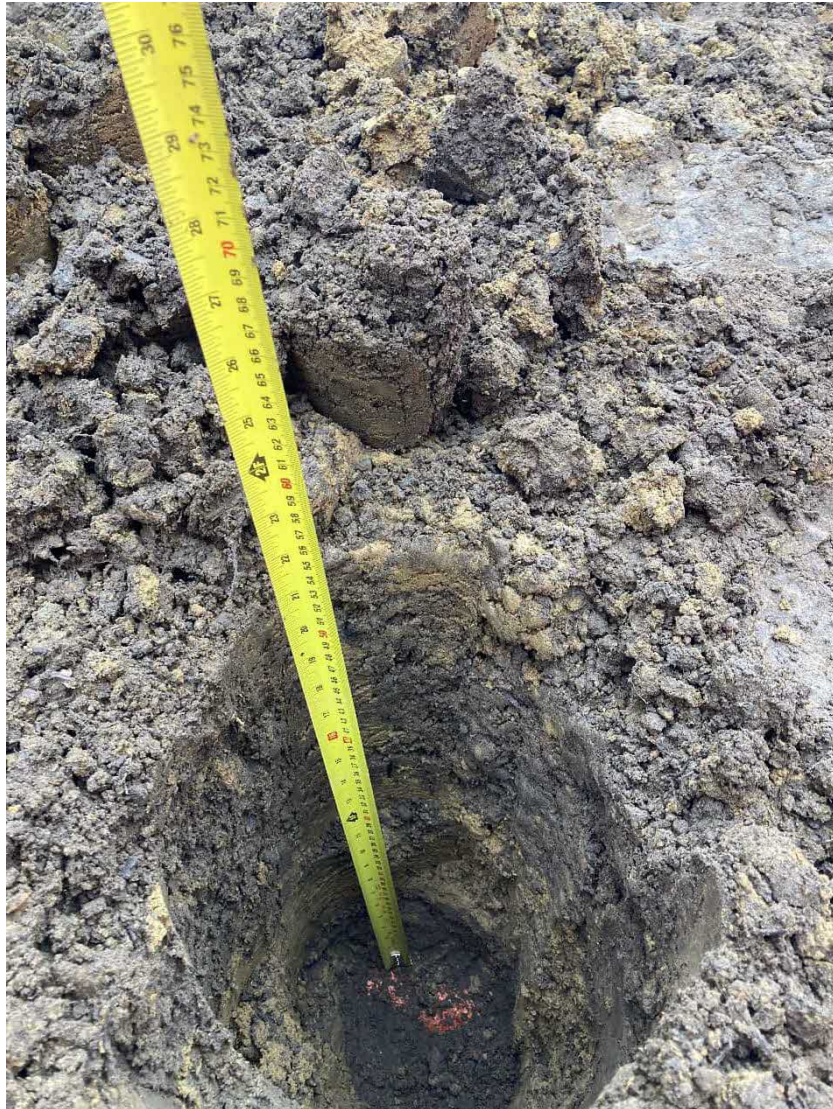
Photo 3: Plots 2 and 3 (front garden)

Plot 2 and Plot 3 front garden (shared) had 300 mm bgl of topsoil, over subsoil which consisted of soft beige grey very sandy CLAY with rare fine sub-angular to sub-rounded flint gravel to 500 mm bgl, overlying a geotextile. A hand pit was undertaken to 0.50 m and samples were taken from the subsoil (at 0.50 m bgl) and were scheduled for heavy metals, speciated PAH, TPH CWG, asbestos, SOM and pH.

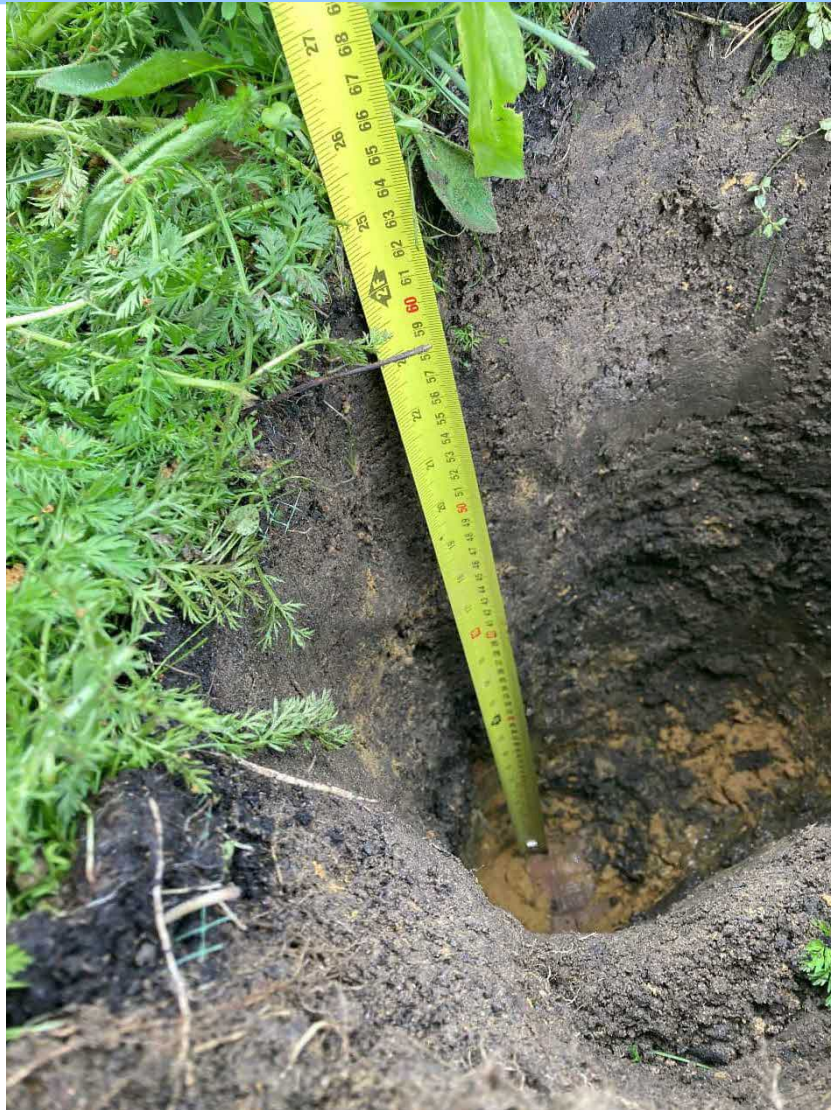
Photo 5: POS

The public open space adjacent to the existing marketing suite had 500 mm bgl of topsoil, over subsoil which consisted of orange yellow sand and topsoil to 700 mm bgl. The geotextile was present at 0.70 m bgl.
