RECORD OF SITE VISIT

<p>JNP GROUP CONSULTING ENGINEERS</p> <p>www.jnpgroup.co.uk</p>	<p>Site: Former Sunninghill Gas Works, Ascot</p> <p>Client: Berkeley Homes</p> <p>Job No: M41977</p>
<p>Date of Inspection: 19th May 2021 Time: 11:10 – 12:30 PM</p> <p>Weather: Warm and sunny. 15°C. Inspection made by Hilary Ilsley</p>

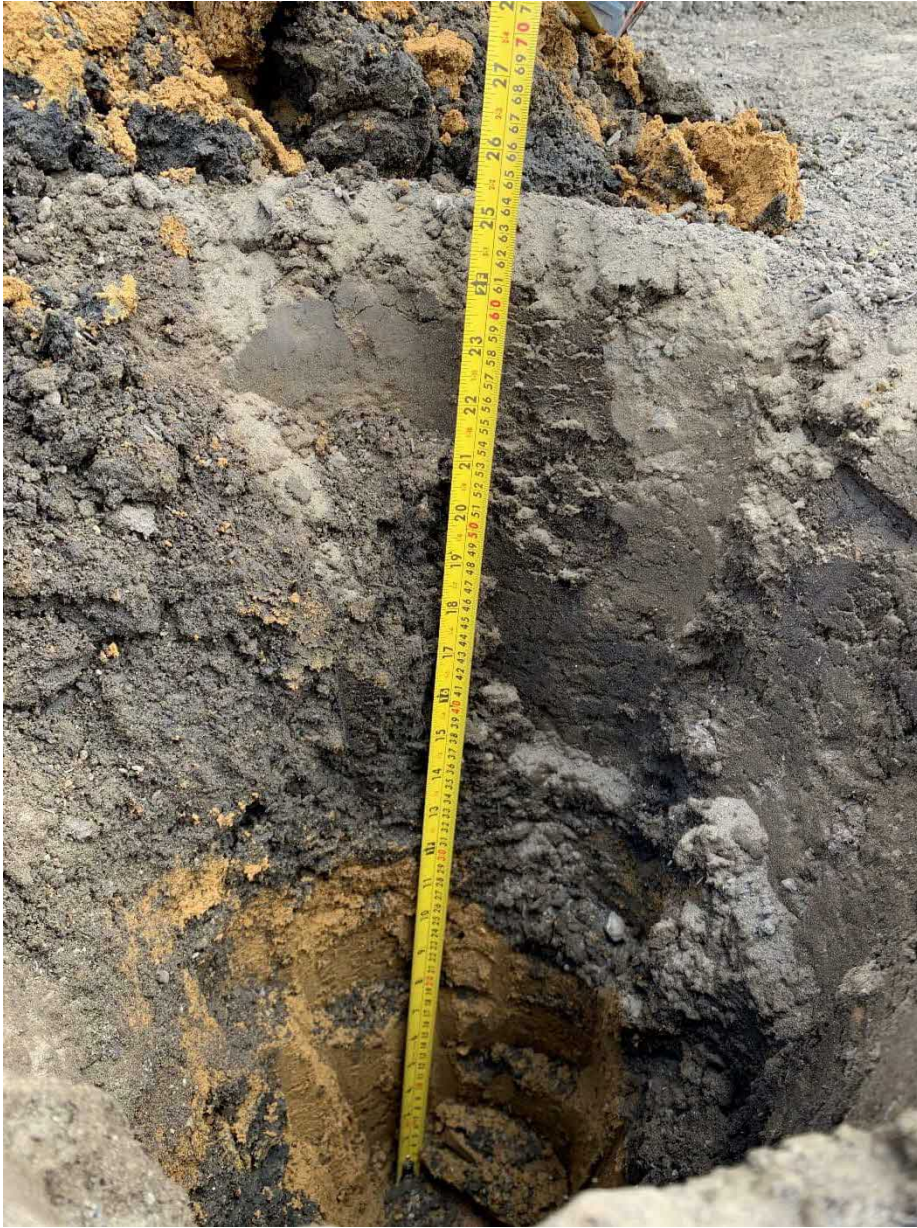
Plot 36 front garden had 350 mm bgl of topsoil and 250 mm bgl subsoil, with visible geotextile at 0.60 m underlying the subsoil. Refer to Photo 1 in the Appendices.

Photo 1: Plot 36 Front Garden showing topsoil, subsoil and geotextile.

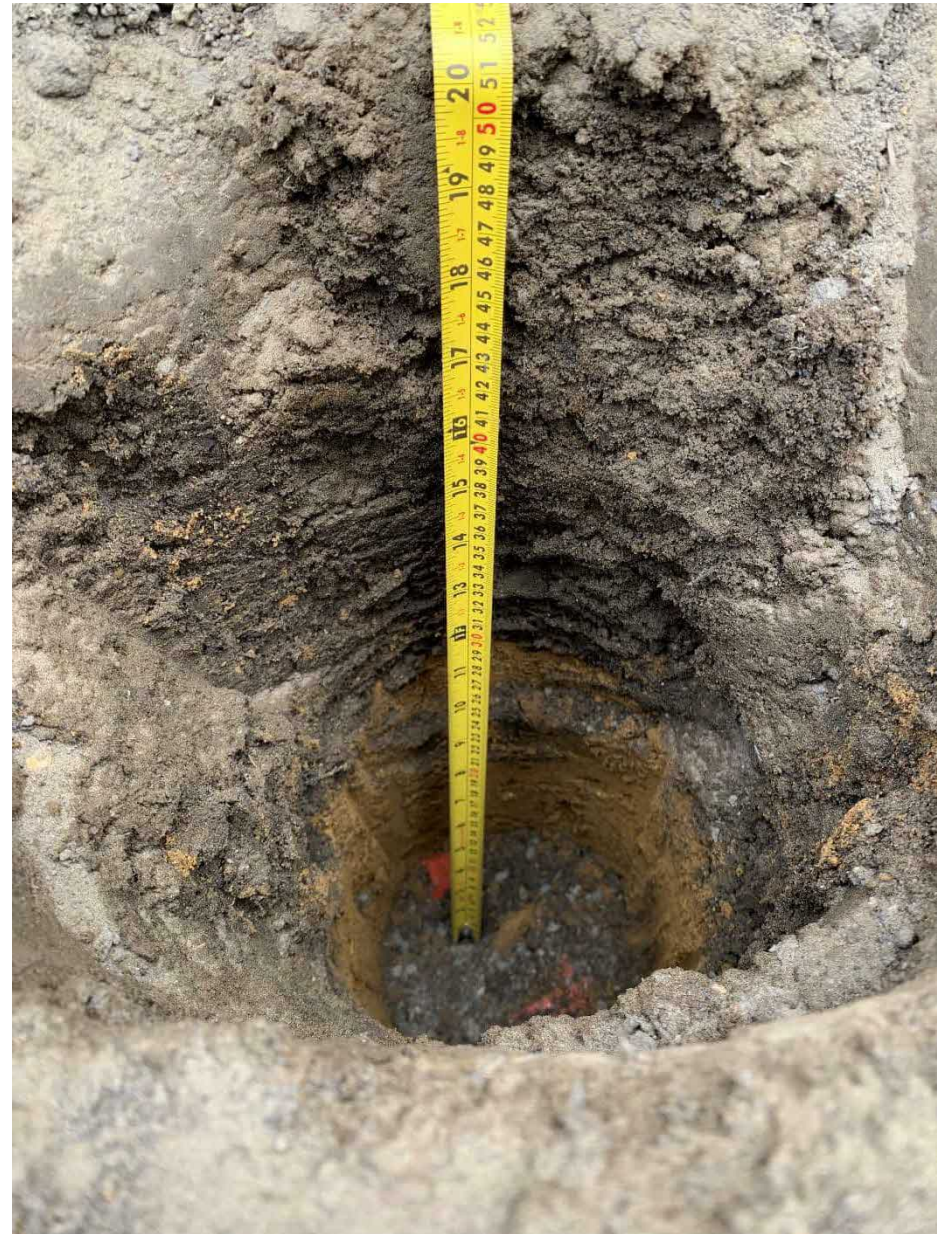
Plot 37 front garden had 350 mm bgl topsoil and 200 mm bgl subsoil, with visible geotextile at 0.55 m. Subsoil was sampled at 0.50 m and scheduled for heavy metals, speciated PAH, TPH CWG, asbestos, SOM and pH. Refer to Photo 2 in the Appendices. **An additional 50 mm of topsoil is required to be placed.**

Photo 2: Plot 37 Front garden showing topsoil, subsoil and geotextile.

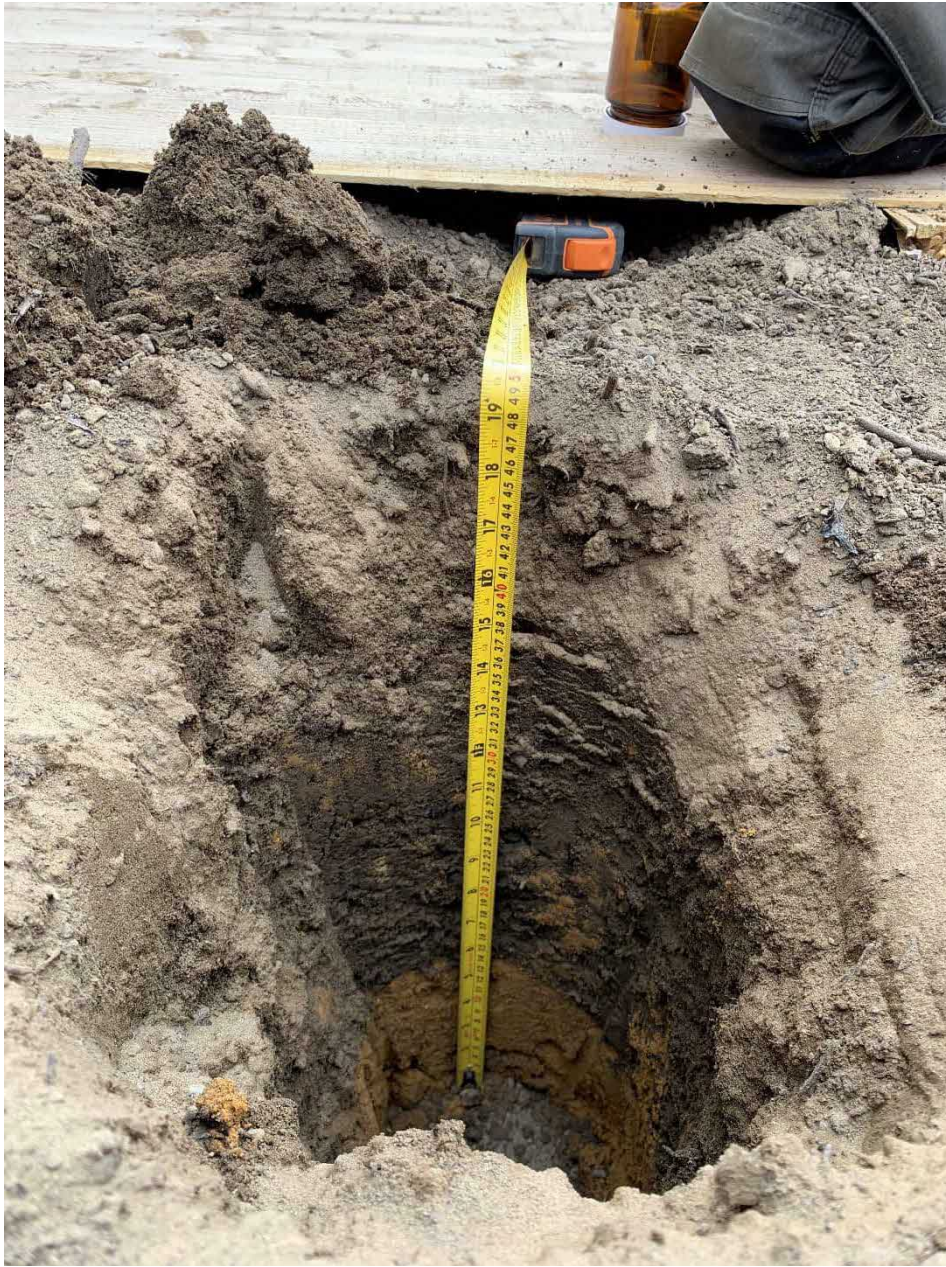
Plot 39 front garden had 350 mm bgl topsoil and 150 mm bgl subsoil, with visible geotextile at 0.50 m. Topsoil was sampled at 0.20 m and scheduled for heavy metals, speciated PAH, TPH CWG, asbestos, SOM and pH. Refer to Photo 3 in the Appendices. **An additional 100 mm of topsoil is required to be placed.**

Photo 3: Plot 39 Front garden showing topsoil, subsoil and geotextile.

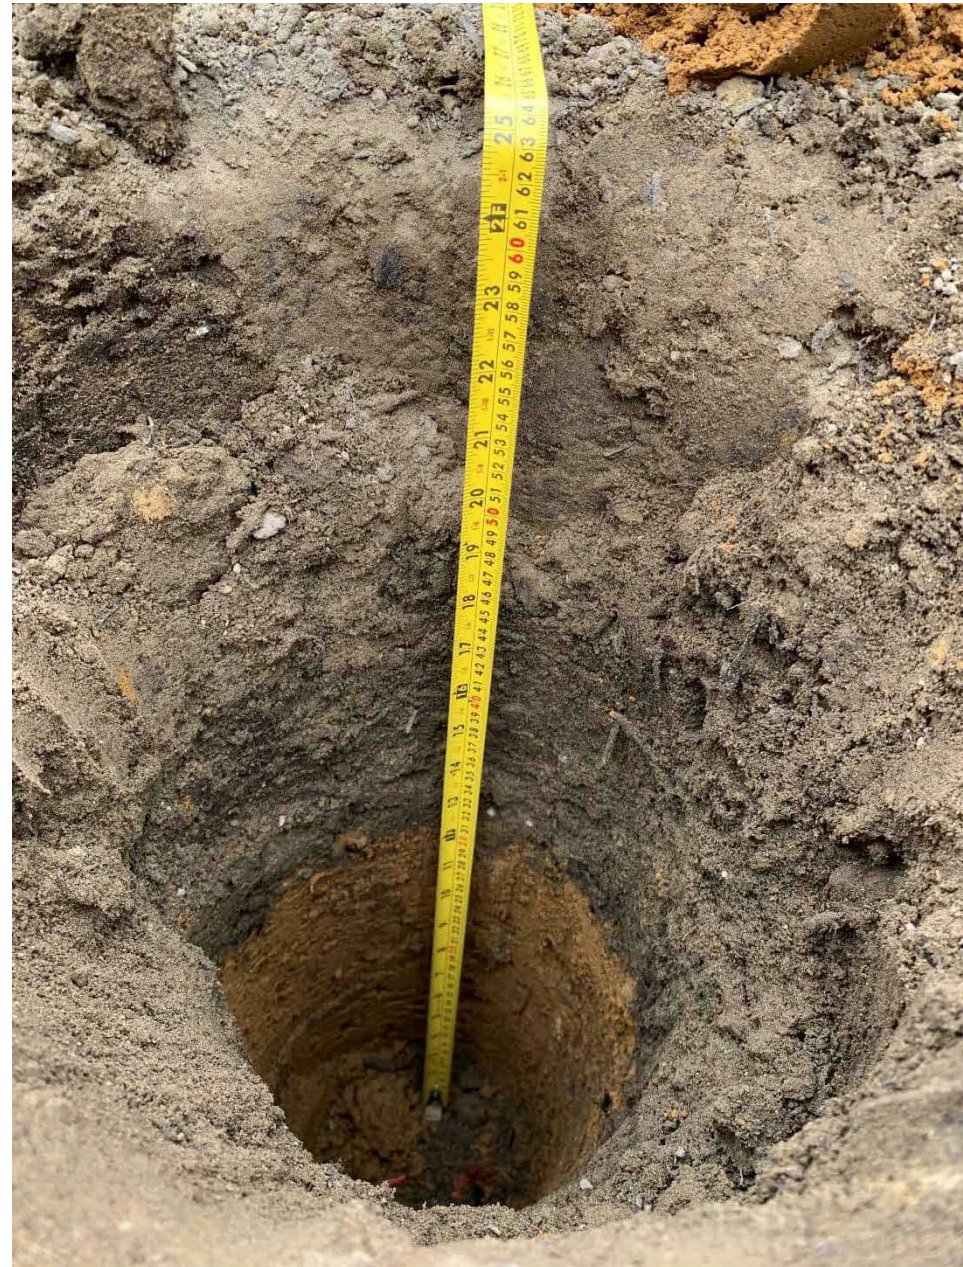
Plot 36 and 39 rear garden had 350 mm bgl topsoil and 300 mm bgl subsoil, with visible geotextile at 0.65 m. Subsoil was sampled in Plot 36 at 0.40 m bgl and scheduled for heavy metals, speciated PAH, TPH CWG, asbestos, SOM and pH. Refer to Photo 4 in the Appendices for evidence in Plot 36.

Photo 4: Plot 36 Rear garden showing topsoil, subsoil and geotextile.

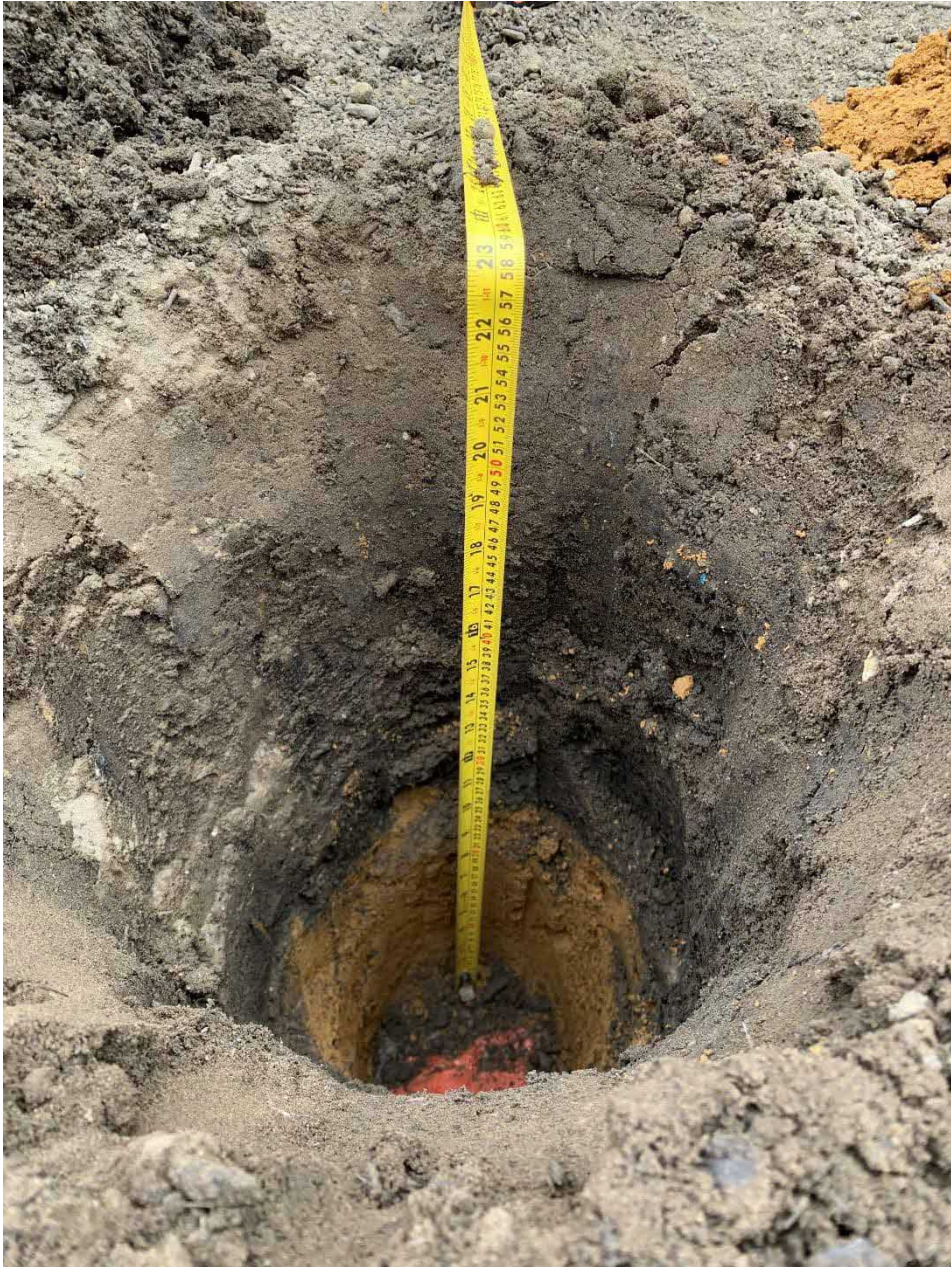
Plot 38 rear garden had 350 mm bgl of topsoil and 250 mm subsoil, with visible geotextile at 0.60 m bgl. Topsoil was sampled at 0.20 m and scheduled for heavy metals, speciated PAH, TPH CWG, asbestos, SOM and pH. Refer to Photo 5 in the Appendices.

Photo 5: Plot 38 Rear garden showing topsoil, subsoil and geotextile.
