# Appendix E - Additional Photographs

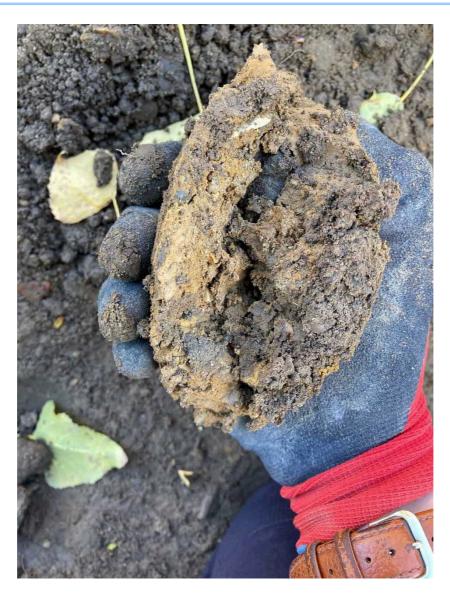
Photo 5: Plot 1 subsoil

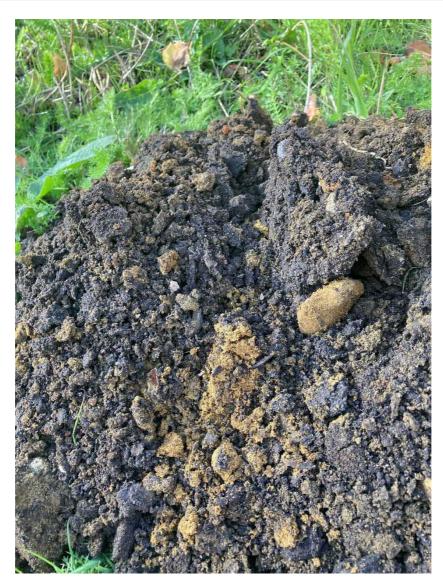
Photo 9: POS1 arisings

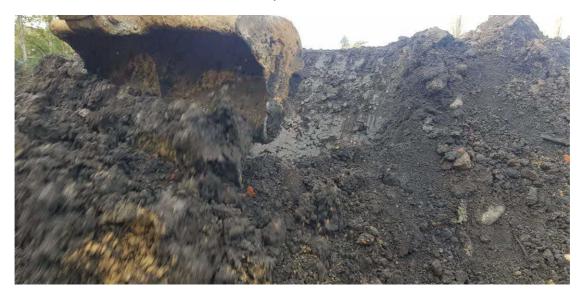
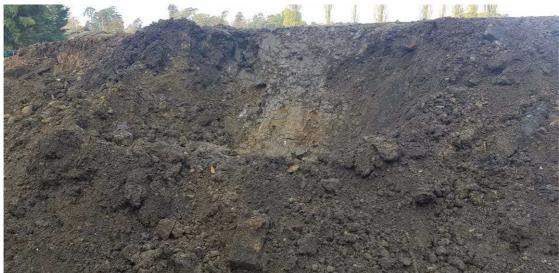
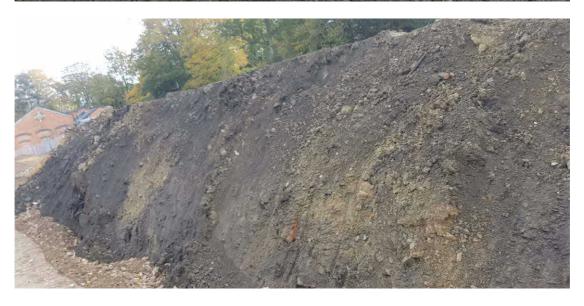
Photos below: Non-Hazardous Waste Stockpile

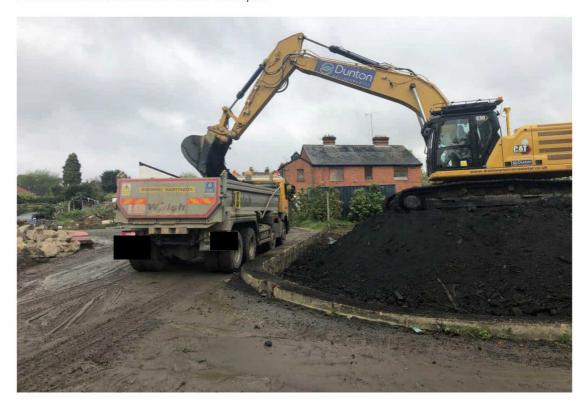
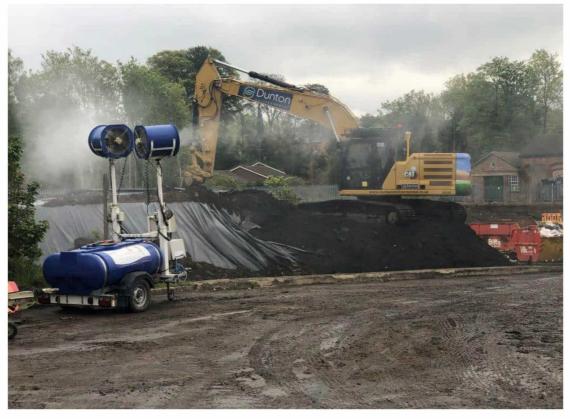
Photos below: Hazardous Waste Stockpile

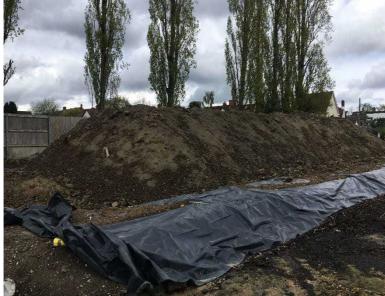
Above: Windrow Turning in South-West of the Site

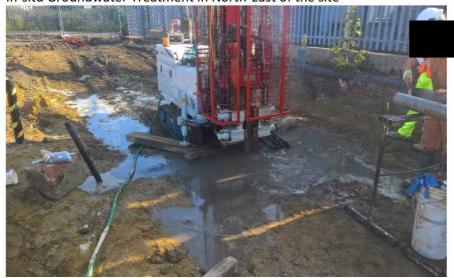
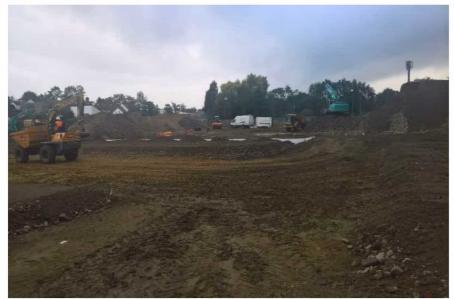
In-situ Groundwater Treatment in North-East of the site
