Validation Letter

Our Ref: M41977-JNP-XX-XX-RP-G-0024-P01

Re: Former Sunninghill Gas Works – Validation of Capping Layer for Plots 42- 50 inclusive (Block F)

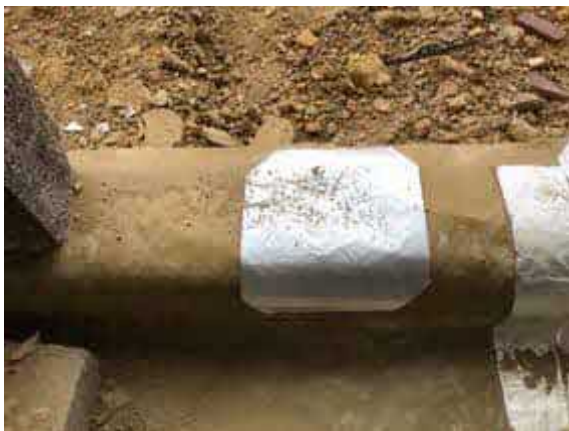
Patch repair using SAGM to damaged perimeter membrane.

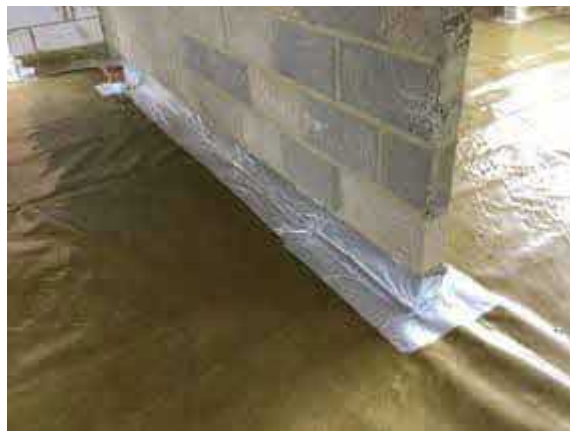
Retro fit detail using SAGM to the internal block work wall.

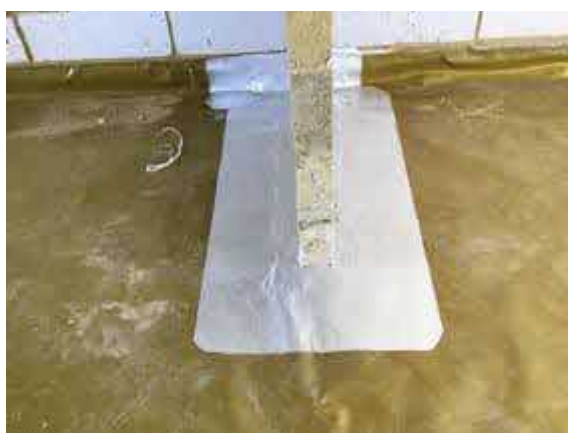
Plot 3 retro fit detail over the damaged membrane that is under the internal block work wall.

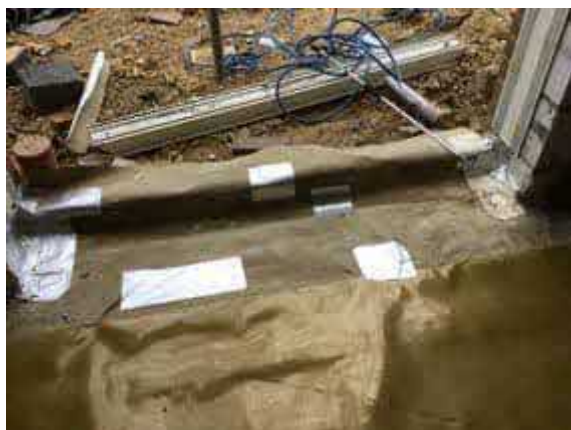
Plot 75 repaired damaged membrane using SAGM.

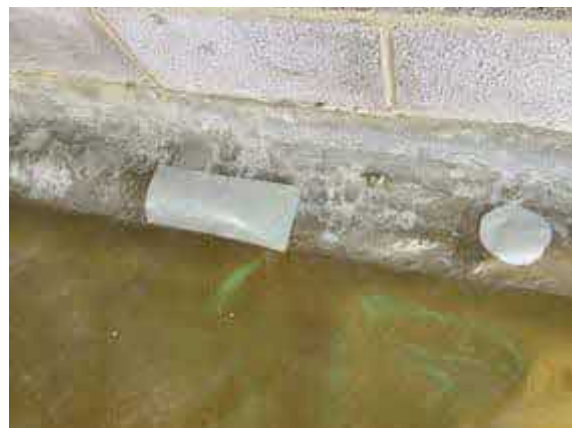
Plot 4 patch repair using SAGM.

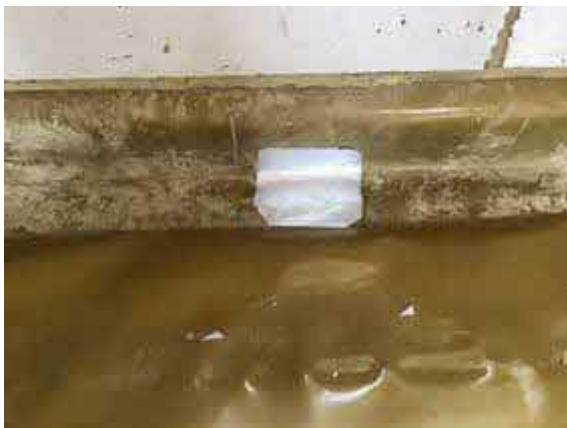
Plot 7 patch repair using SAGM.

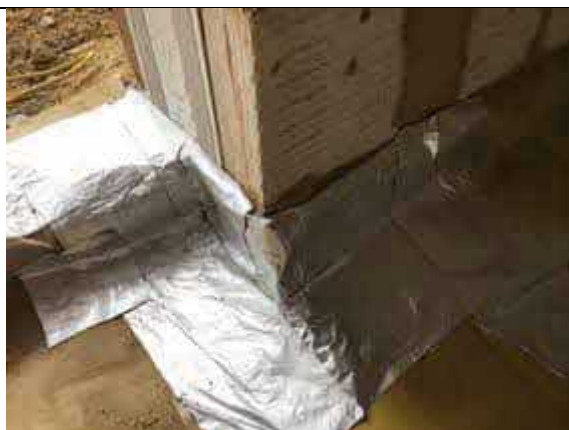
Plot 6 repaired door threshold detail using SAGM.

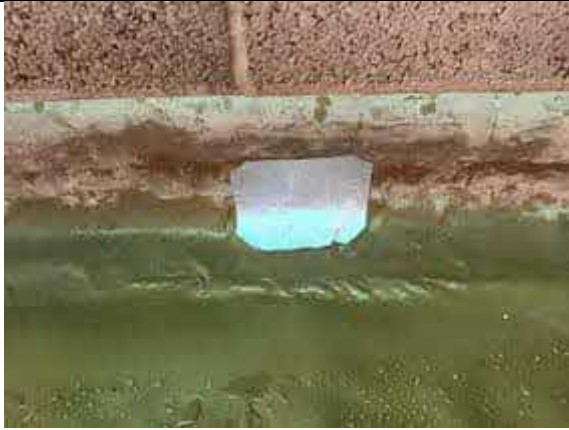
Plot 34 patch repair using SAGM to damaged perimeter membrane.

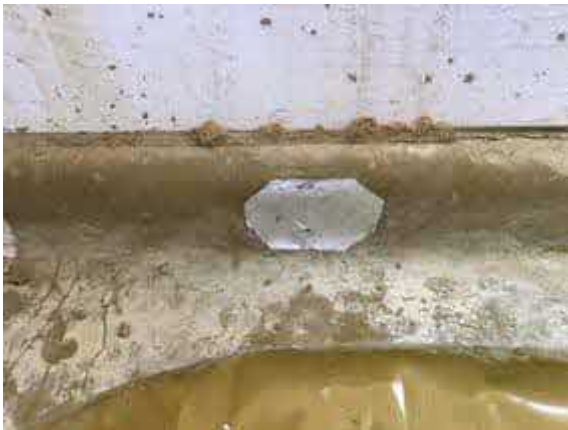
Plot 32 patch repair to damaged membrane caused by follow on trades and repaired using SAGM.

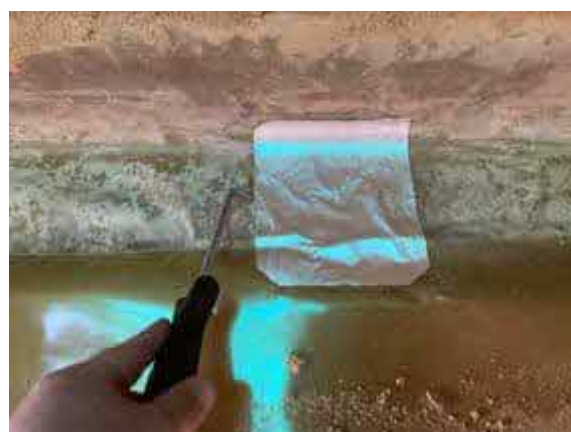
Plot 29 - Pick test upon a successful patch repair using SAGM.

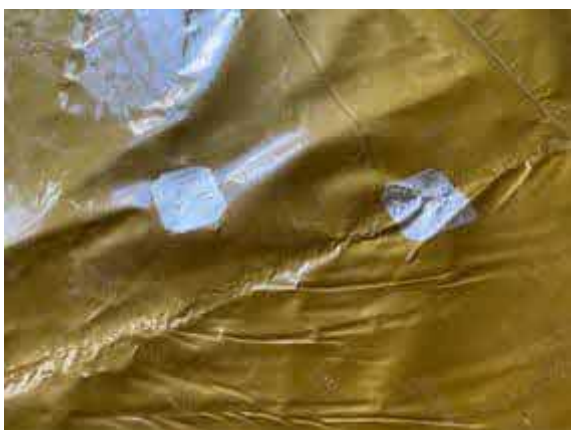
Plot 30 - Patch repairs using SAGM.

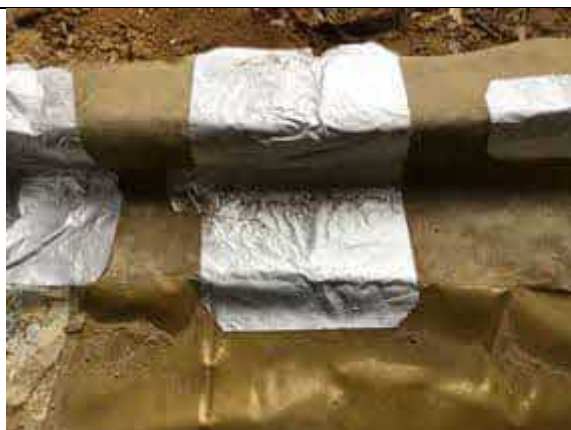
Plot 27 patch repair using SAGM to damage caused by follow on trades.

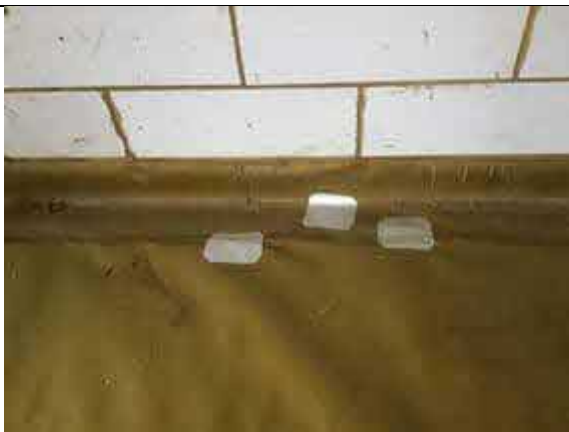
Patch repairs using SAGM to plot 36.

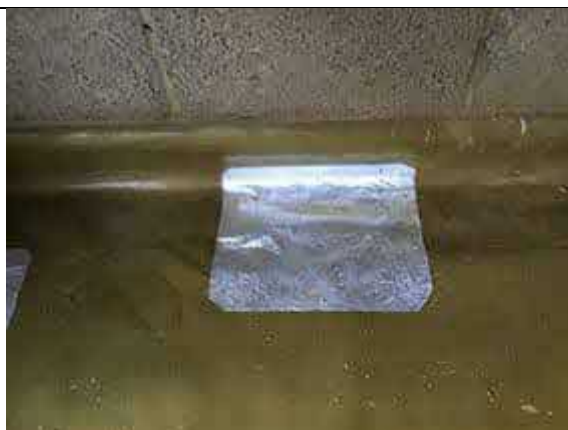
Repaired damaged perimeter membrane using SAGM to plot 39.

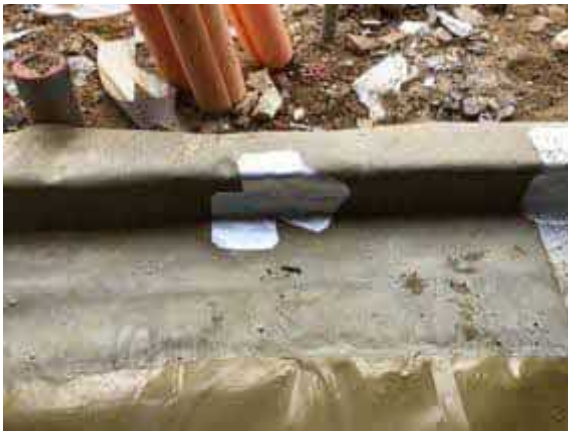
Patch repairs to damaged perimeter membrane using SAGM.

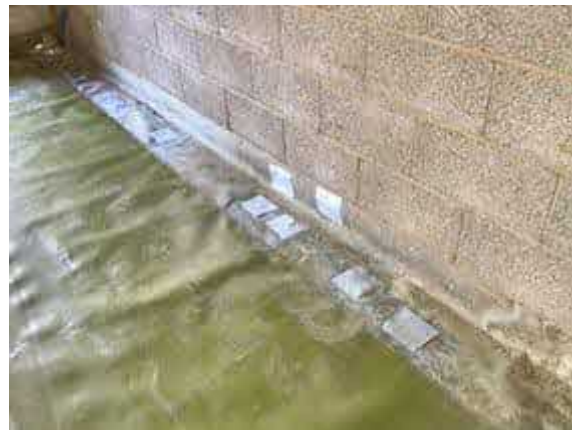
Patch repairs to damaged perimeter membrane using SAGM to plot 67.

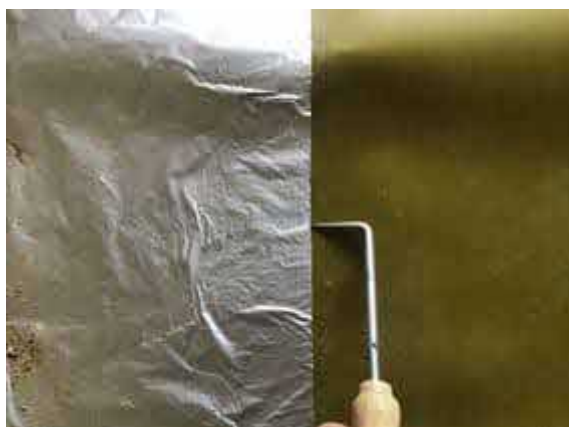
Pick testing all SAGM patches to damaged perimeter membrane to plot 37.

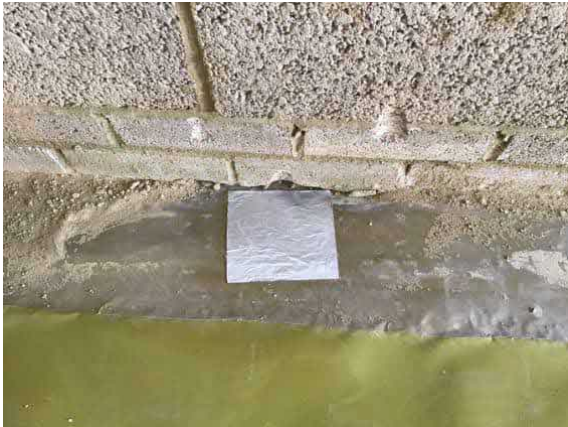
Patch repair using SAGM to damaged perimeter membrane in plot 41 garage.

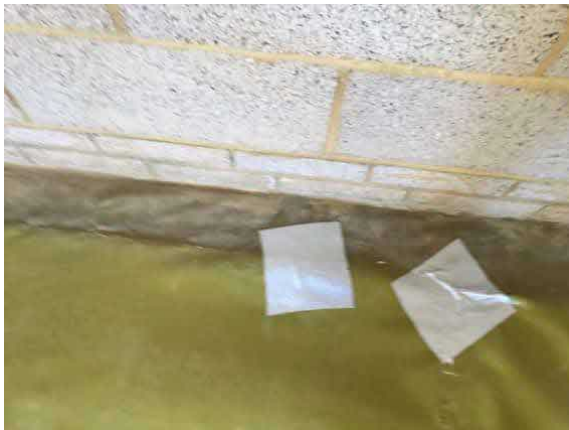
Patch repairs using SAGM to damaged membrane.

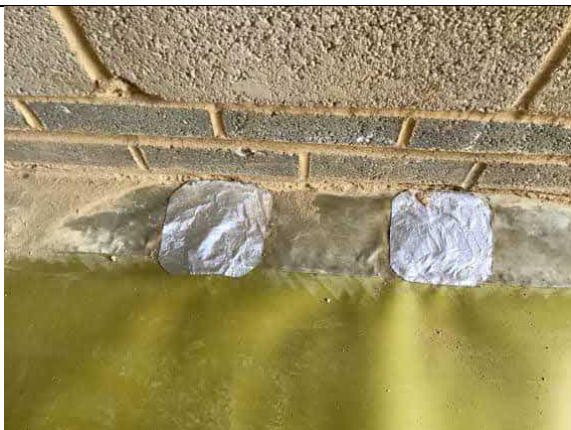
Patch repairs using SAGM to damaged perimeter membrane.
