Validation Letter

Our Ref: M41977-JNP-XX-XX-RP-G-0025-P01

Re: Former Sunninghill Gas Works – Validation of Capping Layer for Plots 51- 53 inclusive (Block G)

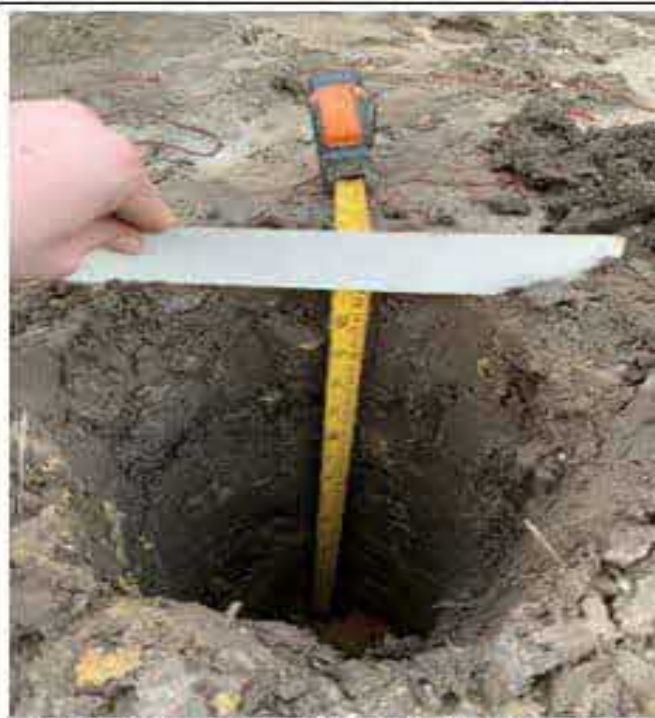
Photo 1: Plot 51 front garden showing depth to geotextile.

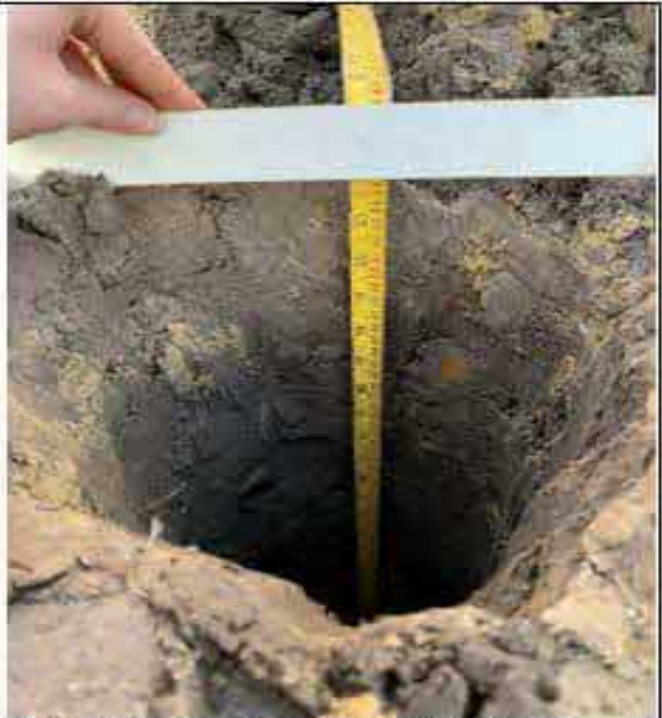
Photo 2: Plot 53 front garden showing depth to geotextile.

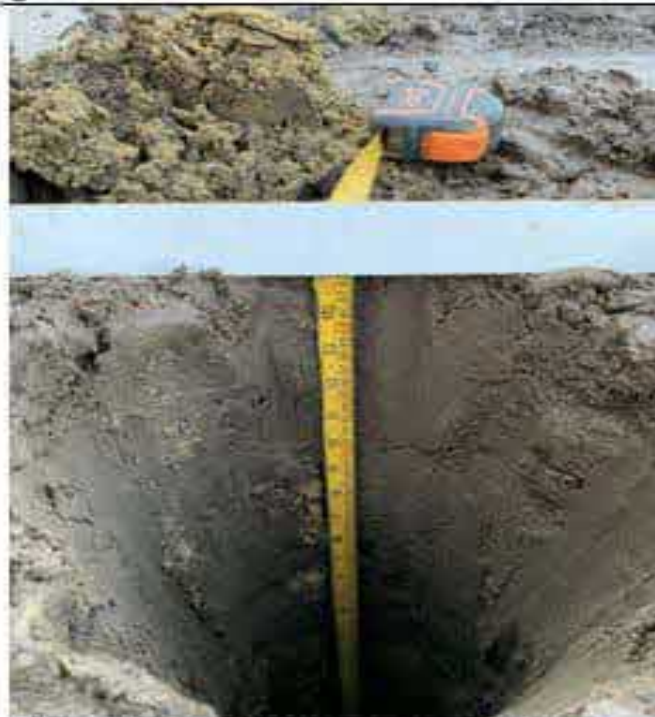
Photo 3: Plot 52 rear garden showing depth to geotextile.

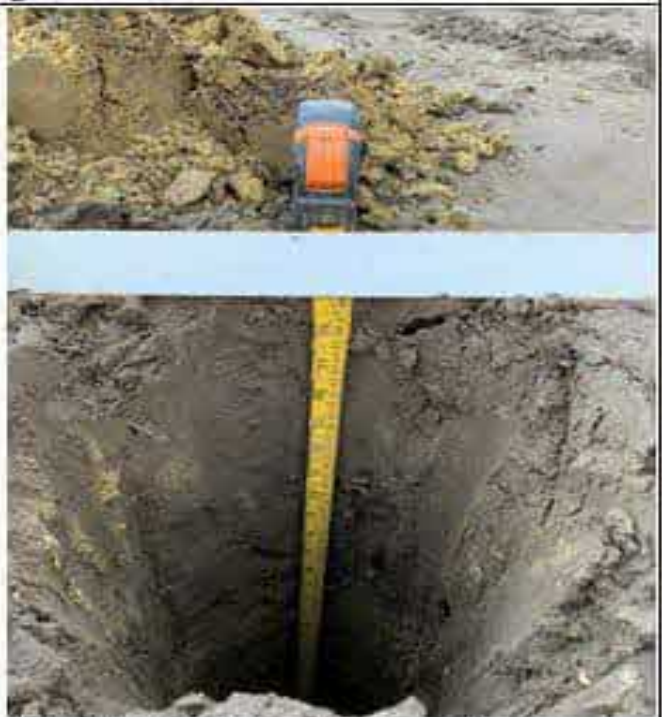
Photo 4: Plot 53 rear garden showing depth to geotextile.

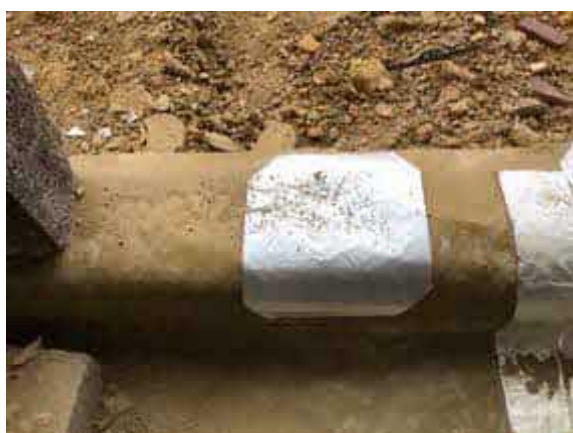
Patch repair using SAGM to damaged perimeter membrane.

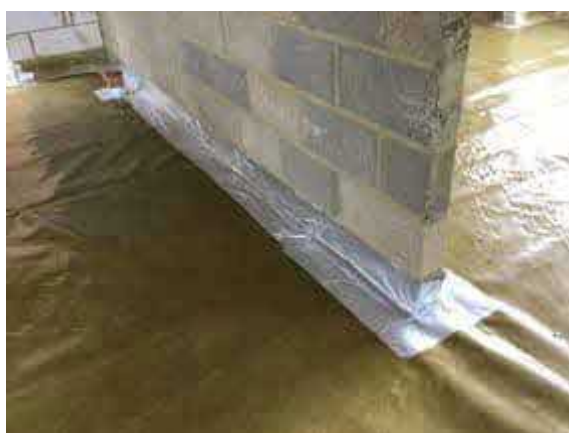
Retro fit detail using SAGM to the internal block work wall.

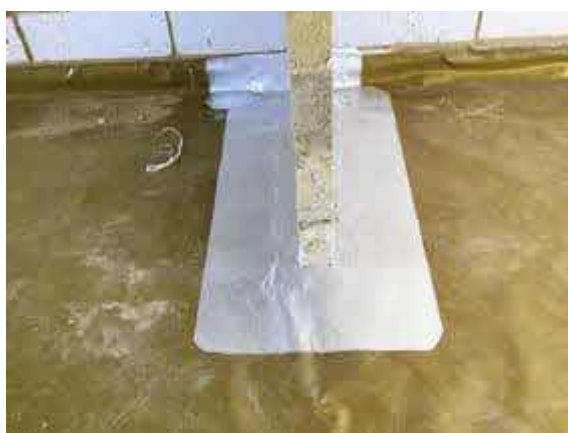
Plot 3 retro fit detail over the damaged membrane that is under the internal block work wall.

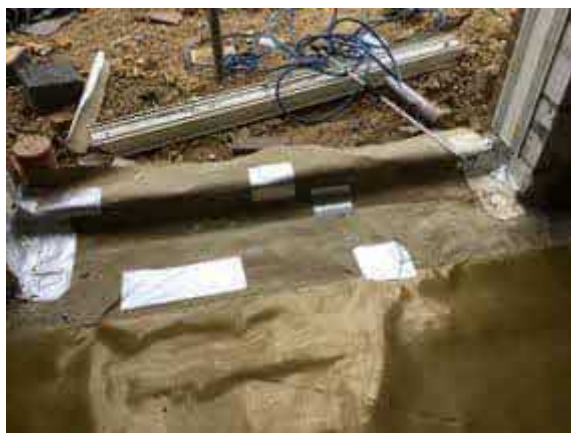
Plot 75 repaired damaged membrane using SAGM.

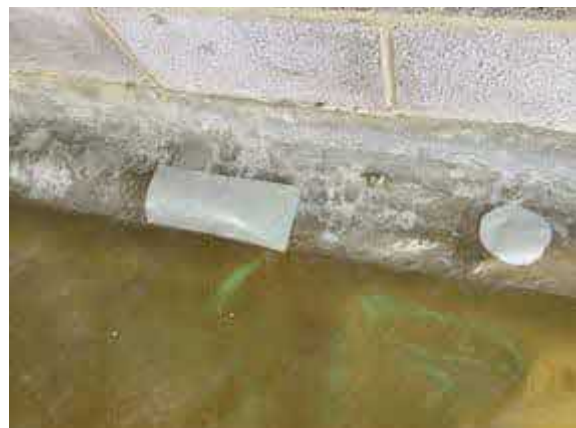
Plot 4 patch repair using SAGM.

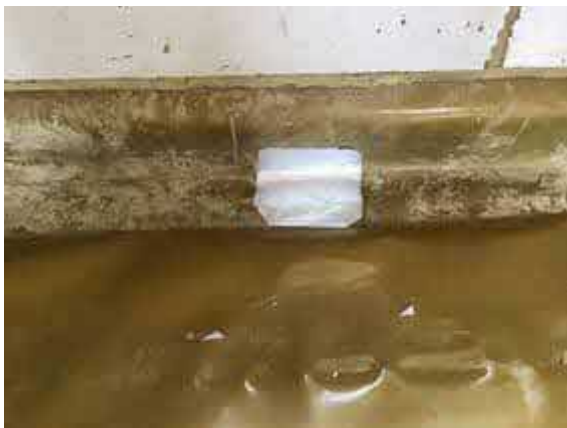
Plot 7 patch repair using SAGM.

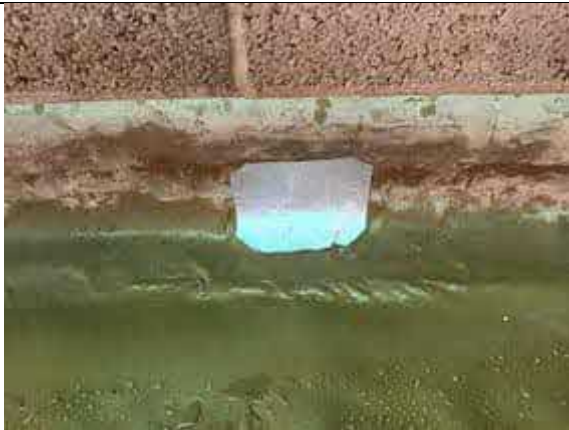
Plot 34 patch repair using SAGM to damaged perimeter membrane.

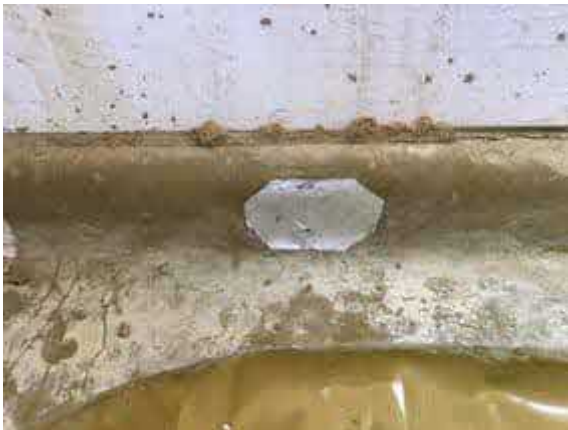
Plot 32 patch repair to damaged membrane caused by follow on trades and repaired using SAGM.

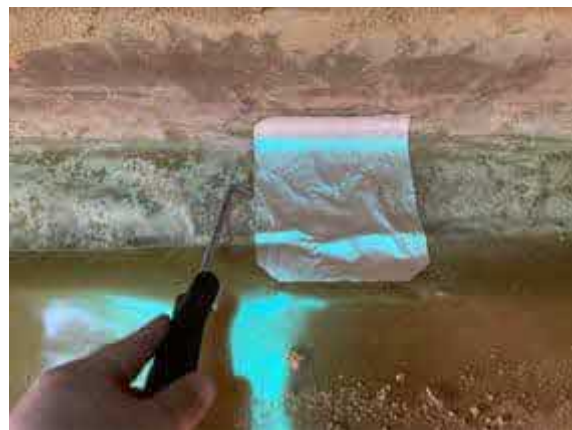
Plot 29 - Pick test upon a successful patch repair using SAGM.

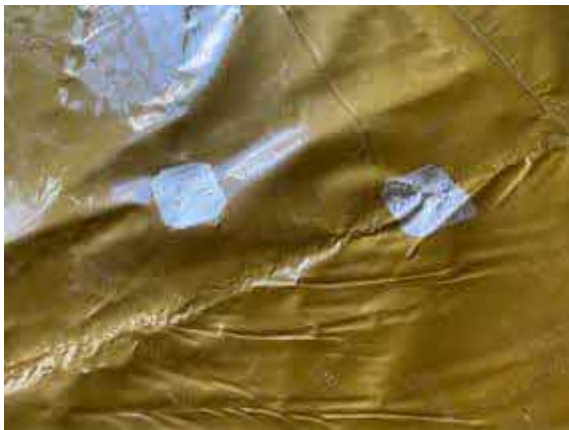
Plot 30 - Patch repairs using SAGM.

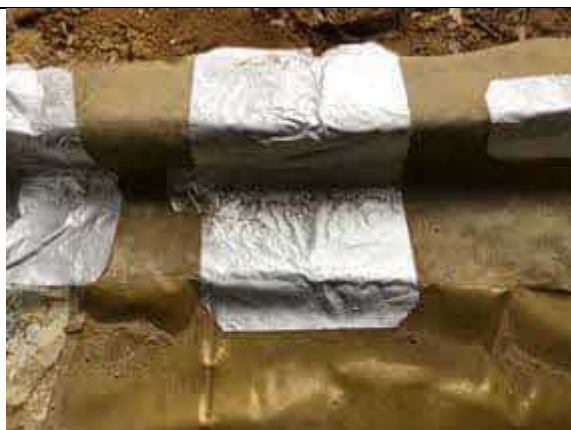
Plot 27 patch repair using SAGM to damage caused by follow on trades.

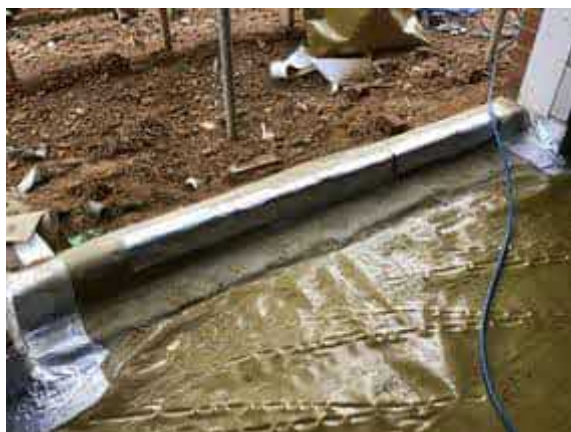
Repaired damaged to the door threshold due to follow on trades using SAGM.

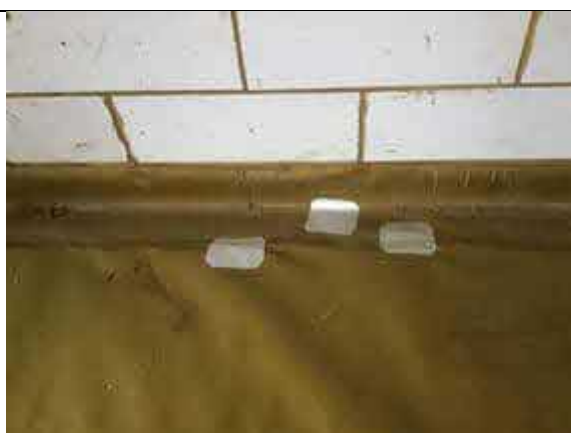
Patch repairs using SAGM to plot 36.

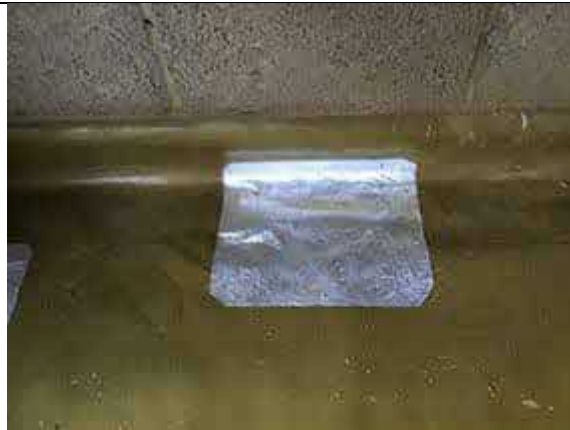
Repaired damaged perimeter membrane using SAGM to plot 39.

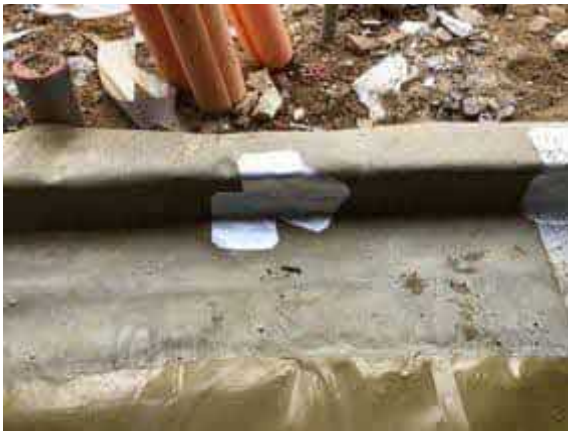
Patch repairs to damaged perimeter membrane using SAGM.

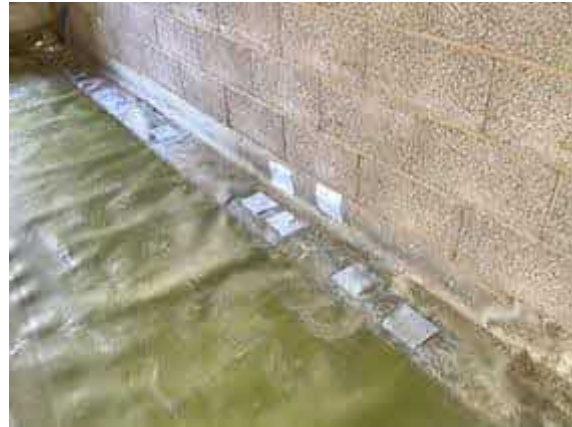
Patch repairs to damaged perimeter membrane using SAGM to plot 67.

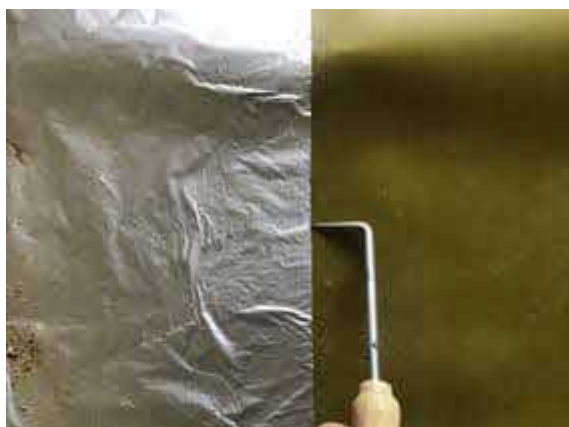
Pick testing all SAGM patches to damaged perimeter membrane to plot 37.

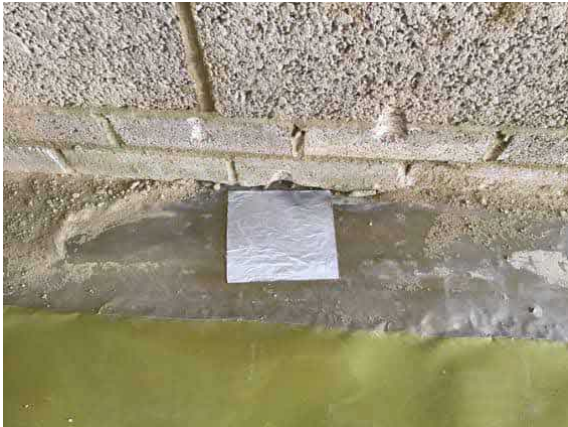
Patch repair using SAGM to damaged perimeter membrane in plot 41 garage.

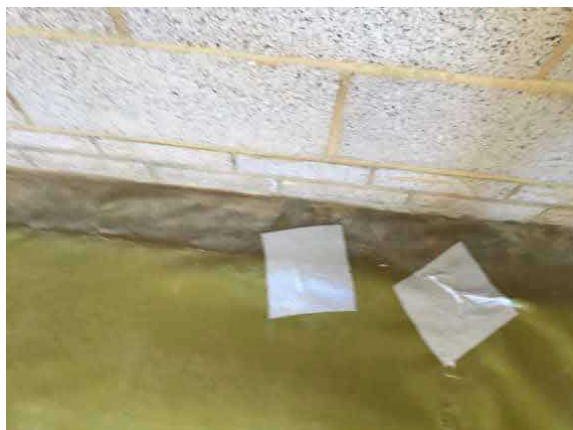
Patch repairs using SAGM to damaged membrane.

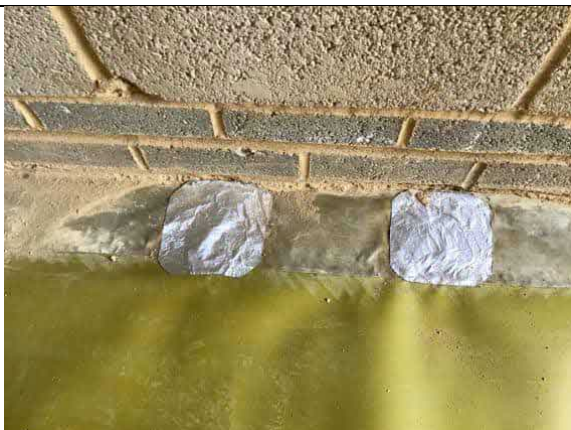
Patch repairs using SAGM to damaged perimeter membrane.
