Parmoor, 26 Cambray Place, Cheltenham, Gloucestershire GL50 2JN

23/00272/LBC Internal and external refurbishment works at 26 Cambray Place, Cheltenham

Details and Method of Repair for Existing Window Shutters

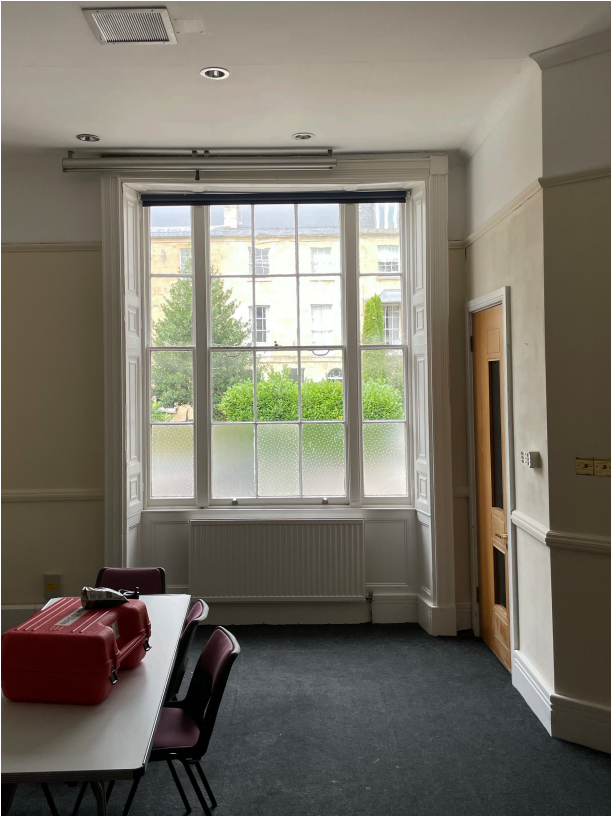
Upper Ground Floor: North Elevation

At 26 Cambray Place 4no. existing upper ground floor windows have panelled reveals and shutters. It is unclear whether the panelling and shutters are original or replica, reinstated after the fire. Existing timber panelled shutters have been painted shut and therefore currently inoperable.

Window in the proposed Conference Space left of the upper ground floor entrance (viewed internally)

1. Before shutters are removed for repair they will be carefully recorded to ensure that they are reinstalled in the correct locations.
2. Existing shutters painted shut to be gently freed and areas of excess paint build-ups, which interfere with operation, and any loose or defective paint to be removed before exposed surfaces are rubbed down (using wet abrasion to minimise hazardous dust). Where essential stripping of paint is required this will be undertaken using an organic solvent stripper, care will be taken to clean the timber down thoroughly after stripping.

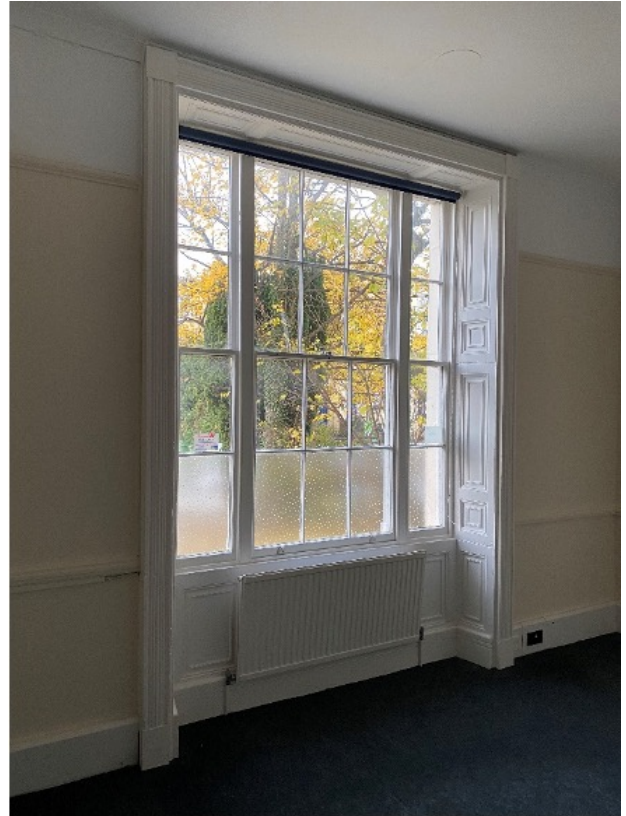
Window in the proposed Conference Space right of the upper ground floor entrance (viewed internally)

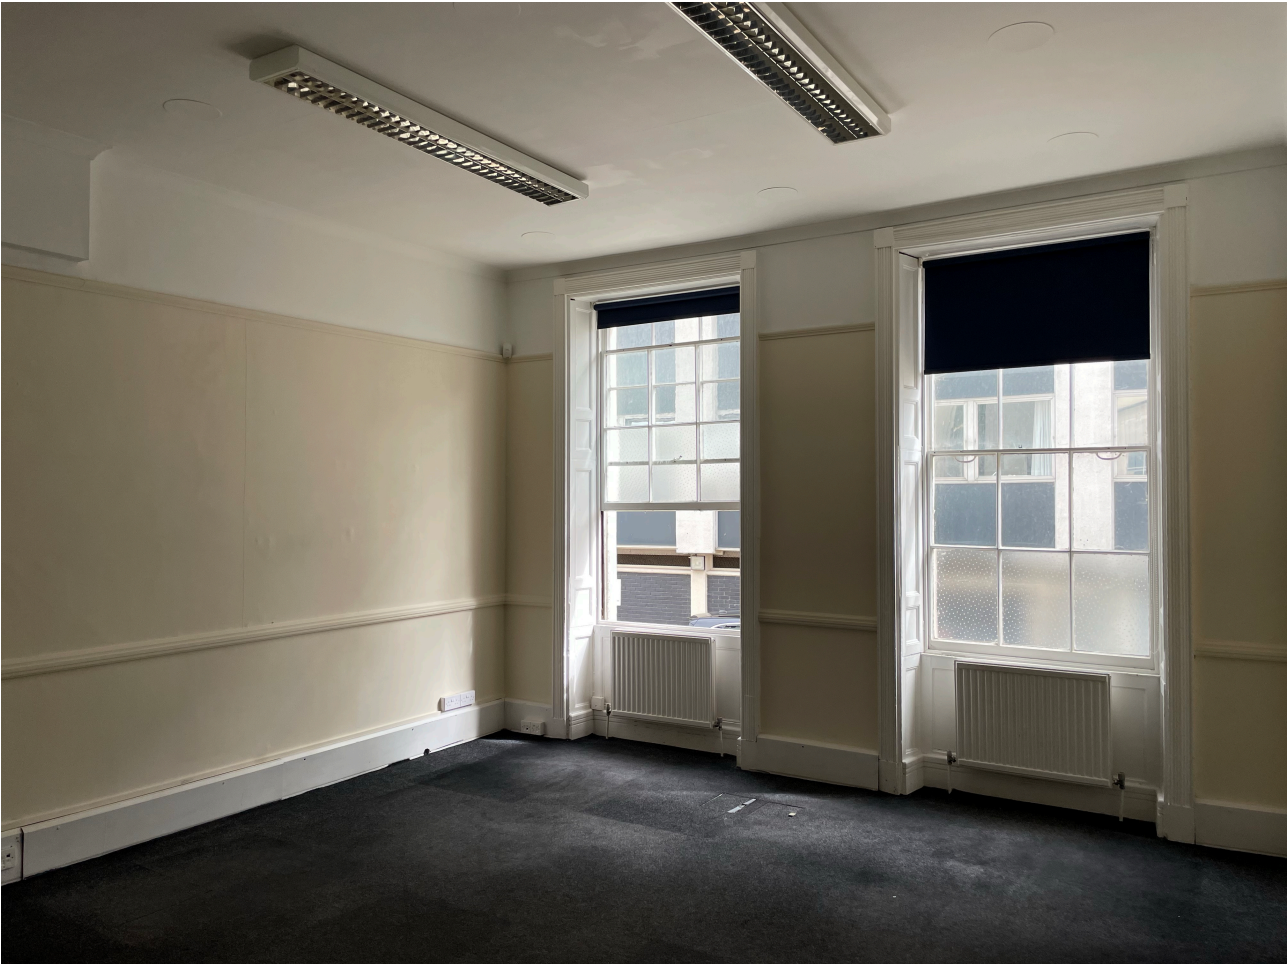
Upper Ground Floor: South Elevation

Pair of windows to the rear of the proposed refreshments area.
