Asbestos Inspection Report

DR Bejan roohi (home partners group limited)

Frenches Farm, Wigley Bush Lane, South Weald, Brentwood, Essex

Demolition Survey

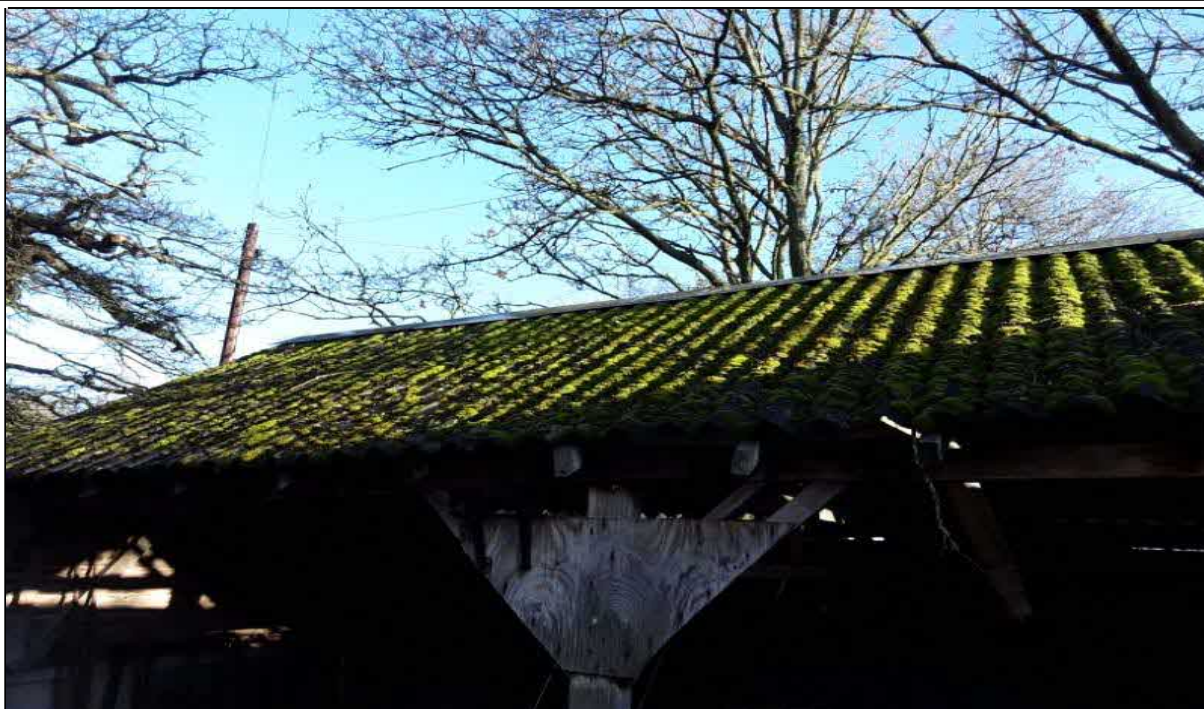
SAMPLE REFERENCE	CH000719	ASBESTOS	YES
PRESUMPTION REFERENCE	N/A	RISK LEVEL	VERY LOW RISK

AREA	External	MATERIAL ASSESSMENT	
FLOOR	External	PRODUCT TYPE	1 - Cement sheet
UNIQUE ROOM IDENTIFIER	Barn 1	DAMAGE	0 - Good Condition
DESCRIPTION OF SAMPLE TAKEN OR PRESUMPTION	Cement sheet Roof	SURFACE TREATMENT	1 - Surface Sealed
EXTENT	36 Sq. m	ASBESTOS TYPE	1 - Chrysotile
ACCESSIBILITY	Low	MATERIAL ASSESSMENT SCORE	3
LEVEL OF IDENTIFICATION	Sampled	POTENTIAL TO RELEASE FIBRES	Very Low Risk
RECOMMENDATIONS C - Removal by Trained Operatives	COMMENTS -

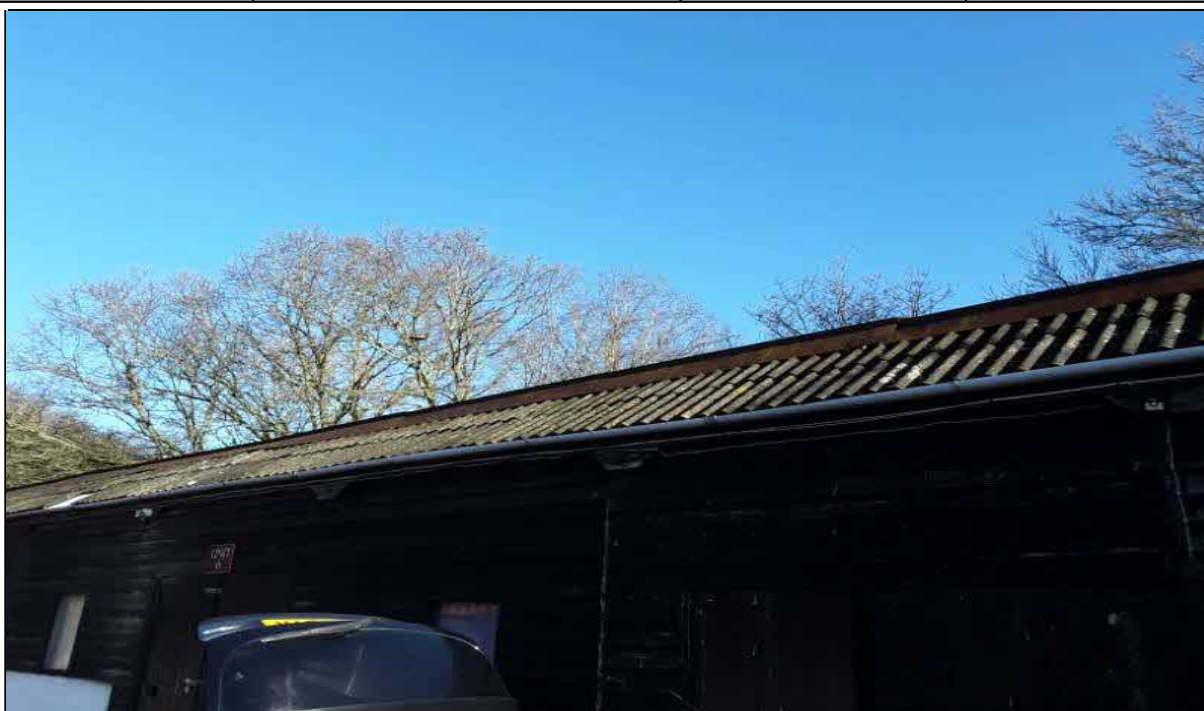
SAMPLE REFERENCE	CH000720	ASBESTOS	YES
PRESUMPTION REFERENCE	N/A	RISK LEVEL	VERY LOW RISK

AREA	External	MATERIAL ASSESSMENT	
FLOOR	External	PRODUCT TYPE	1 - Cement sheet
UNIQUE ROOM IDENTIFIER	Barn 2	DAMAGE	1 - Low Damage
DESCRIPTION OF SAMPLE TAKEN OR PRESUMPTION	Cement sheets Roof	SURFACE TREATMENT	1 - Surface Sealed
EXTENT	80 Sq. m	ASBESTOS TYPE	1 - Chrysotile
ACCESSIBILITY	Low	MATERIAL ASSESSMENT SCORE	4
LEVEL OF IDENTIFICATION	Sampled	POTENTIAL TO RELEASE FIBRES	Very Low Risk
RECOMMENDATIONS C - Removal by Trained Operatives	COMMENTS -

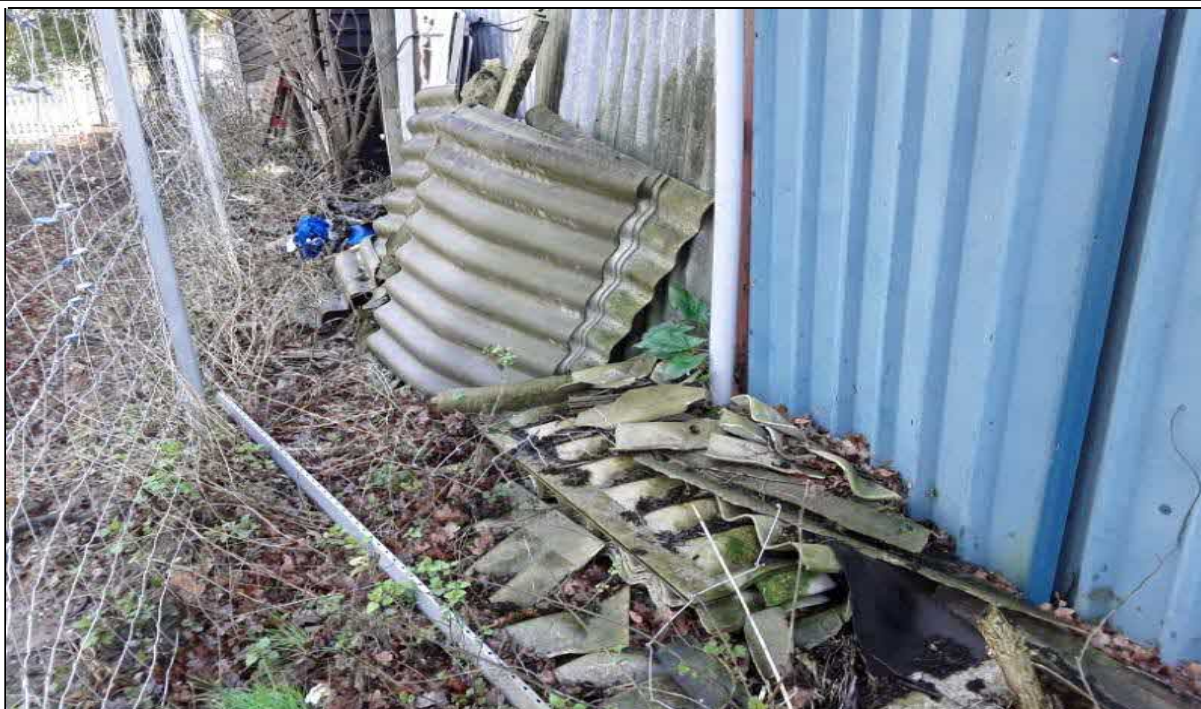
SAMPLE REFERENCE	CH000721	ASBESTOS	YES
PRESUMPTION REFERENCE	N/A	RISK LEVEL	LOW RISK

AREA	External	MATERIAL ASSESSMENT	
FLOOR	External	PRODUCT TYPE	1 - Cement sheet
UNIQUE ROOM IDENTIFIER	Behind barns 3 and 4	DAMAGE	3 - High Damage
DESCRIPTION OF SAMPLE TAKEN OR PRESUMPTION	Roof sheets Ground	SURFACE TREATMENT	1 - Surface Sealed
EXTENT	Numerous	ASBESTOS TYPE	1 - Chrysotile
ACCESSIBILITY	High	MATERIAL ASSESSMENT SCORE	6
LEVEL OF IDENTIFICATION	Sampled	POTENTIAL TO RELEASE FIBRES	Low Risk
RECOMMENDATIONS C - Removal by Trained Operatives		COMMENTS -

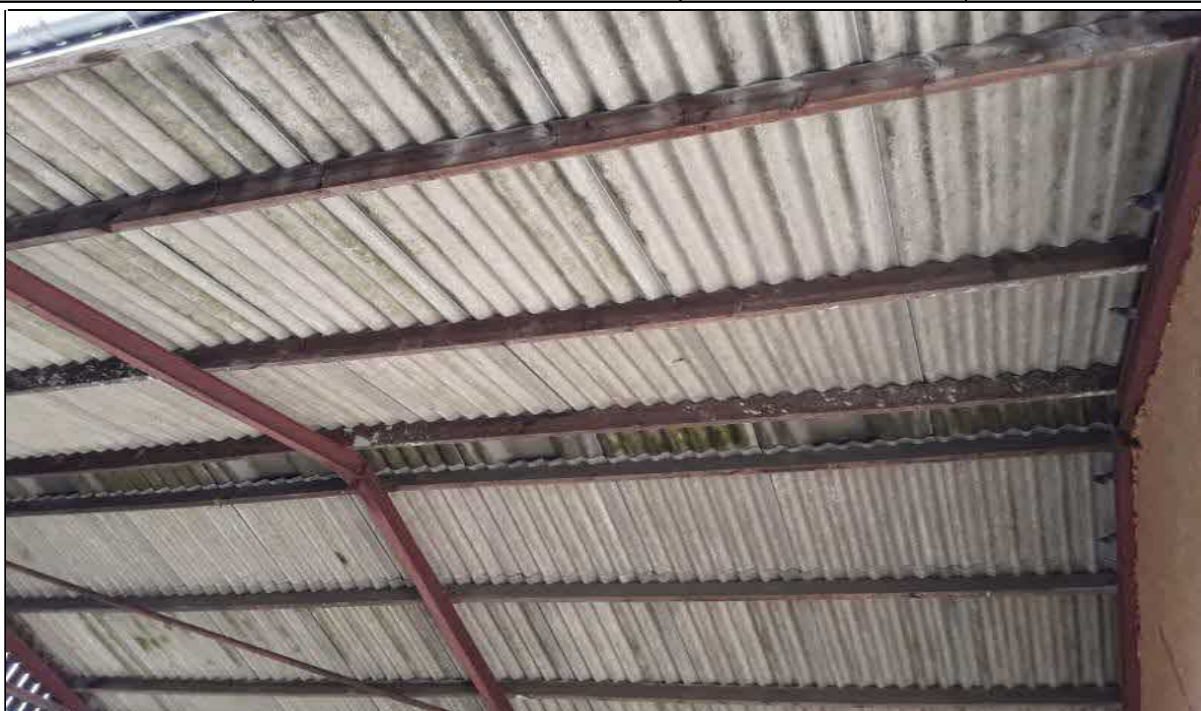
SAMPLE REFERENCE	Item No: 9	ASBESTOS	YES
PRESUMPTION REFERENCE	As Per CH000721	RISK LEVEL	VERY LOW RISK

AREA	External	MATERIAL ASSESSMENT	
FLOOR	External	PRODUCT TYPE	1 - Cement sheet
UNIQUE ROOM IDENTIFIER	Barn 4	DAMAGE	0 - Good Condition
DESCRIPTION OF SAMPLE TAKEN OR PRESUMPTION	Cement sheet Roof	SURFACE TREATMENT	1 - Surface Sealed
EXTENT	150 Sq. m	ASBESTOS TYPE	1 - Chrysotile
ACCESSIBILITY	Low	MATERIAL ASSESSMENT SCORE	3
LEVEL OF IDENTIFICATION	Strongly Presumed	POTENTIAL TO RELEASE FIBRES	Very Low Risk
RECOMMENDATIONS C - Removal by Trained Operatives		COMMENTS As per CH000721

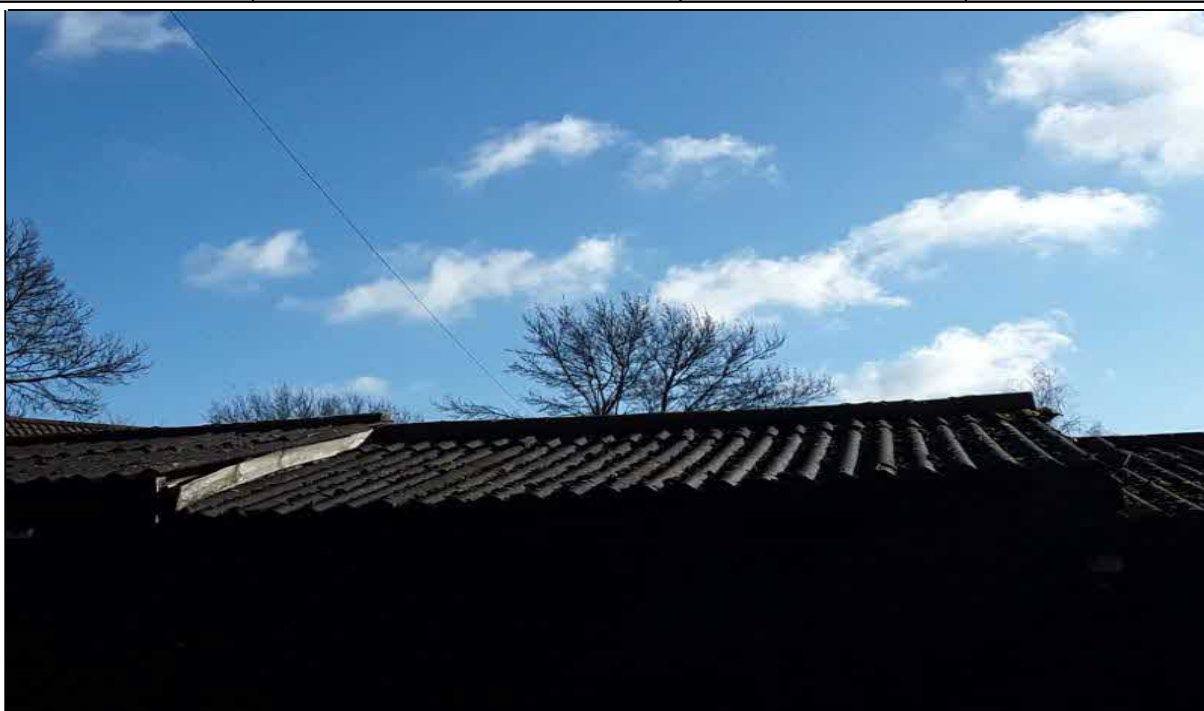
SAMPLE REFERENCE	CH000722	ASBESTOS	YES
PRESUMPTION REFERENCE	N/A	RISK LEVEL	VERY LOW RISK

AREA	External	MATERIAL ASSESSMENT	
FLOOR	External	PRODUCT TYPE	1 - Cement sheet
UNIQUE ROOM IDENTIFIER	Stables 1	DAMAGE	0 - Good Condition
DESCRIPTION OF SAMPLE TAKEN OR PRESUMPTION	Cement sheet Roof	SURFACE TREATMENT	1 - Surface Sealed
EXTENT	40 Sq. m	ASBESTOS TYPE	1 - Chrysotile
ACCESSIBILITY	Low	MATERIAL ASSESSMENT SCORE	3
LEVEL OF IDENTIFICATION	Sampled	POTENTIAL TO RELEASE FIBRES	Very Low Risk
RECOMMENDATIONS C - Removal by Trained Operatives		COMMENTS -

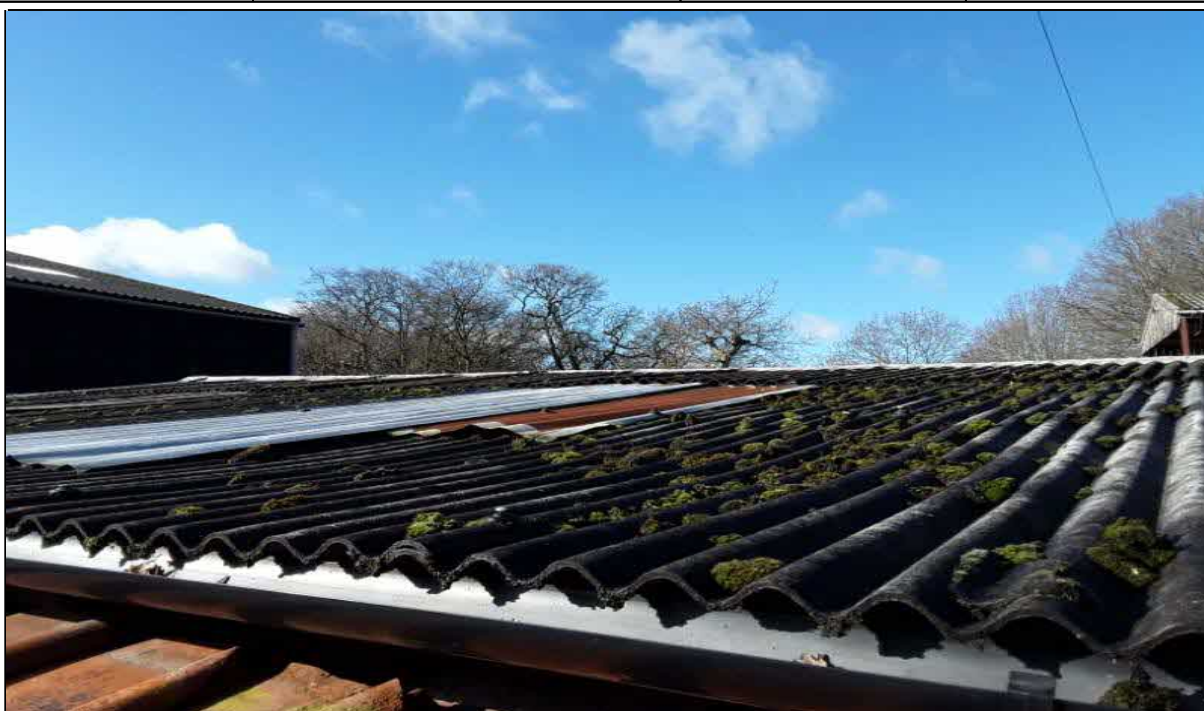
SAMPLE REFERENCE	Item No: 12	ASBESTOS	YES
PRESUMPTION REFERENCE	As Per CH000722	RISK LEVEL	VERY LOW RISK

AREA	External	MATERIAL ASSESSMENT	
FLOOR	External	PRODUCT TYPE	1 - Cement sheet
UNIQUE ROOM IDENTIFIER	Stables 2	DAMAGE	0 - Good Condition
DESCRIPTION OF SAMPLE TAKEN OR PRESUMPTION	Cement sheet Roof	SURFACE TREATMENT	1 - Surface Sealed
EXTENT	40 Sq. m	ASBESTOS TYPE	1 - Chrysotile
ACCESSIBILITY	Low	MATERIAL ASSESSMENT SCORE	3
LEVEL OF IDENTIFICATION	Strongly Presumed	POTENTIAL TO RELEASE FIBRES	Very Low Risk
RECOMMENDATIONS C - Removal by Trained Operatives		COMMENTS As per CH000722

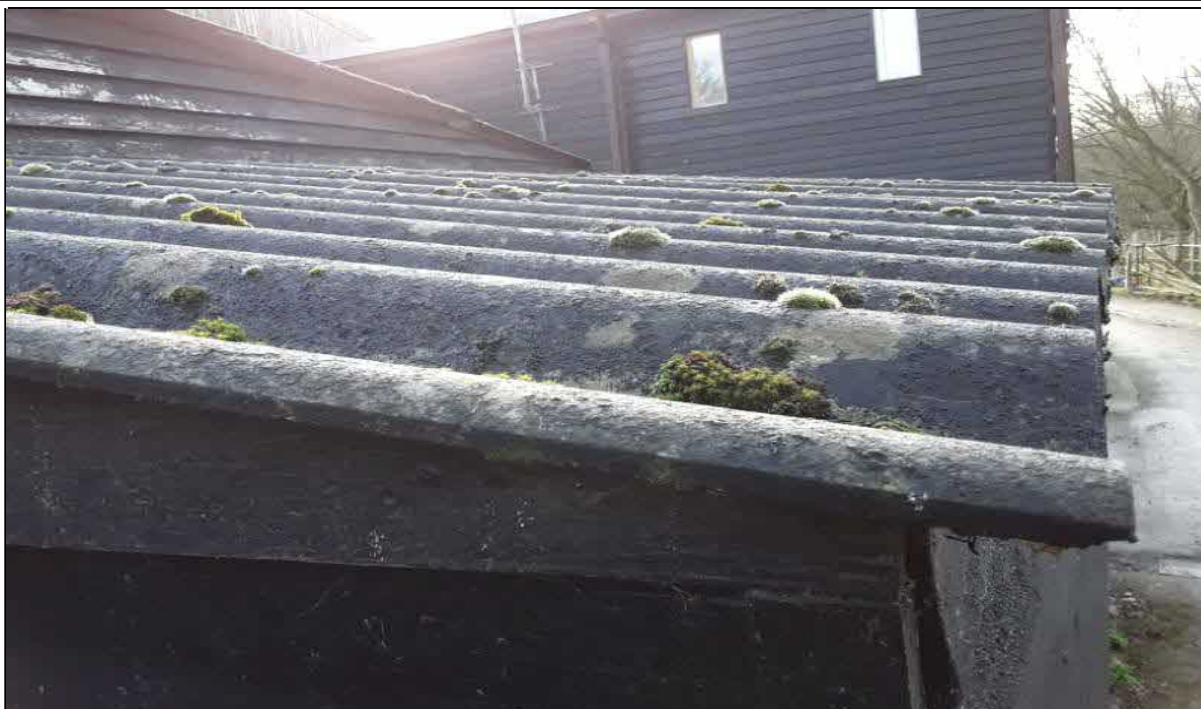
SAMPLE REFERENCE	Item No: 12	ASBESTOS	YES
PRESUMPTION REFERENCE	As Per CH000722	RISK LEVEL	VERY LOW RISK

AREA	External	MATERIAL ASSESSMENT	
FLOOR	External	PRODUCT TYPE	1 - Cement sheet
UNIQUE ROOM IDENTIFIER	Stables 3	DAMAGE	0 - Good Condition
DESCRIPTION OF SAMPLE TAKEN OR PRESUMPTION	Cement sheet Roof	SURFACE TREATMENT	1 - Surface Sealed
EXTENT	28 Sq. m	ASBESTOS TYPE	1 - Chrysotile
ACCESSIBILITY	Low	MATERIAL ASSESSMENT SCORE	3
LEVEL OF IDENTIFICATION	Strongly Presumed	POTENTIAL TO RELEASE FIBRES	Very Low Risk
RECOMMENDATIONS C - Removal by Trained Operatives		COMMENTS As per CH000722

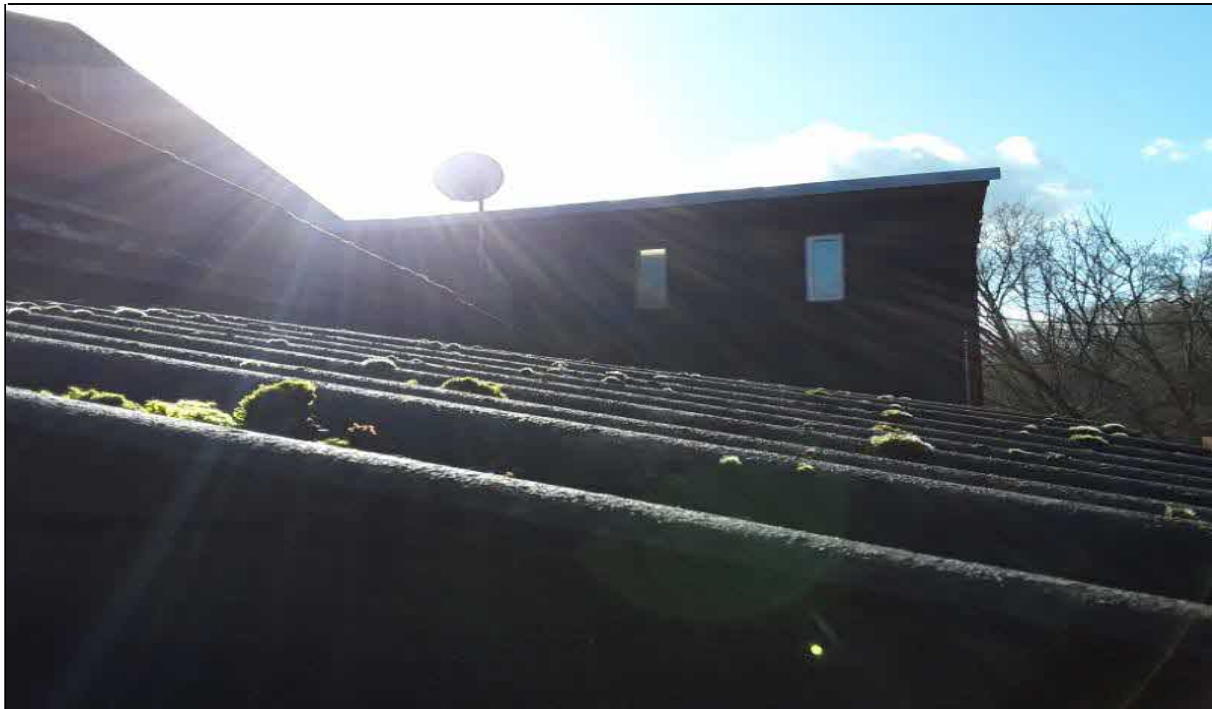
AREA	External	MATERIAL ASSESSMENT	
FLOOR	External	PRODUCT TYPE	1 - Cement sheet
UNIQUE ROOM IDENTIFIER	Barn 5	DAMAGE	0 - Good Condition
DESCRIPTION OF SAMPLE TAKEN OR PRESUMPTION	Cement sheets Roof	SURFACE TREATMENT	1 - Surface Sealed
EXTENT	40 Sq. m	ASBESTOS TYPE	1 - Chrysotile
ACCESSIBILITY	Low	MATERIAL ASSESSMENT SCORE	3
LEVEL OF IDENTIFICATION	Sampled	POTENTIAL TO RELEASE FIBRES	Very Low Risk
RECOMMENDATIONS C - Removal by Trained Operatives	COMMENTS -

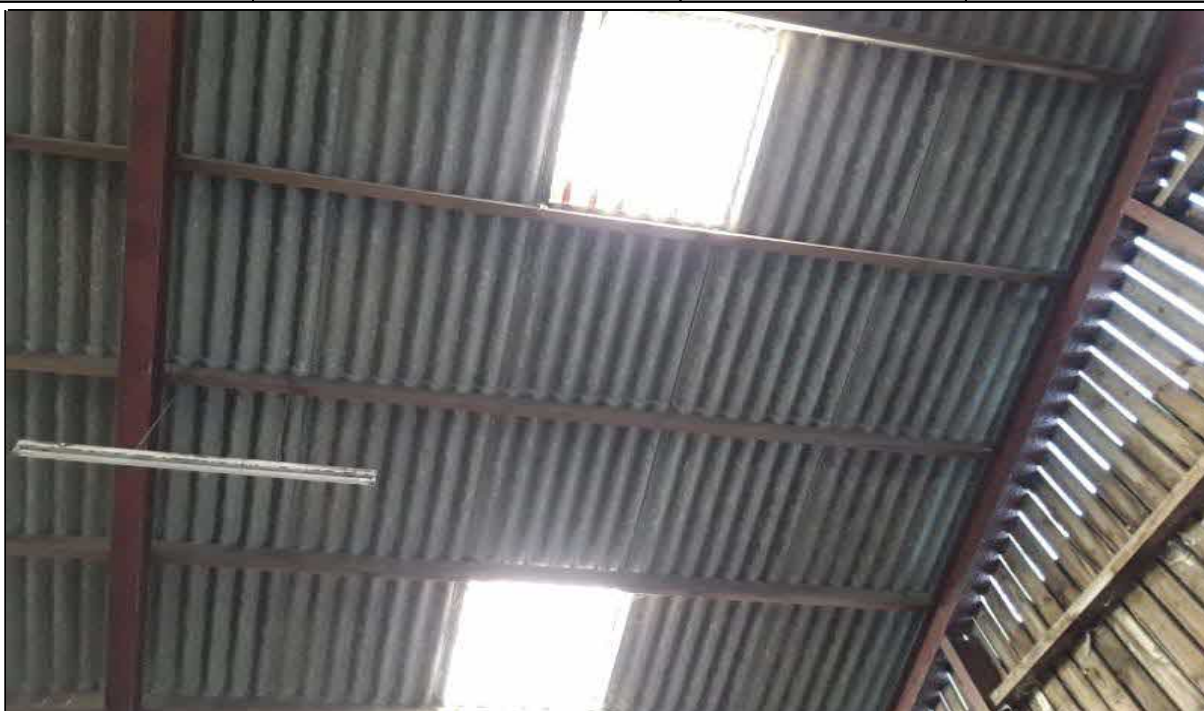
AREA	External	MATERIAL ASSESSMENT	
FLOOR	External	PRODUCT TYPE	1 - Cement sheet
UNIQUE ROOM IDENTIFIER	Barn 6	DAMAGE	0 - Good Condition
DESCRIPTION OF SAMPLE TAKEN OR PRESUMPTION	Cement sheet Roof	SURFACE TREATMENT	1 - Surface Sealed
EXTENT	300 Sq. m	ASBESTOS TYPE	1 - Chrysotile
ACCESSIBILITY	Low	MATERIAL ASSESSMENT SCORE	3
LEVEL OF IDENTIFICATION	Sampled	POTENTIAL TO RELEASE FIBRES	Very Low Risk
RECOMMENDATIONS C - Removal by Trained Operatives	COMMENTS -

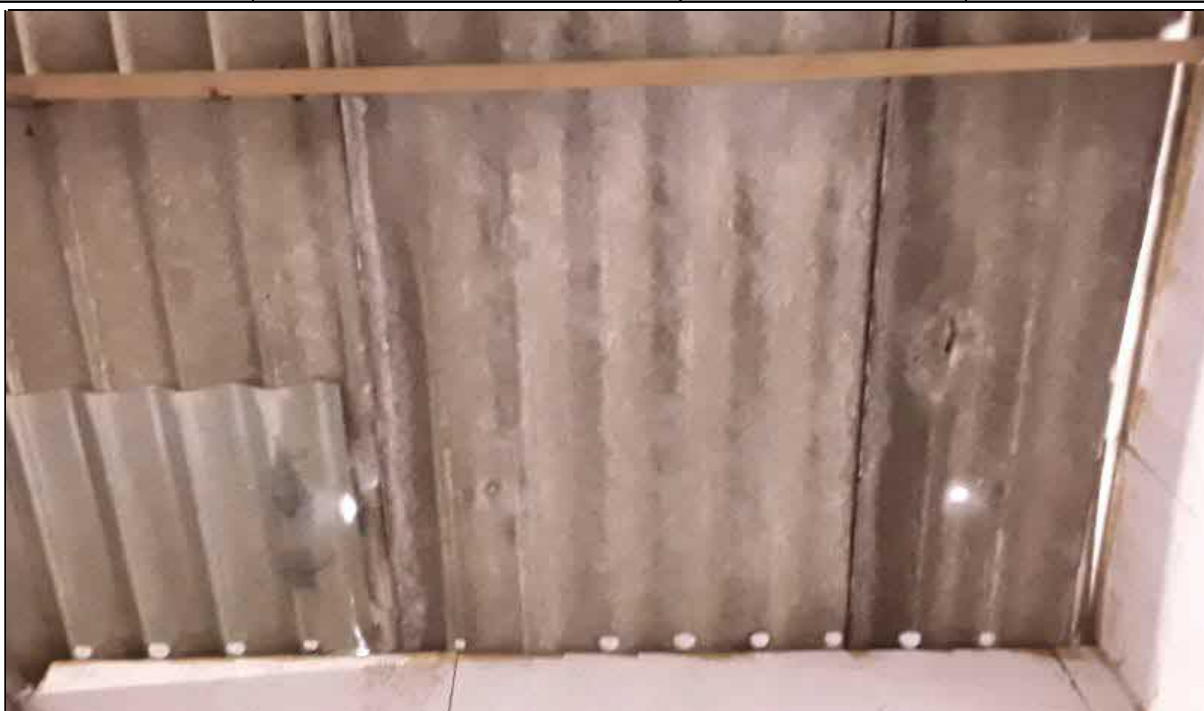
AREA	External	MATERIAL ASSESSMENT	
FLOOR	External	PRODUCT TYPE	1 - Cement sheet
UNIQUE ROOM IDENTIFIER	Barn 8	DAMAGE	0 - Good Condition
DESCRIPTION OF SAMPLE TAKEN OR PRESUMPTION	Cement sheet Roof	SURFACE TREATMENT	1 - Surface Sealed
EXTENT	100 Sq. m	ASBESTOS TYPE	1 - Chrysotile
ACCESSIBILITY	Low	MATERIAL ASSESSMENT SCORE	3
LEVEL OF IDENTIFICATION	Strongly Presumed	POTENTIAL TO RELEASE FIBRES	Very Low Risk
RECOMMENDATIONS C - Removal by Trained Operatives		COMMENTS As per CH000726

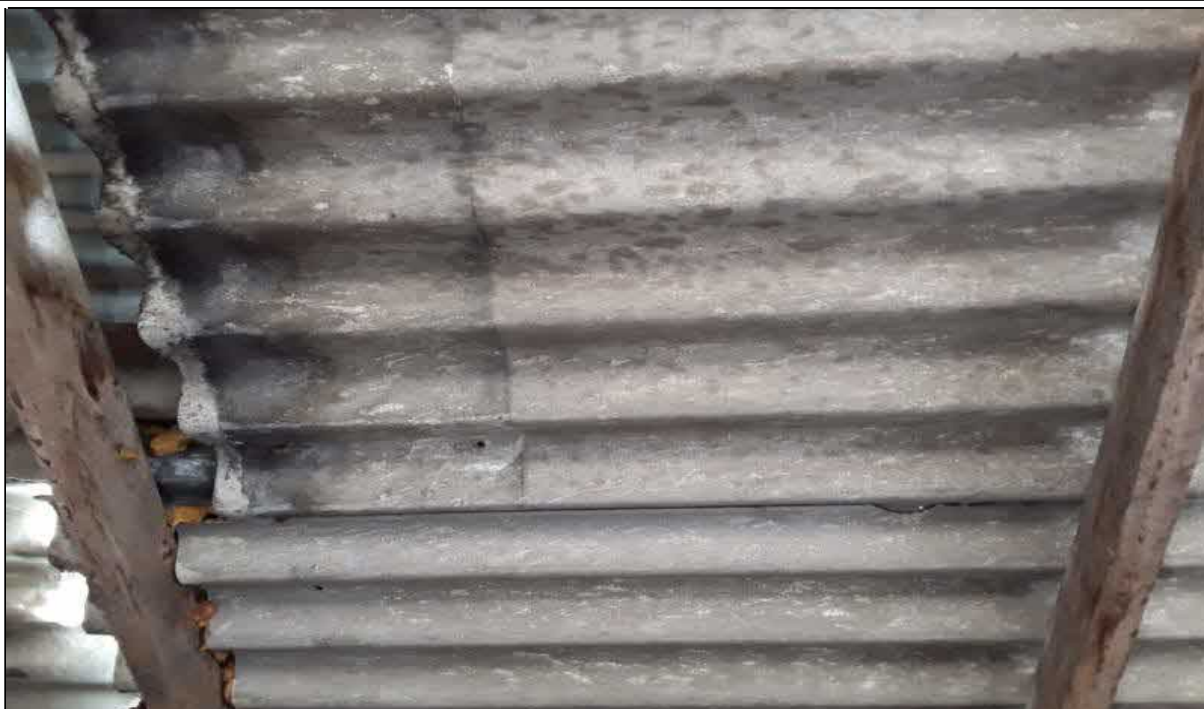
AREA	External	MATERIAL ASSESSMENT	
FLOOR	External	PRODUCT TYPE	1 - Cement sheet
UNIQUE ROOM IDENTIFIER	Barn 9	DAMAGE	0 - Good Condition
DESCRIPTION OF SAMPLE TAKEN OR PRESUMPTION	Cement sheet Roof	SURFACE TREATMENT	1 - Surface Sealed
EXTENT	60 Sq. m	ASBESTOS TYPE	1 - Chrysotile
ACCESSIBILITY	Low	MATERIAL ASSESSMENT SCORE	3
LEVEL OF IDENTIFICATION	Strongly Presumed	POTENTIAL TO RELEASE FIBRES	Very Low Risk
RECOMMENDATIONS C - Removal by Trained Operatives		COMMENTS As per CH000726

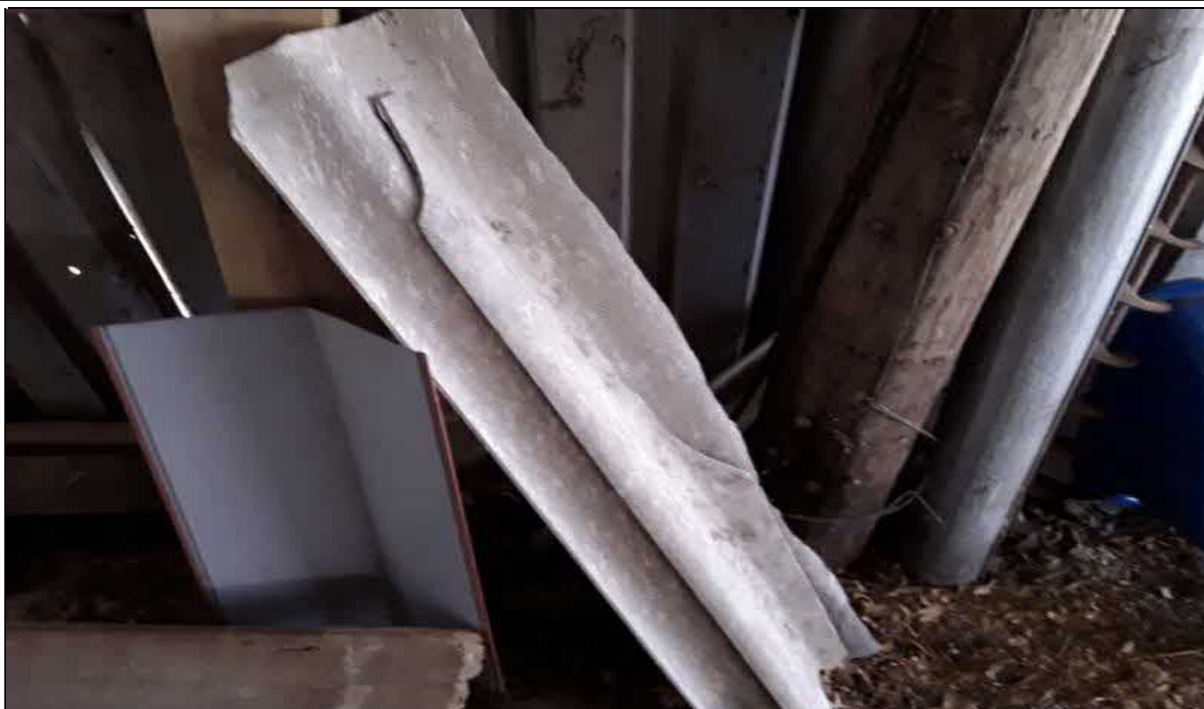
AREA	Internal	MATERIAL ASSESSMENT	
FLOOR	Ground Floor	PRODUCT TYPE	1 - Cement sheet
UNIQUE ROOM IDENTIFIER	Barn 10	DAMAGE	3 - High Damage
DESCRIPTION OF SAMPLE TAKEN OR PRESUMPTION	Cement sheet debri Floor	SURFACE TREATMENT	1 - Surface Sealed
EXTENT	Numerous	ASBESTOS TYPE	1 - Chrysotile
ACCESSIBILITY	High	MATERIAL ASSESSMENT SCORE	6
LEVEL OF IDENTIFICATION	Sampled	POTENTIAL TO RELEASE FIBRES	Low Risk
RECOMMENDATIONS C - Removal by Trained Operatives	COMMENTS -

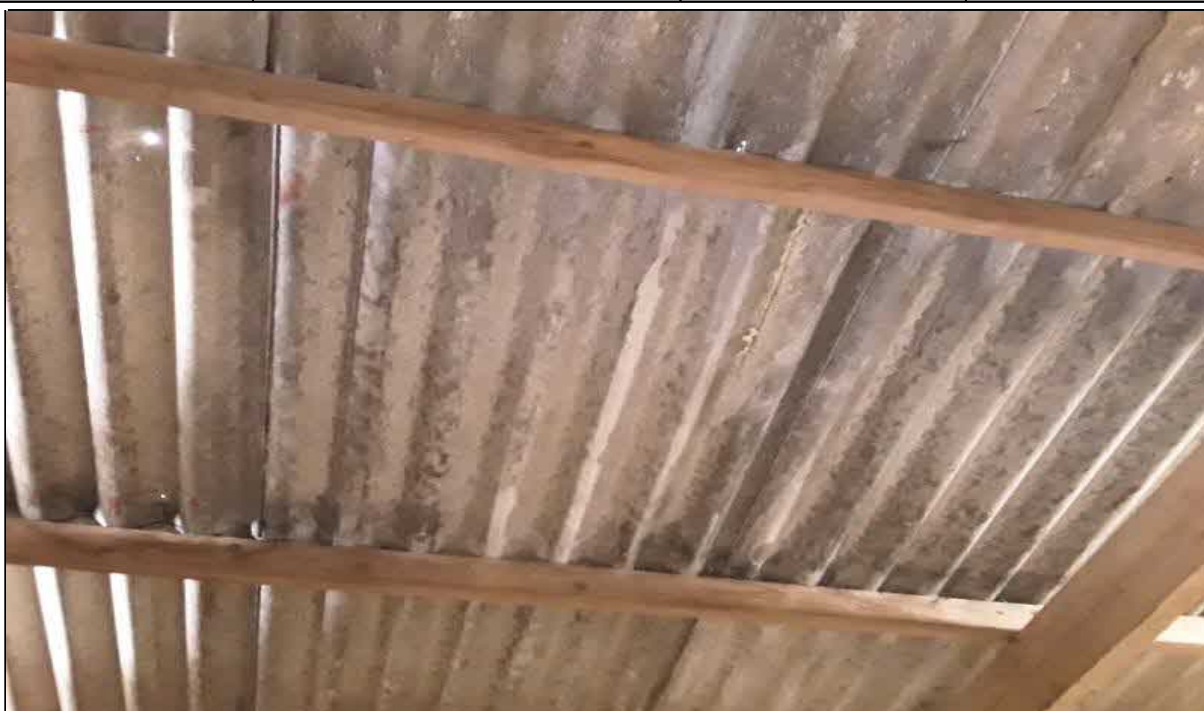
AREA	External	MATERIAL ASSESSMENT	
FLOOR	External	PRODUCT TYPE	1 - Cement sheet
UNIQUE ROOM IDENTIFIER	Barn 10	DAMAGE	0 - Good Condition
DESCRIPTION OF SAMPLE TAKEN OR PRESUMPTION	Cement Sheet	SURFACE TREATMENT	1 - Surface Sealed
EXTENT	120 Sq. m	ASBESTOS TYPE	1 - Chrysotile
ACCESSIBILITY	Low	MATERIAL ASSESSMENT SCORE	3
LEVEL OF IDENTIFICATION	Strongly Presumed	POTENTIAL TO RELEASE FIBRES	Very Low Risk
RECOMMENDATIONS C - Removal by Trained Operatives		COMMENTS As per CH000726

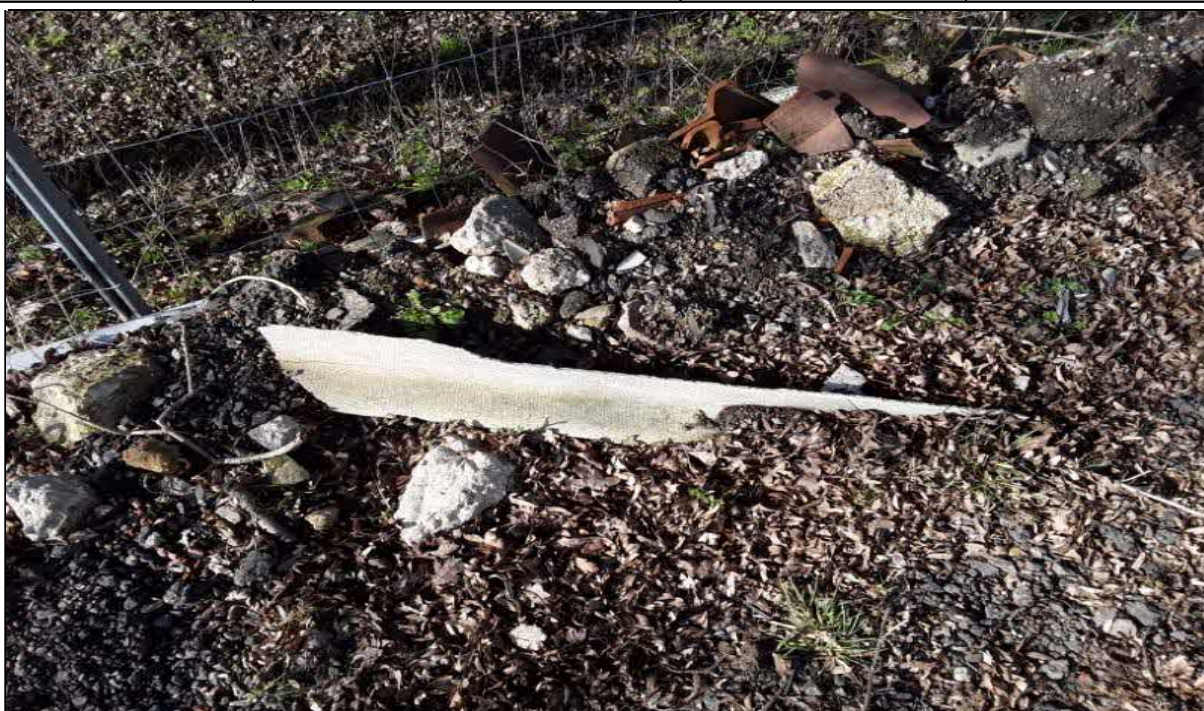
AREA	External	MATERIAL ASSESSMENT	
FLOOR	External	PRODUCT TYPE	1 - Cement sheet
UNIQUE ROOM IDENTIFIER	Grounds	DAMAGE	3 - High Damage
DESCRIPTION OF SAMPLE TAKEN OR PRESUMPTION	Cement debris Floor	SURFACE TREATMENT	1 - Surface Sealed
EXTENT	Throughout	ASBESTOS TYPE	1 - Chrysotile
ACCESSIBILITY	High	MATERIAL ASSESSMENT SCORE	6
LEVEL OF IDENTIFICATION	Sampled	POTENTIAL TO RELEASE FIBRES	Low Risk
RECOMMENDATIONS C - Removal by Trained Operatives	COMMENTS -
