# ARBORICULTURAL IMPLICATIONS ASSESSMENT FOR PROPOSED CHILLER PLANT

13-15 SHERRINGTON WAY LISTER ROAD BASINGSTOKE RG22 4DQ

Our ref: J65.29 9th February 2024

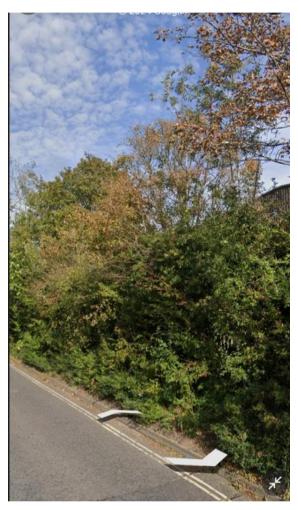
Extract from Google Street View: View of site from Lister Road looking north-east.

Note hedgeline and emergent Ash/Sycamore dominate

with Field Maple behind barely visible.
