BS5837:2012 Tree Survey

Land at Crieff Road, Perth

January 2022

Survey Reference: BS_080122

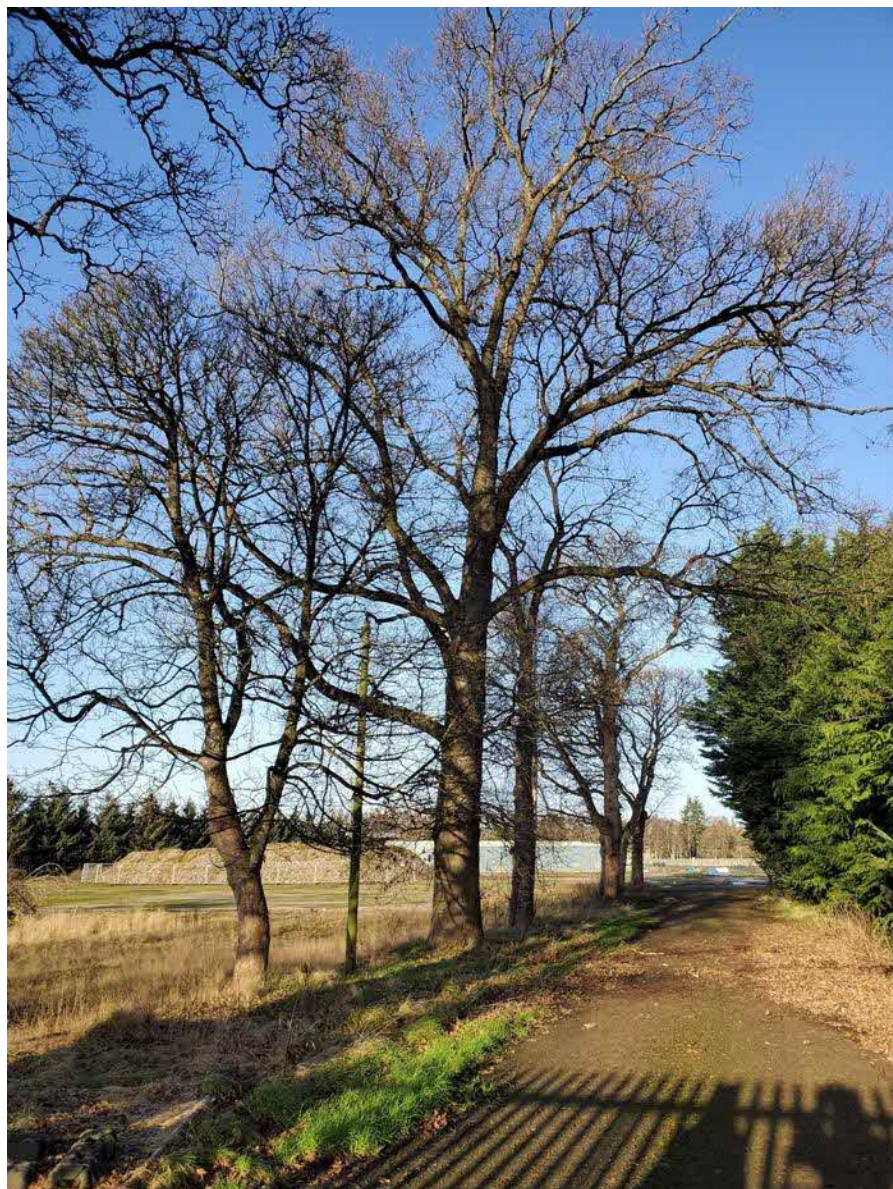
BS_080122 Land at Crieff Road, Perth Image No 01

6.2.1 Mature broadleaves of varying stature and condition, including a number of fine tall finely-structured trees, as well as a few less well-formed examples and one moribund specimen. There is also an evident history of coarse tree surgery. See Images No 01 & 02 at Appendix 1, below.

Specimen trees to W of entrance avenue, featuring dominant Oak No 5229

5227	NO 09175.69 24917.17	Sycamore, Acer pseudoplatanus	Mature	20	640	—	N:5 E:5 S:4 W:7	4, S	2.5	Radius: 7.7m. Area: 186 m ² .	Good	Fair to Good	Good upright mature avenue specimen Crown development slightly suppressed from S 2 co-dominant stems from 10.0m via tension union Multiple pruning wounds from historic tree surgery to raise clear canopy height with minor decay cavities	—	—	40+ Years	A2	—
5228	NO 09170.88 24927.36	Sycamore, Acer pseudoplatanus	Mature	13	430	—	N:4 E:6 S:5 W:8	3, E	2	Radius: 5.2m. Area: 85 m ² .	Good	Fair	Subdominant specimen Crown development substantially suppressed from N 2 co-dominant stems from 2.2m via compression union Minor deadwoods	—	—	40+ Years	B2	Image No 01
5229	NO 09169.56 24934.01	Pedunculate Oak, Quercus robur	Mature	27	1040	—	N:6 E:10 S:7 W:12	2.5, W	1	Radius: 12.5m. Area: 491 m ² .	Good	Good	Fine dominant avenue specimen 2 co-dominant stems from 11.0m via compression union Substantial decaying branch stub at 6.0m SE Multiple snags and deadwoods Multiple deadwoods on limb arising at 6.0m E extending over access road	Prune out deadwoods on limb arising at 6.0m E extending over access road, and for crown cleaning	In the event of site becoming occupied	40+ Years	A2	Image No 01

6.2.2 Within this group there is a current recommendation for the removal of one tree (Sycamore No 5230) and the removal of deadwoods from two others (Oak No 5229 & Sycamore No 5232).

The deadwoods, which oversail the entrance driveway, are detailed in the Survey Schedule, but we recommend that these trees are also crown-cleaned to remove further deadwoods within this programme of works.

7.1.2 However deadwoods should be removed from Trees No 5529 & 5532 in the event of the site becoming occupied.

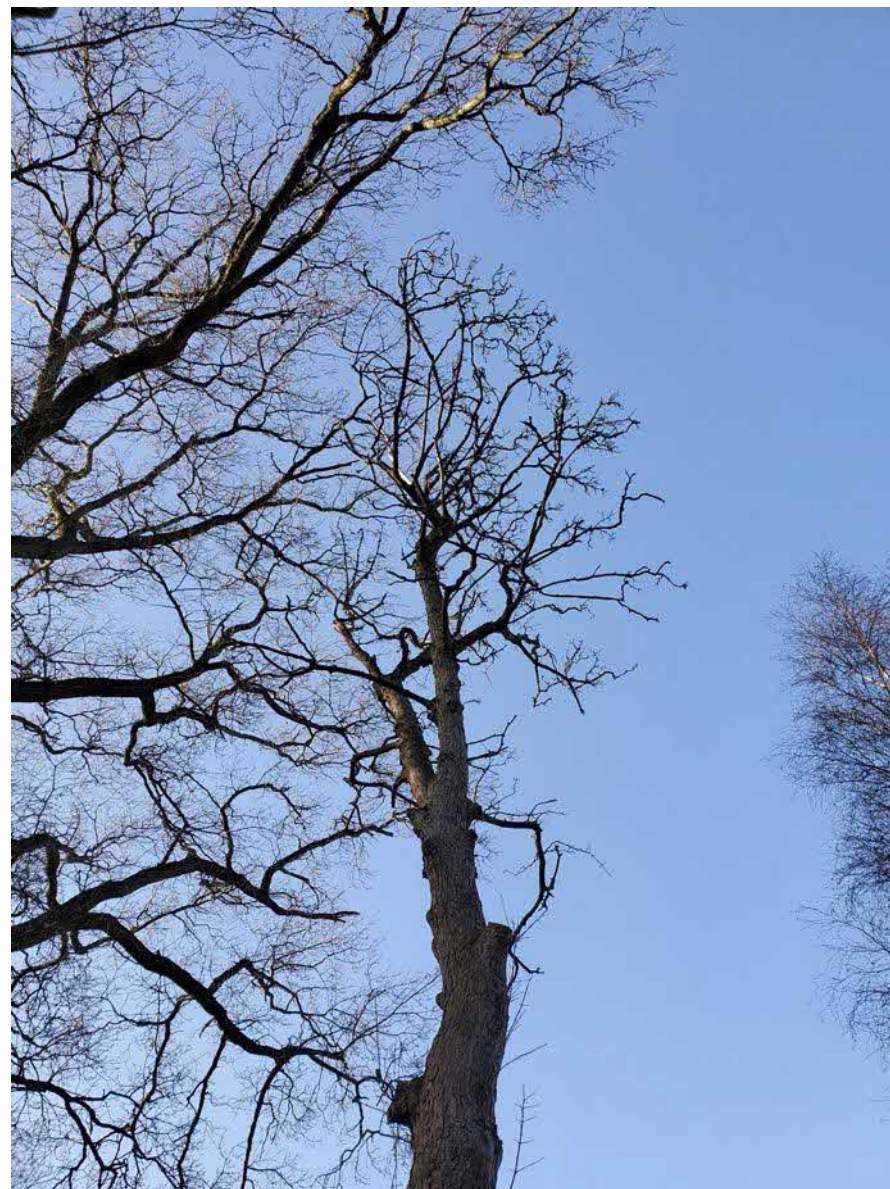
BS_080122 Land at Crieff Road, Perth Image No 02

6.2.3 BS5837 Retention Category classification of trees in this group varies from Category A for the healthier, more dominant specimens to Category U for the moribund tree.

Moribund Sycamore No 5230 to W of entrance Avenue

5230	NO 09167.27 24939.99	Sycamore, Acer pseudoplatanus	Mature	19	530	—	N:4 E:5 S:3 W:5	8, S	8	N/A: Retention Category U	Poor	Poor	Moribund specimen, 90% dead	Remove to ground level	—	0 Years	U	Image No 02
5231	NO 09164.45 24944.42	Silver Birch, Betula pendula	Early Mature	13	230	—	N:2.5 E:2.5 S:2.5 W:2.5	2.7, SW	2.5	Radius: 2.8m. Area: 25 m ² .	Good	Fair to Good	Finely structured young tree emerging from decaying stump 2 co-dominant stems from 5.0m via compression union	—	—	20+ Years	B2	—
5232	NO 09160.93 24955.87	Sycamore, Acer pseudoplatanus	Mature	23	880	—	N:5 E:8 S:6 W:8	5, W	4.5	Radius: 10.6m. Area: 353 m ² .	Good	Fair	Reasonably well structured avenue specimen with history of coarse pruning 2 co-dominant stems from 3.0m via tension union Multiple pruning wounds from historic tree surgery to raise clear canopy height with some decaying stumps Substantial deadwoods at 12.0m E over internal road	Prune out deadwoods at 12.0m E over internal road, and for crown cleaning	In the event of site becoming occupied	20+ Years	A2	—

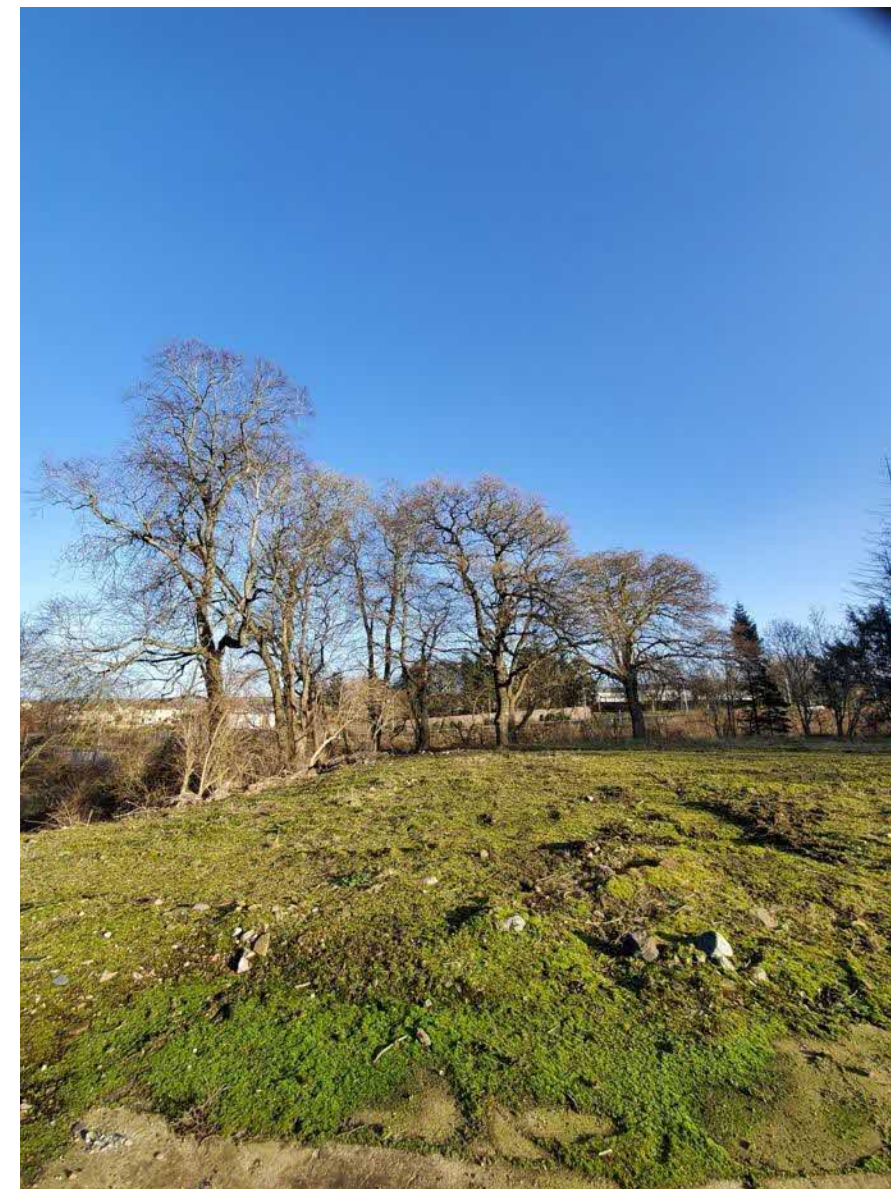
BS_080122 Land at Crieff Road, Perth Image No 03

6.3.1 Comprising a small copse of mature broadleaves, the condition of these trees is diverse, including some fine dominant mature trees as well as others with a range of structural defects, and one windthrown Beech. See Images No 03 & 04 at Appendix 1, below.

6.3.2 A number of Ash sps within this group are symptomatic of Chalara Ash Dieback, but the disease cannot be confirmed in all specimens, which were dormant at the time of inspection. See s4.2, above in this connection.

Mature broadleaf trees No 5244-5256 on NE-facing embankment

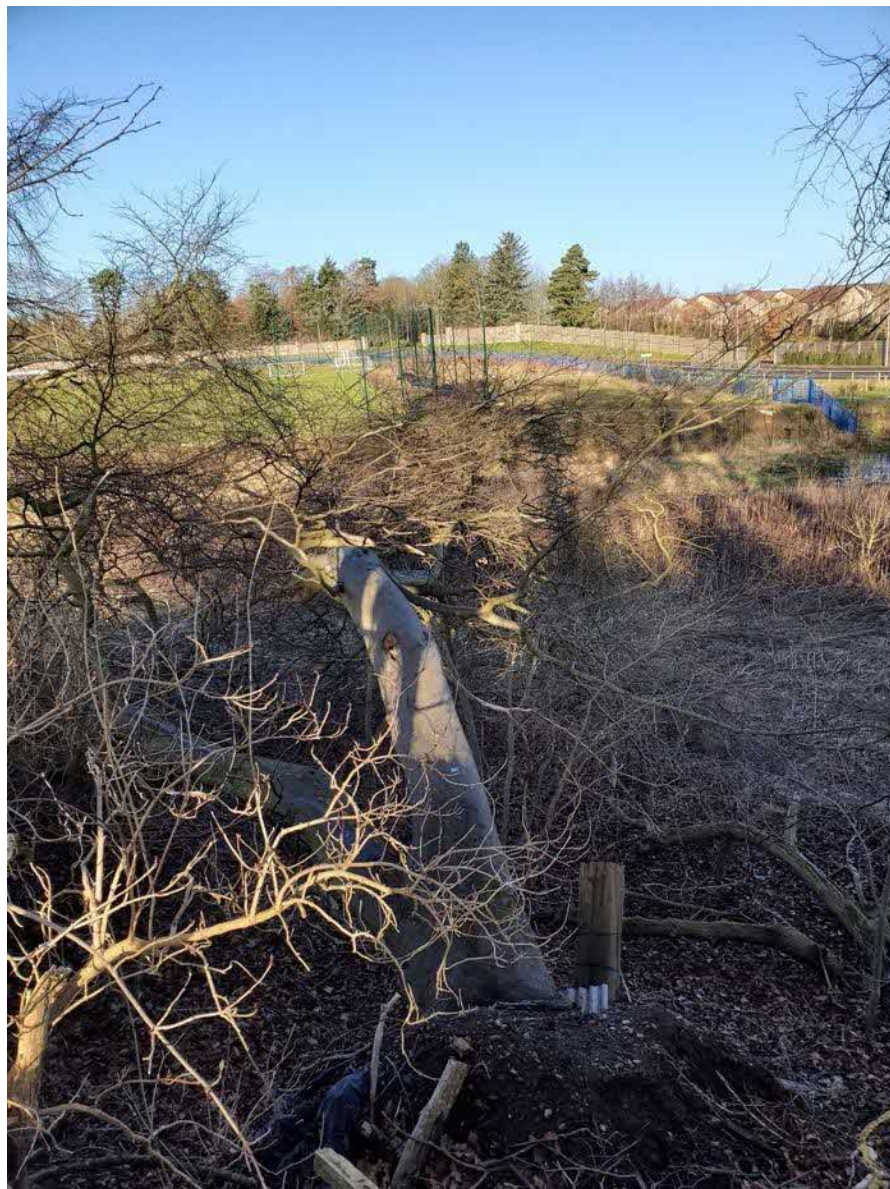
6.3.3 BS5837 Retention Category grading varies from Category A for the healthier, more dominant specimens to Category U for the windthrown tree.

BS_080122 Land at Crieff Road, Perth Image No 04
Windthrown Beech No 5253 on NE-facing embankment

5253	NO 09170.12 25051.58	Common Beech, Fagus sylvatica	Mature	20	—	510, 490	N:0 E:0 S:0 W:0	0, N	0	N/A: Retention Category U	Fair	Poor	Specimen windthrown from S and lying prostrate	—	—	0 Years	U	Image No 04
5254	NO 09172.93 25044.45	Common Lime, Tilia x vulgaris	Mature	13	370	—	N:5 E:4 S:3 W:3	3.5, S	3.5	Radius: 4.4m. Area: 61 m ² .	Fair	Fair	Suppressed subdominant specimen on N facing embankment	—	—	10+ Years	C2	—
5255	NO 09170.71 25045.31	European Ash, Fraxinus excelsior	Mature	22	690	—	N:7 E:9 S:5 W:5	4.5, NW	3.5	Radius: 8.3m. Area: 216 m ² .	Fair	Fair	Crown development suppressed from S Substantial deadwoods in mid crown Specimen not currently symptomatic of Chalara Ash Dieback	—	—	20+ Years	B2	—
5256	NO 09170.43 25043.80	European Ash, Fraxinus excelsior	Mature	20	650	—	N:8 E:2 S:3 W:7	7, SE	6	Radius: 7.8m. Area: 191 m ² .	Poor	Fair	Crown development substantially suppressed from S with stem bowed to N Minor deadwoods Areas of mechanical bark damage on lower bole Specimen symptomatic of Chalara Ash Dieback	—	—	<10 Years	C2	—

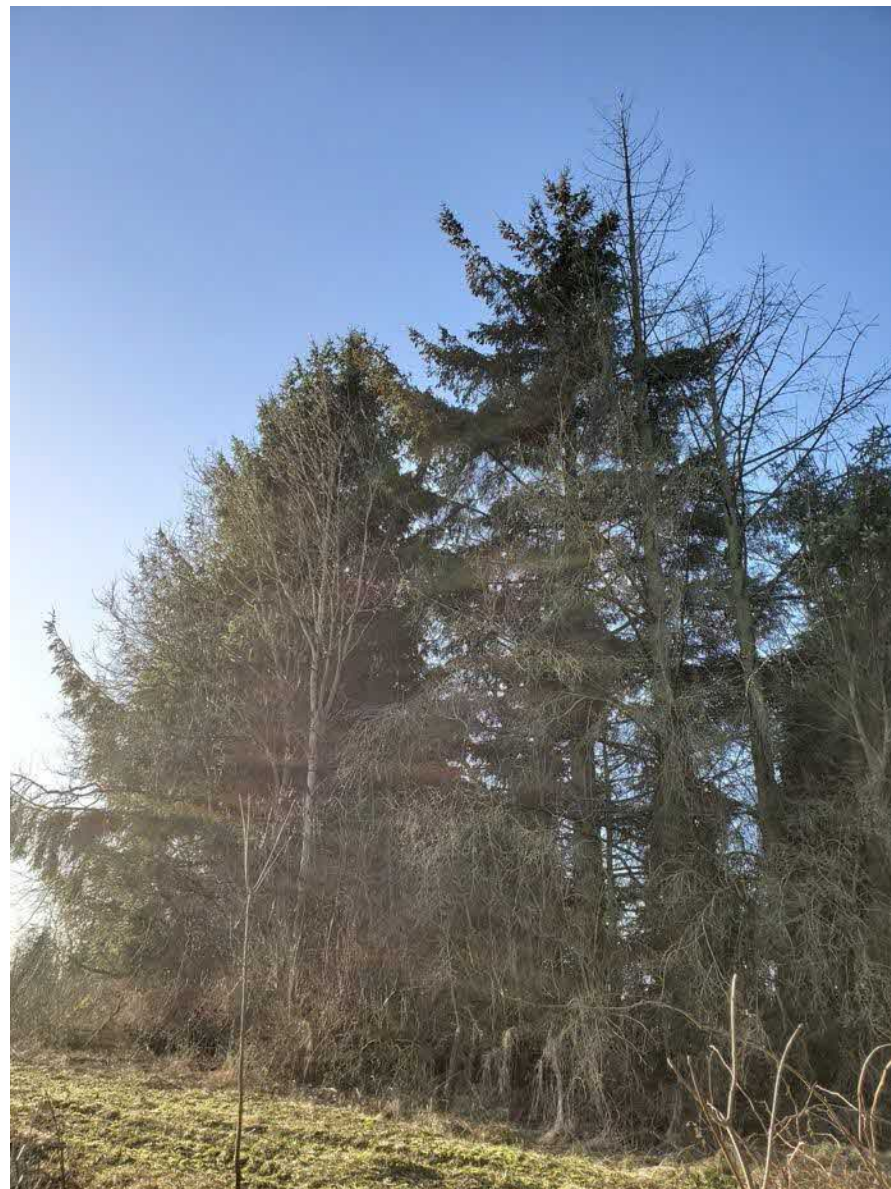
6.5.3 A curved linear group of Sitka Spruce on the SE edge of building remnants. Varying considerably in stature and condition, with tall, reasonably well-developed specimens towards the SW end, and a number of standing dead trees at the NE. See Image No 05 at Appendix 1, below.

6.5.4 The outer (SE) edge of this group features a sporadic undercanopy of young self-generated young broadleaves, mostly Ash, all of which are symptomatic of Chalara Ash Dieback. The Spruce are graded in the survey at Retention Category B. See s4.2, above in this connection.

BS_080122 Land at Crieff Road, Perth Image No 05
Linear group of Sitka Spruce G3, showing standing dead specimens at NE end
and young self-generated specimens on outer (SE) edge

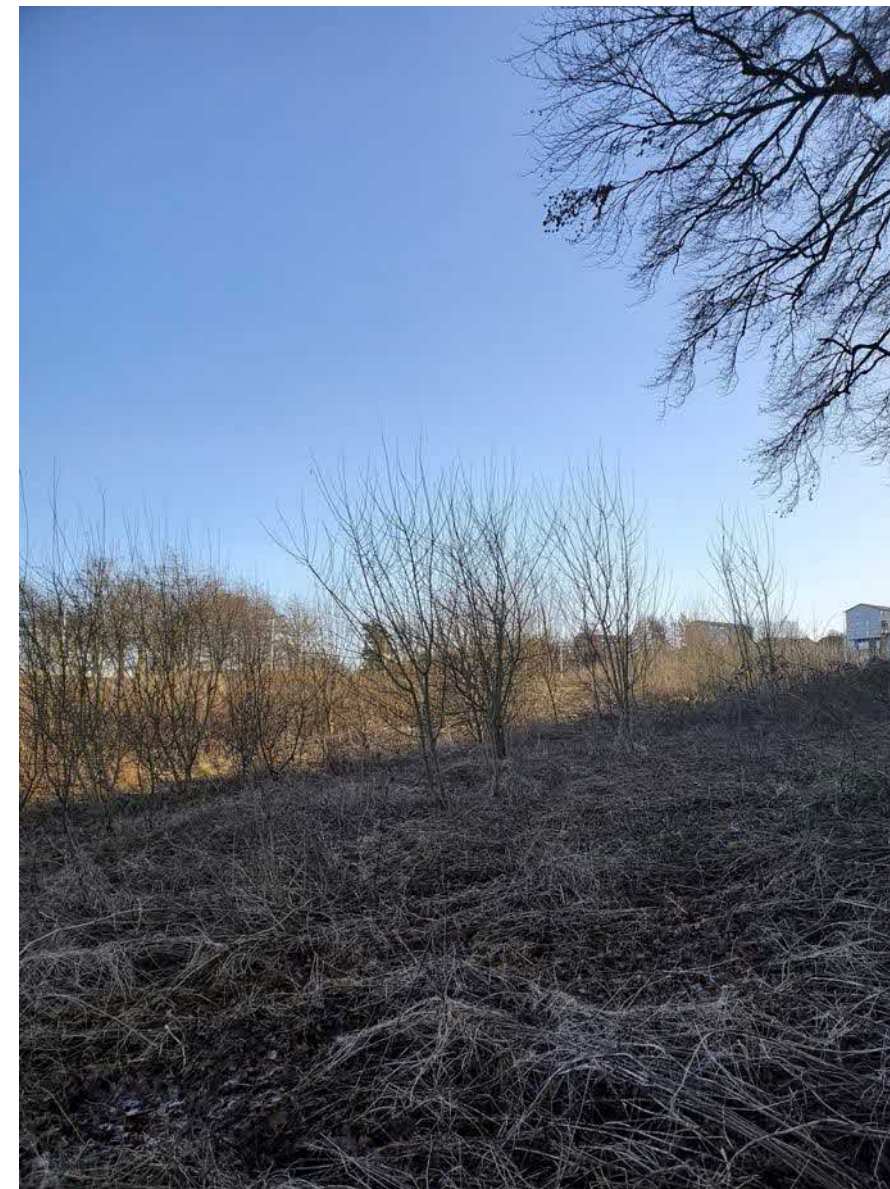
6.7.1 A substantial area in the eastern sector of the site is undeveloped and has become colonised by modest juvenile broadleaf trees, predominantly Goat Willow. See Image No 06 at Appendix 1, below. CA1 is graded in the survey at Retention Category B.

BS_080122 Land at Crieff Road, Perth Image No 06
Canopy area G1, featuring self-generated scrub and minor trees

Canopy Areas																		
CA1	NO 09227.41 24985.23	Goat Willow, Salix caprea European Ash, Fraxinus excelsior Sycamore, Acer pseudoplatanus	Juvenile	<6	<100	—	—	—	—	—	Fair to Good	Fair	Sporadic young colonising broadleaves on undeveloped land	—	—	10+ Years	C2	Image No 06
