## GROUND FLOOR

Project Title: THE OLD RECTORY, CHURCH ROAD, EVERSLEY			
Client: MR SUTHERLAND			
Description: GROUND FLOOR PLAN			
Date	SEPT 22	Scale	1/50 @ A1
Job No.	MS/2100	Surveyor	BL
Dwg No.	01	Drawn	BL

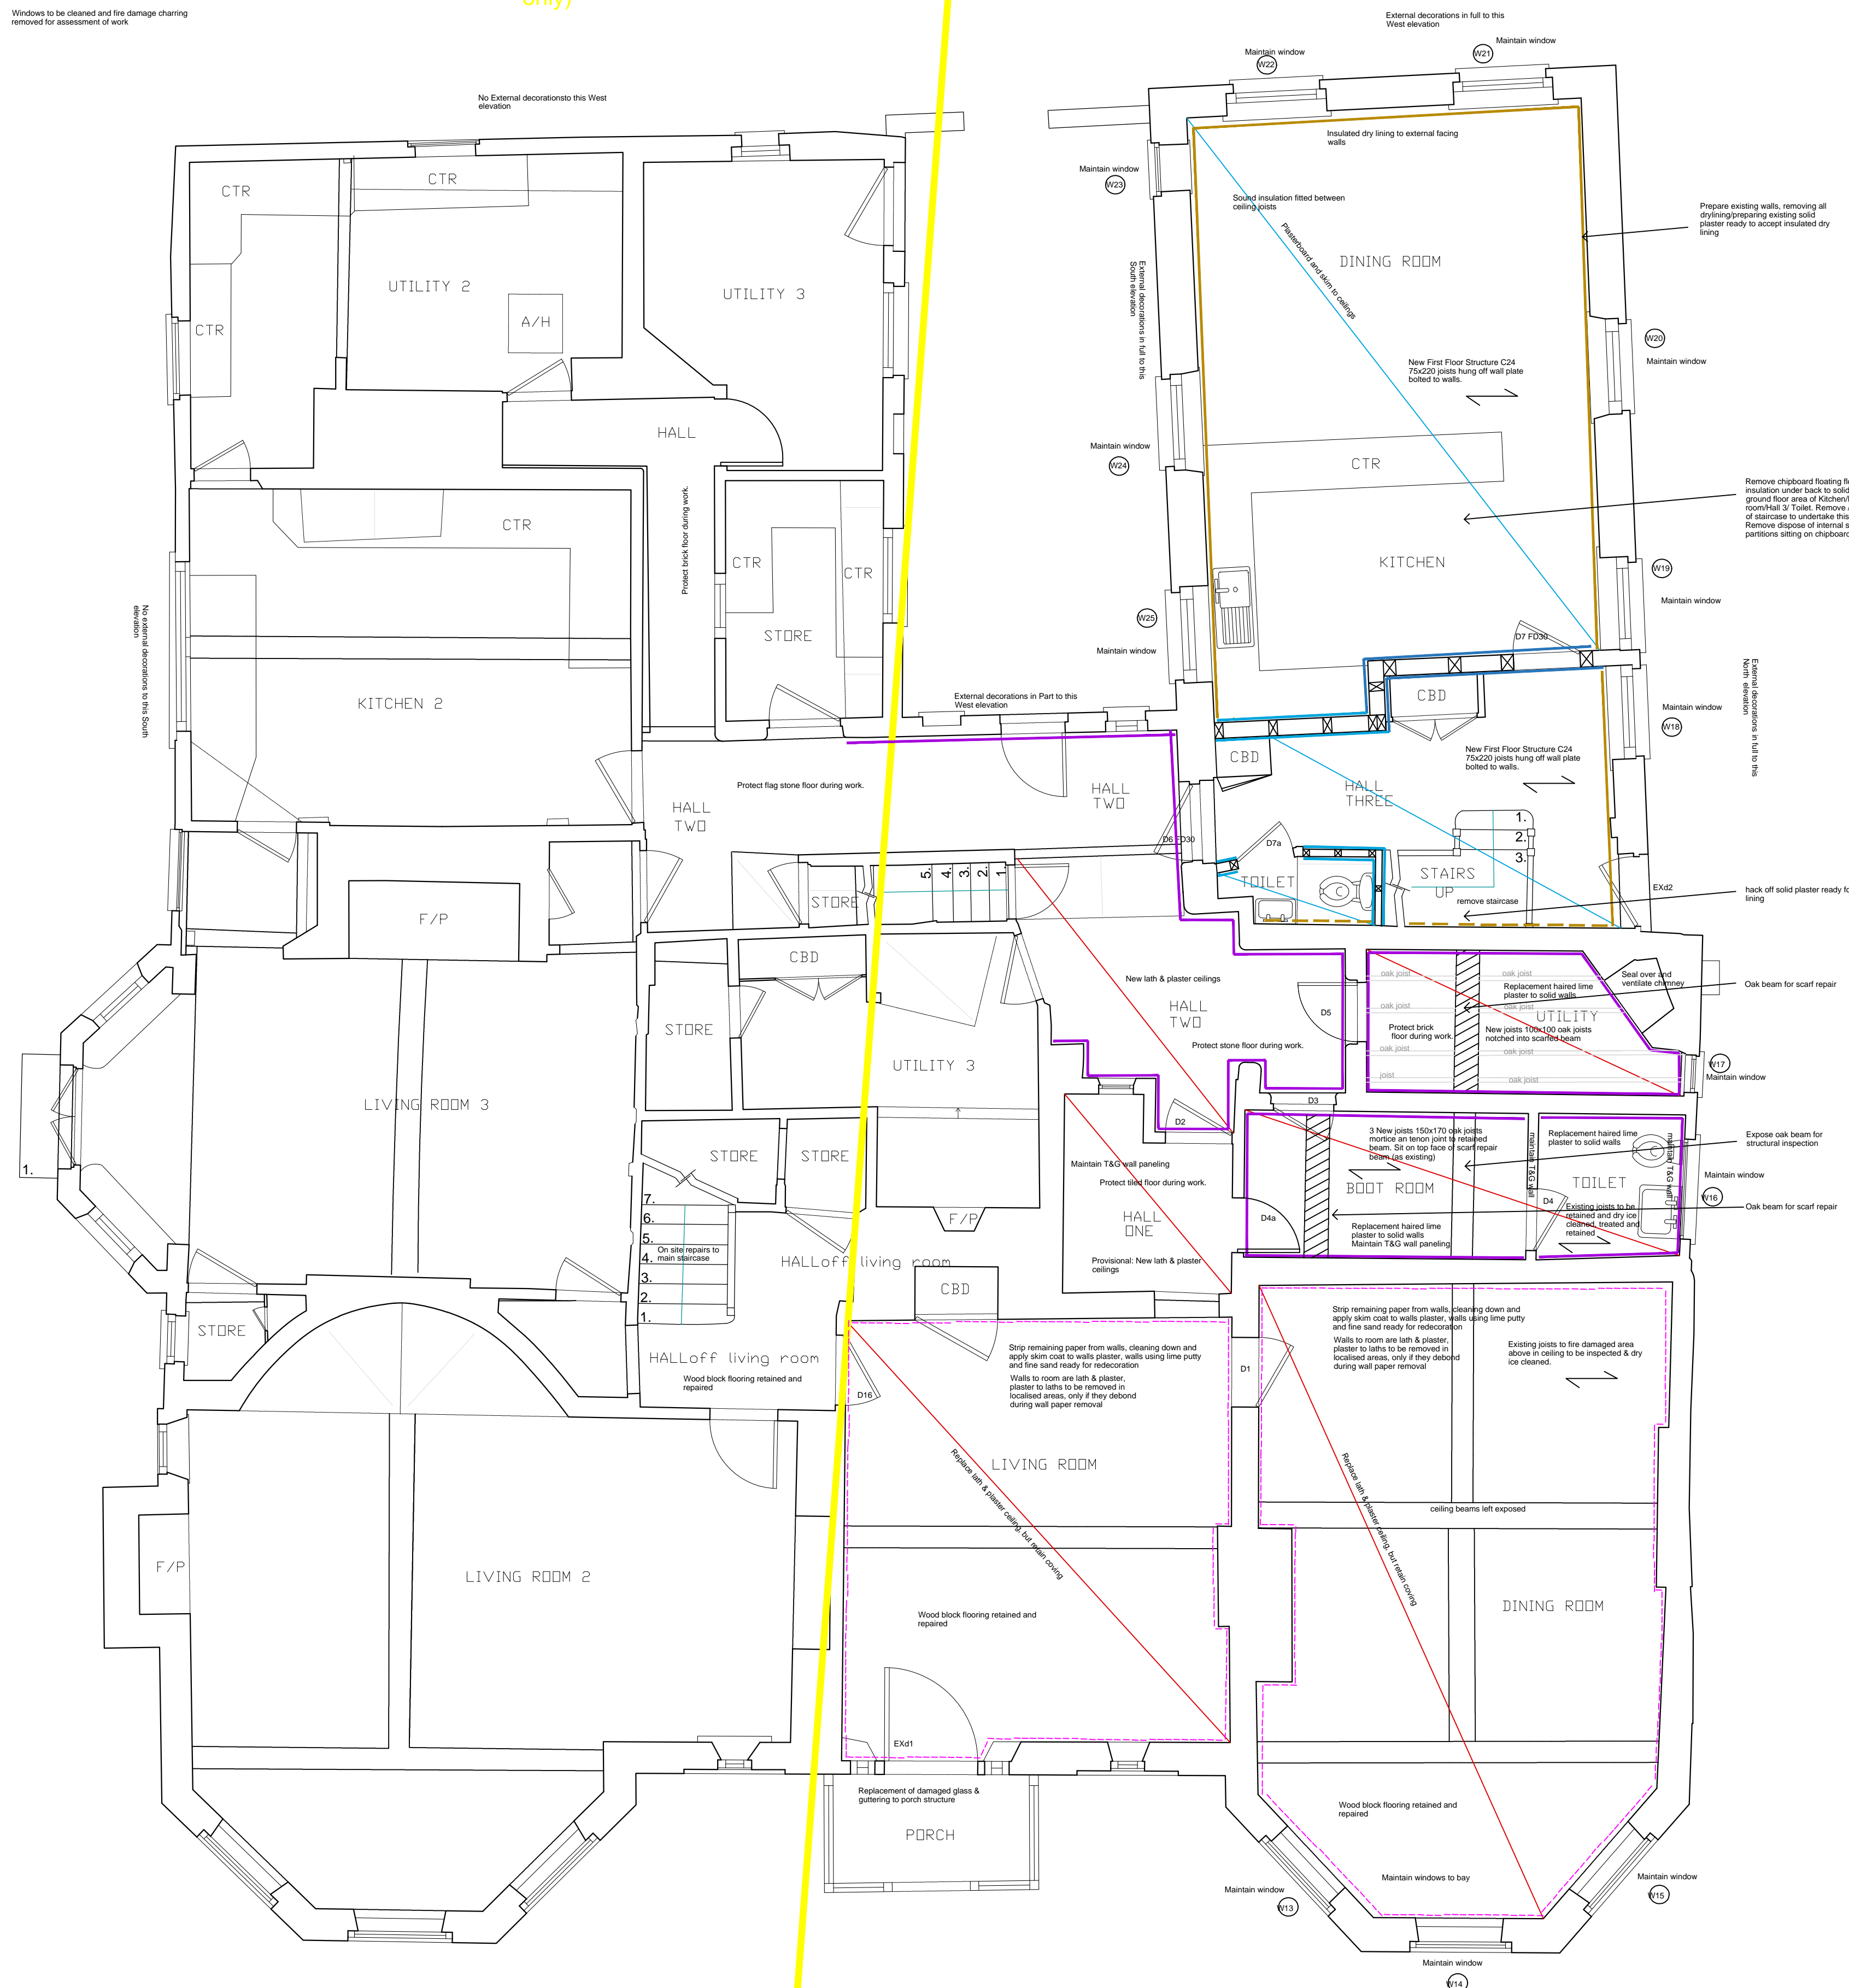
NON FIRE DAMAGED SECTION OF DWELLING (requiring decoration only)

FIRE DAMAGED SECTION OF DWELLING

- WORKS TO WALLS**
- Removal of localized area of fire damaged plaster, replace with on existing lath
  - Plasterboard reinstatement to walls
  - New even laths and haired lime plaster (3 coat work)

- Hacking off loose / fire damaged plaster, prepare solid wall surfaces and re-plate with 3 coat lime plaster - Render and float (NHL2) Finish coat Lime putty plaster

- Washing cleaning down, prepare and apply skim coat of high hydraulic lime putty to existing wall surfaces. To include removal of any wall paper prior to work. Provisional removal of loose lime to lath (treat lath)

- Dry Lining to internal wall surfaces
  - Insulated Dry Lining to external facing solid wall surfaces - insulated dry lining to external wall faces FL3000 (20mm thick board 0.54 U value)

- INSULATION**
- Insulation to sloping ceilings - Sheepwood (0.51 u value)
  - Insulation to loft spaces using sheepwood (0.16 u value)
- WORKS TO CEILINGS**

- Complete removal and reinstatement of lath & plaster ceiling. Re-render as 12.5mm plaster board with gypsum skim finish
  - Windows to be cleaned and fire damage charring removed for assessment of work
