Project Title:	THE OLD RECTORY, CHURCH ROAD, EVERSLEY		
Client:	MR SUTHERLAND		
Description:	FIRST FLOOR PLAN

Date	SEPT 22	Scale	1/50 @ A1
Job No.	MS/2100	Surveyor	BL
Drawn	02	Drawn	BL

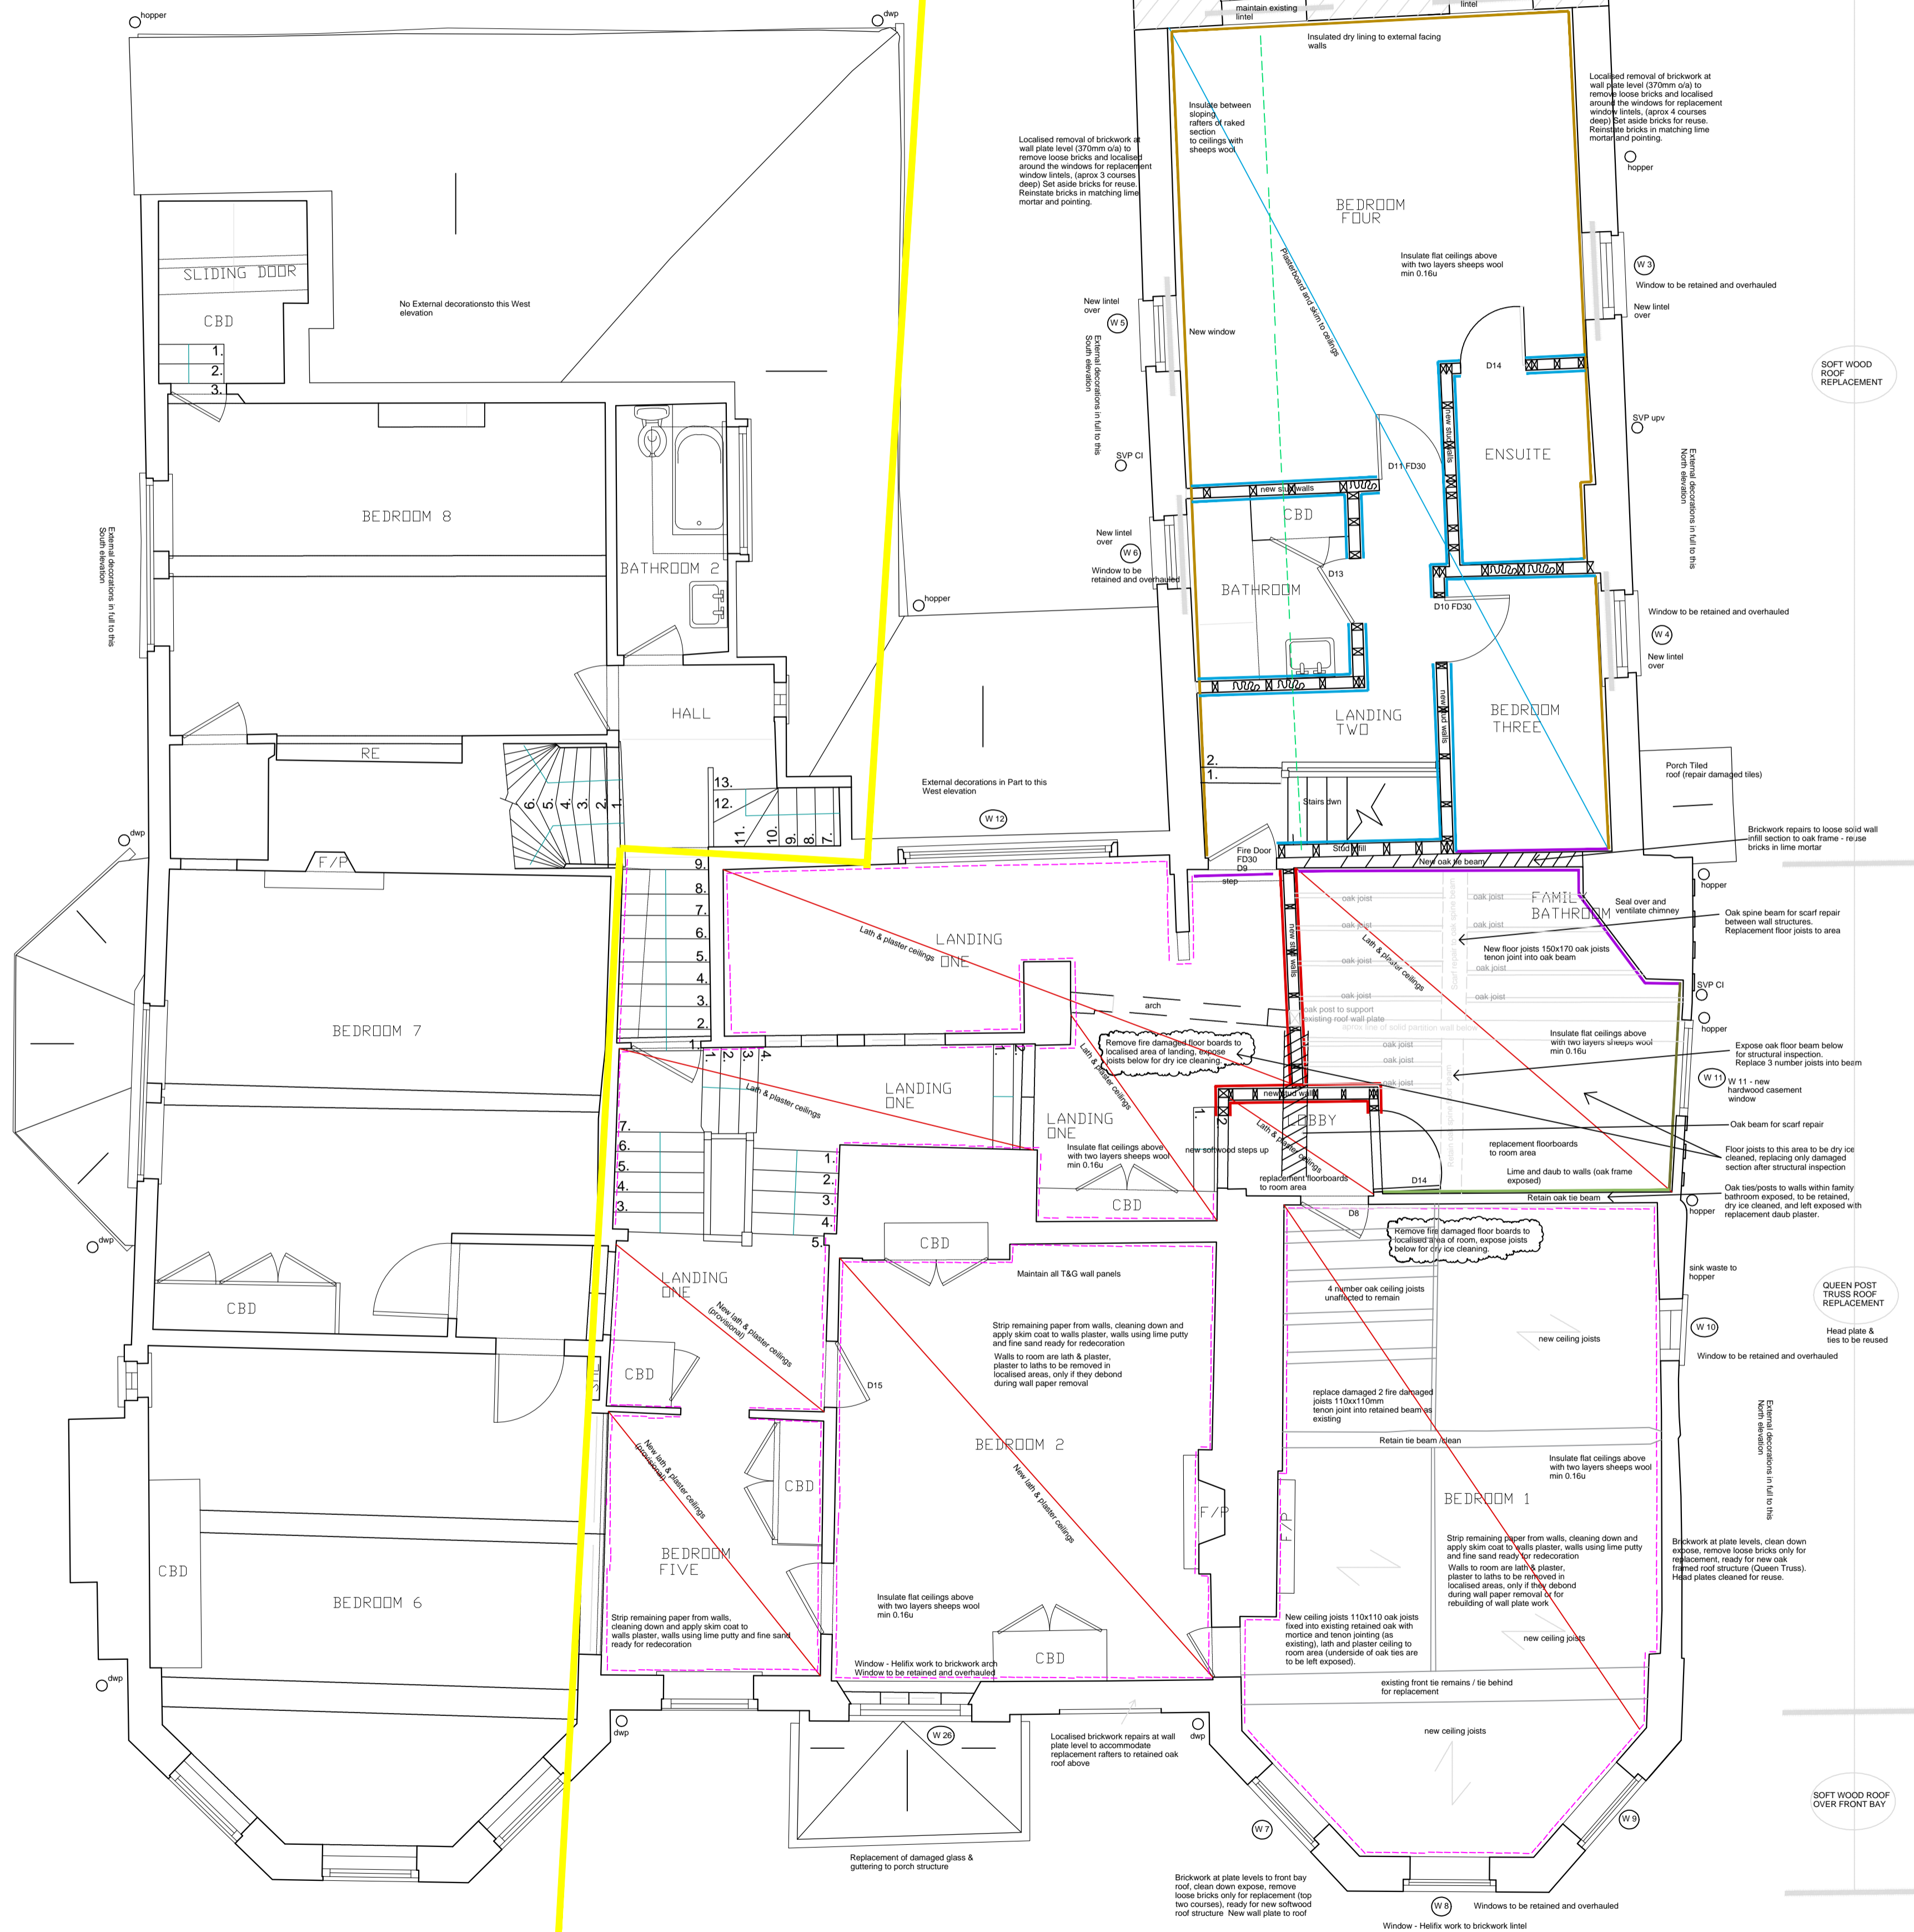
FIRST FLOOR

NON FIRE DAMAGED SECTION OF DWELLING (requiring decoration only)

FIRE DAMAGED SECTION OF DWELLING

- WORKS TO WALLS**
- Removal of localised area of fire damaged daub panel, replace daub on existing laths
 - Plasterboard reinstatement to walls
 - Treated softwood studwork to form mills and whole wall replacement. New timber studwork to match original as closely as possible, mill studs with softwood board insulation

- New riven laths and haired lime plaster (3 coat work)
 - Hacking off loose / fire damaged plaster, prepare solid wall surfaces and replaster walls with 3 coat lime plaster - Render and float (NHL2) Finish coat Lime putty plaster.

- Washing cleaning down, prepare and apply skim coat of non hydraulic lime putty to existing wall surfaces. To include for removal of any wall paper prior to work. Provisional - removal of loose lime to lath (renew lath)

- Dry Lining to internal wall surfaces
 - Insulated Dry Lining to external facing solid wall surfaces - Insulate dry lining to external wall face PL3000 (25mm thick board 0.54 U value)

- Insulation to sloping ceilings - Sheepswool (0.51 u value)
 - Insulation to loft spaces using sheepswool (0.16 u value)
- INSULATION**
- Complete removal and reinstatement of lath & plaster ceiling. New riven laths and haired lime plaster (3 coat work)

- Complete removal and reinstatement of plasterboard ceiling. Replaster as 12.5mm plaster board with gypsum skim finish
 - Windows to be cleaned and fire damage charring removed for assessment of work
